HISTORIC PROPERTIES REPORT  
HARRY DIAMOND LABORATORIES, MARYLAND  
AND SATELLITE INSTALLATIONS  
WOODBIDGE RESEARCH FACILITY, VIRGINIA  
AND  
BLOSSOM POINT FIELD TEST FACILITY, MARYLAND

FINAL REPORT

JULY 1984

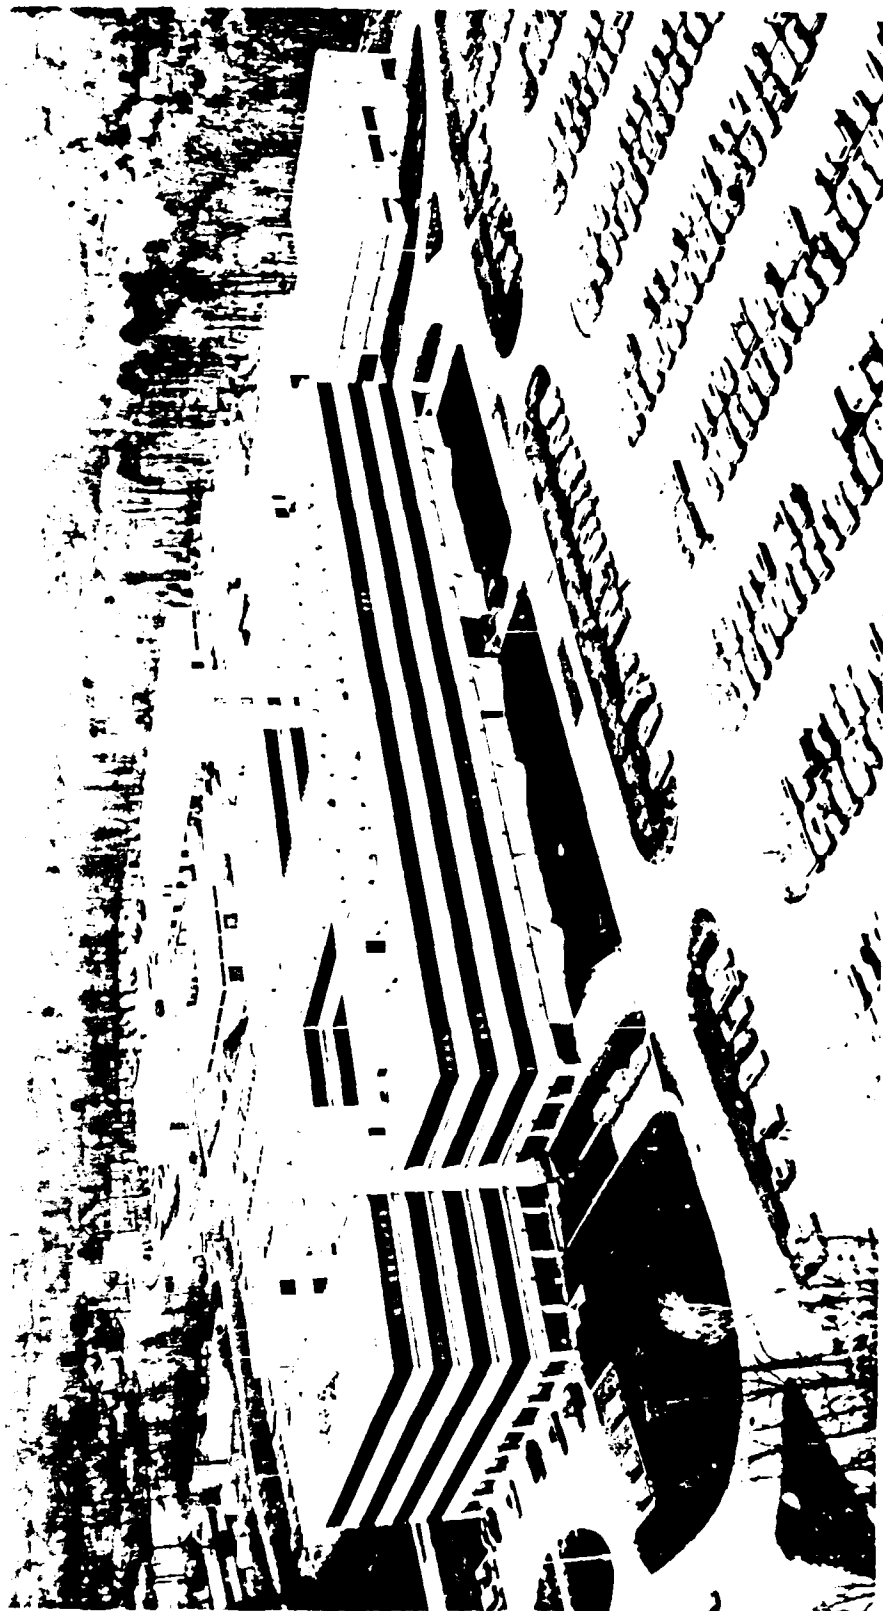
1. The 100 area is composed of nine structures (Buildings 100-108) that house the installation's service and storage facilities.
2. The 200 area contains HDL's primary administration and laboratory facilities. It is composed of a sentry station (Building 200) and four major buildings. Three of the buildings (Buildings 202, 204, and 205) form a complex that functions as one building and the fourth structure (Building 203) is located to the rear of this complex; together they house HDL's main administrative offices and the major portion of its basic research and development laboratories. The design of the three-building complex is architecturally distinctive. Built between 1974 and 1977, it varies from four to five stories and has a facade of precast concrete interrupted by long, unbroken horizontal bands of dark glass at each floor above ground level (Figure 2).

Figure 2. Main administration and laboratory complex (Buildings 202, 204, 205), view from northeast. Harry Diamond Laboratories, Adelphi, Maryland. (Source: HDL Real Estate Office)

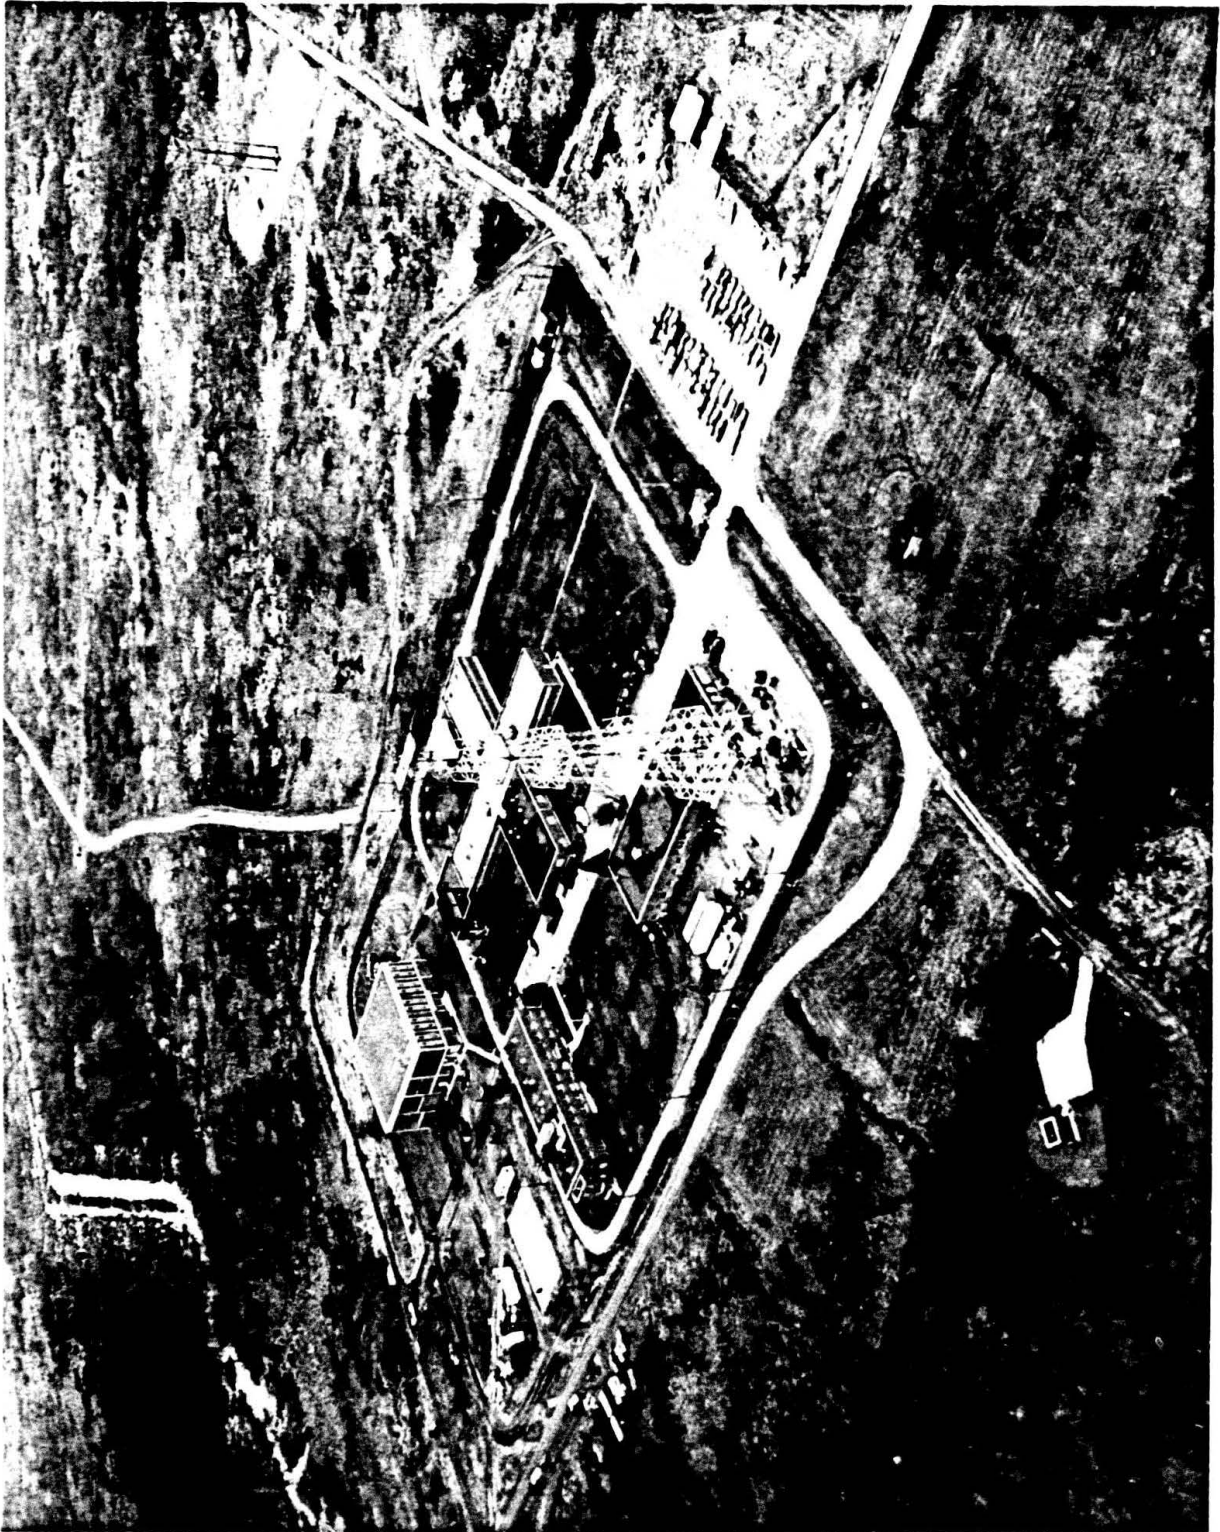
2. The main compound area is the inner secure area of the research facility (Figure 5). It consists of four permanent brick-faced buildings (Buildings 201, 202, 203, and 211), a 250-foot antenna tower, and a brick guard house (Building 210). The four permanent buildings are primarily used for administration or specialized research and development work in high-voltage technology. Building 201 is an electronics laboratory. Building 203, an electronics laboratory and administration building, Building 202, a high voltage EMP simulations building, and Building 211, a high-voltage EMP simulations laboratory. Buildings 201-203 were built in 1952 and Building 211 in 1979.

Figure 5. Aerial view of main compound area (200 area), view from northwest. Woodbridge Research Facility, Woodbridge, Maryland, (Source: HDL Real Estate Office)

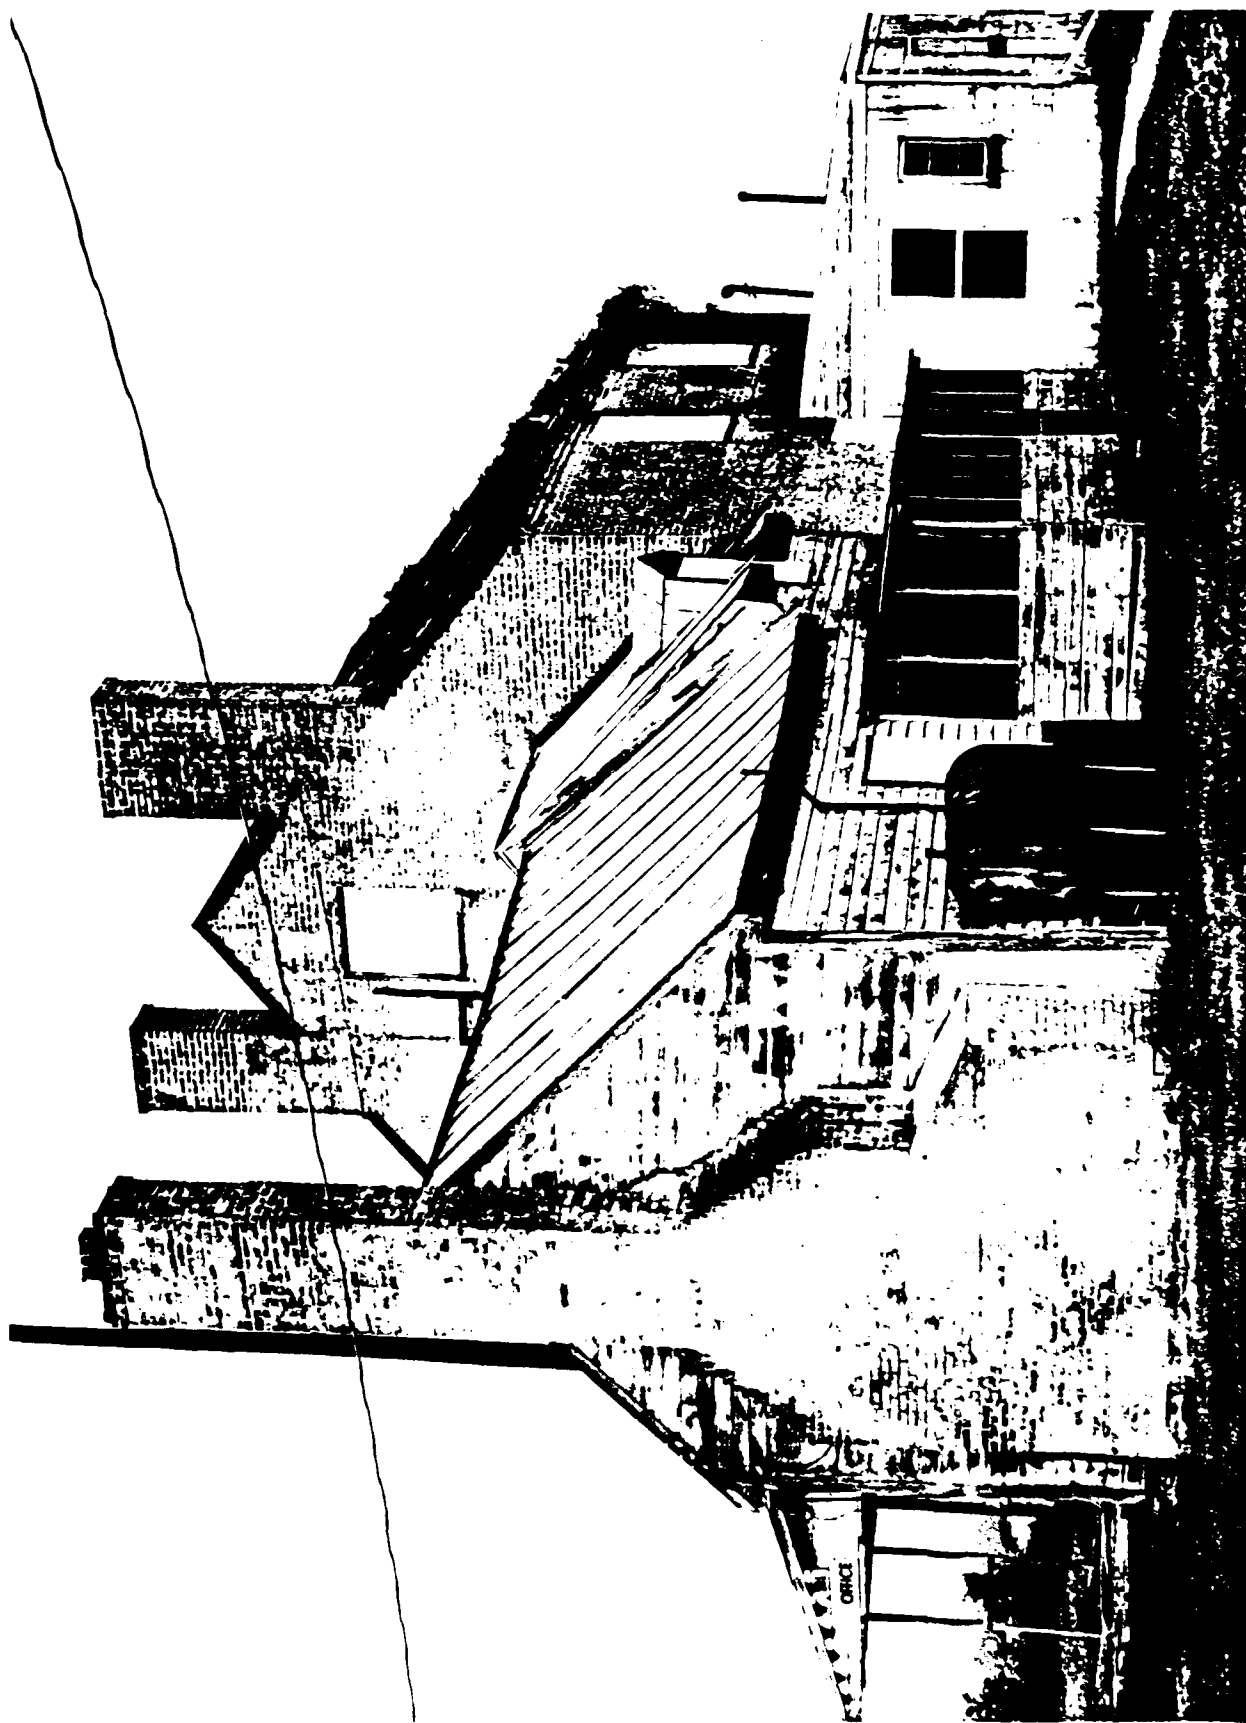
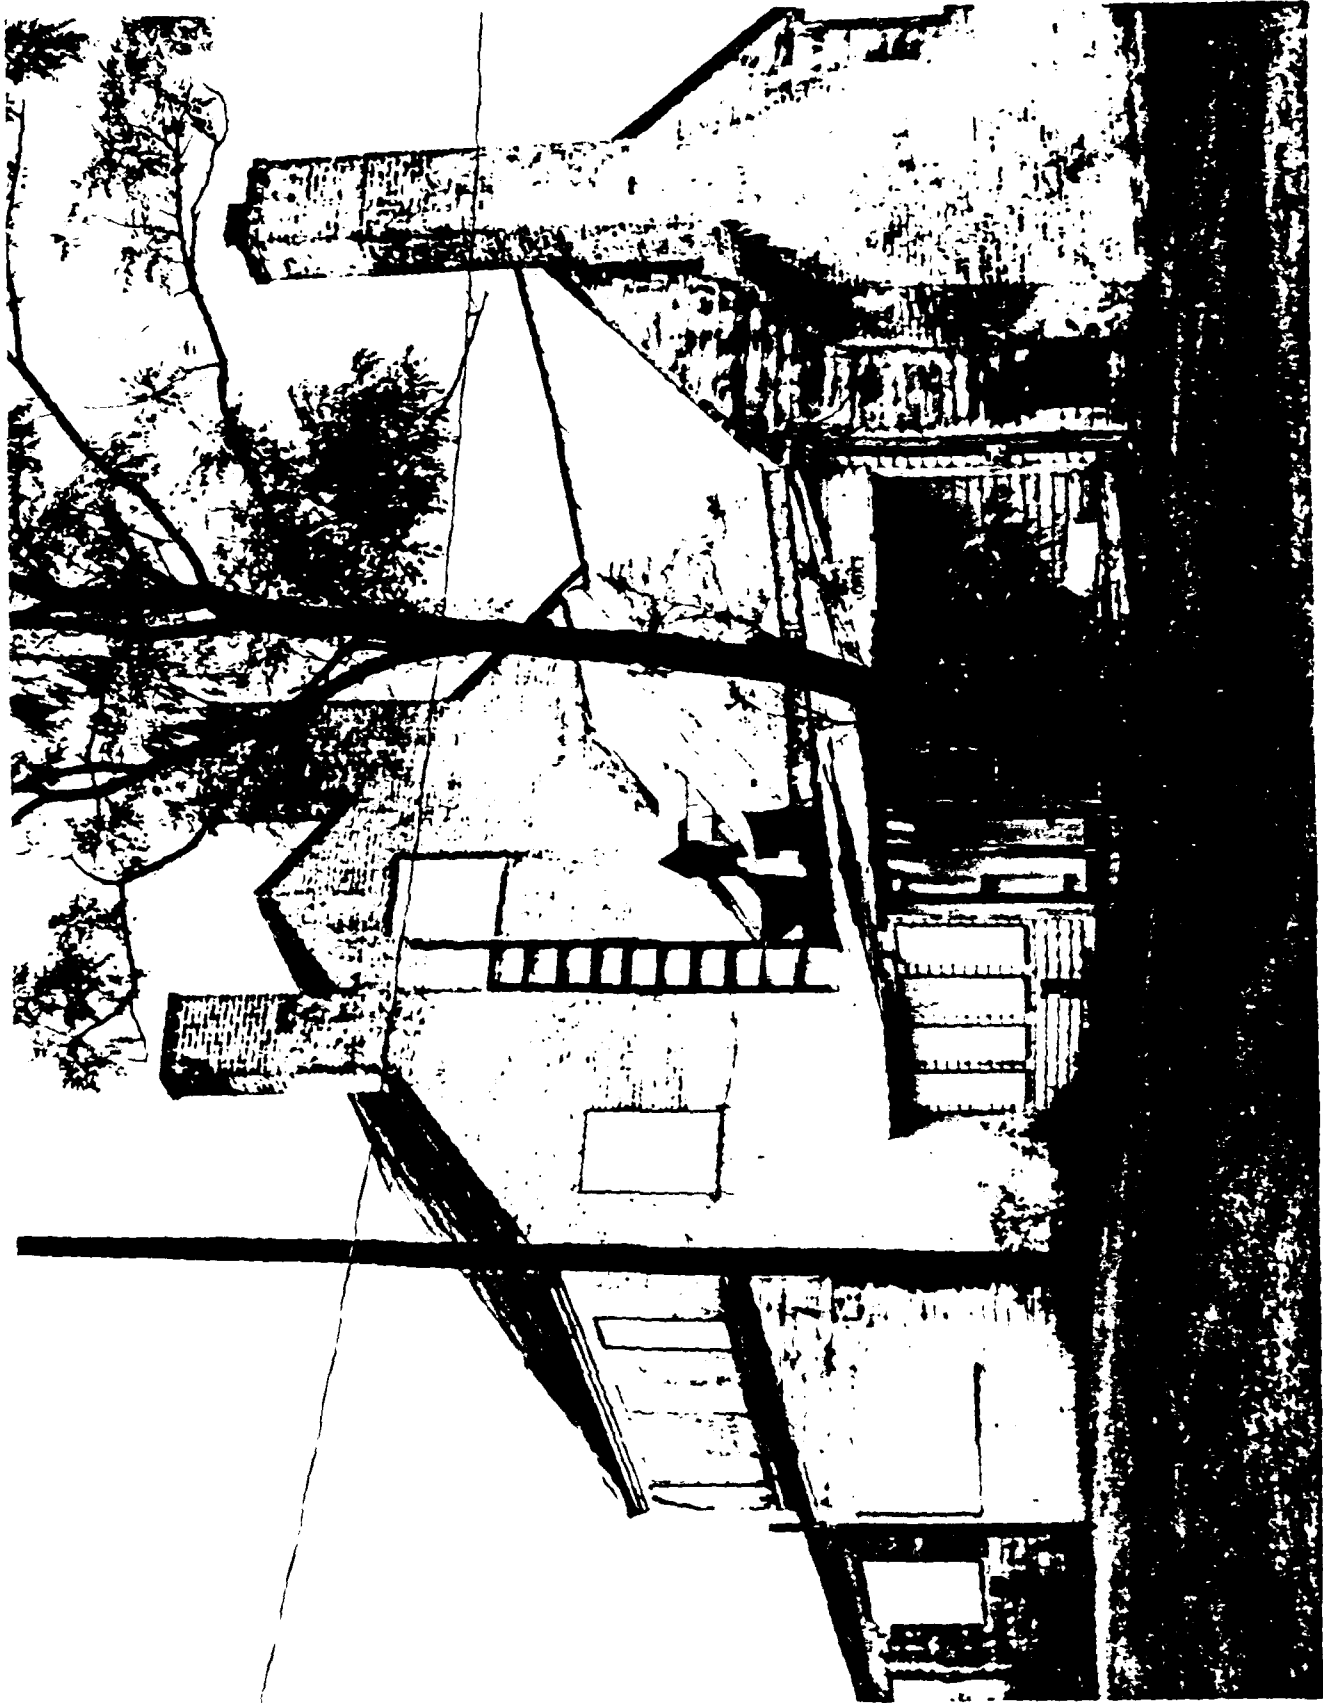
The Ballast House (c. 1790-1815) is a two-story structure that exemplifies the architectural design and craftsmanship of the Federal period in rural Maryland (Figures 8-9). It is of brick construction and has several additions of a later period. The structure was used as a farmhouse until 1942, and then as a field office until it was boarded up in the 1960s. Ballast House was listed on the National Register of Historic Places in 1979 and was documented in 1979-80 by the Historic American Buildings Survey of the U.S. Department of the Interior.<sup>8</sup>

Figure 8. Ballast House (Building P-101), view from northeast. Blossom Point Field Test Facility, Charles County, Maryland, (Source: HDL Real Estate Office)

Figure 9. Ballast House (Building P-101), view from southeast. Blossom Point Field Test Facility, Charles County, Maryland. (Source: HDL Real Estate Office)

- Condition and potential adverse impacts. The Ballast House was converted to a field office by the Army in 1942, was boarded up in the 1960s, and has remained vacant since that time. An inspection of the building in January 1984 revealed that the building's 8" thick brick bearing walls are in generally good condition, although there is cracking above and below the middle second floor window on the northeast elevation and delamination of the outer brick layer near the ground line; mortar deterioration and two areas of bulging on both gable ends; and some masonry cracking above and below the first and second story windows on the northwest elevation. The wooden window sills are extremely deteriorated. There is significant mortar deterioration on the kitchen chimney. The kitchen porches are highly deteriorated and partially collapsed, and the floors of the flanking southwest porch are deteriorated and in some places badly damaged. The interior face of the exterior brick walls, where exposed, is in some locations damp and suffering mortar deterioration. Above the ground floor line the interior wood framing appears intact, as does most of the plaster and wood trim; when probed with a moisture meter, these components had moisture readings below 20%, well within safe range.

The Ballast House is located on the edge of a steep embankment on the Potomac River. In recent years this embankment has eroded to the point that the house is in danger. A study by the Army Corps of Engineers in 1978 found that protection of the embankment would be extremely expensive, with alternative stabilization schemes ranging in cost from \$467,000 to \$1,045,000. Since that time, the Army has added some rock fill below the embankment as a stopgap measure. Current estimates of the length of time remaining before the embankment begins to undermine the house vary from one to ten years, depending on natural events associated with the river that are largely unpredictable.

- 2) If support were not forthcoming within a reasonable period of time, the Army should be allowed to demolish the building. In this event, an expert in historic building interiors should be first retained by the Army to evaluate the building's interior woodwork, determine if it should be salvaged, and recommend appropriate recipients for the woodwork if it were to be removed. Although the Ballast House was recorded by the Historic American Buildings Survey in 1979, detailed measured drawings of its woodwork were not prepared. If the woodwork were found to be of special significance, such measured drawings should then be completed and added to the existing HABS documentation.
