DEEP SEA MOORINGS FISHBITE HANDBOOK

WOODS HOLE OCEANOGRAPHIC INSTITUTION
Woods Hole, Massachusetts 02543

March 1987

TECHNICAL REPORT

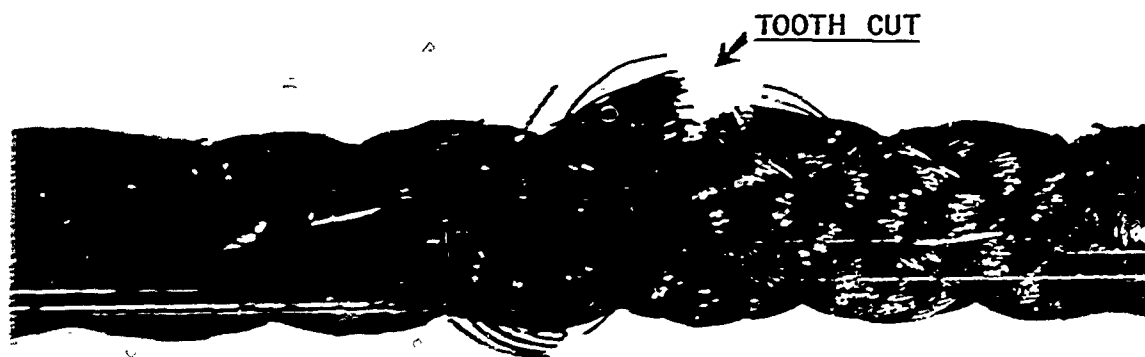
Figure 1.1 Typical fishbite on 5/16" diameter polypropylene rope (Prindle and Walden, 1975).

Ropes of synthetic fiber have been found severed or cut part way with cuts appearing clean as though made with a keen edge. Figure 1.1 shows the first such cut recorded in the buoy program at the Woods Hole Oceanographic Institution (WHOI) in 1959 (Stimson, 1964). Figure 1.2 shows a nylon rope damaged at a later date. In the latter case, most of the rope cross section was cut through so that the line parted (quite dramatically!) as it was being hauled aboard ship. The parted ends, therefore, show effects of both cutting and tensile break, e.g. truncated ends on the cut yarns and a "ponytail" appearance on yarns broken by tension.

Fishbites in unjacketed fiber lines may show up as sharply cut yarns or strands which often stick out from the side of a rope as seen in Figure 1.1. If the line has parted in service, and only a fag end is retrieved, it will often be found that many of the yarns have truncated ends, which indicates cutting by a sharp instrument, such as fish teeth. At the same time, the ends of a few yarns may have a "ponytail" appearance, which is indicative of tensile failure. Such a pattern is characteristic of a line which had most of its yarns cut by fishbites, leaving only a few yarns to sustain the tensile load (Figure 2.5).

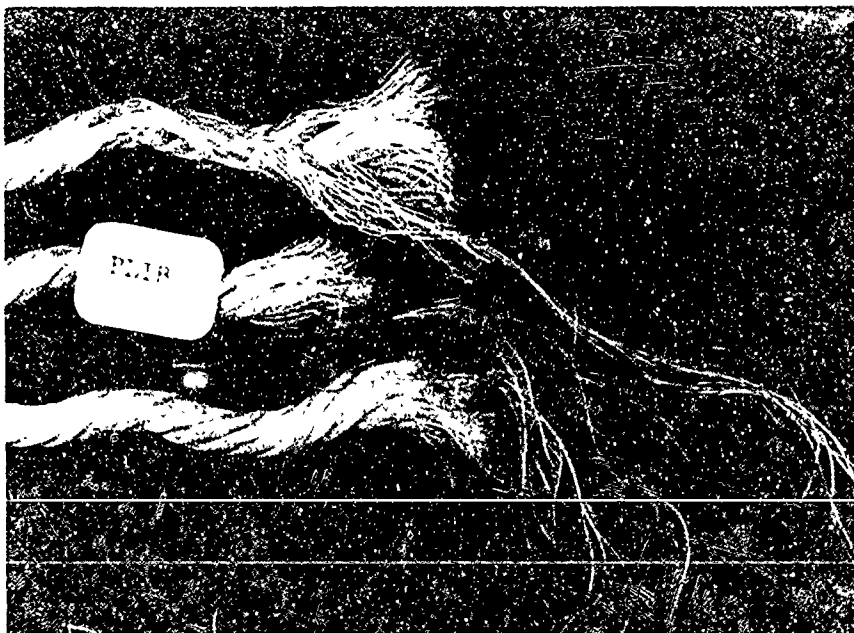
Figure 2.6 Parted mooring line (washed and dried).

SAMPLE PREPARATION FOR MICROSCOPIC ANALYSIS OF FAILED FIBER ROPES
