AFWAL-TR-87-2004

EFFECTS OF AIRCRAFT ENGINE BLEED AIR DUCT FAILURES ON SURROUNDING
AIRCRAFT STRUCTURE

A. M. Johnson
BOEING MILITARY AIRPLANE COMPANY
Propulsion Technology
P.O. Box 3707
Seattle, WA 98124-2207

April 1987
INTERIM for period March 1986 to May 1986

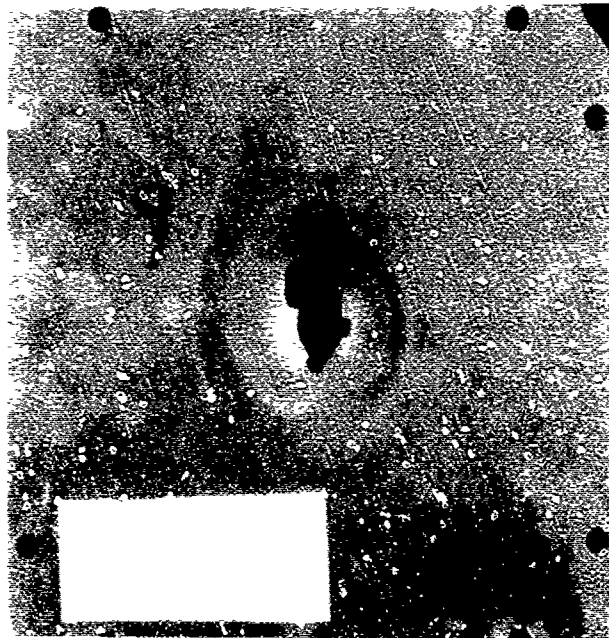
Figure 2. Simulated F-16 Panel Tested One Inch from Jet Exit Plane

Test conditions included jet temperatures up to 1000°F and jet pressures up to 220 psia, to which the AENFTS facility is limited, but which are representative of fighter engine bleed duct conditions. During the initial tests with the 0.050-inch thick 2024-T81 panels which simulated the F-16 aft tank wall, little damage was done to the panels when they were placed six inches from the jet exit plane. The center of the panel was dented, but no perforation had occurred after ten minutes of exposure to the jet (Figure 1). Panel perforation did not occur until the panel was located two inches from the jet exit plane. At that point, perforation occurred within the first six seconds of jet impingement (Figure 2).

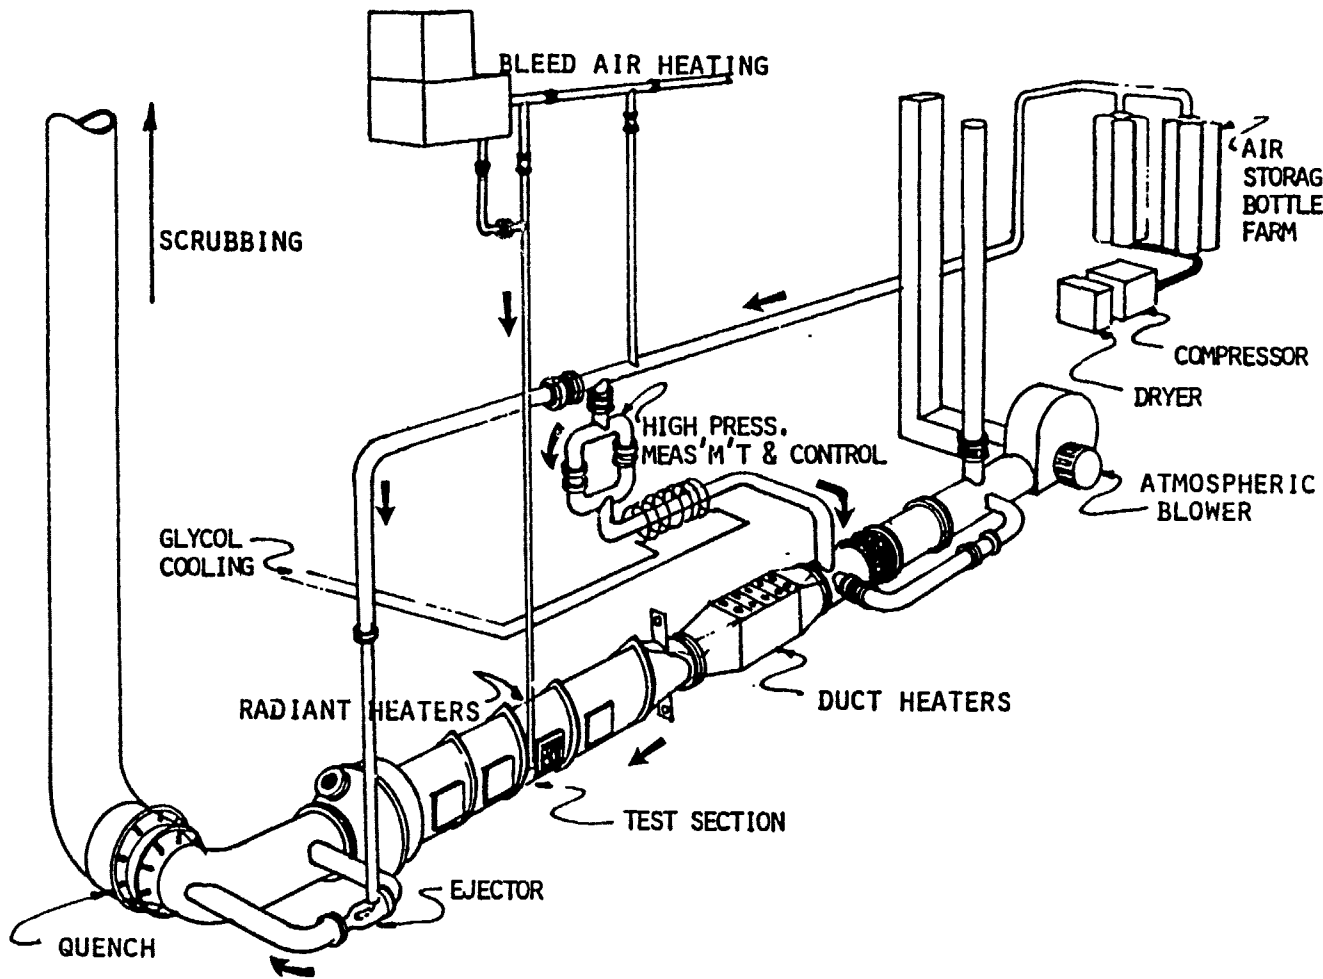
(ARROWS INDICATE AIRFLOW DIRECTION)

Figure 5. Components of the AEN

The Aircraft Engine Nacelle Fire Test Simulator (AENFTS) is a ground test facility designed to simulate potential fire hazards in the annular compartment around an aircraft engine. The simulator is installed in I-Bay of Building 71-B in Area B of Wright-Patterson Air Force Base in Ohio. The facility includes air delivery and conditioning equipment to simulate engine compartment ventilation and bleed airflow. The test section is used for safe, dynamic fire testing. This test section is connected to an exhaust system that includes equipment to cool and scrub combustion gases prior to releasing them into the atmosphere (Figure 5).

Simulation of the hazards associated with high temperature engine bleed air leaks from either damaged ducts or the engine case is provided by the AEN bleed air heating system. A natural gas fired heater, mounted on a platform above the AEN test cell, heats the incoming high-pressure air. This air supply is a 2000 psig air storage bottle farm equipped with automatic flowrate and temperature control. Testing is possible at flowrates up to 1 pound per second with the temperature up to 1500°F and pressures up to 220 psia.

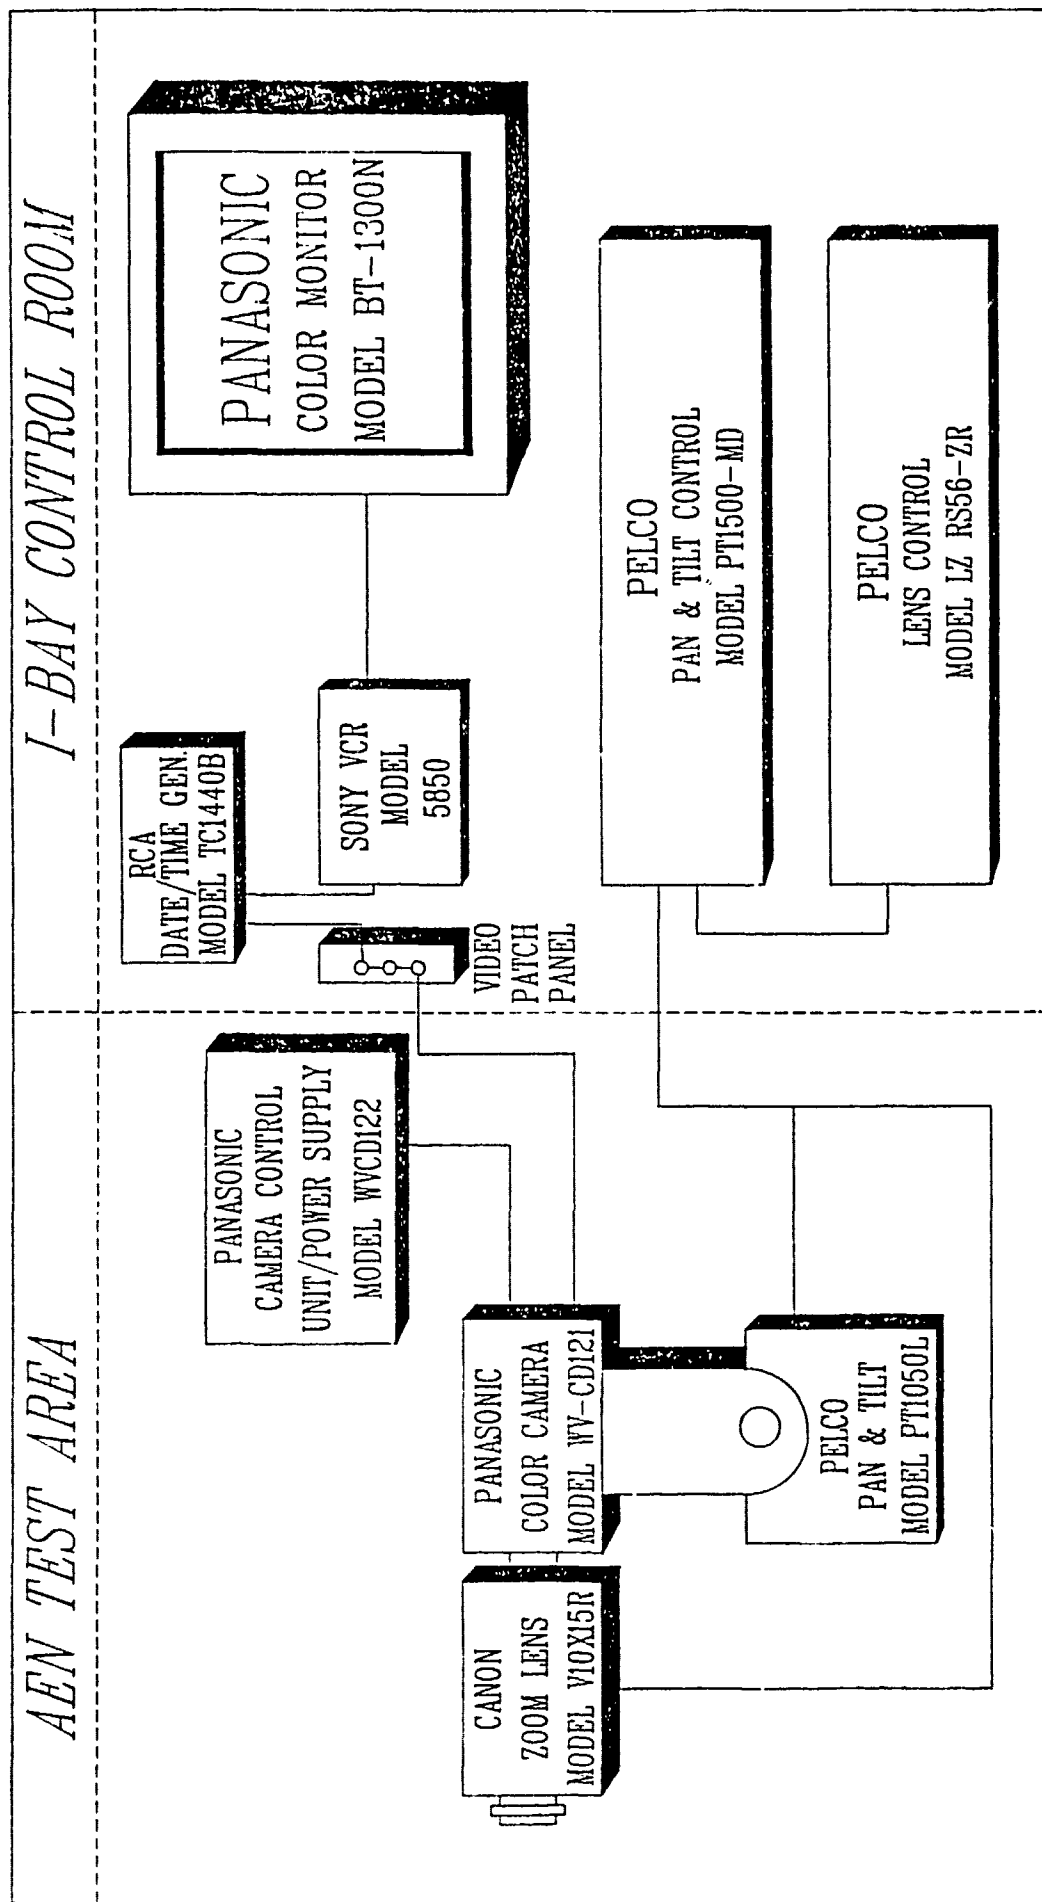
Figure 7. AEN Video Equipment

A closed circuit television camera equipped with a F 2.8, 15- to 150-mm zoom lens was mounted on a pan and tilt platform. During these tests, the camera was focused on the point where the simulated bleed air jet impinged on the test panel. The output signal could be monitored on a video monitor on the AEN control panel to allow the test operator to observe the jet impingement effects on the test panel and the exact time at which the panel failed in those cases where perforation occurred.

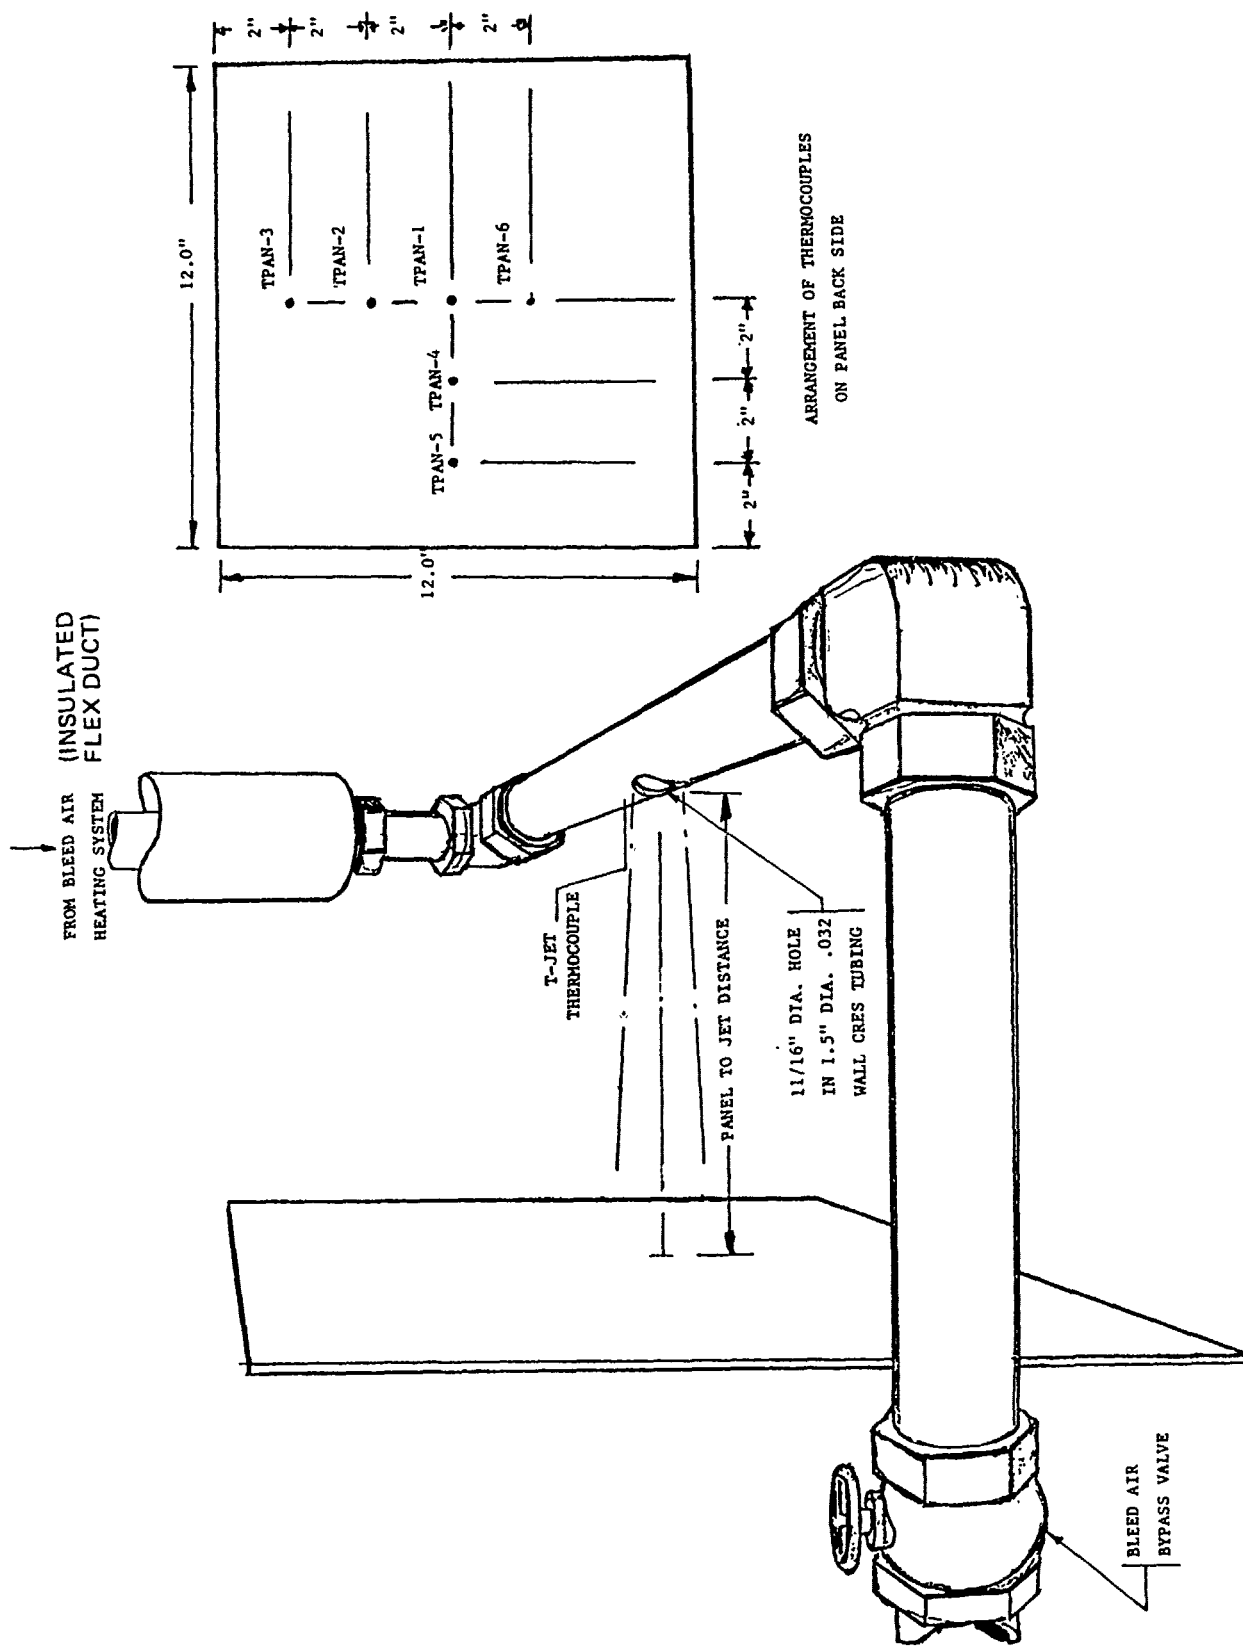
Figure 10. Test Article for F-16 Panel Penetration Testing

The panels were bolted to the Unistrut structure which supported the simulated bleed duct. The outer 3/4-inch of the edge of each panel was bolted to and supported by the Unistrut channel (Figure 13); the center of the panels was unsupported. Thermocouples were located behind the panel to measure the backside temperature, and were held in place by coil springs (Figure 14). The springs were used so that the thermocouples would not provide any additional support to the center of the panels. The thermocouple positions on the back side of the panel are identified in Figure 10.

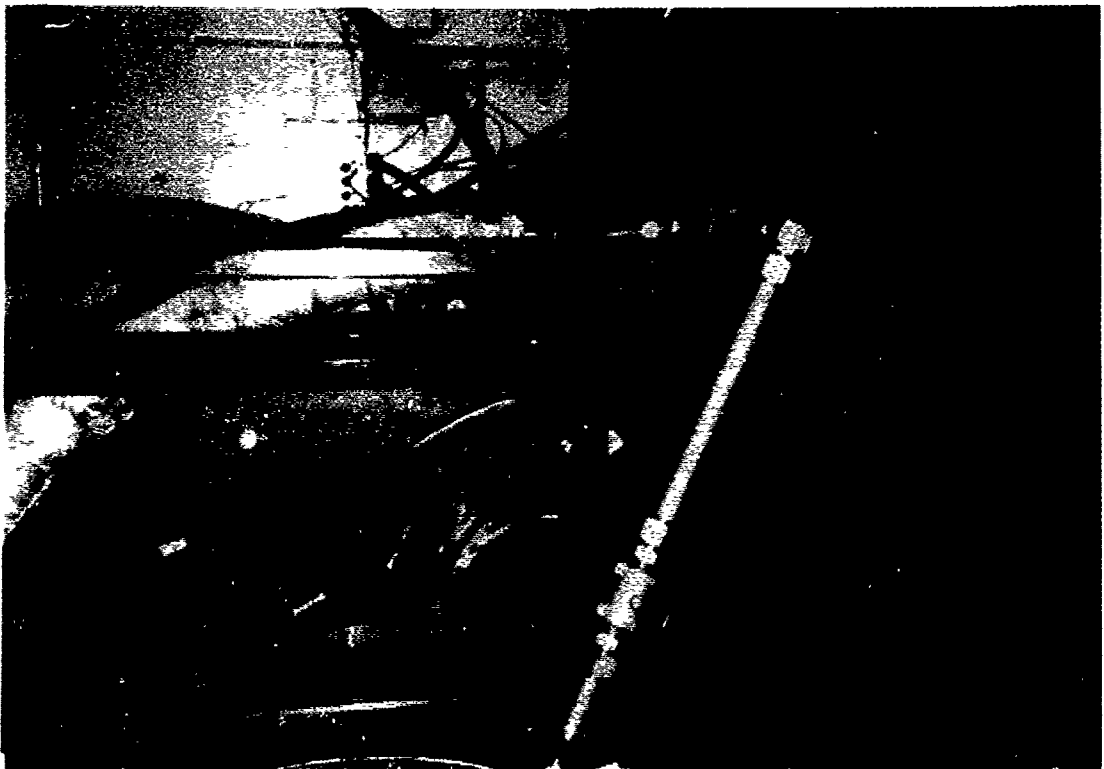
Figure 11. Test Article Viewed From Side

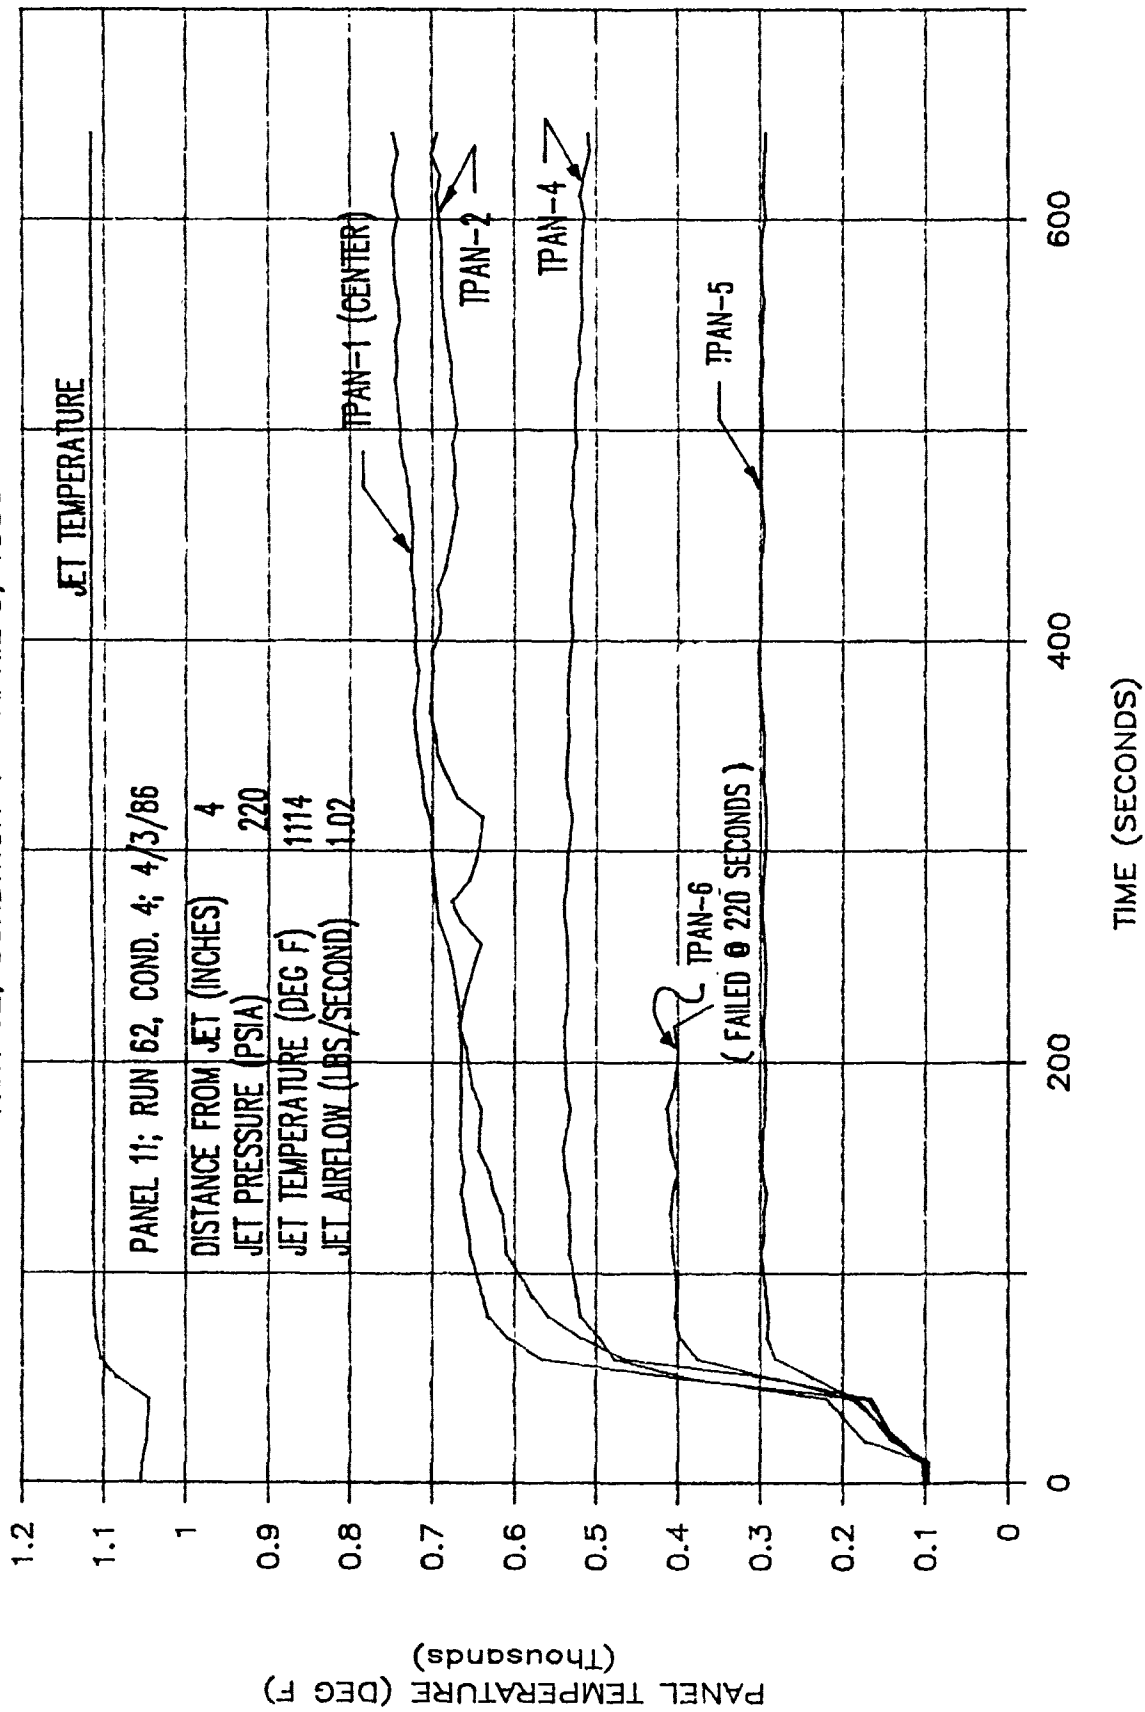
2024-T81 PANELS, 0.050" THICK

RUN 62, CONDITION 4 - APRIL 3, 1986

Figure 15. Panel Backside Temperature Variation During Ten Minute Test

The temperatures on the panel backside increased to a relatively constant maximum value during the first minute that the jet was impinging on the panel and then remained fairly constant. Generally, panel failure, when it occurred, happened within the first 12 seconds of the test. If there was no failure, the test was continued for ten minutes before concluding that the panel would not be penetrated.

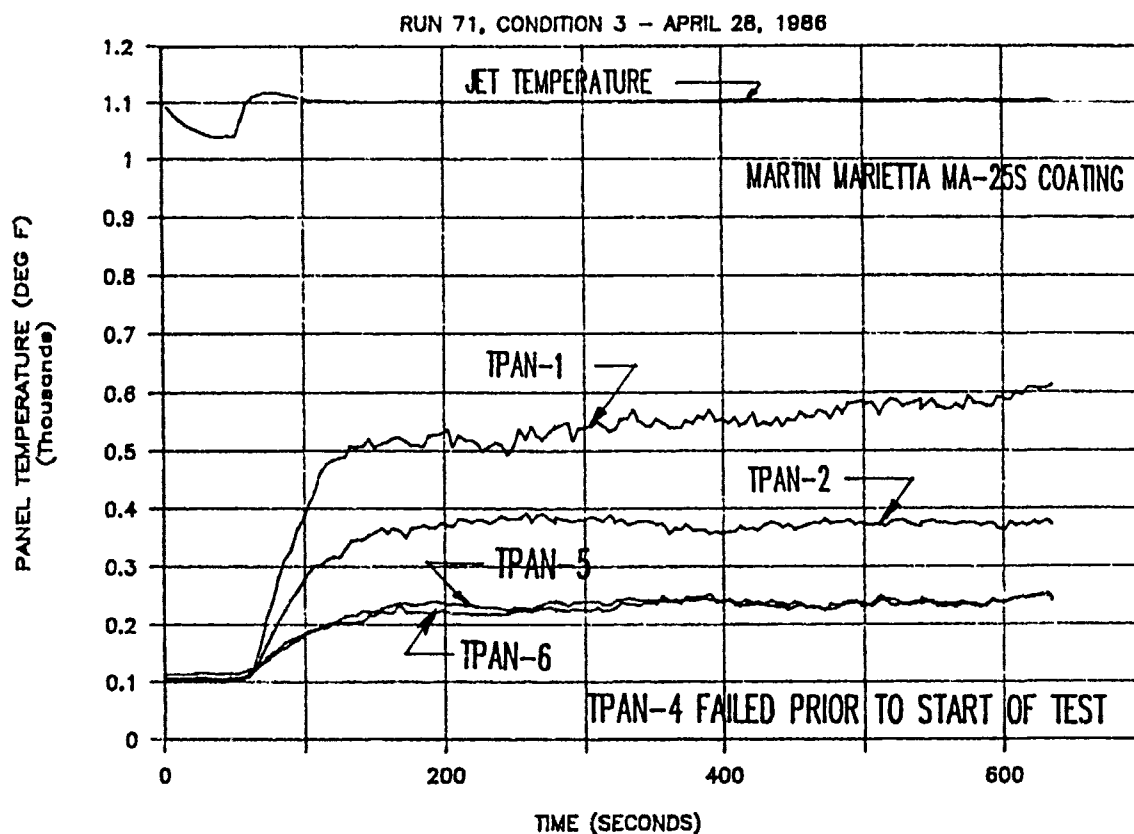
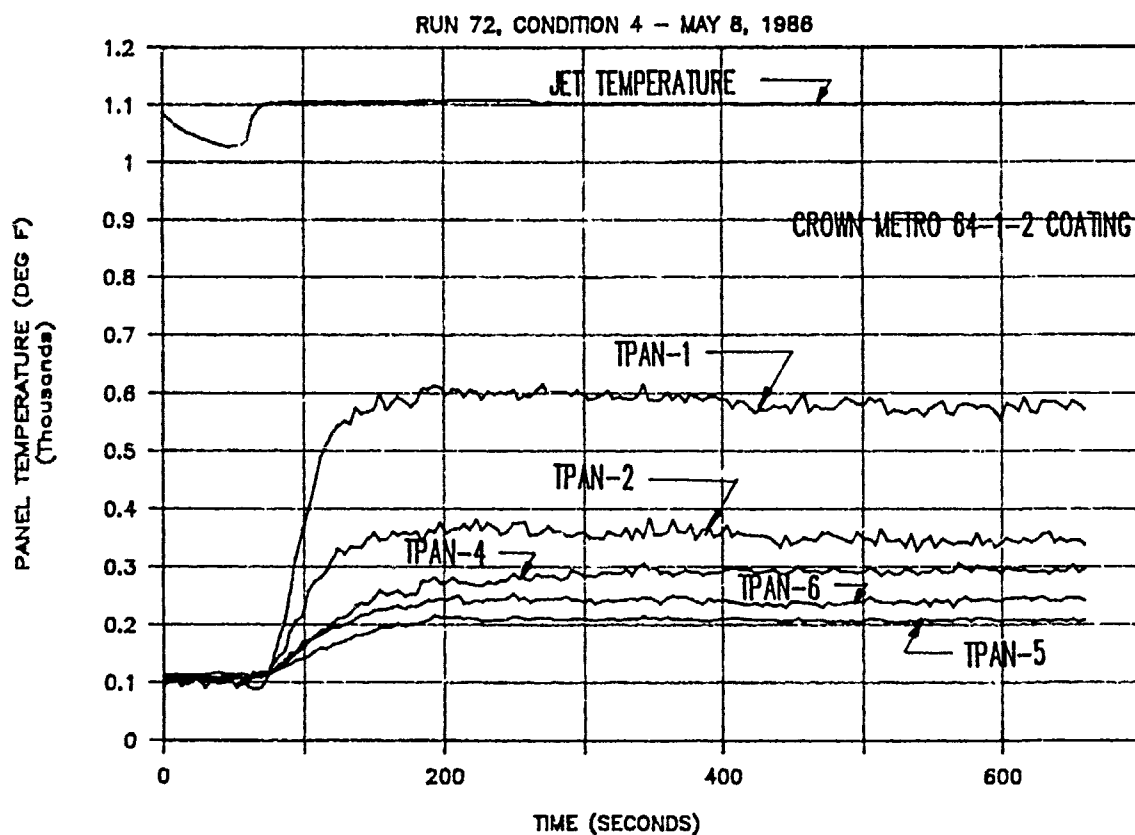
Figure 16. Comparison of Insulating Capabilities with 1100 deg F Jet at 4 Inches

The backside temperatures experienced with 0.090-inch thick coatings of the two materials for ten minutes of exposure to an 1100°F jet at a distance of four-inches are compared in Figure 16. The backside temperatures experienced with the MA-25S are shown in the top half of the figure while the backside temperatures experienced with the Crown Metro material are shown in the lower half. The thermocouple in the panel center, TPAN-1, reads a 50 to 80 degrees lower temperature with the MA-25S material during the first half of the run but reaches about the same level as with the Crown Metro during the remainder, although the video tape suggests the insulation had been eroded away from the panel center in about the first 30 seconds. TPAN-2, which is two inches above

the center, and TPAN-6 which is two inches below the panel center, appear about the same with either material. TPAN-5, which is four inches to the left (upstream) of the panel center, appears to have been 20 to 30 degrees cooler with the Crown Metro material.

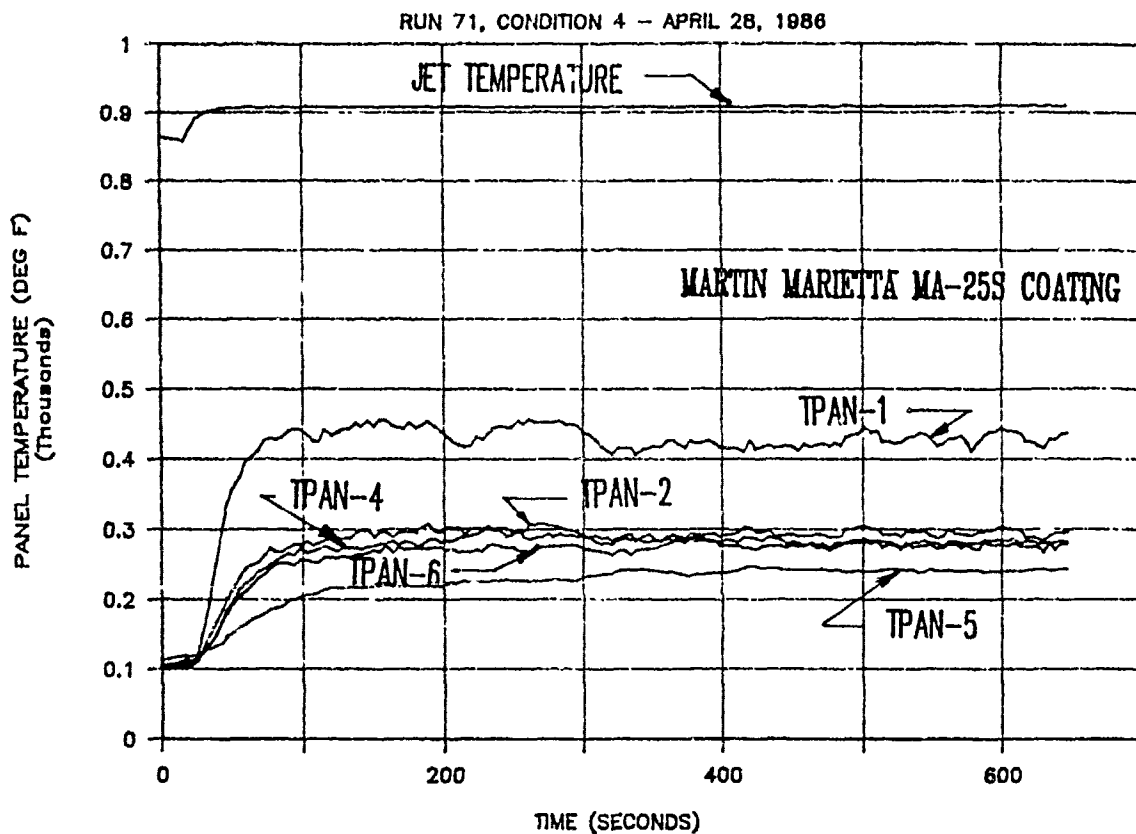
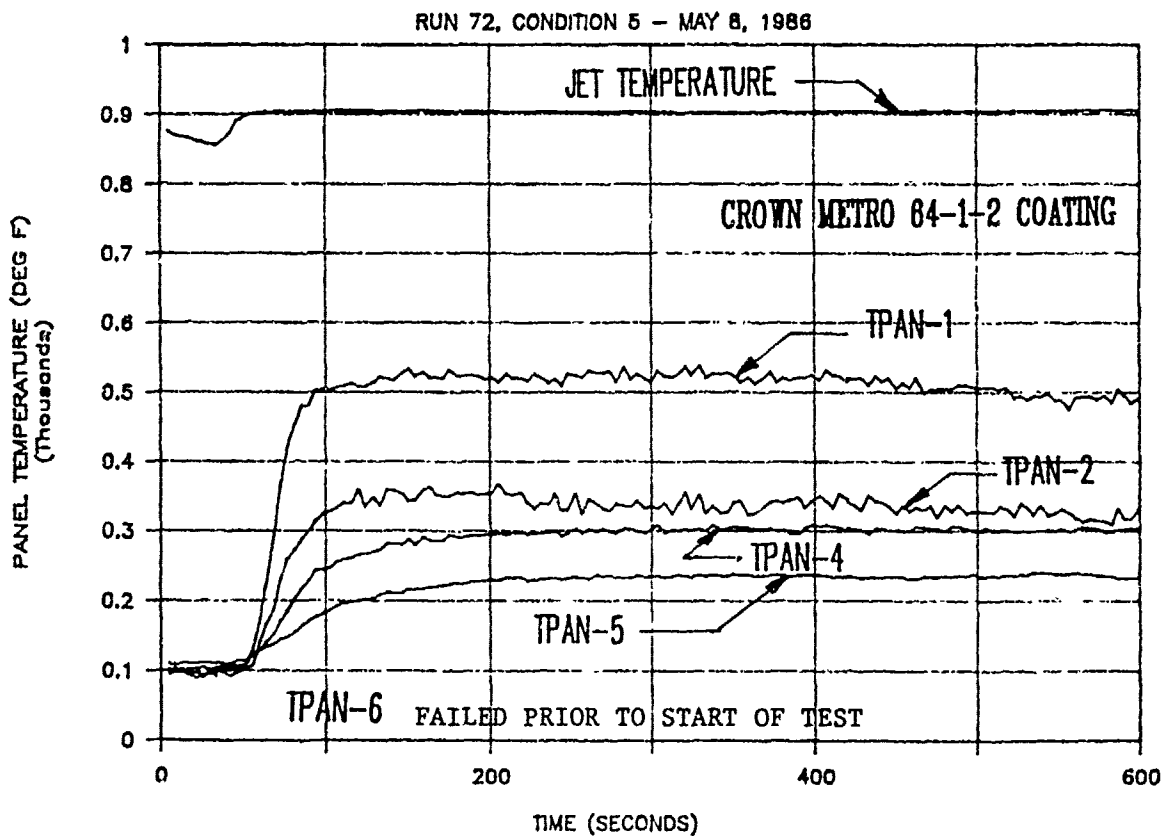
Figure 17. Comparison of Insulating Capabilities with 900 deg F Jet @ 2"

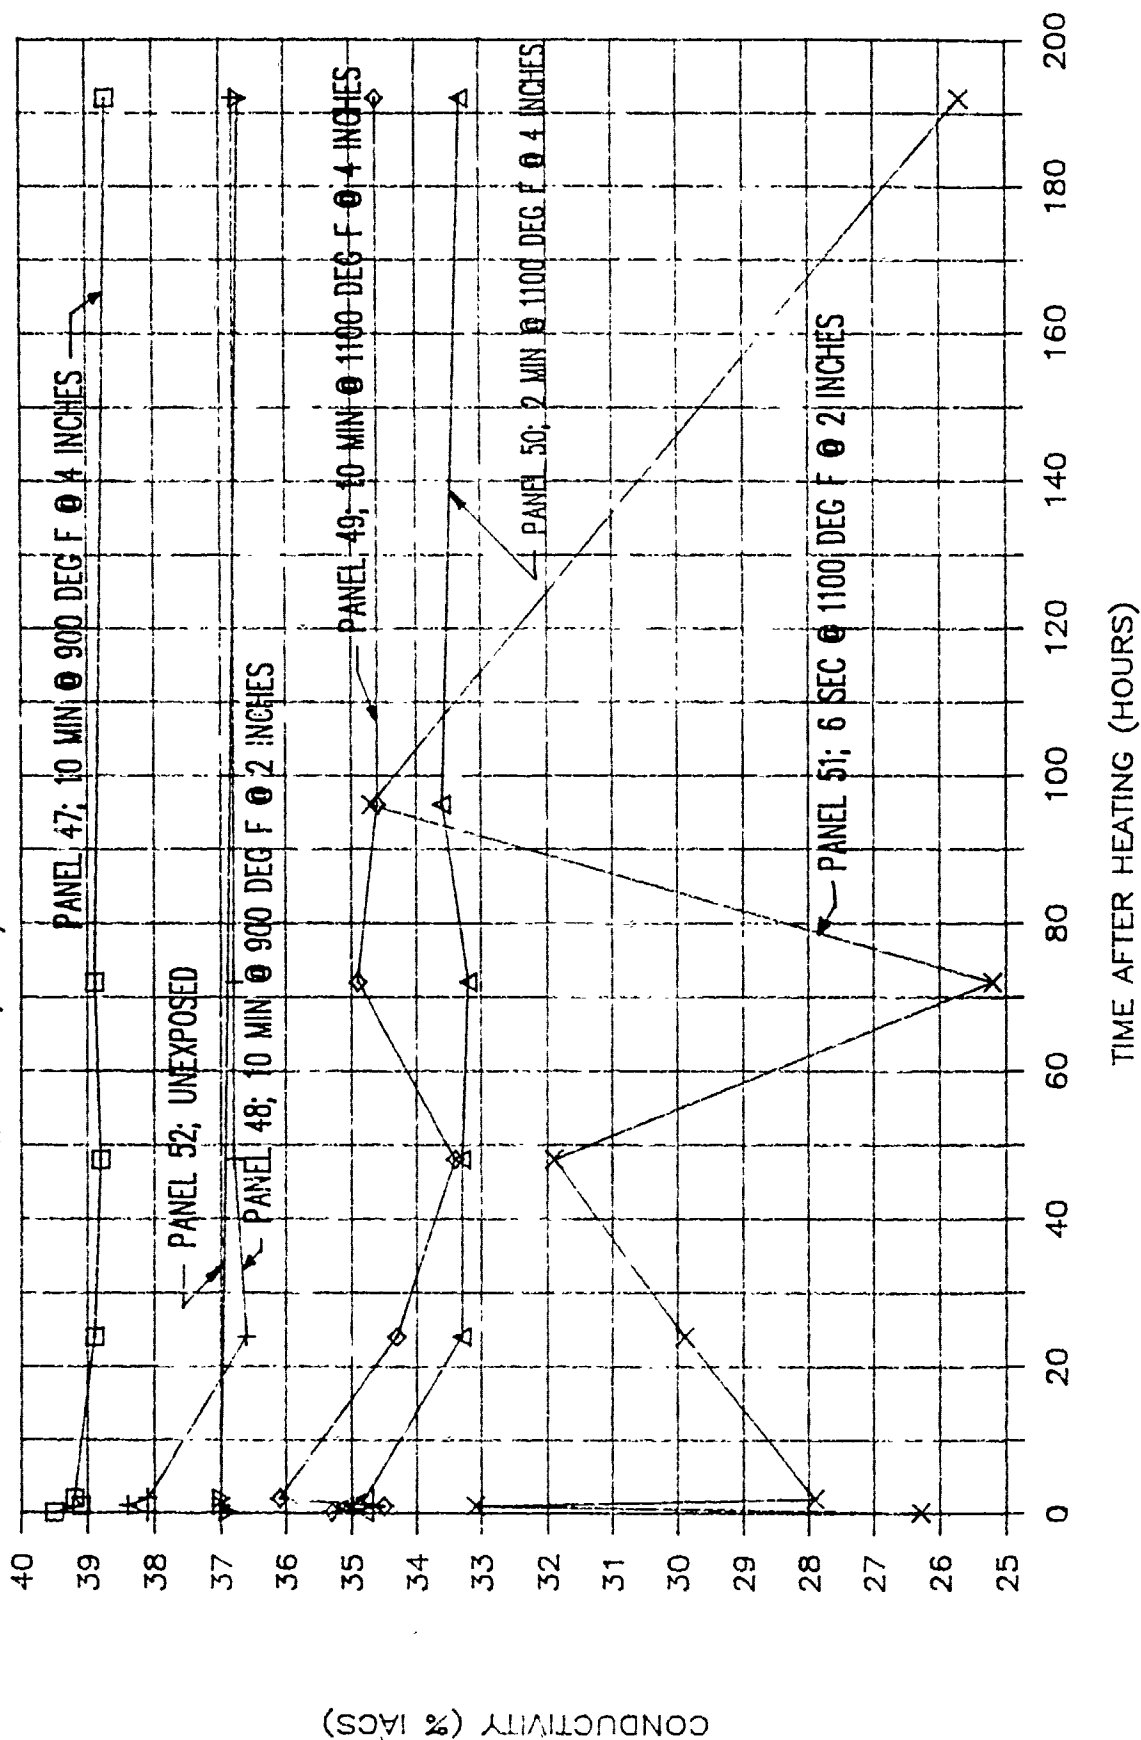
CONDUCTIVITY OF 2024-T81 PANELS

LOC. "T", 1 1/2" ABOVE PANEL CENTER

Figure 18. Effect of Time after Exposure on Panel Conductivity

The variation in conductivity readings taken on the panel surface 1.5-inches above the panel centers over the first eight days after exposure to the hot jets was plotted (Figure 18). The erratic nature of the data for panel 51 is probably due to the surface roughness caused by exposure to the hot jet at the

location where the readings were taken, just above the hole where the jet penetrated the panel. The conductivity of panels 48 and 50 decreased about 1% in this location during the first 24 hours and then remained relatively constant during the next week while the conductivity of panel 49 decreased about 2% and then increased again to remain fairly constant at about 1% below the original level.

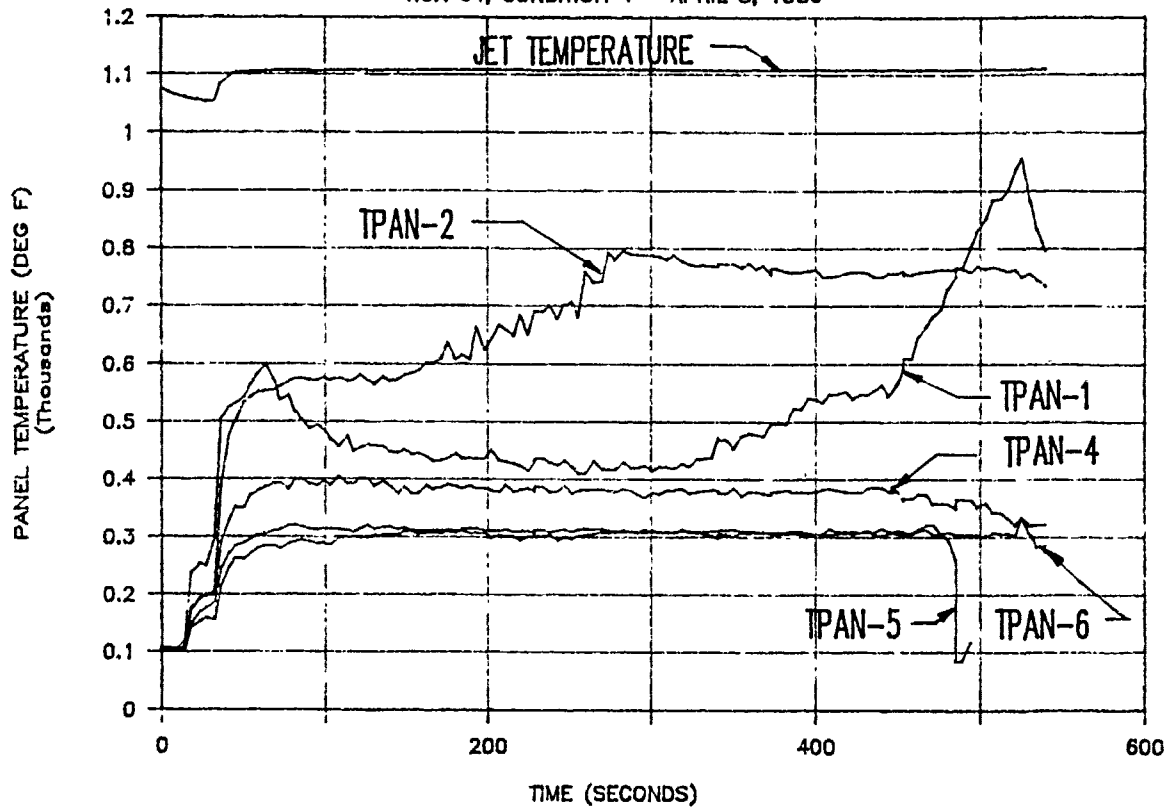
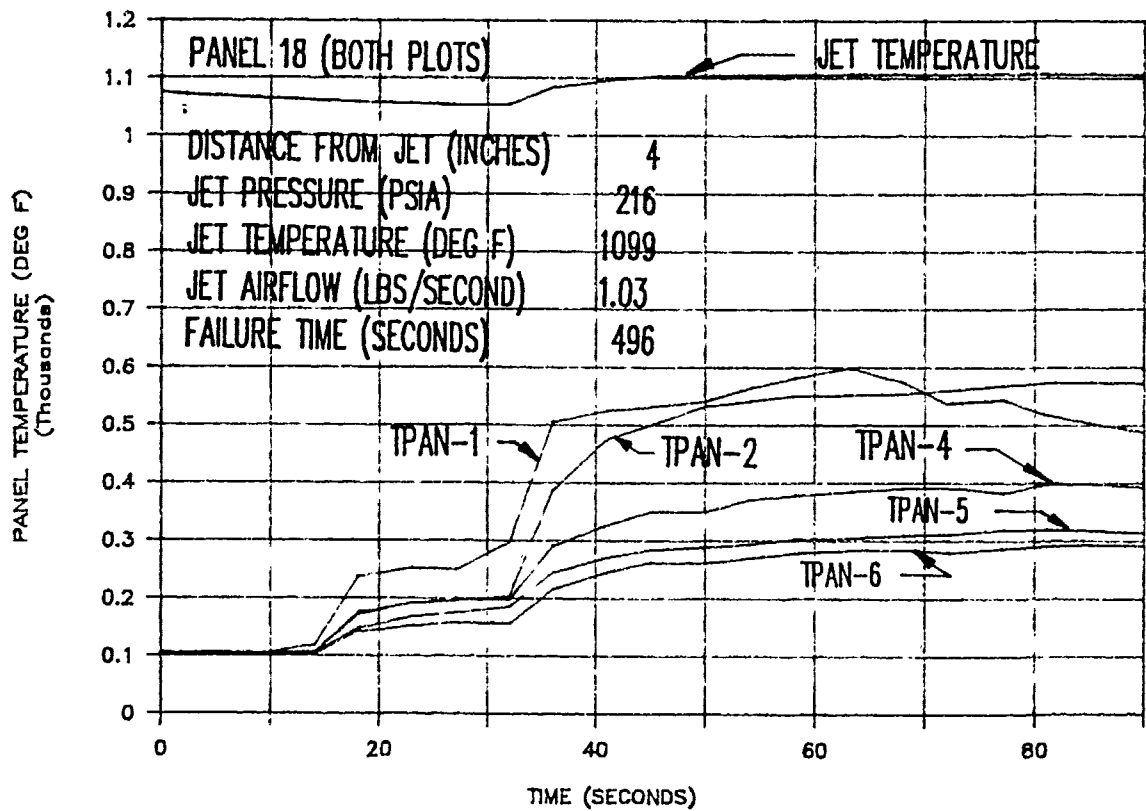
2024-T3 PANELS, 0.032" THICK

RUN 64, CONDITION 4 - APRIL 8, 1986

Figure 21. Panel Backside Temperature History

moving the panel center back, away from the jet. Hence, the center thermocouple, TPAN-1, read lower temperatures while the thermocouple two inches above the center, TPAN-2 continued to climb. After about 300 seconds, TPAN-2 leveled off at about 800°F. The thermocouples farther from the center of the panel had reached steady state at much lower temperatures in the first minute of the test. Between the 400 second mark and the panel failure, which occurred at about 500 seconds, TPAN-1 started to climb again, when the panel could elongate no further and the dent was no longer growing.

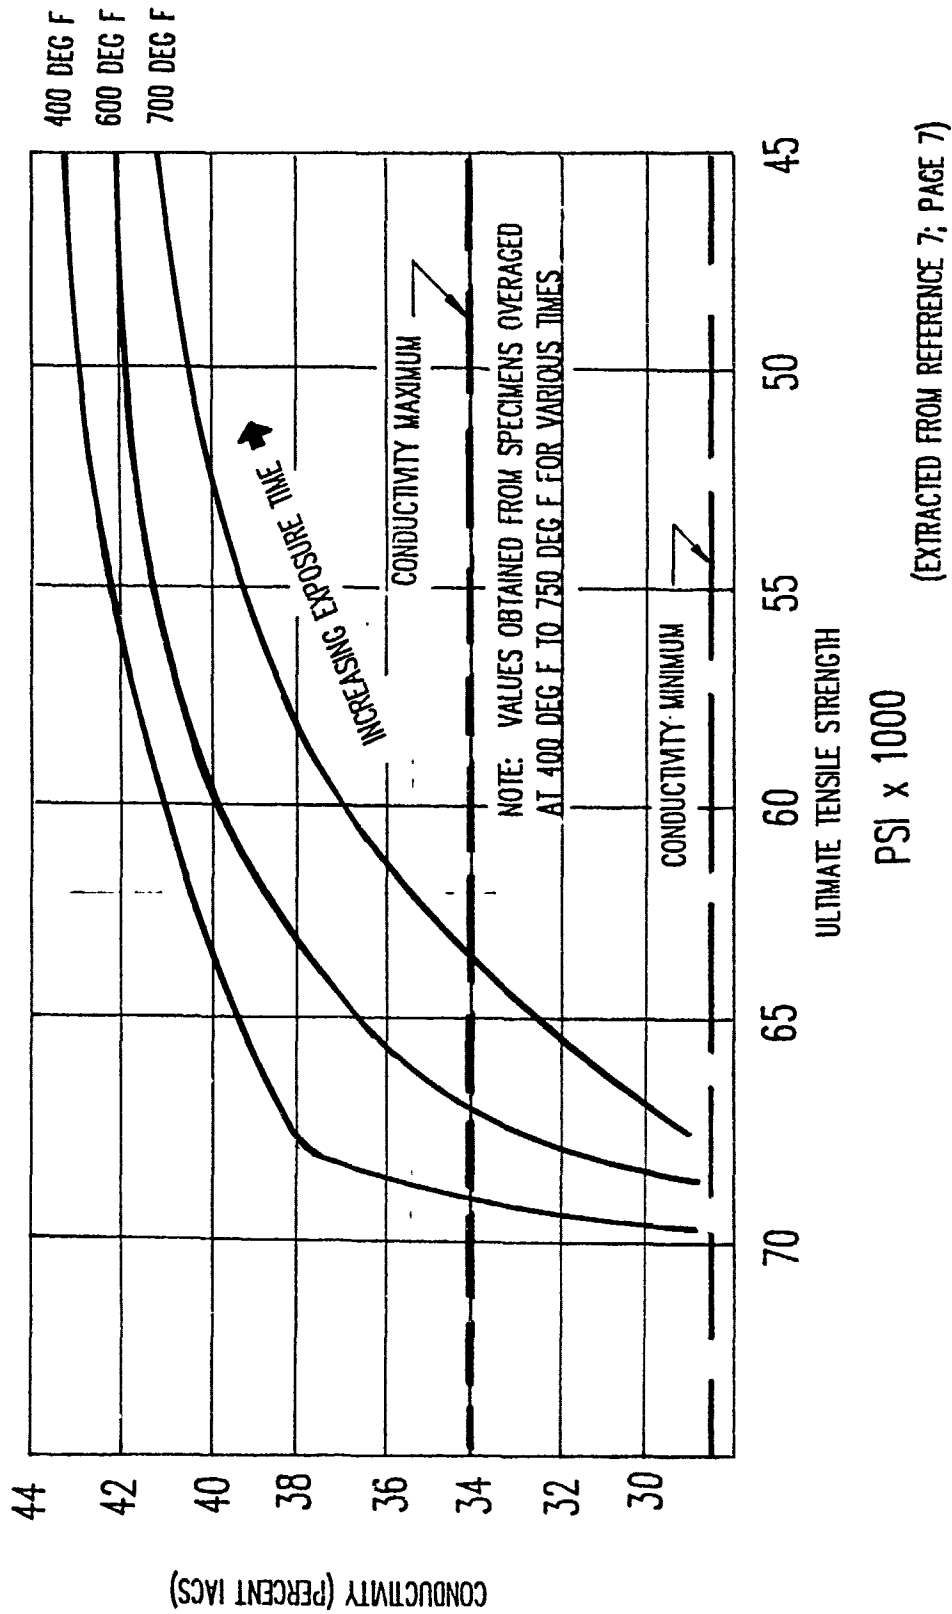
Figure 22. Conductivity versus Tensile Strength for Overaged 2024-T4 Bare Aluminum Alloy Sheet

As noted in paragraph 4.4, conductivity measurements of panel 52 indicated that the material which was representative of an F-16 glove tank wall had probably been heat treated too long. Figure 22 is extracted from Reference 7 and shows the effect of excessive heat treating on 2024-T4 sheet. While the range of acceptable conductivities for this material are lower than for the T81, the effects of excessive treatment would be similar. With the T4 material, a conductivity 1.2% below the acceptable limit would imply an ultimate tensile strength from 0.4% to 1.6% higher than the specification material, depending on the temperature and exposure time. A similar increase would be expected with the T81 material.

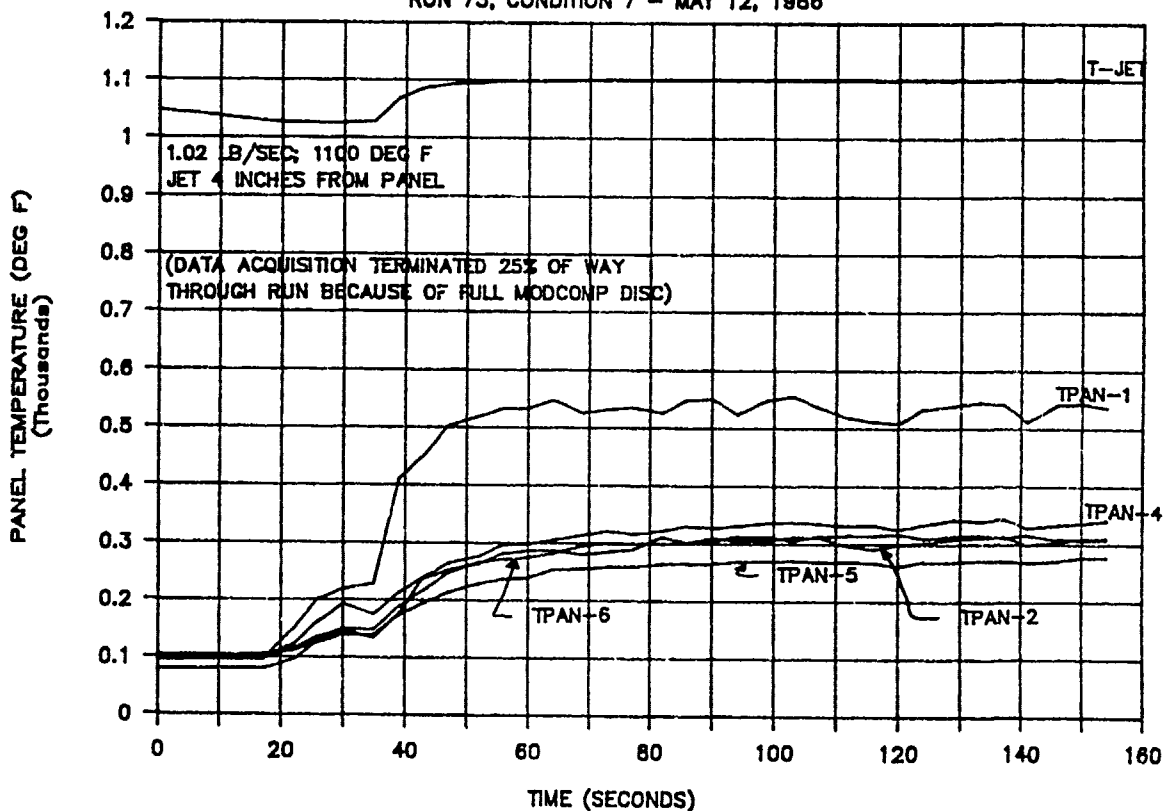
PANEL 50; CONDUCTIVITY TESTING

RUN 73, CONDION 7 - MAY 12, 1986
