DISTURBANCE AND RECOVERY OF ARCTIC ALASKAN TUNDRA  
TERRAIN A REVIEW OF REC (U) COLD REGIONS RESEARCH AND  
ENGINEERING LAB HANOVER NH D A WALKER ET AL JUL 87  
CRREL-87-11

## REPORT 87-11

### *Disturbance and recovery of arctic Alaskan tundra terrain*

*A review of recent investigations*

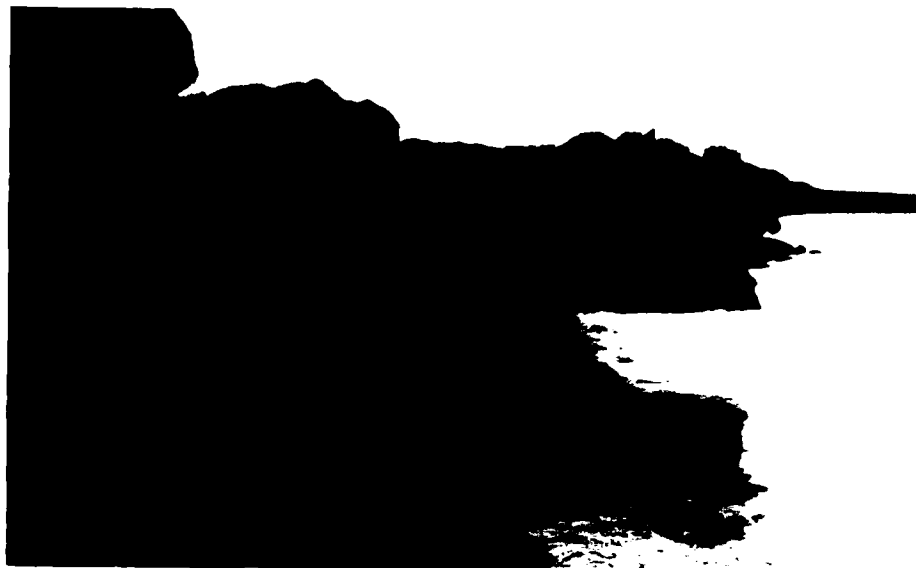
*Figure 5. Thermoerosional niche in massive ice adjacent to the Sagavanirktok River near Deadhorse. The niche extends approximately 7 m horizontally beneath the ice face in the foreground. (Photo by D.A. Walker, 10 Aug 1984.)*

Eroding banks in permafrost, whether along streams or lakes, are typically characterized by thermoerosional niches (e.g. Williams 1952, Abramov 1957, Walker and Morgan 1964, Miles 1977, Scott 1978, Walker 1983) (Fig. 5). These niches result from thermal and mechanical erosion and undercutting of banks by currents and waves. They extend laterally into bank sediments, which eventually collapse into the river (Fig. 6). Niches

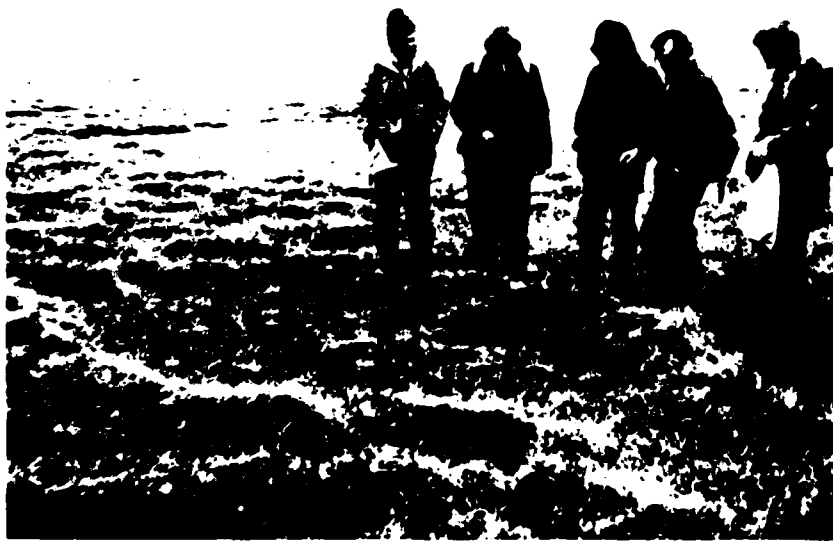
*Figure 8. Large frost scar at Prudhoe Bay. This scar has a hummocky raised marginal ring typical of many frost scars on wetter terrain in the region. (Photo by D.A. Walker, Aug 1974.)*

Frost scars (Fig. 8) are analogous to small-scale anthropogenic disturbances. In fact, frost scars are often a major part of anthropogenic disturb-

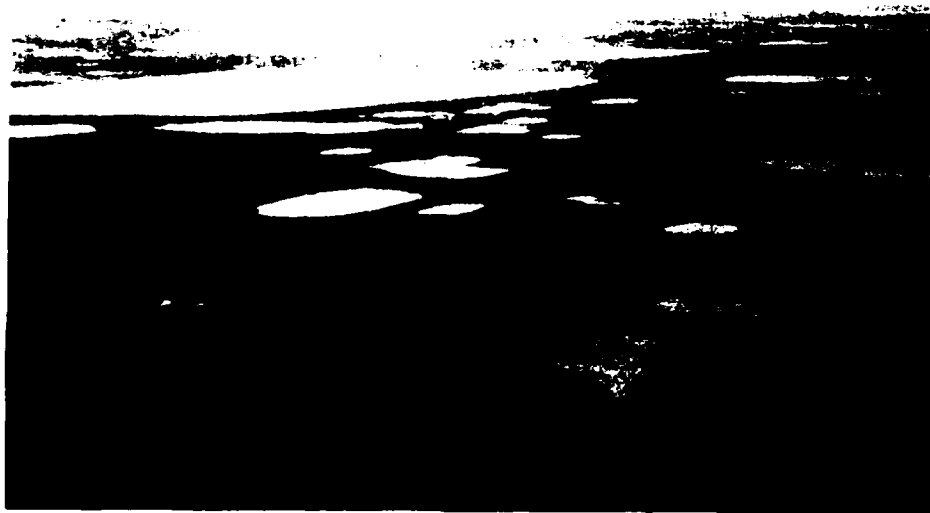
*Figure 12. Peat road near Prudhoe Bay. (Photo by D.A. Walker, 27 July 1984.)*

peat roads (Fig. 12, 13). These roads were made by removing peat from both sides of the road and piling the material in the center to form a raised surface. The scraped margins of the roads quickly subsided due to the thermal erosion, particularly along ice wedges. Bulldozing the tundra for roads is prohibited today.

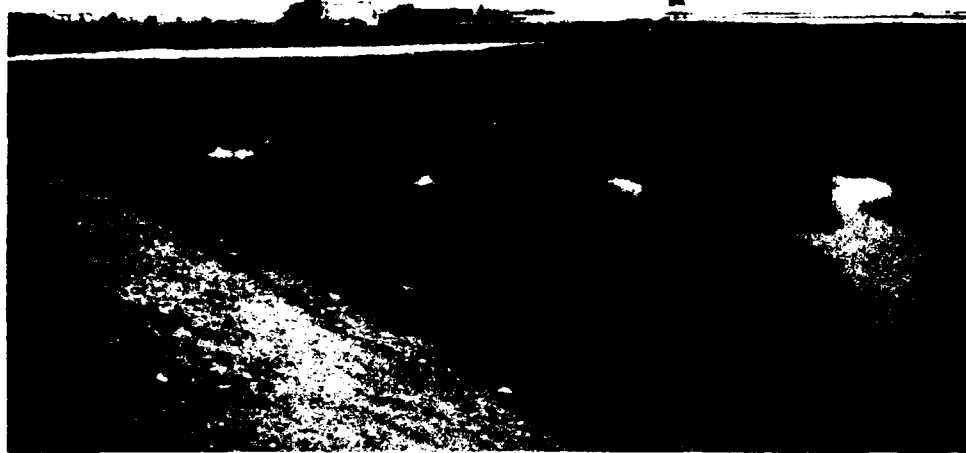
*Figure 29. Roadside environment along the Prudhoe Bay Spine Road. Note the barren area caused by dust and water-filled ice-wedge polygon troughs. High-centered polygons have formed since the road was built in the 1970s. (Photo by D.A. Walker, 16 Aug 1983.)*
