11. TITLE (Include Security Classification) Corrosion of Metals Exposed to Combustion Products Generated During Shipboard Fires		10. SOURCE OF FUNDING NOS.

12. PERSONAL AUTHOR(S) E. A. Powell, B. T. Zinn		PROGRAM ELEMENT NO.	
13a. TYPE OF REPORT Final		PROJECT NO.	
13b. TIME COVERED FROM _____ TO _____		TASK NO.

CORROSION OF METALS EXPOSED TO COMBUSTION PRODUCTS
GENERATED DURING SHIPBOARD FIRES

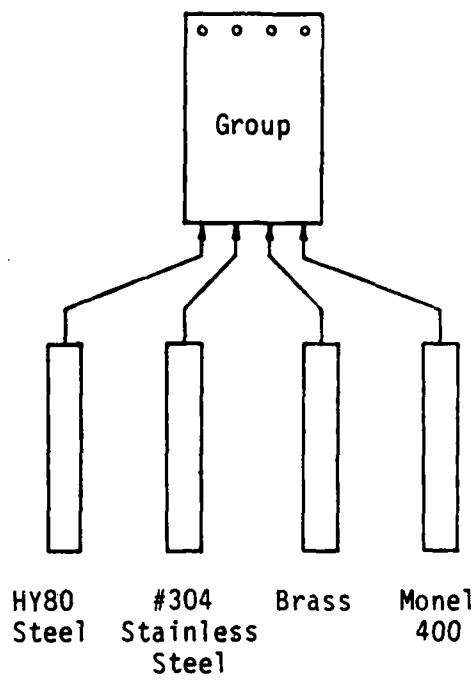
Figure 5. Specimen Mounting Configuration for Test W-11.

Installation in Mounting Racks. The coupons for both vertical stations were installed in their mounting racks a few hours before the fire tests. Due to the complexity of the flow patterns and smoke movement in the fire compartment, it was likely that the deposition of smoke particulates on the metal coupons would be sensitive to location on the mounting rack. Therefore coupons of the same material were not all grouped together on the mounting racks. Instead, the coupons for Test W-11 were divided into 12 groups as shown in Figure 5, with each group containing one coupon of each material (except Monel 400 for a few groups). This arrangement was expected to reduce the possibility of experimental bias due to location on the rack. The coupons

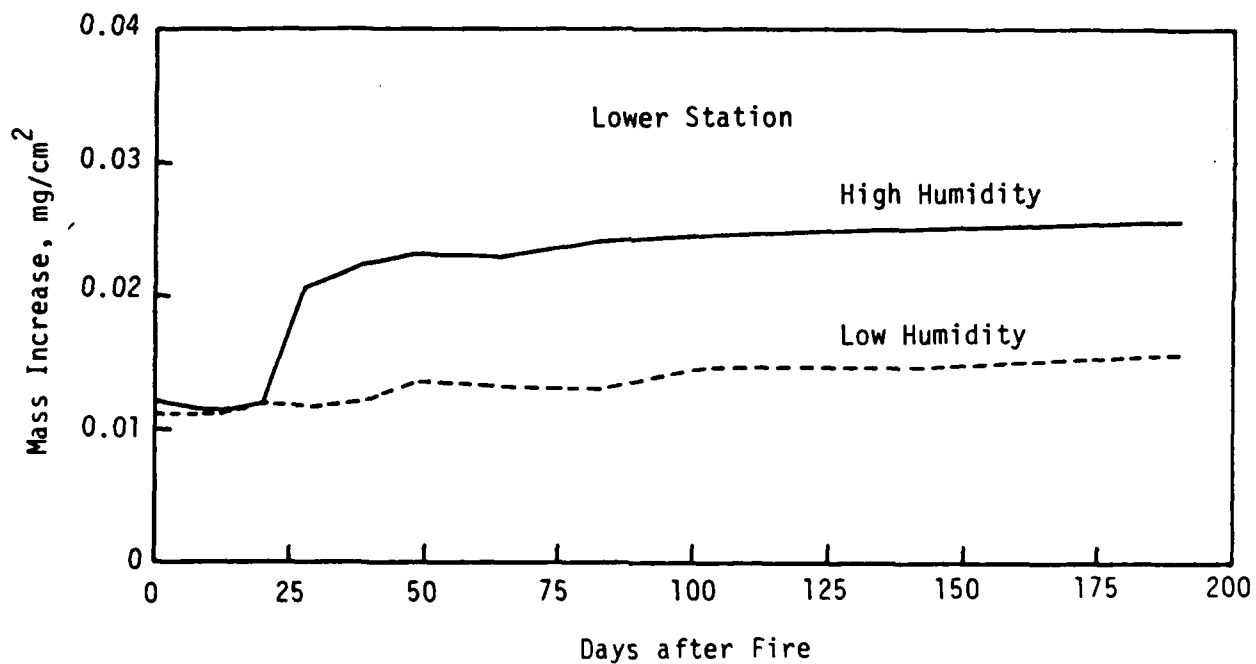
Figure 22. Mass Increases due to Corrosion for Brass for Test W-13 (Nonflaming).

The gravimetric data for the brass specimens are presented in Figures 22 and 23. For the W-13 specimens (nonflaming) in the low humidity group, Figure 22 shows that a slow steady increase in mass occurred during the post-fire period, but that this mass increase was small compared to the initial mass increase incurred during the fire. For the specimens in the high humidity group, an additional rapid mass increase occurred during the first eight days of the high humidity phase with very little further mass increase afterwards. As in the case of stainless steel, this increase in mass with the onset of high humidity was probably due to water adsorption. The amount of adsorbed water was about $.01 \text{ mg/cm}^2$ regardless of the vertical location of the specimens. Figure 23 shows a similar behavior for the W-13A (flaming) specimens from the lower station, with a much larger water adsorption of about 0.12
