INVESTIGATION OF THE STRESS CORROSION CRACKING
SUSCEPTIBILITY OF ANNEALED AND HEAT TREATED
ALLOY 625 CASTINGS AND FORGINGS IN SEA WATER

OCEAN ENGINEERING - COURSE XIII A

Submitted to the Department of Ocean Engineering
on May 8, 1987 in partial fulfillment of the
requirements for Degrees of Ocean Engineer
and Master of Science in Materials Engineering

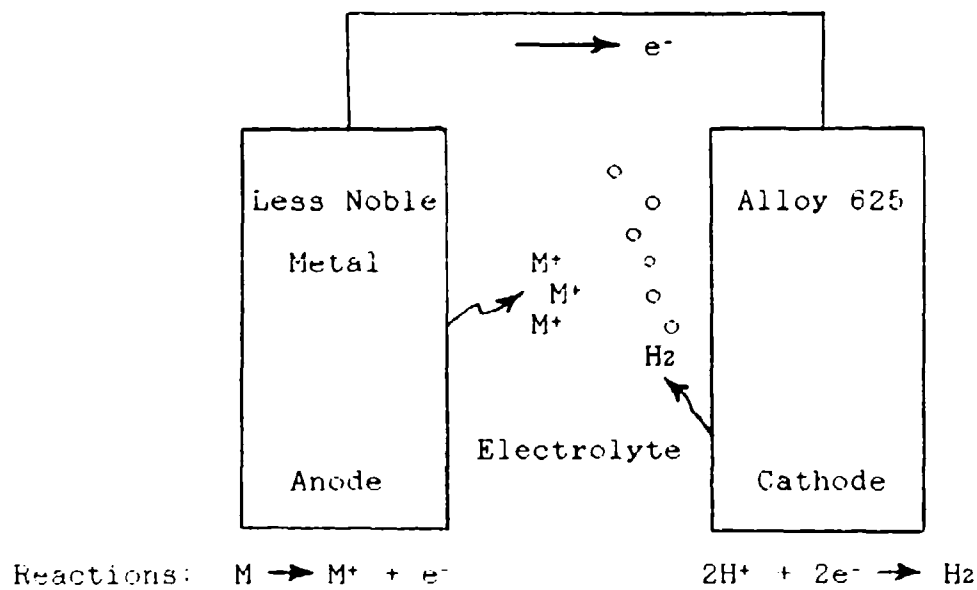
Figure 1 depicts the corrosion cell formed when an alloy is coupled with a less noble metal/alloy in an electrolyte. The less noble alloy undergoes loss of material through an anodic oxidation reaction of metal dissolution producing an excess of electrons, while a more noble alloy supports a cathodic reduction reaction transforming monatomic hydrogen into hydrogen gas, using up

the excess electrons. Either half of this system can be simulated by the application of a potential causing electron flow in the desired direction. The reduction reaction will take place, evolving hydrogen if the electron flow is into the material. The amount of hydrogen produced will be a function of the rate of electron flow. Likewise, the amount of hydrogen diffusion into the alloy will be a function of its availability.

Figure 1 Corrosion Cell Produced When Alloy 625 is Coupled With a less Noble Metal

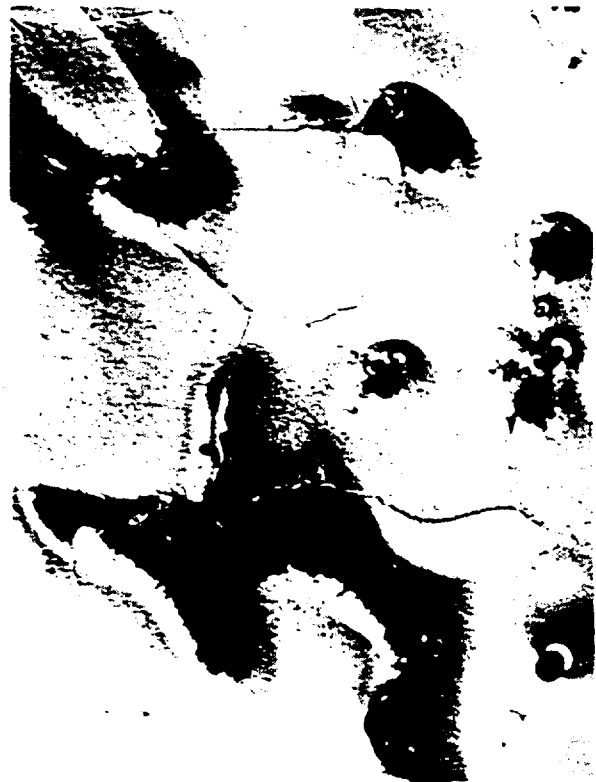
Figure 5 Photomicrographs of "Cast/Homogenized" Alloy 625

The photomicrographs in Figure 5 show the enormous grains that grew during homogenization. The MC carbides have spheroidized in the matrix and a fine film of either $M_{23}C_6$ or M_6C carbides was formed along the grain boundaries. The segregation and dendritic structure was completely eliminated by using such a high temperature (2225-2250°F) for homogenization.

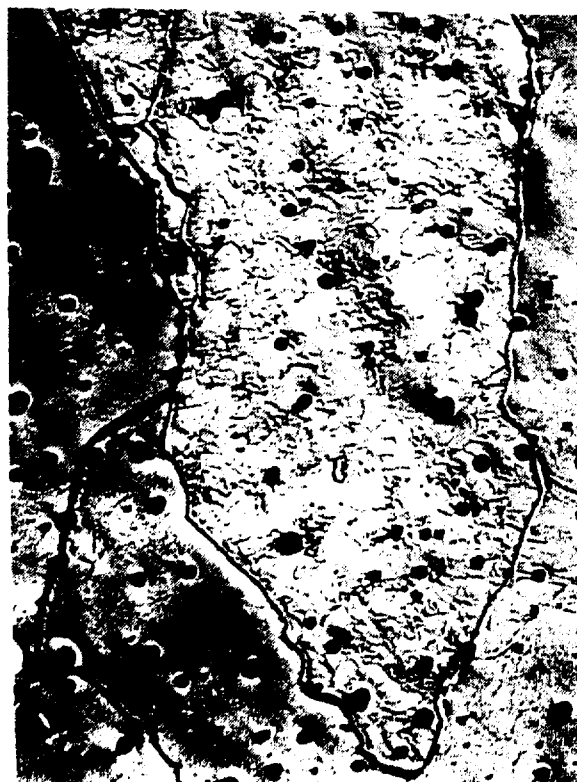
Figure 8 Photomicrographs of "Forged/Annealed" Alloy 625

Figure 8 shows the results of forging and annealing Alloy 625. The grain size is about an ASTM 6. There are discontinuous blocky carbides along the grain boundaries. The bottom right photomicrograph shows a secondary phase precipitated out from the grain boundaries that appears to be gamma prime. There is still a high percentage of blocky spheroidized MC carbides dispersed throughout the matrix.

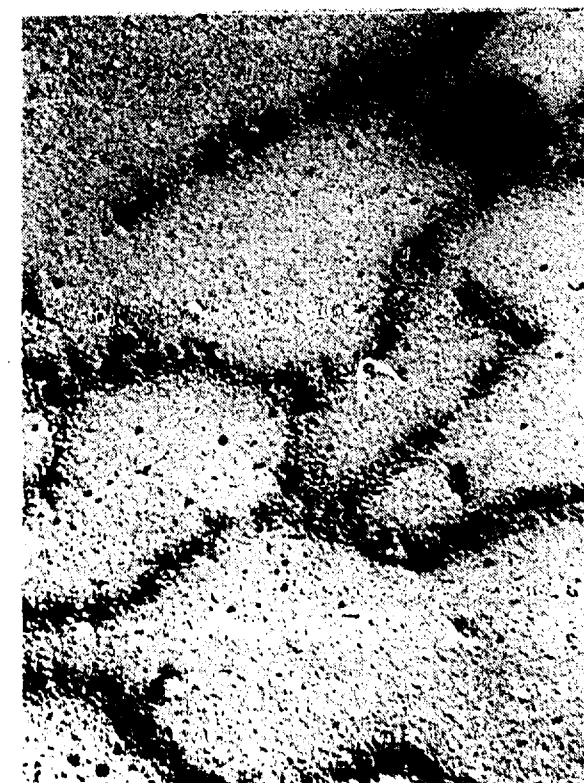
Figure 9 Photomicrographs of "Forged/Heat Treated"
Alloy 625

Heat treating the forged material caused some grain growth and enlargement of the grain boundary carbides as shown in Figure 9. Again the heat treatment caused dislocation slip bands to appear throughout the matrix.

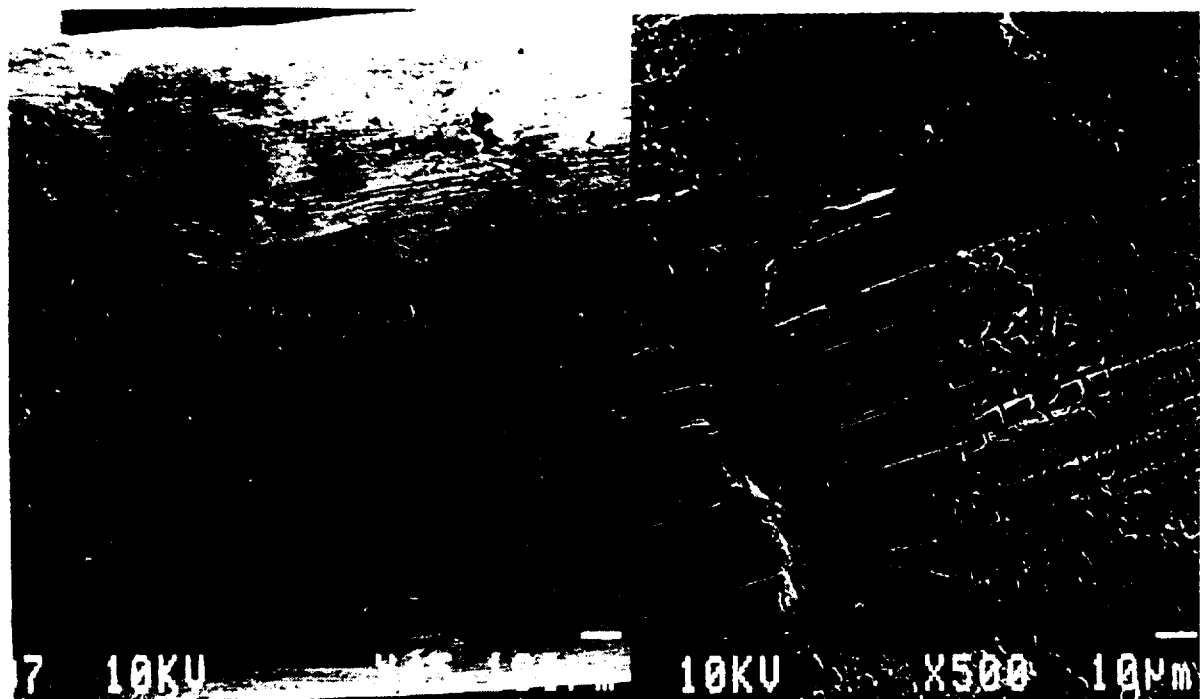
Figure 21 Photomicrographs of "As Cast" Alloy 625
Elongated Gage Length for Air and +1.0 Volt
Test Conditions - Specimens 4 and 7

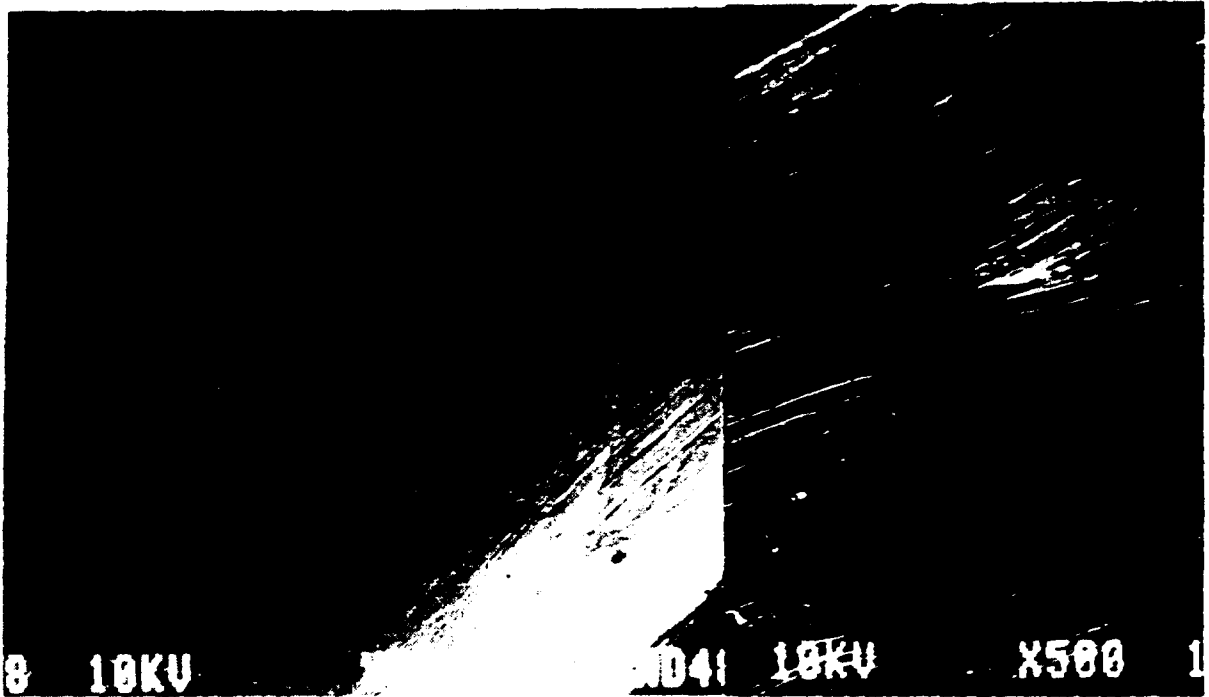
Figure 22 Photomicrographs of "As Cast" Alloy 625
Elongated Gage Length for -1.0 and -3.0 Volts
Test Conditions - Specimens 8 and 9

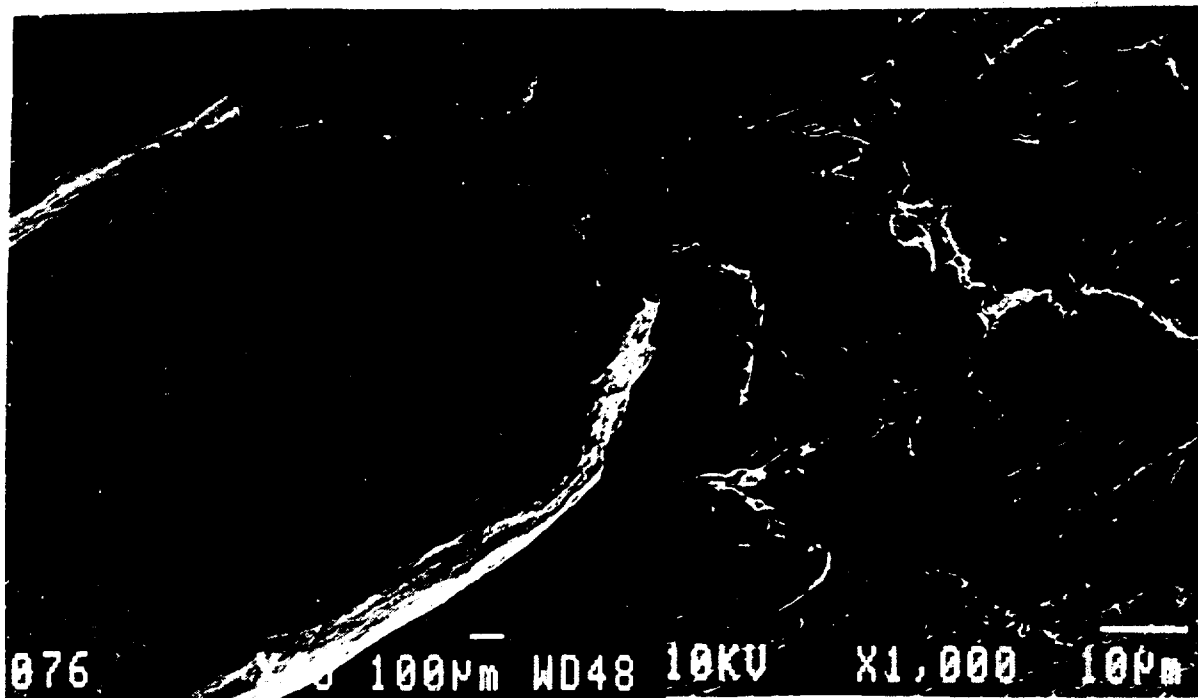
Figure 24 Photomicrographs of "Forged/Annealed" Alloy 625
Elongated Gage Length for Air and Sea Water
Test Conditions - Specimens 76 and 78

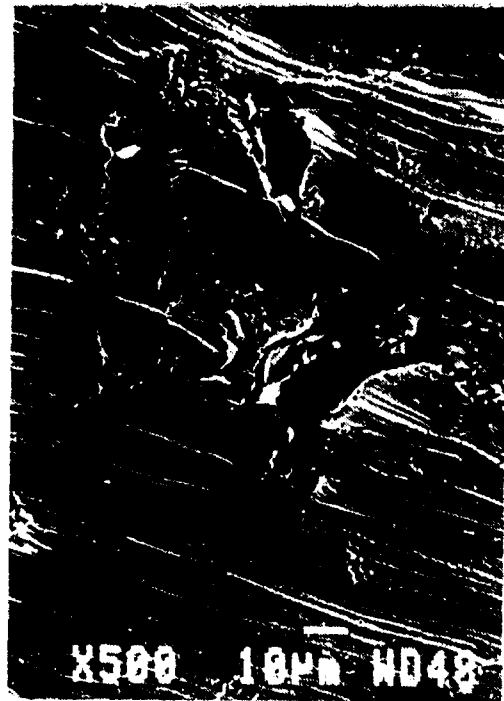
Figure 25 Photomicrographs of "Forged/Annealed" Alloy 625
Elongated Gage Length for +1.0 and -1.0 Volts
Test Conditions - Specimens 81 and 83

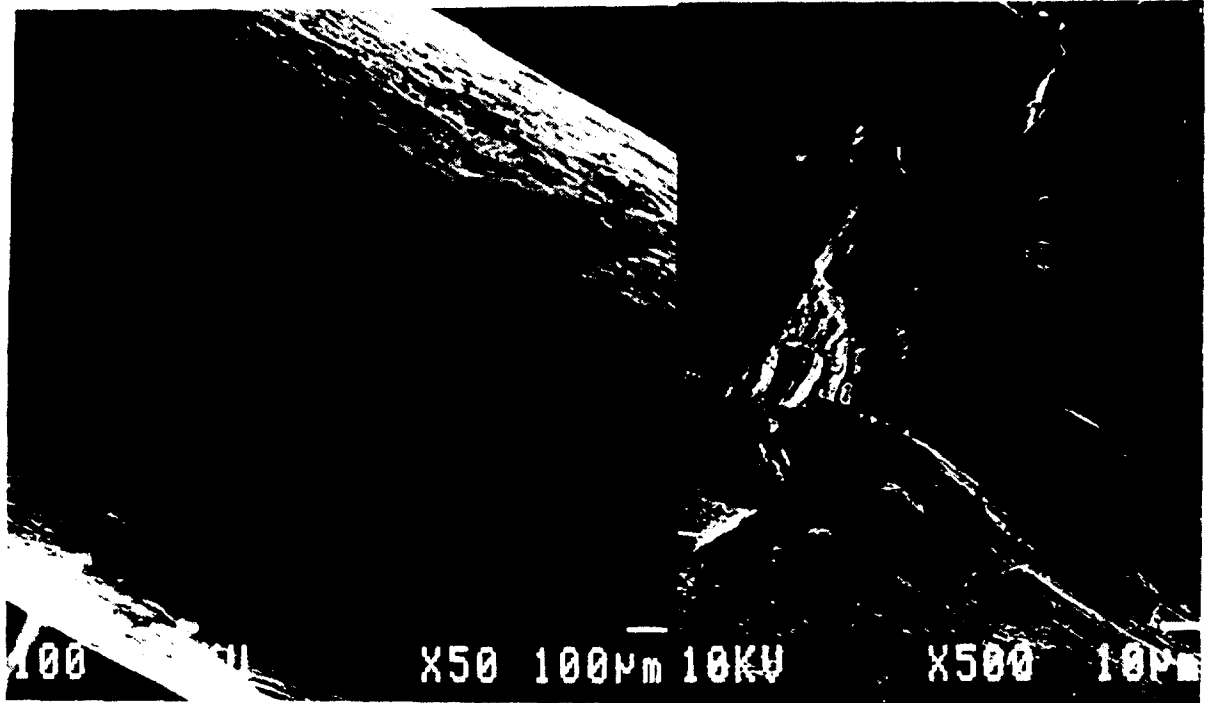
Figure 27 Photomicrographs of "Forged/Heat Treated"
Alloy 625
Elongated Gage Length for -1.0 and +1.0 Volts
Test Conditions - Specimens 100 and 101

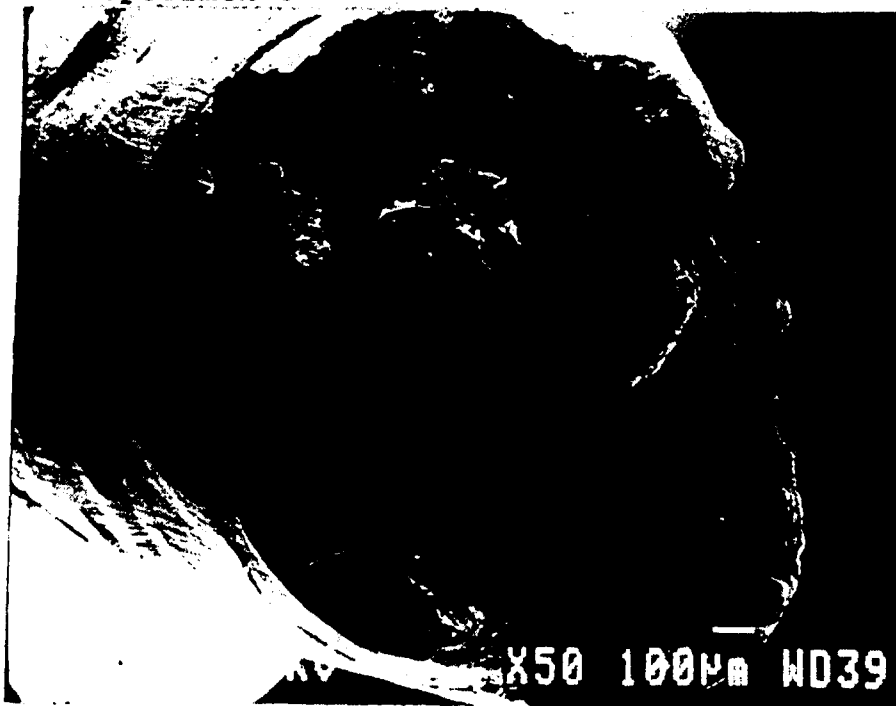
Figure 29 Photomicrographs of "As Cast" Alloy 625
Fracture Surface for -3.0 Volts Test Condition
Specimen 9

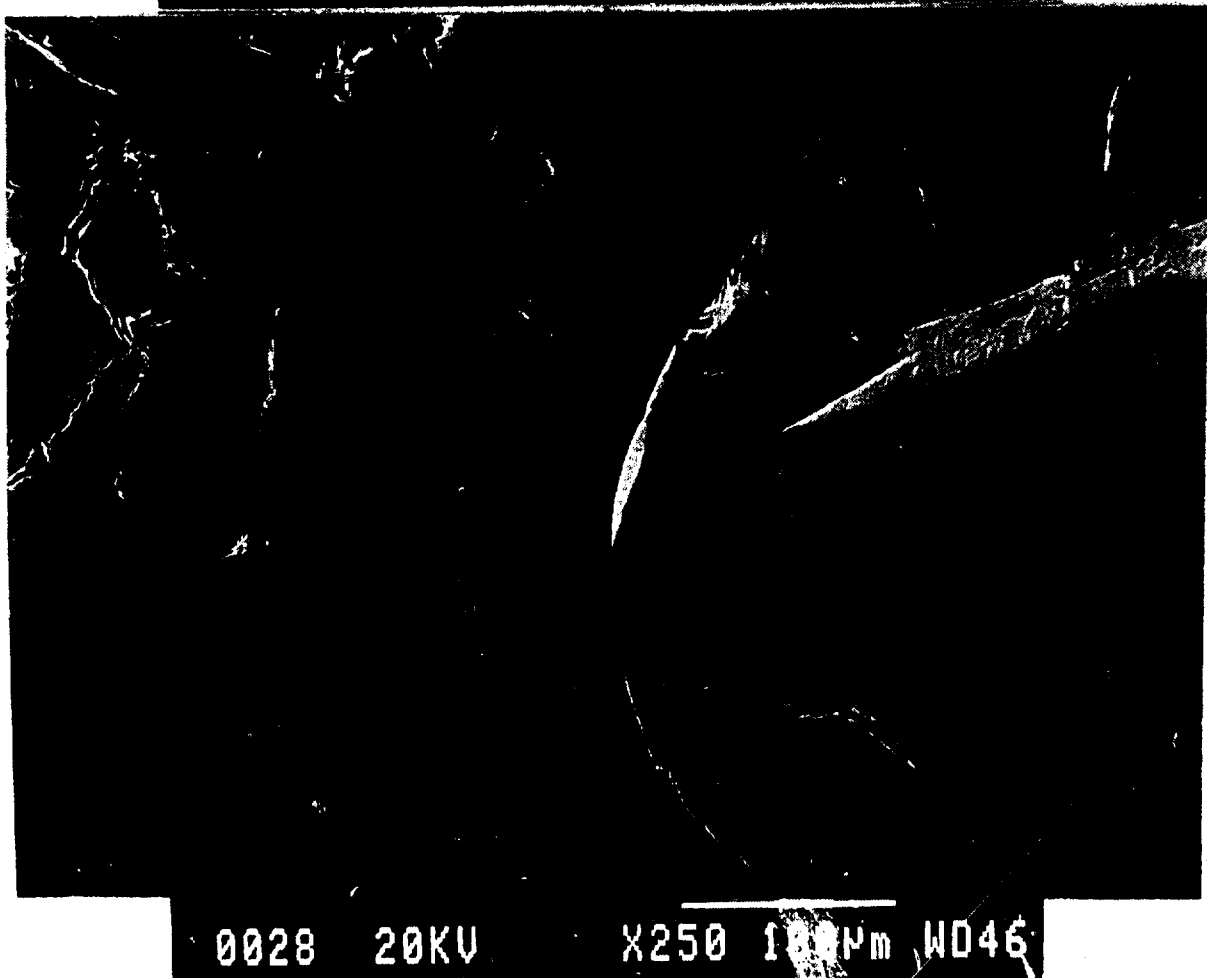
Figure 31 Photomicrographs of "Cast/Homogenized" Alloy 625
Fracture Surface for -1.0 Volt Test
Condition - Specimen 28

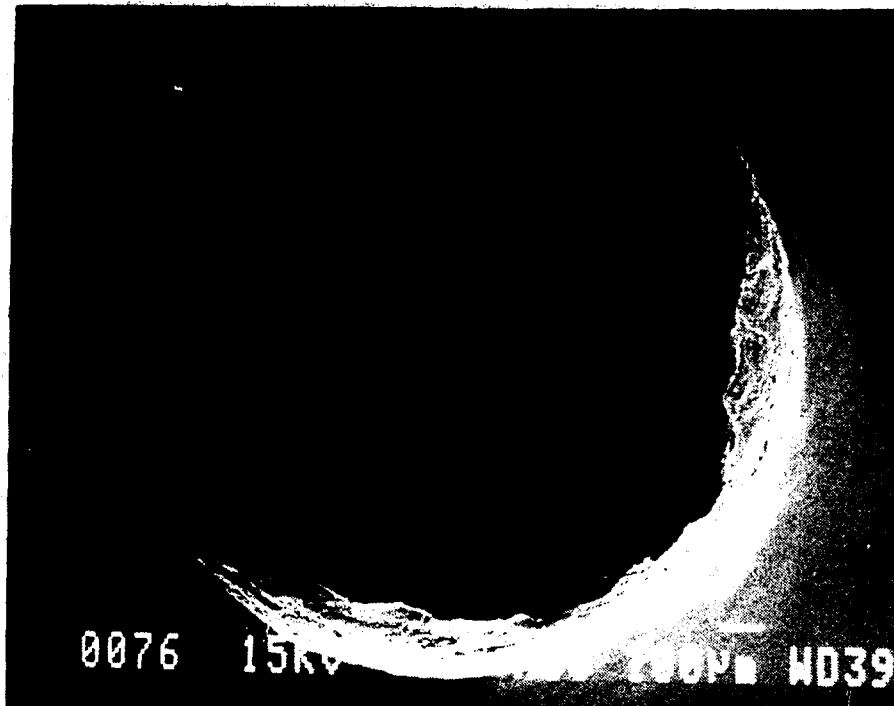
Figure 32 Photomicrographs of "Forged/Annealed" Alloy 625
Fracture Surface for Air Test Condition
Specimen 76
