Special Report 86-29

October 1986

Blistering of built-up roof membranes Pressure measurements

Charles Korhonen

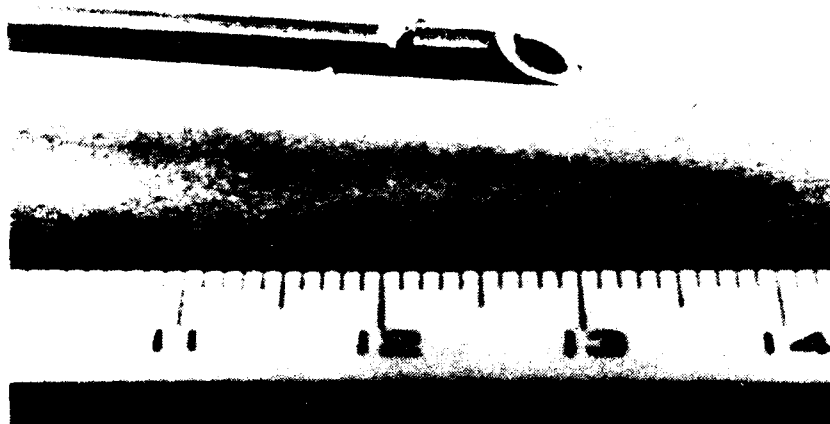
Figure 2. Close-up of the side-vented needle fabricated from 1/8-in. O.D. stainless steel tubing.

Internal pressures were measured by inserting a hypodermic-type needle through the wall of a blister (Fig. 1). For this operation a side-vented needle (Fig. 2) worked best. Needles that were open only at the end became plugged with bitumen. The needle was sealed to the pressure sensing port of the Microswitch sensor. The sensor's other port was connected to a plastic tube vented in a bottle of desiccant at atmospheric pressure. This prevented moisture from entering the port and damaging the sensor.

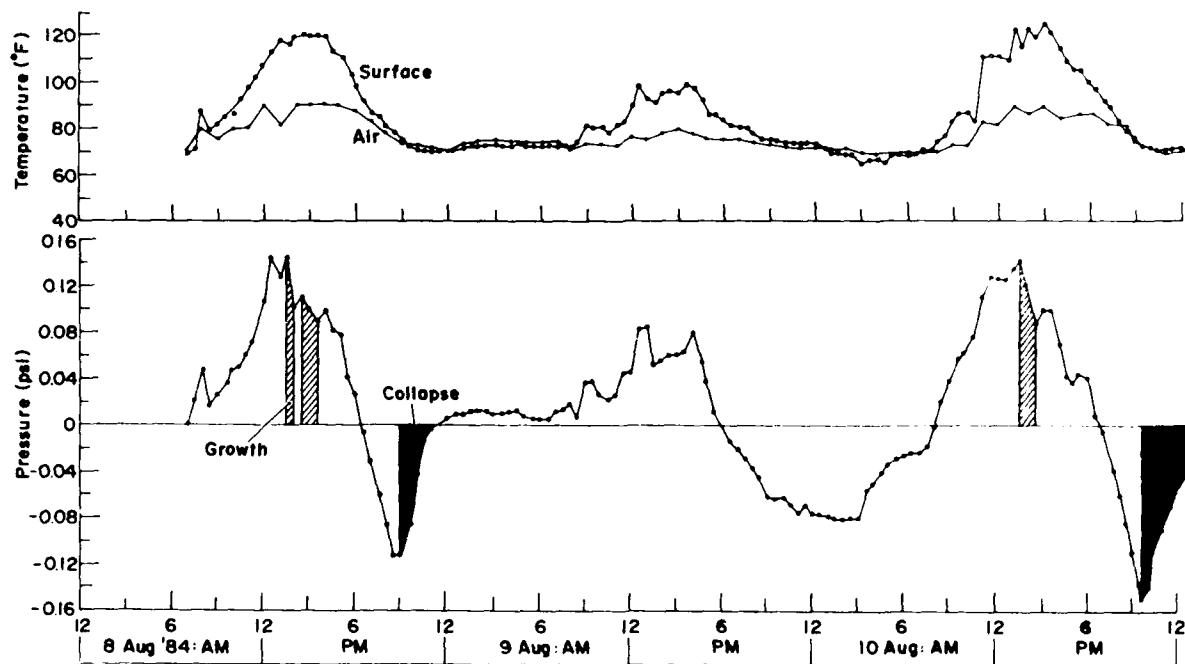
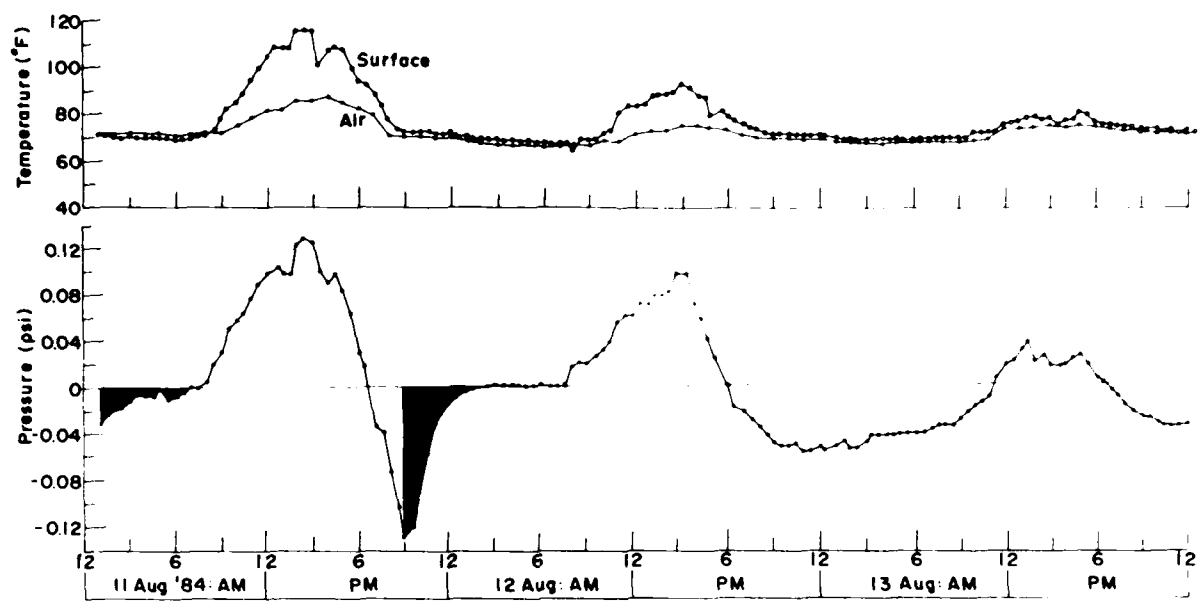
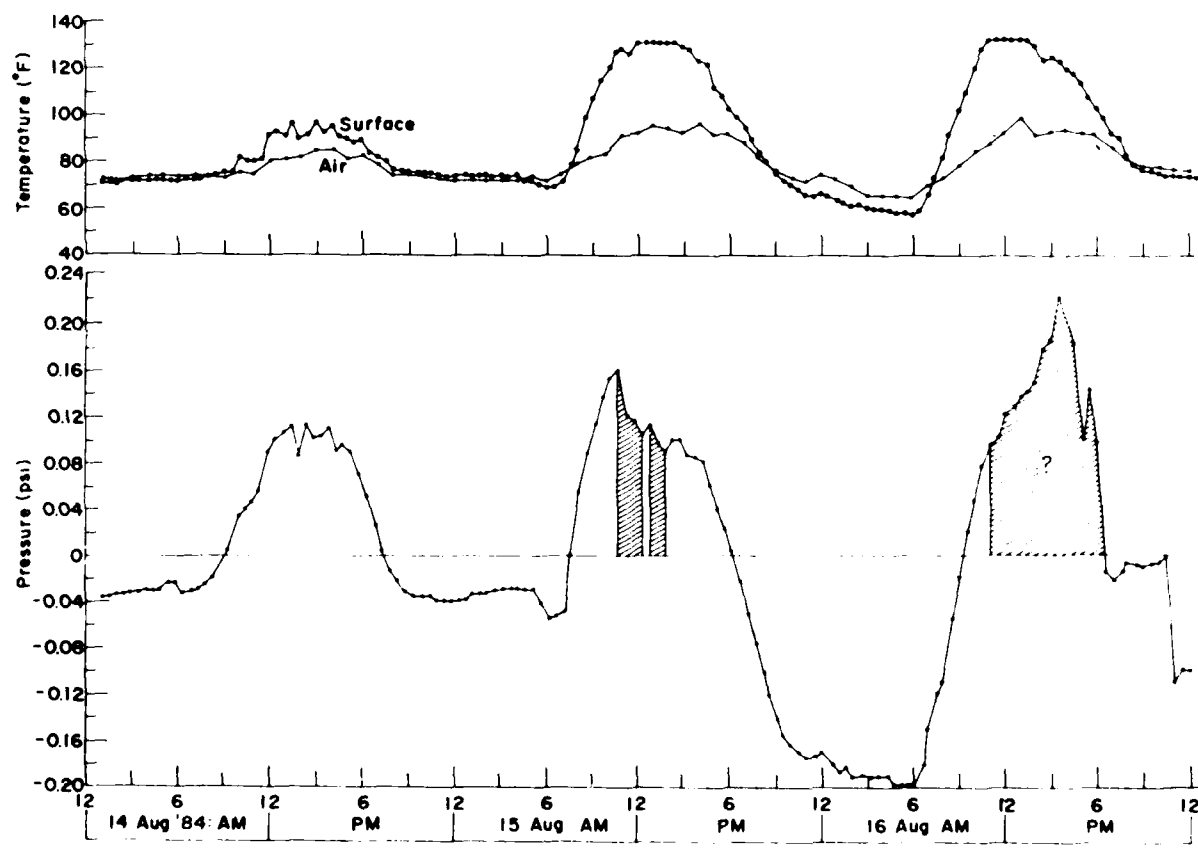
Figure 7. Temperatures and pressures for the Devens blister.

Figure 7 (cont'd). Temperature and pressures for the Devens blister.

Surface temperatures and internal pressures for each blister are shown in Figures 7-11. As can be seen, changes in roof surface temperature reflect changes in blister pressure. The pressures range from positive (above atmospheric pressure) during the heat of the day to negative (partial vacuum) during the cool of the night. If a blister were completely sealed and rigid, its internal pressures could be determined by referring to Figure 12, which was derived from the ideal gas law.

In over thirty days of field testing I found obvious indications of blister growth on only four days. On 8 August (Fig. 7), for example, the roof surface temperature at Fort Devens rose to a high of 120°F at 2 pm and held there for two hours. The pressure, meanwhile, rose to a high of 0.14 psi at 12:30 pm, dropped to 0.13 psi at 1 pm, and rose again to 0.14 psi at 1:30 pm. At 2 pm, when the surface temperature was still high, the pressure rapidly fell to 0.09 psi. This rapid drop in pressure, when it should have remained high, must be caused by an increase in the volume of the blister, as opposed to a sudden venting. In other words, the blister grew.

Nighttime temperatures significantly affect the daytime growth of a blister. During the evenings of 8, 10 and 11 August (Fig. 7) the roof surface temperatures remained at approximately 70°F from 11 pm until morning. The vacuum, instead of also remaining stable, began to rise rapidly shortly before midnight on each night. In these cases the blister walls were not rigid enough to resist the vacuum, so they partially collapsed, as indicated by the rapid pressure change. Collapses such as these inhibit growth the following day by reducing the amount of air that is drawn into a blister at night. For example, on the day following the 10 August collapse, no growth (that is, no sudden drop in pressure) was evident even though the temperatures were sufficiently high.

When nighttime collapses do not occur, on the other hand, the potential for growth is increased. On the evening of 15 August (Fig. 7), for example, the blister vacuum steadily increased as the temperature dropped. No sudden pressure change, indicating a collapse, was evident, so air must have been drawn into the blister all night. Consequently, daytime blister pressures were considerably higher on 16 August than on 15 August even though surface temperatures were essentially the same on each day. Of the four days of growth, the most growth appears to have occurred on 16 August (Fig. 7).

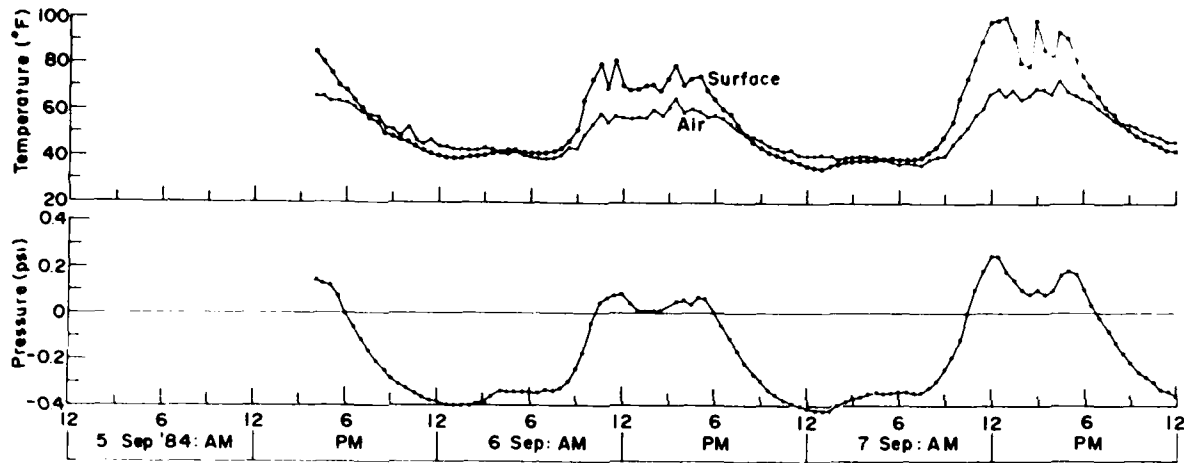
Figure 8. Temperatures and pressures for CRREL blister #1.

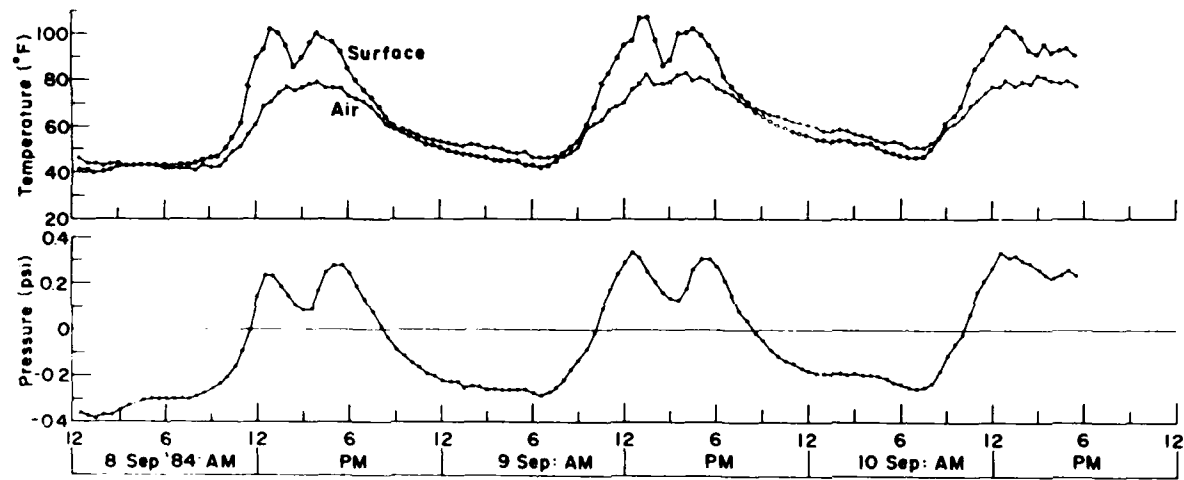
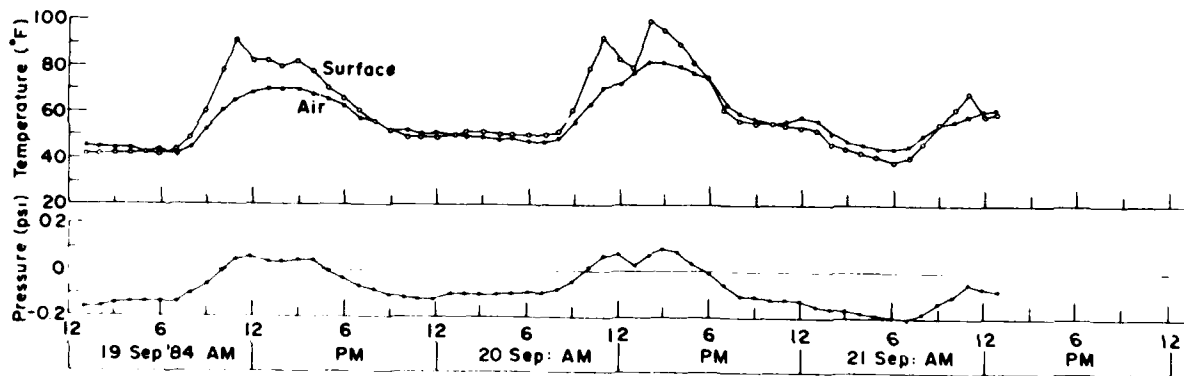
Figure 9. Temperatures and pressures for CRREL blister #2.

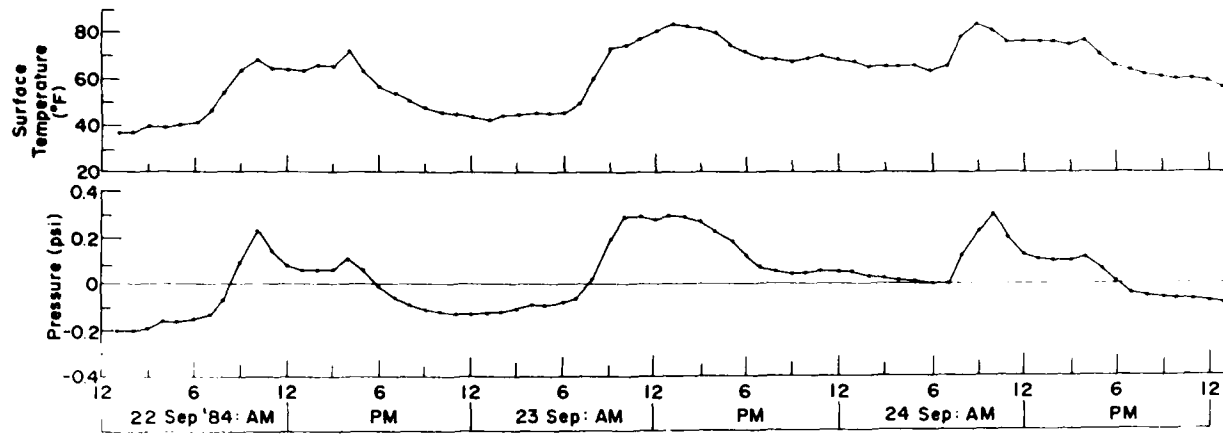
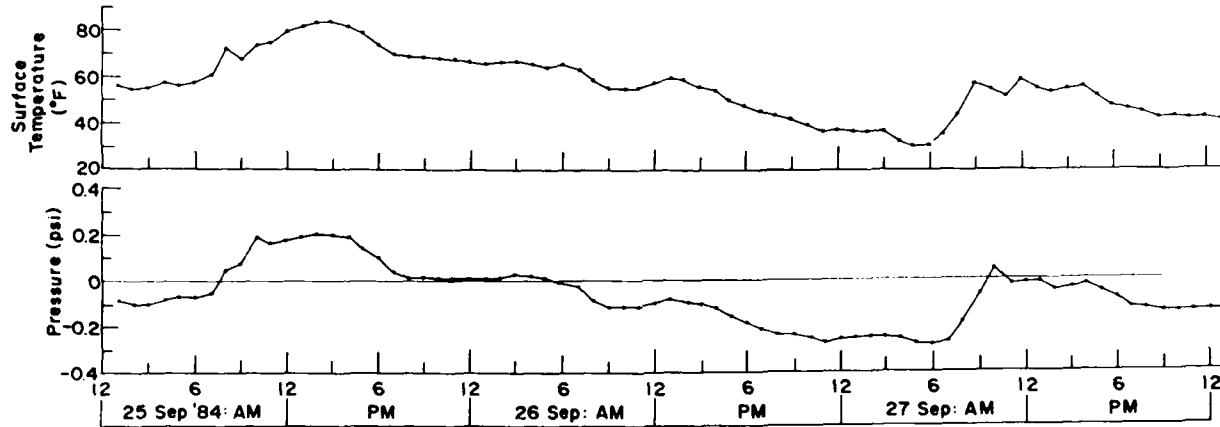
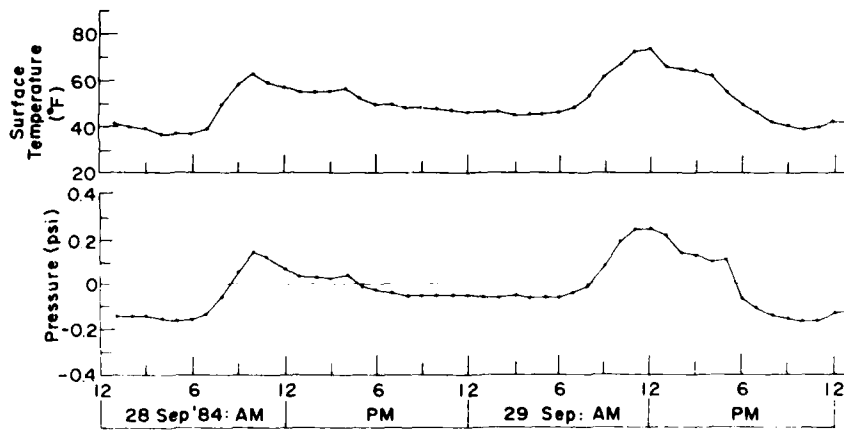
Figure 10. Temperatures and pressures for CRREL blister #3.

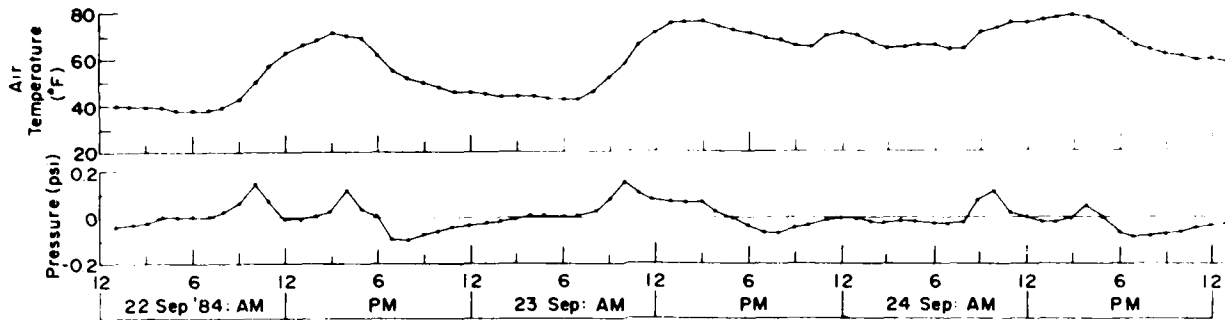
Figure 11. Temperatures and pressures for CRREL blister #4.

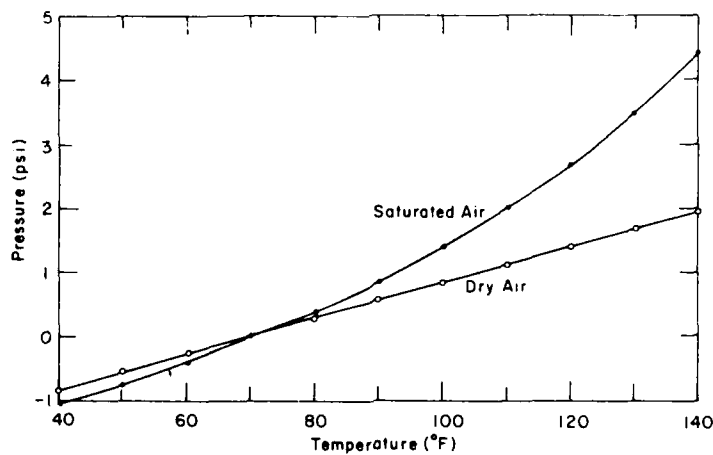
Figure 12. Pressure increases of dry and saturated air.

Comparison with Figures 7-11 shows that measured pressures are significantly less than Figure 12 would suggest. Figure 12 shows, for example, that dry air at 70°F and atmospheric pressure, when elevated to 100°F,

increases in pressure by 0.8 psi. If that air were saturated with moisture, the pressure increase would be 1.4 psi -- a considerable increase. In comparison, at 11:30 a.m. on 10 August (Fig. 7), the roof surface temperature at Devens was 112°F but the internal blister pressure was only 0.13 psi. Thus, theoretically, dry air alone is all that is required to create these pressures. This lower-than-expected pressure also indicates that air may be slowly escaping from the blister or that the blister may be expanding in volume or both.

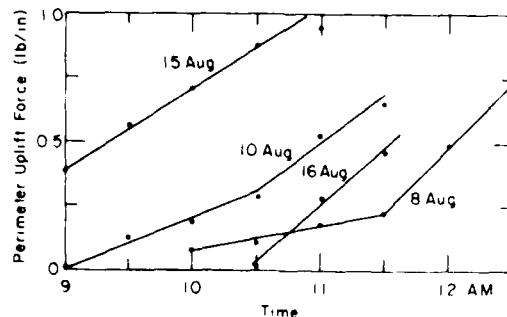
Figure 15. Perimeter uplift force vs time prior to growth.

Table 2 lists these forces along with the roof temperature for the four days when growth was evident. The rate of increase in uplift force along the perimeter of each blister just prior to growth (sudden pressure drop) is shown in Figure 15.

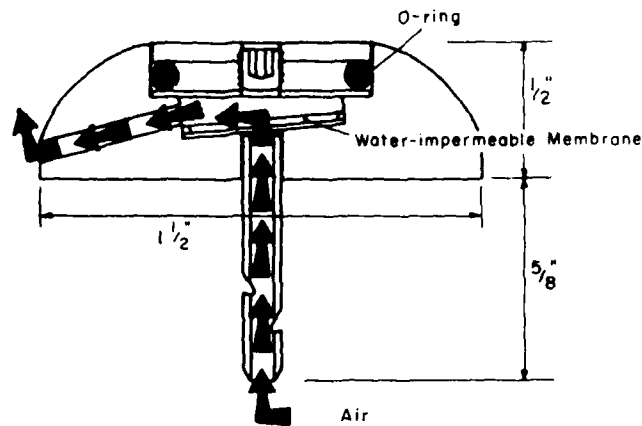
Figure 17. Blister pressure relief valve.

maintenance might not be required at all. To stop blister growth, I devised a pressure relief valve (Fig. 17). It consists of a membrane, permeable to air but impermeable to liquid water, enclosed in a small housing attached to a needle. I tested this device by inserting the needle into a blister. Figure 18 shows that it worked as planned. No pressure developed after the valve was installed. Because the pressure valve is small, its vulnerability to damage from foot traffic is also small. I walked on it several times on a cool day without dislodging it from the roof. In fact, when it was necessary to remove it, I had to pry it loose with a screwdriver. Although more field testing is needed, these devices appear to have the potential to "kill" blisters when they are small. An application for Army patent rights has been filed.

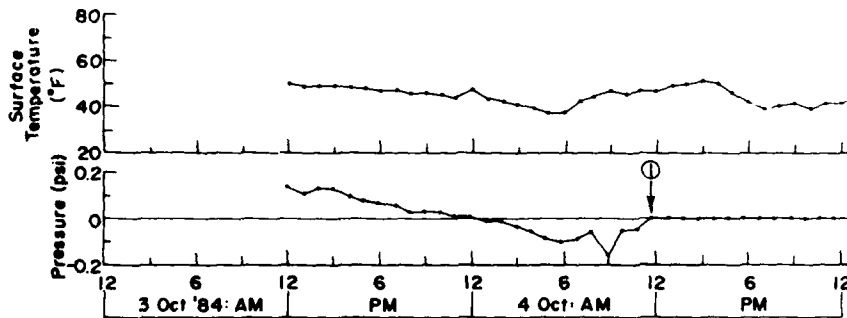
Figure 18. Temperatures and pressures before and after valve was installed (1) into blister.

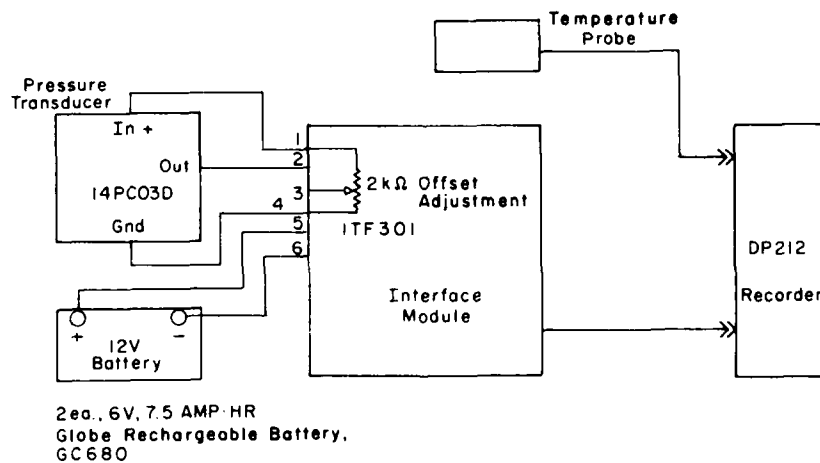
Figure A1. Data acquisition system.

An 8.0-V DC supply voltage was selected to produce a transducer output of exactly 1.0 V per psi, with a 3.5-V offset at ambient atmospheric pressure (Fig. A1). A 2-K Ω , 22-turn resistance potentiometer,* connected across the transducer's voltage supply, was adjusted to produce a transducer offset of 0.50 V at atmospheric pressure. This allowed pressures to be read in the range of -0.50 psi to 1.5 with a 0-2.0 V output.
