Naval Weapons Development & Engineering Center
P.O. Box 10000, Orlando, Florida 32816-0000

Report 2489

Stressed Fabric Abrasion Test Procedure for Urethane Coated Fabric Fuel Tanks

Report Date: June 1988

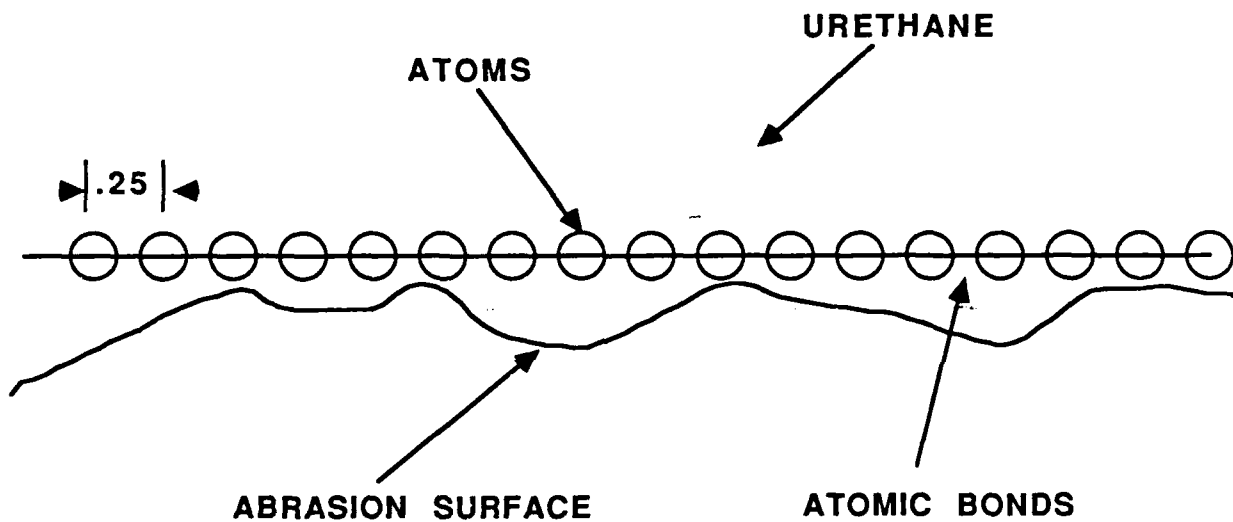
Figure 1. Urethane Unstressed

In urethanes, adhesive abrasion occurs when the adhesive force between adjoining materials is stronger than the chemical bond in the polymer chain. When an atom is removed through this process, the chain is weakened and wear occurs more rapidly. When a urethane is under a tensile stress, the chemical bonds are spread out and adhesive wear can occur with less of an atomic force applied (see Figures 1 and 2). For the same reason, mechanical friction occurs more readily when the urethane is under a tensile stress.

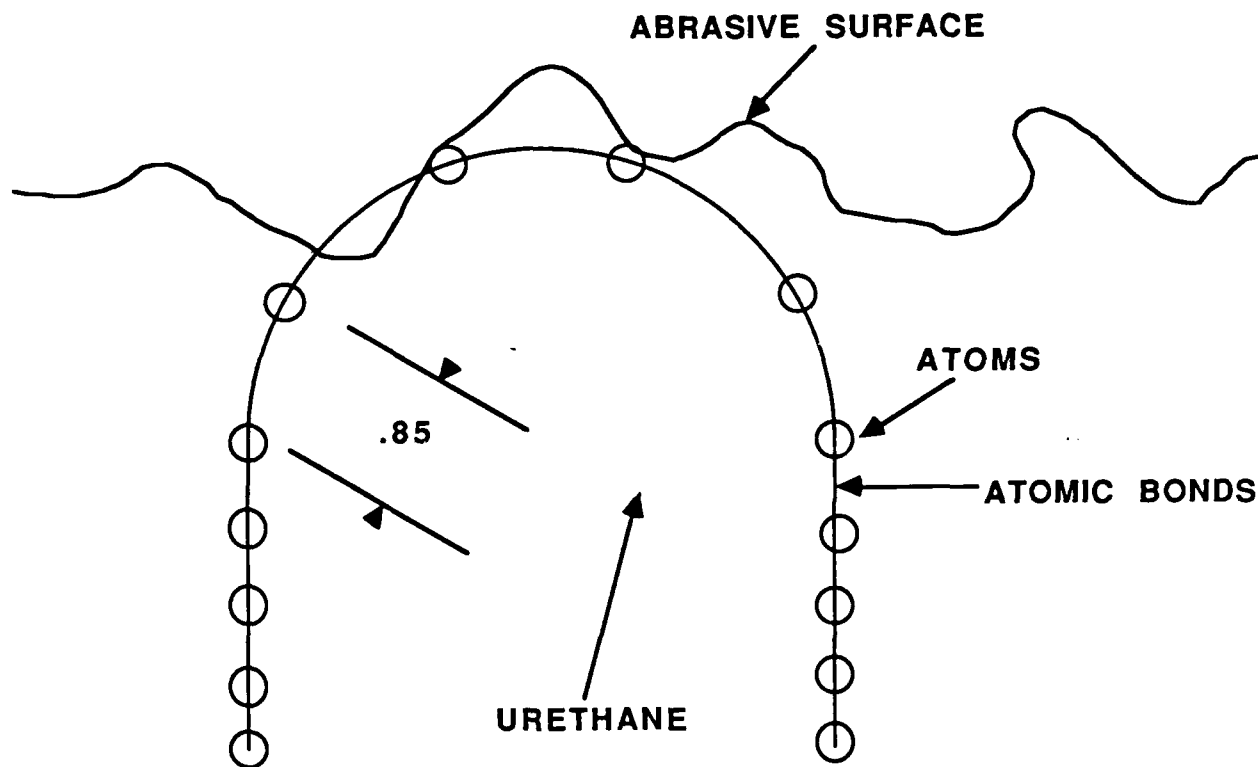
Figure 2. Urethane Stressed

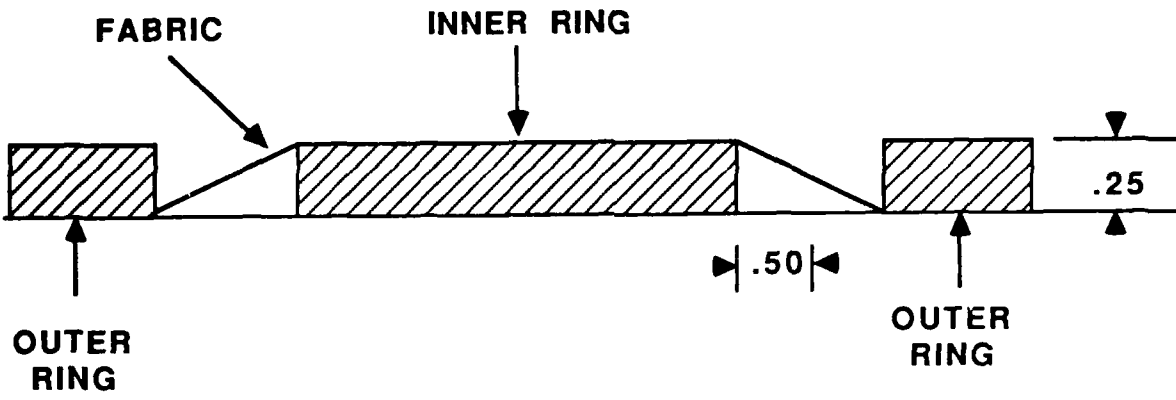
Figure 3. Stressed Abrasion Tester

For this test, an apparatus was designed and made that placed the urethane under a constant and reproducible stress. Because putting material into a compound fold configuration would make the test dependent on the thickness of the material, this solution was unacceptable. Instead, a Taber Abrader was modified to accept a platen that would be adjustable for height in the center with a ring on the outside edge to clamp the material down (Figure 3). In use, the material would be placed

on the platten with the center ring in the down position. After the material is secured to the outer ring, the center section would be raised to a height of $\frac{1}{4}$ inch. The vertical distance between the edge of the center section and the outer ring is $\frac{1}{2}$ inch, giving the material a bend of -30° from the horizontal position (Figure 4). A ceramic abrader wheel (Figure 3) Calibrade H-18 manufactured by Taber Instruments was mounted onto a swivel arm so that the edge of the wheel would ride on the crease created by the platten at an angle of 10° from the horizontal plane. The sample was then subjected to a number of cycles sufficient to expose the base fabric. The ceramic wheel was resurfaced every 500 cycles to minimize error associated with clogging or a worn surface. A standard Taber Abrader was used to gather information about the abrasion characteristics of an unstressed sample from each material.
