TECHNICAL REPORT CERC-88 10

ST. PAUL HARBOR BREAKWATER STABILITY STUDY ST. PAUL, ALASKA

Hydraulic Model Investigation

September 1988
Final Report

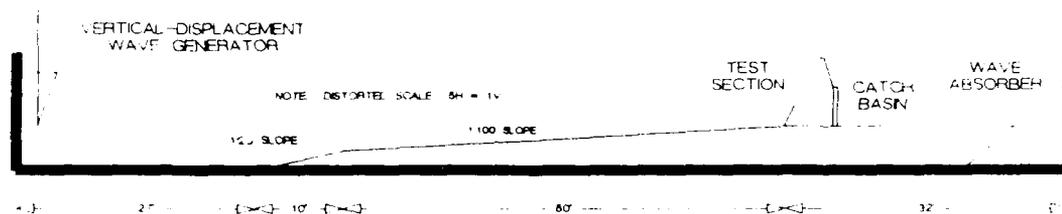
Figure 3. Wave flume cross section

9. All stability tests were conducted in a 5-ft-wide, 4-ft-deep, 119-ft-long wave flume equipped with a vertical-displacement wave generator capable of producing monochromatic waves of various periods and heights (Figure 3). The sea-side toe of the breakwater was located 87 ft from the wave generator, and was preceded by 50 ft of 1:100 slope, 10 ft of 1:20 slope, and 27 ft of flat bottom. Thus, the structure toe was 1 ft above the flat bottom of the wave flume.

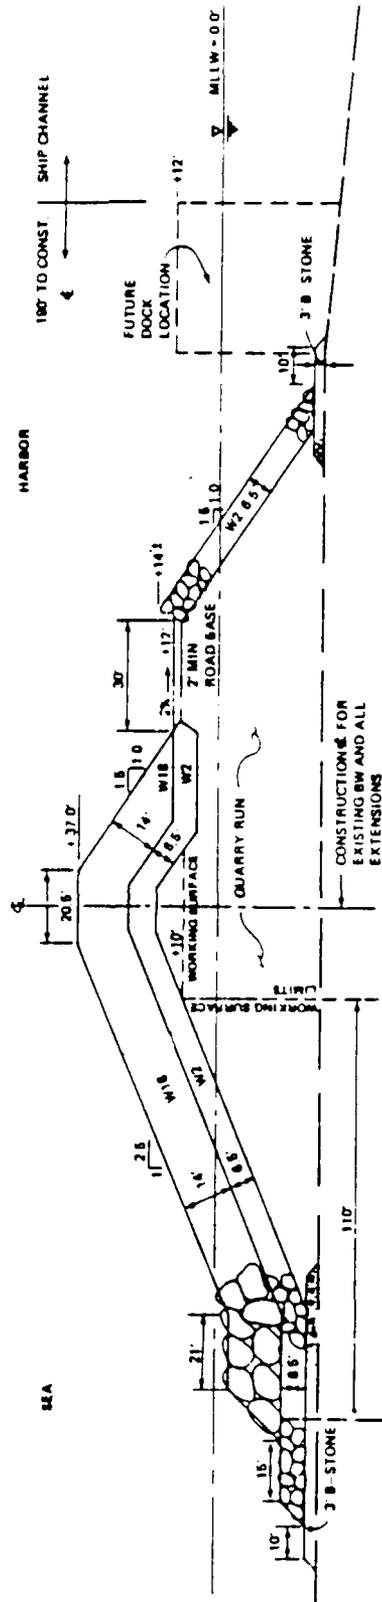
Figure 4. Proposed design of St. Paul Harbor breakwater extension

11. The breakwater design proposed by Tetra Tech, Inc.,* is shown in Figure 4. The test section modeled a cross section of the proposed design from the seaward toe to the roadway on the harbor side of the structure, including the core, bedding layer, underlayer, and primary armor layer.

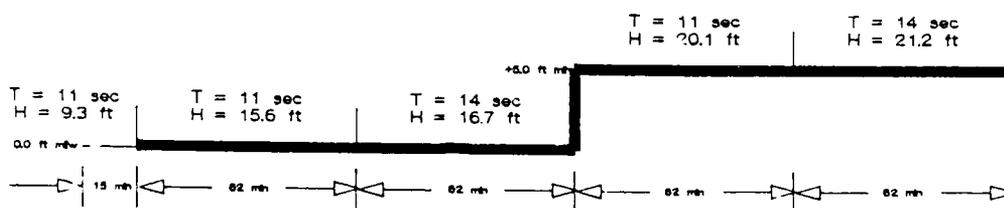
Step	Still-Water Level ft, mllw	Wave Period sec	Wave Height ft	Test Duration min	Wave Type
	0.0	11.0	9.3	15.5	Shakedown
1	0.0	11.0	15.6	62.0	Breaking
2	0.0	14.0	16.7	62.0	Breaking
3	5.0	11.0	20.1	62.0	Breaking
4	5.0	14.0	21.2	62.0	Breaking

Figure 5. Hydrograph for stability tests

represented typical prototype consolidation caused by wave action during construction. Maximum breaking wave conditions were then used for the remainder of the hydrograph, which consisted of 62 min of 11-sec waves followed by 62 min of 14-sec waves, both at a swl of 0.0 ft mllw, then 62 min of 11-sec waves and 62 min of 14-sec waves at a swl of +5.0 ft mllw. The stability hydrograph represented a storm of 4-hr and 8-min duration, after shakedown. The stability hydrograph is shown in Figure 5.

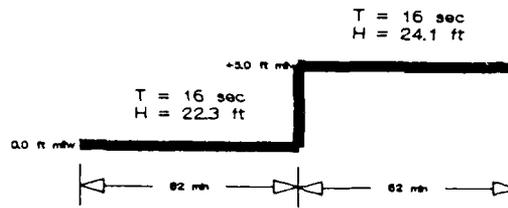
Step	Still-Water Level ft, mllw	Wave Period sec	Wave Height ft	Test Duration min	Wave Type
1	0.0	16.0	22.3	62.0	Breaking
2	5.0	16.0	24.1	62.0	Breaking

Figure 6. Hydrograph for survivability test

31. The structure was not re'uilt after the stability test; therefore, a shakedown was not necessary for the survivability test. Using maximum breaking wave conditions with a 16-sec period, the survivability hydrograph consisted of 62 min at a swl of 0.0 ft mllw followed by 62 min at a swl of +5.0 ft mllw. The survivability hydrograph is shown in Figure 6.

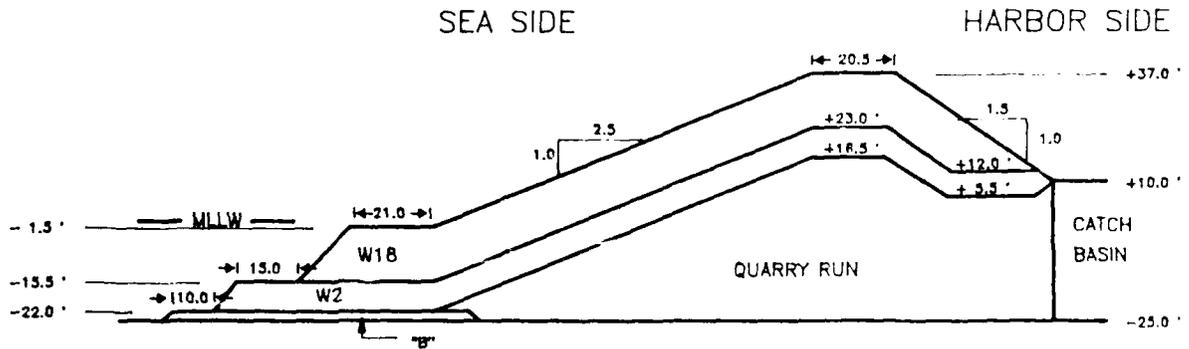
34. Plan 1 (Figure 7, Photos 1-6) modeled a section of the trunk of the proposed breakwater extension as designed by Tetra Tech, Inc.* Prototype dimensions reflected in the model included a crown elevation of +37.0 ft mllw, crown width of 20.5 ft, depth at toe of -25.0 ft mllw, and side slopes of 1:2.5 on the sea-side from the crown to the top of the toe, and 1:1.5 on the harbor side from the crown to a roadway running along the breakwater at an elevation of +12.0 ft mllw.

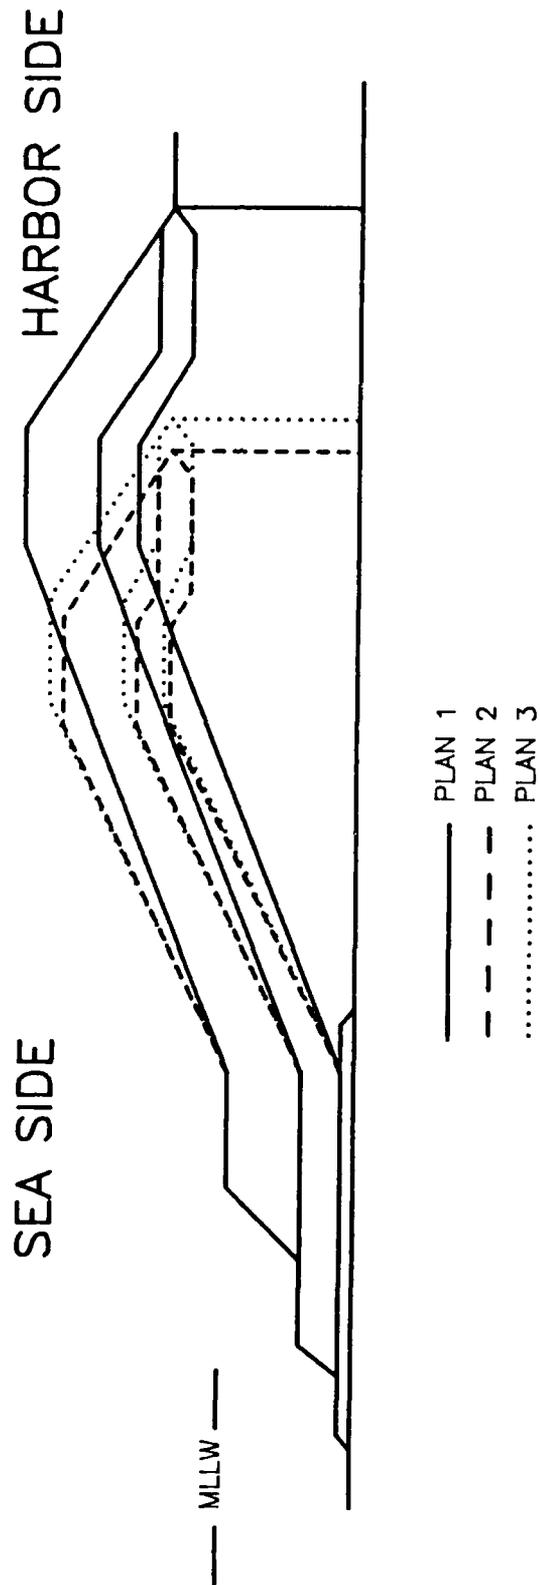
Figure 10. Comparison of Plans 1, 2, and 3, St. Paul Harbor breakwater stability study

60. Plans 1, 2, and 3 are shown together for comparison in Figure 10. All plans tested demonstrated excellent stability on the structure slope and crown, with no stones displaced from either of these areas in any of the tests and only minimal rocking observed. This stability was achieved by the use of special placement techniques, and the assumption that one-half of the stones in the primary armor layer would be parallelepiped-shaped, with the rest of the stones being rough angular. Results given in this report are therefore valid for the prototype only if the following conditions are met:

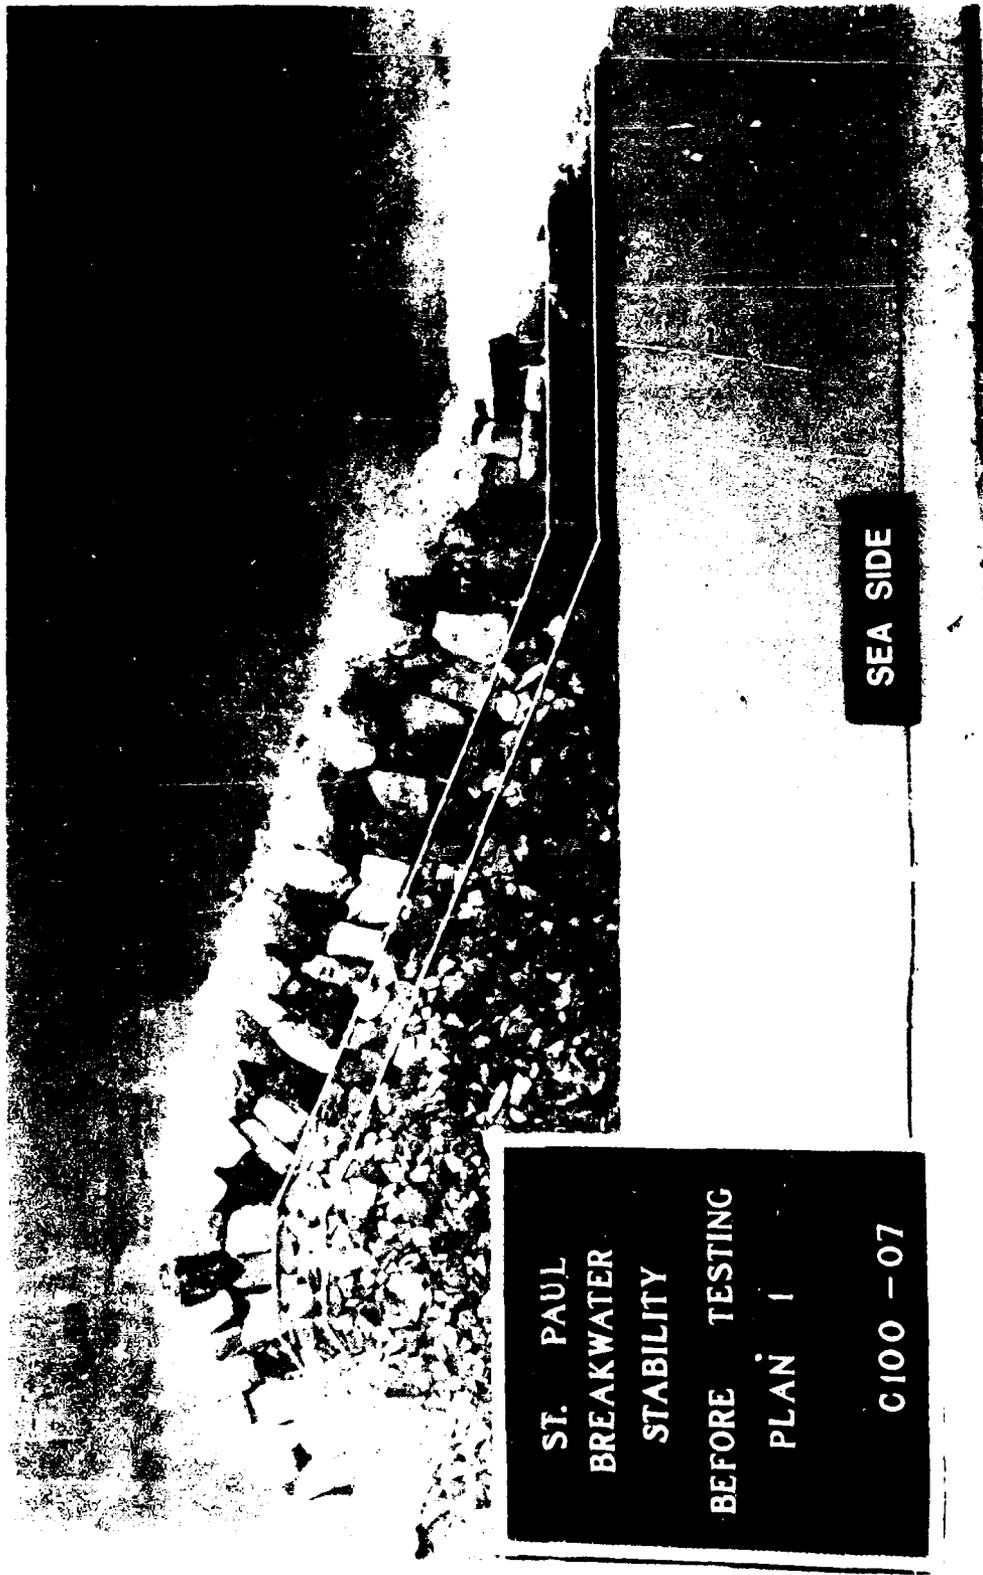
Photo 1. Plan 1, before Test 3, side view; St. Paul Harbor breakwater stability study

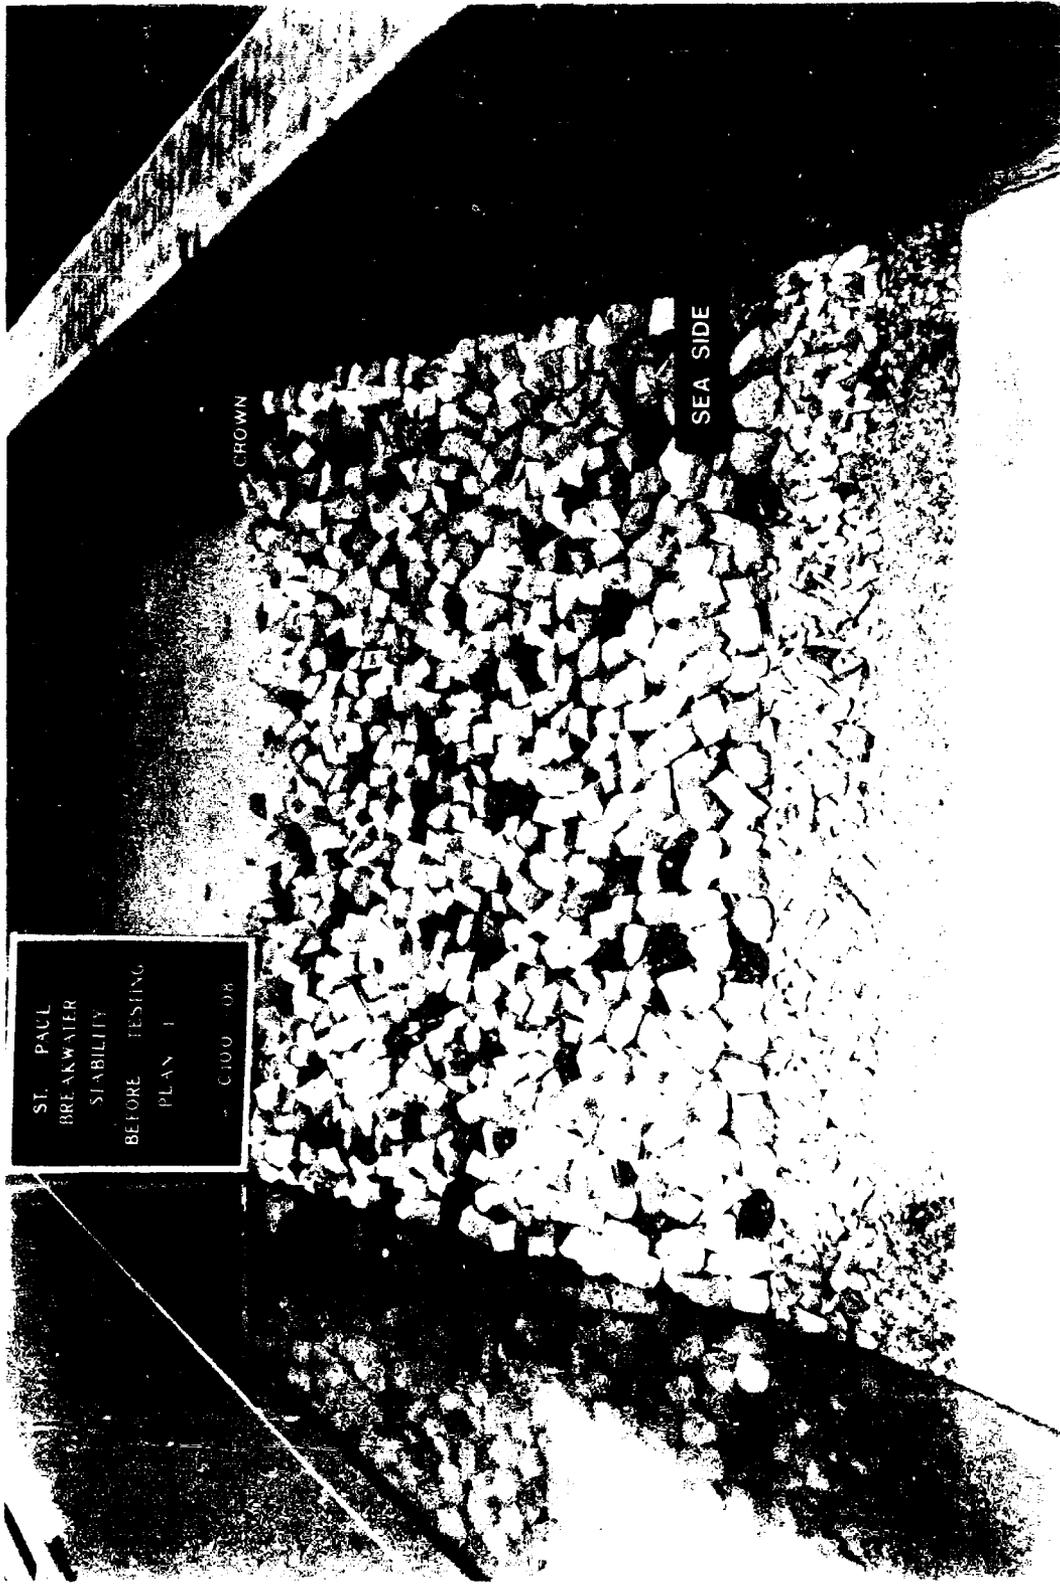
Photo 2. Plan 1. before Test 3, sea-side view; St. Paul Harbor breakwater stability study

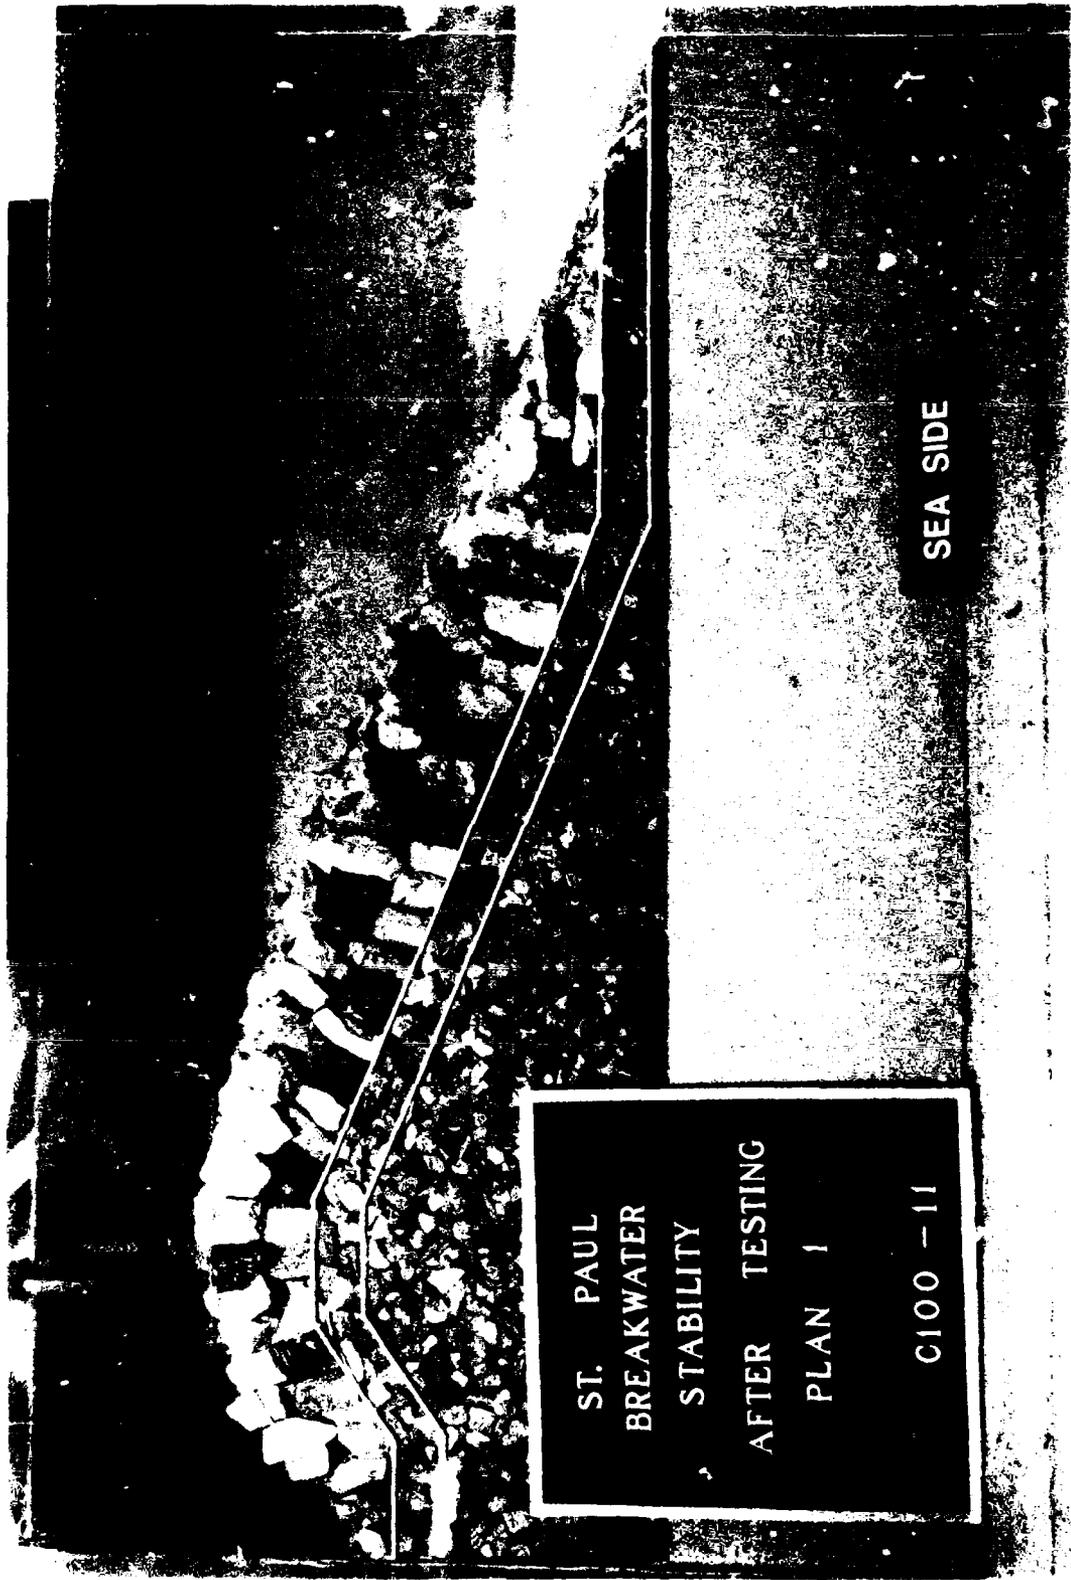
Photo 3. Plan 1, after Test 4, side view; St. Paul Harbor breakwater stability study

37. No stones were displaced during any of the tests. Four stones were observed rocking for a maximum of six cycles during Test 1; otherwise, no stone movement was seen.

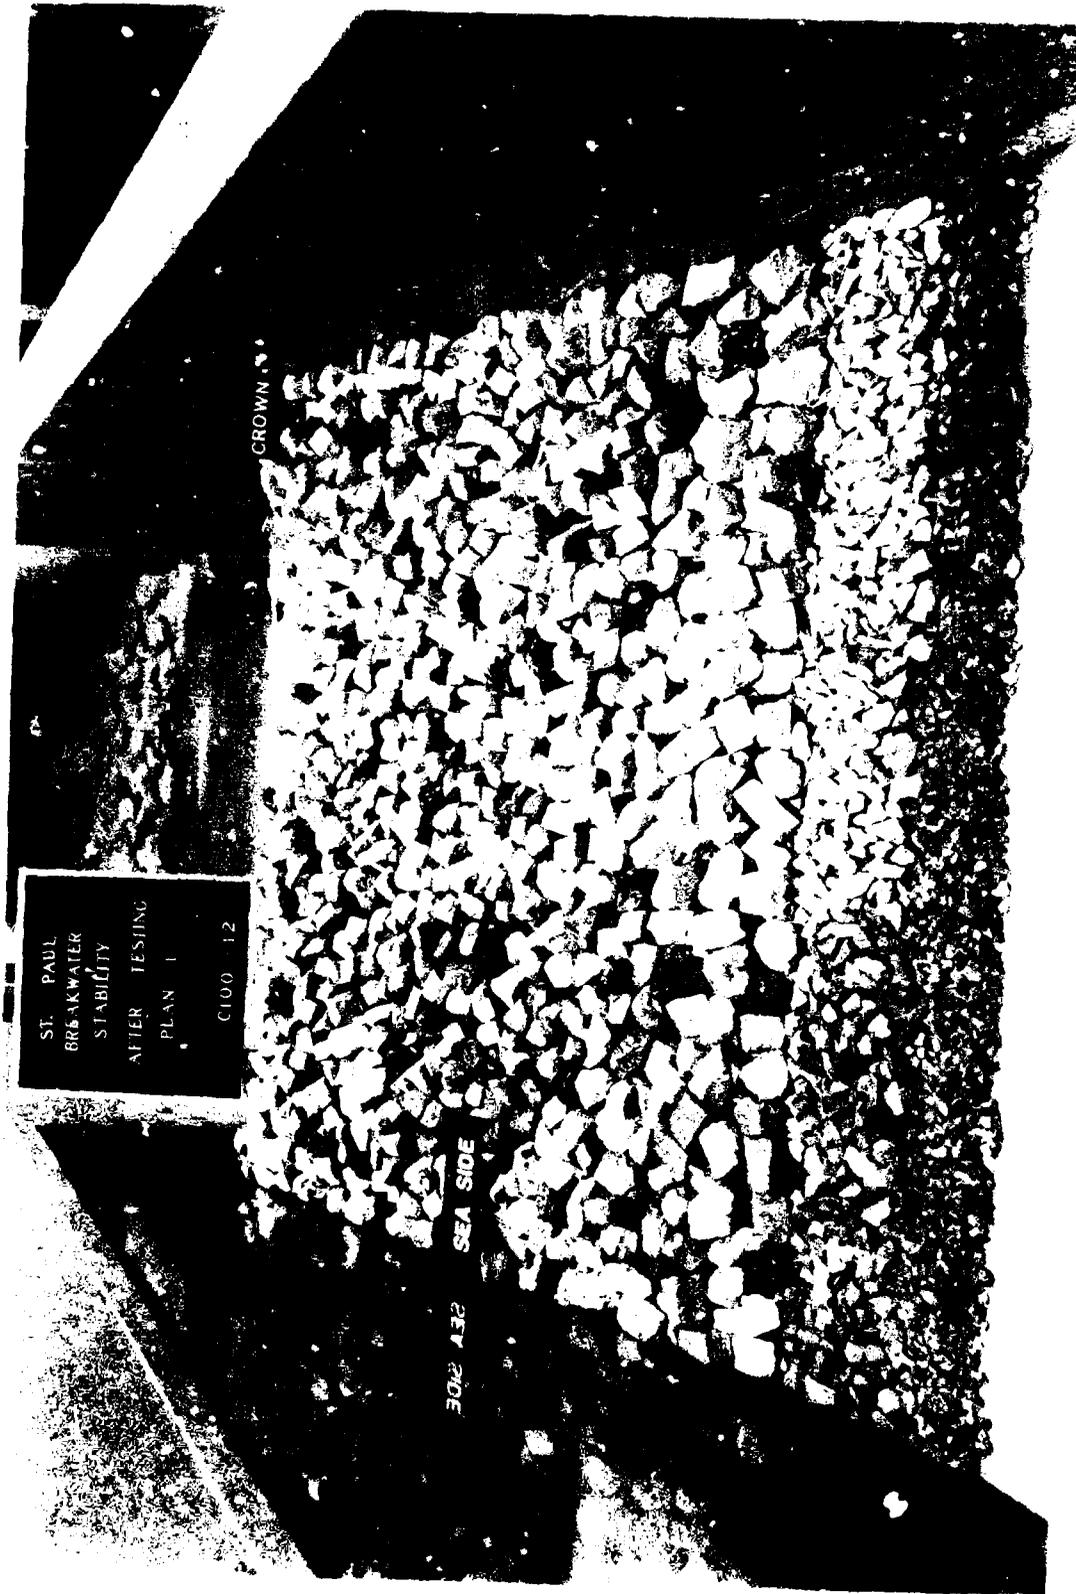
Photo 1. Plan 1, after Test 4, sea-side view; St. Paul Harbor breakwater stability study

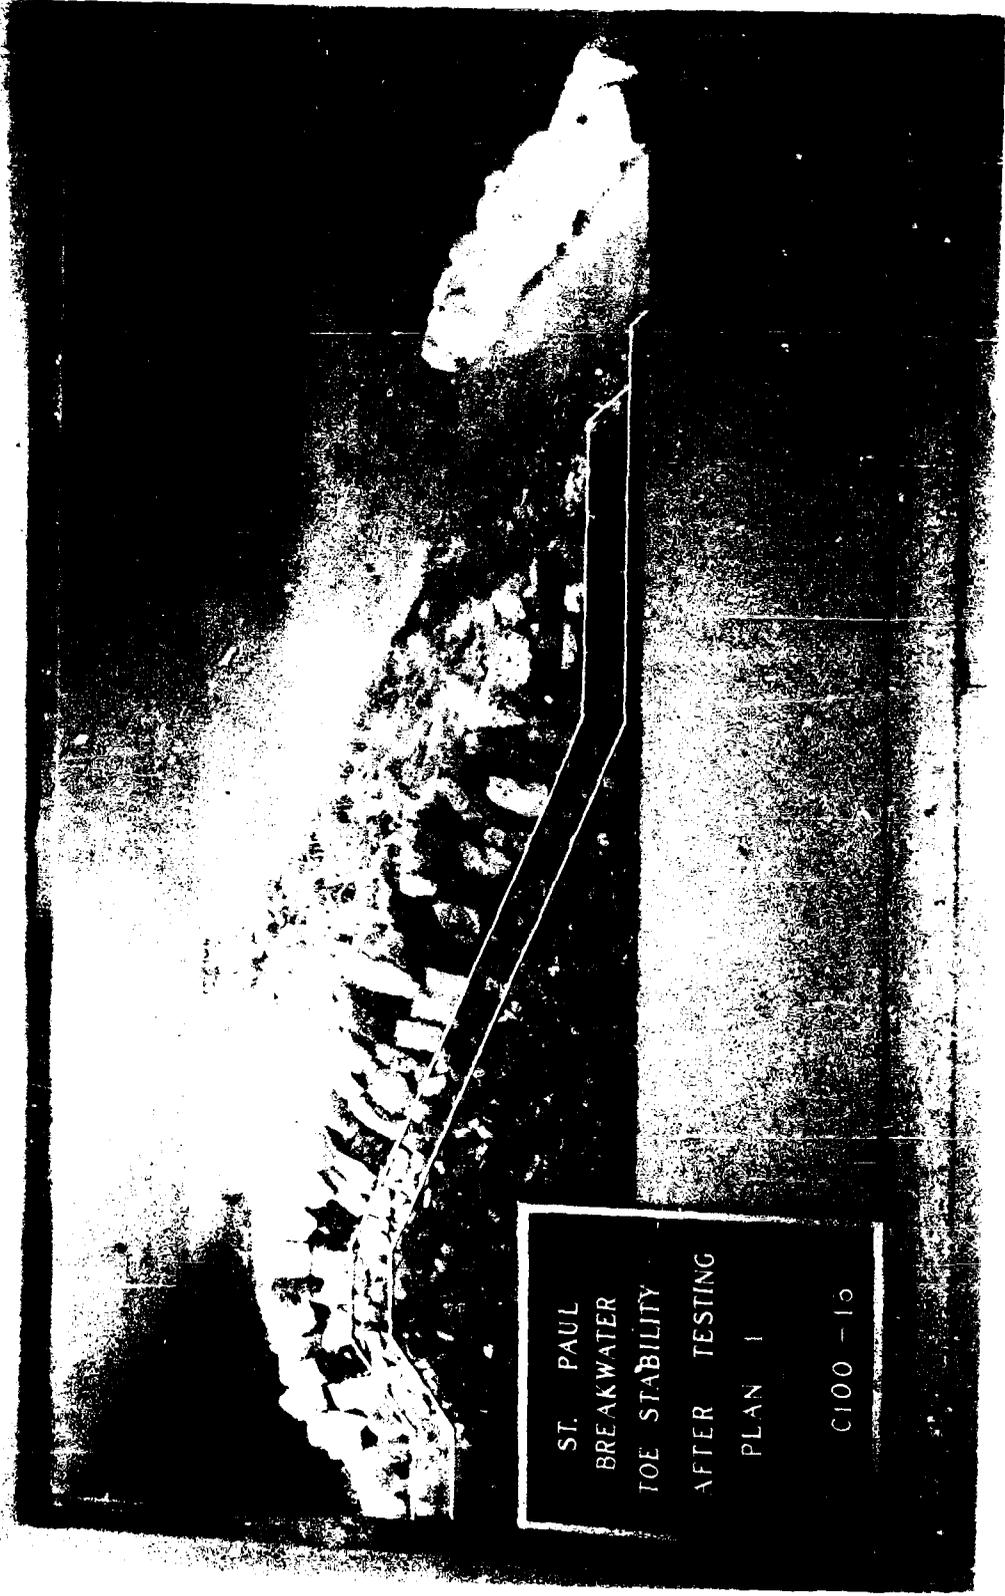
Photo 5. Plan 1, after Test 5, side view; St. Paul Harbor breakwater stability study

40. The toe stability test (Test 5) demonstrated adequate stability of the toe. No stones were displaced and very little movement was observed.

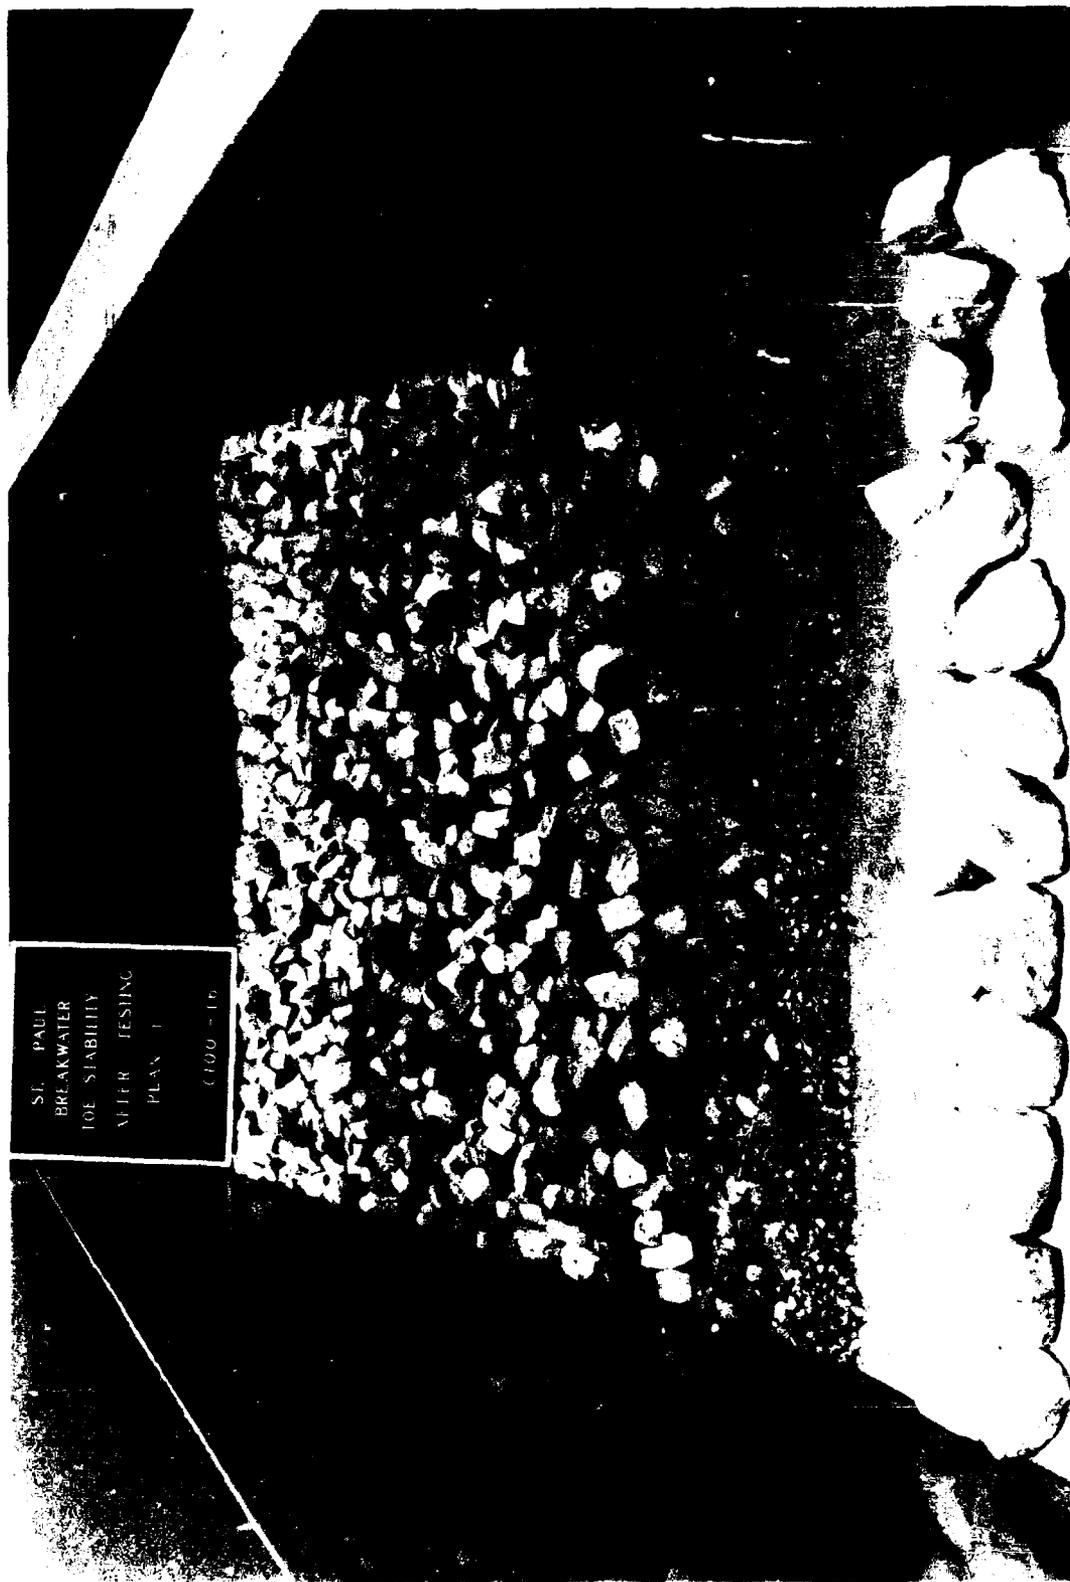
Photo 6. Plan 1, after Test 5, sea-side view; St. Paul Harbor breakwater stability study

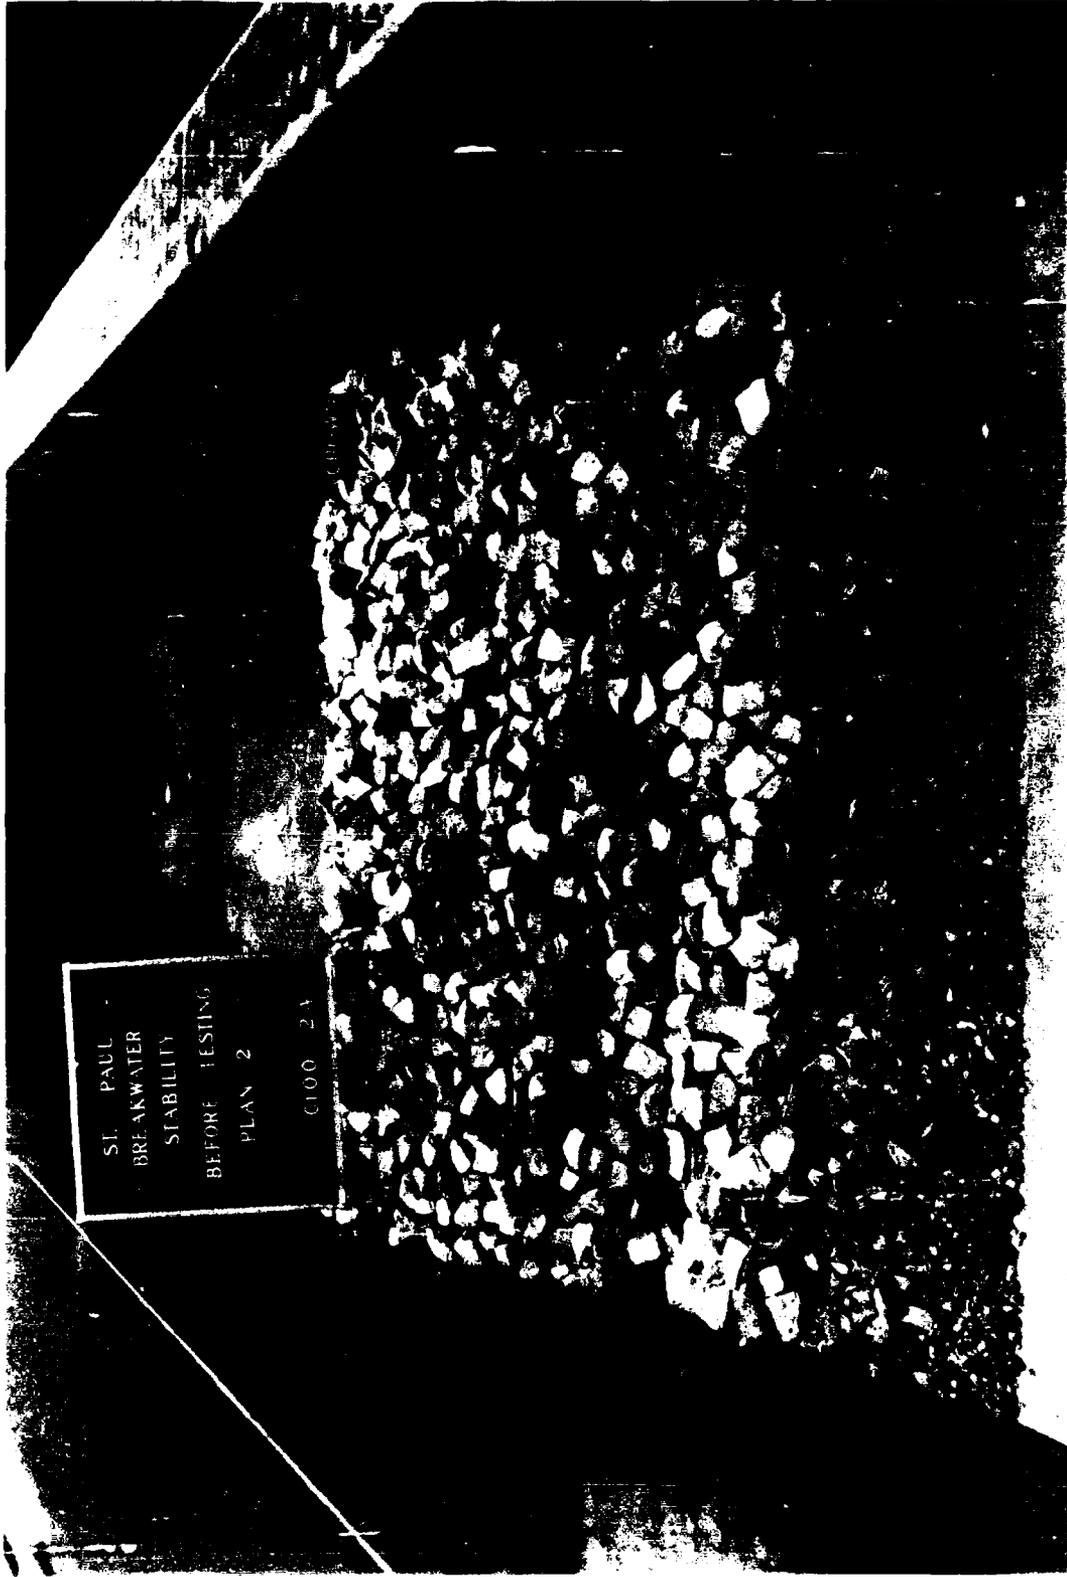
Photo 8. Plan 2, before Tes: 8, sea-side view; St. Paul Harbor breakwater stability study

42. Table 5 summarizes the test conditions and wave runup, rundown, and overtopping results of the six tests conducted on Plan 2. A stability test (Test 6) was followed by a survivability test (Test 7), the structure was disassembled and rebuilt and the tests repeated (Tests 8 and 9), then the structure was tested for toe stability (Tests 10 and 11). Plan 2 is shown before Test 8 in Photos 7 and 8, after Test 9 in Photos 9 and 10, and after Test 11 in Photos 11 and 12.

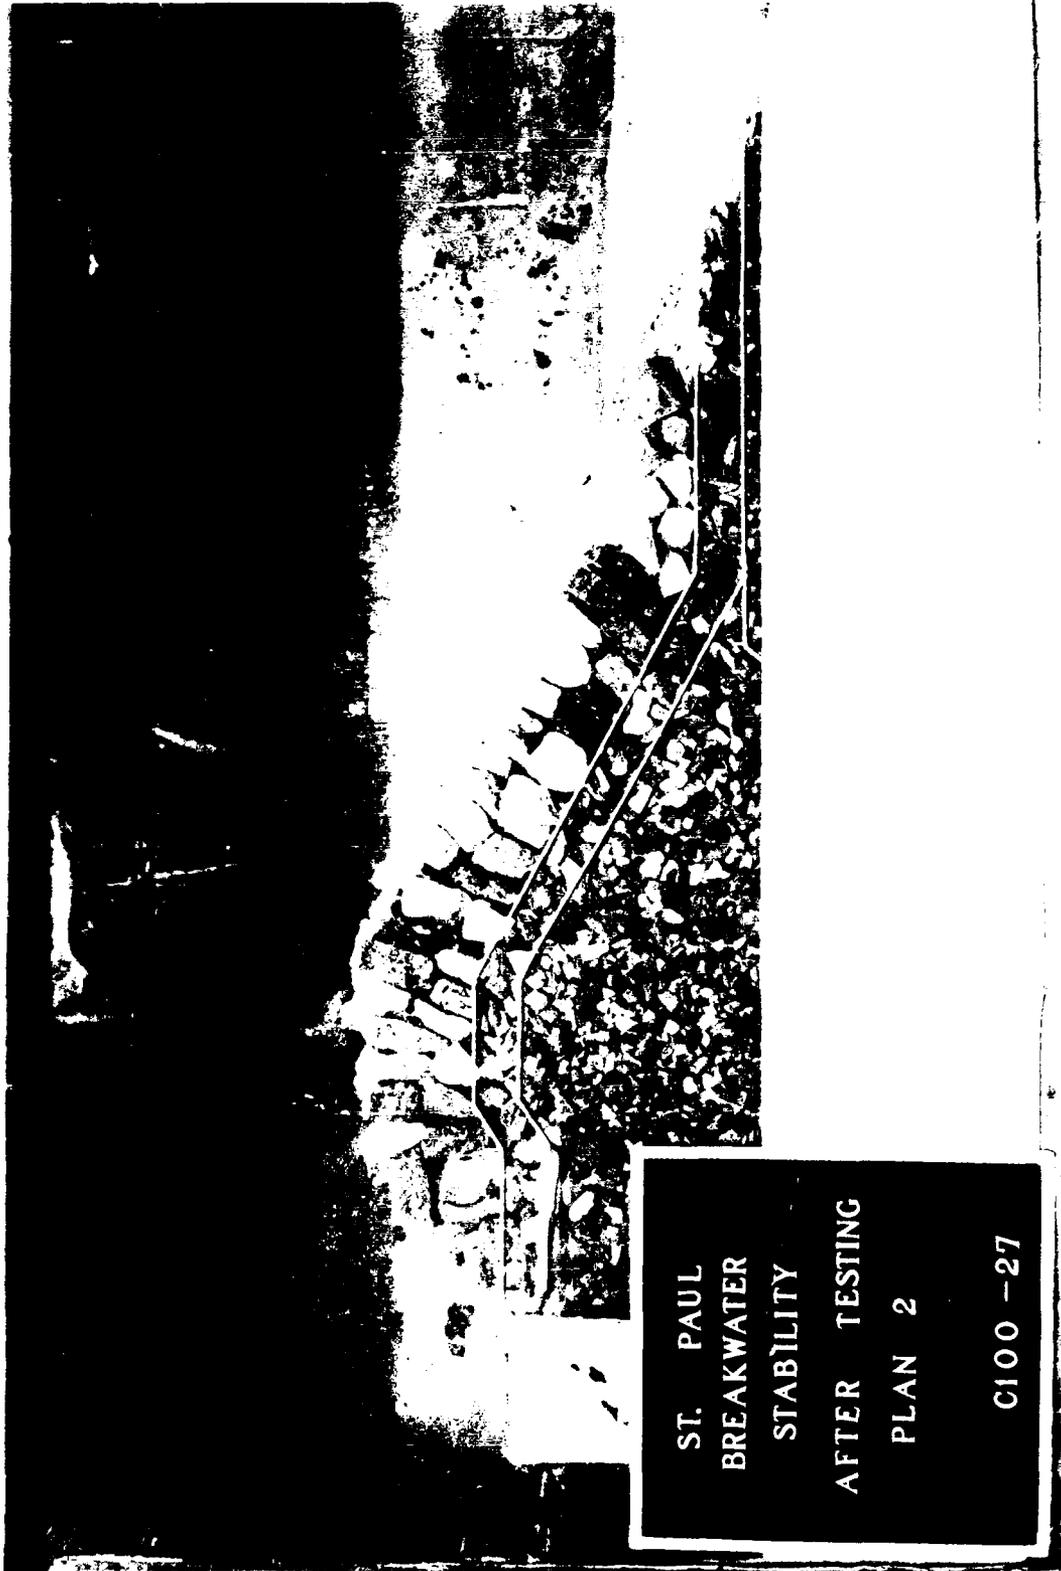
Photo 9. Plan 2, after Test 9, side view; St. Paul Harbor breakwater stability study

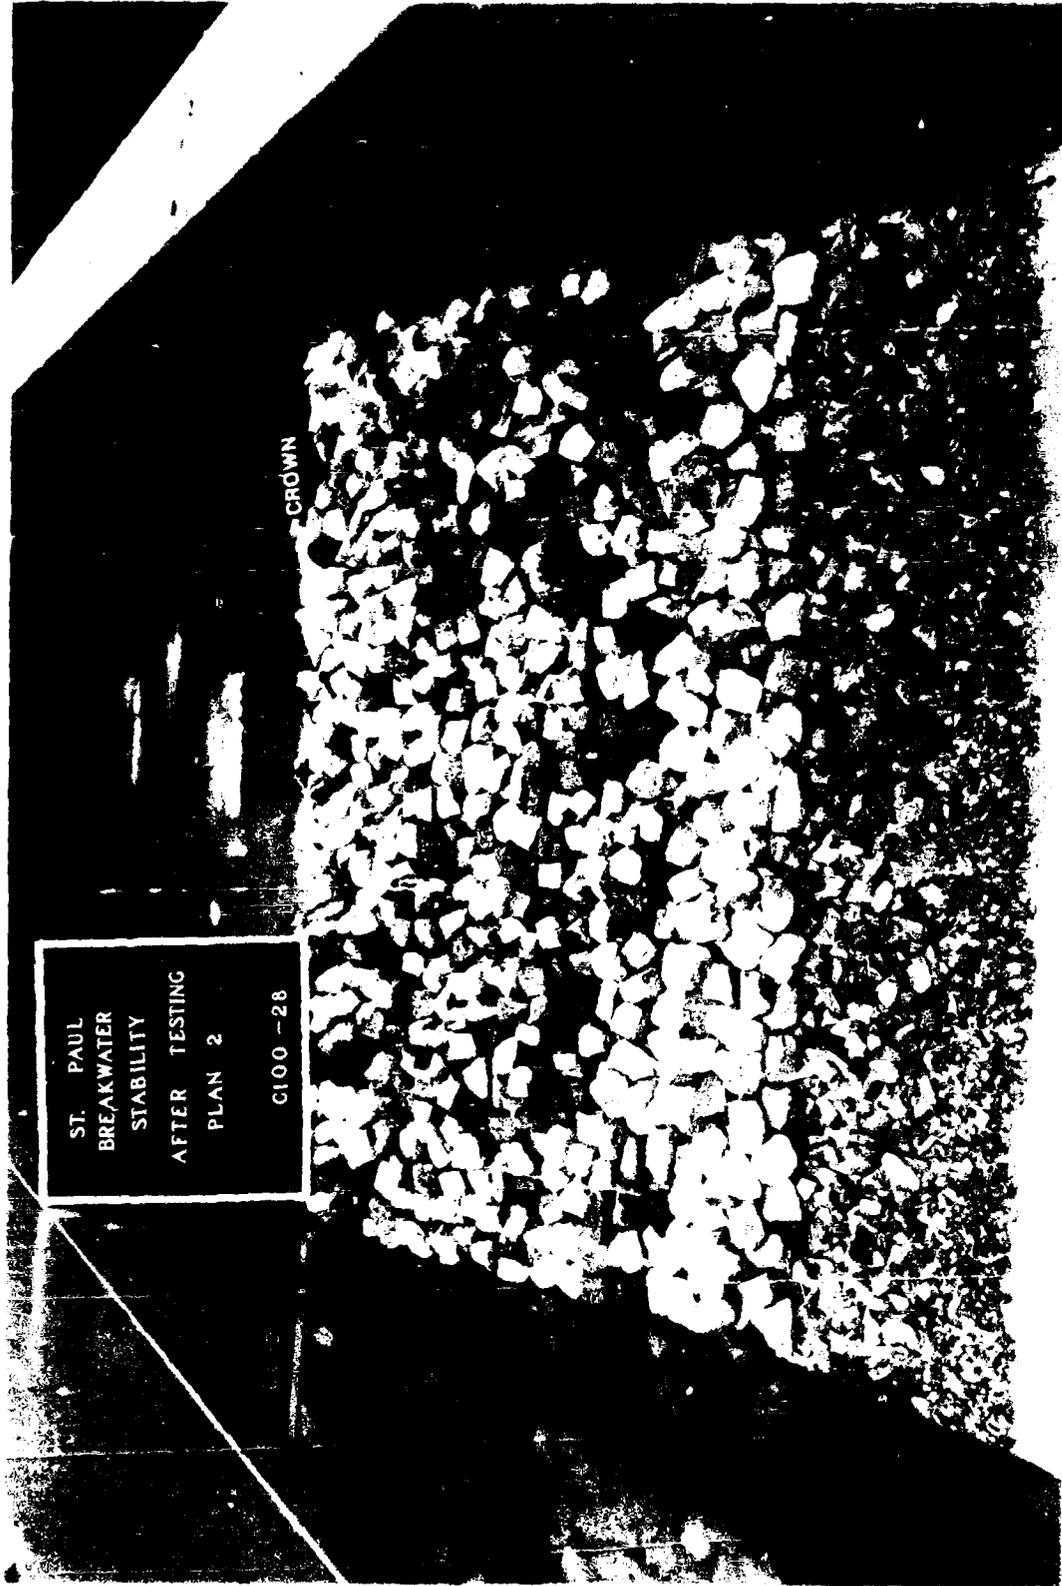
Photo 10. Plan 2, after Test 9, sea-side view; St. Paul Harbor breakwater stability study

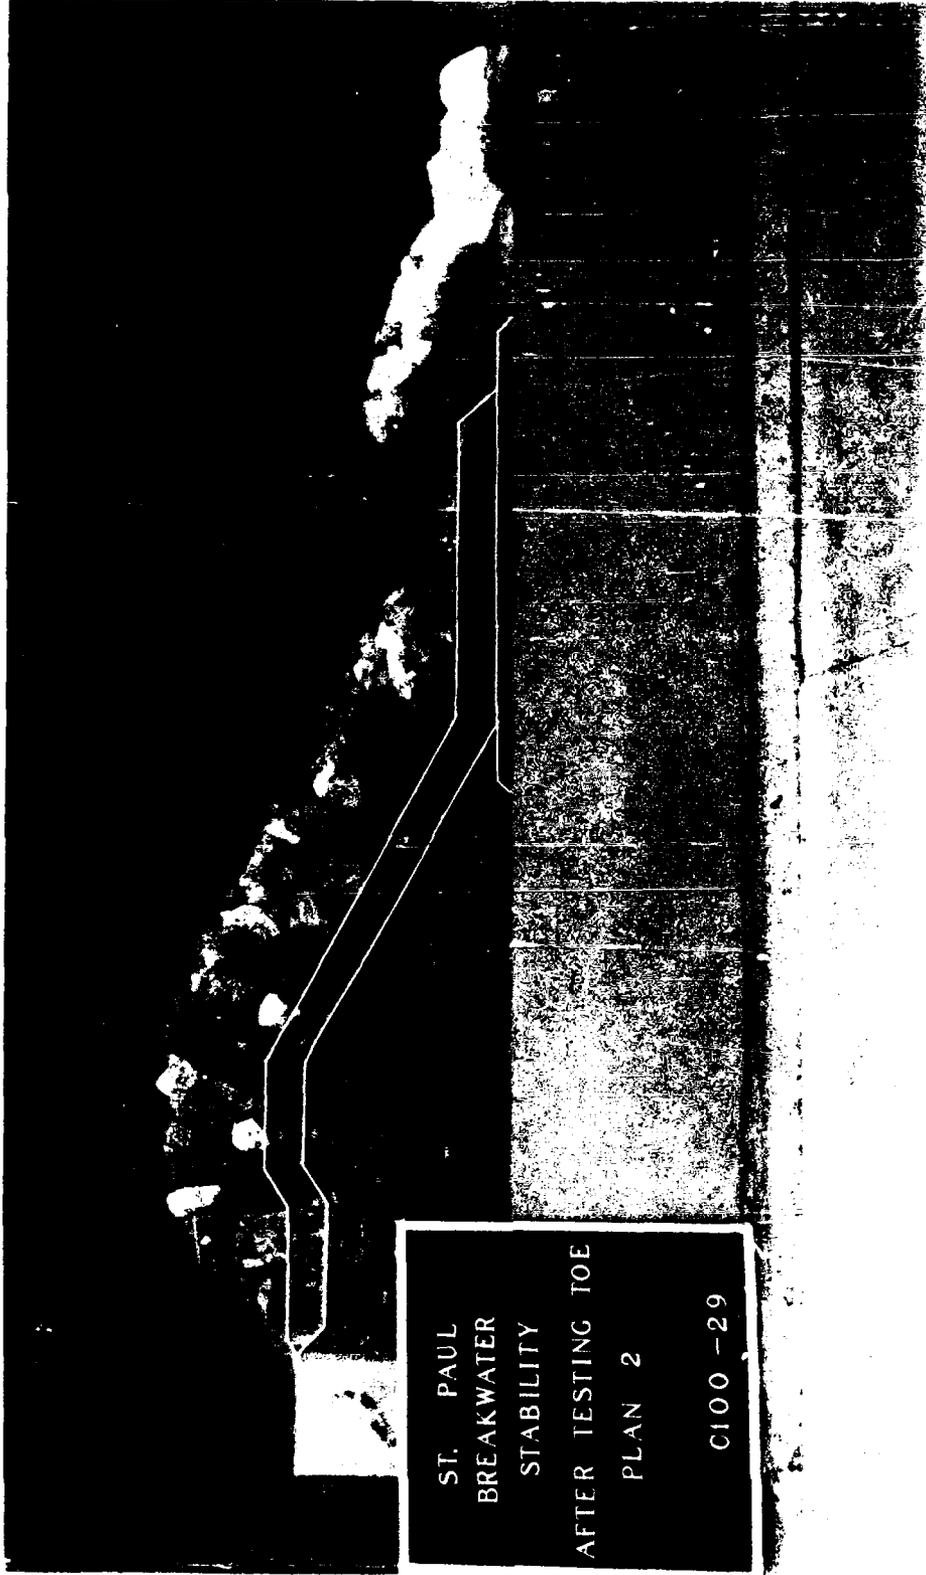
Photo 11. Plan 2, after Test 11, side view; St. Paul Harbor breakwater stability study

44. A limited amount of rocking was observed during the initial toe stability test (Test 10) using 14-sec waves, but no stones were displaced. Due to the large amount of movement observed during the 16-sec waves of the survivability test, it was decided to repeat the toe stability test with 16-sec waves (Test 11). Again, there was very little movement. As the toe stability tests were conducted at a shallower depth than the stability and survivability tests, the depth-limited breaking waves were smaller, accounting for the reduction in observed movement.

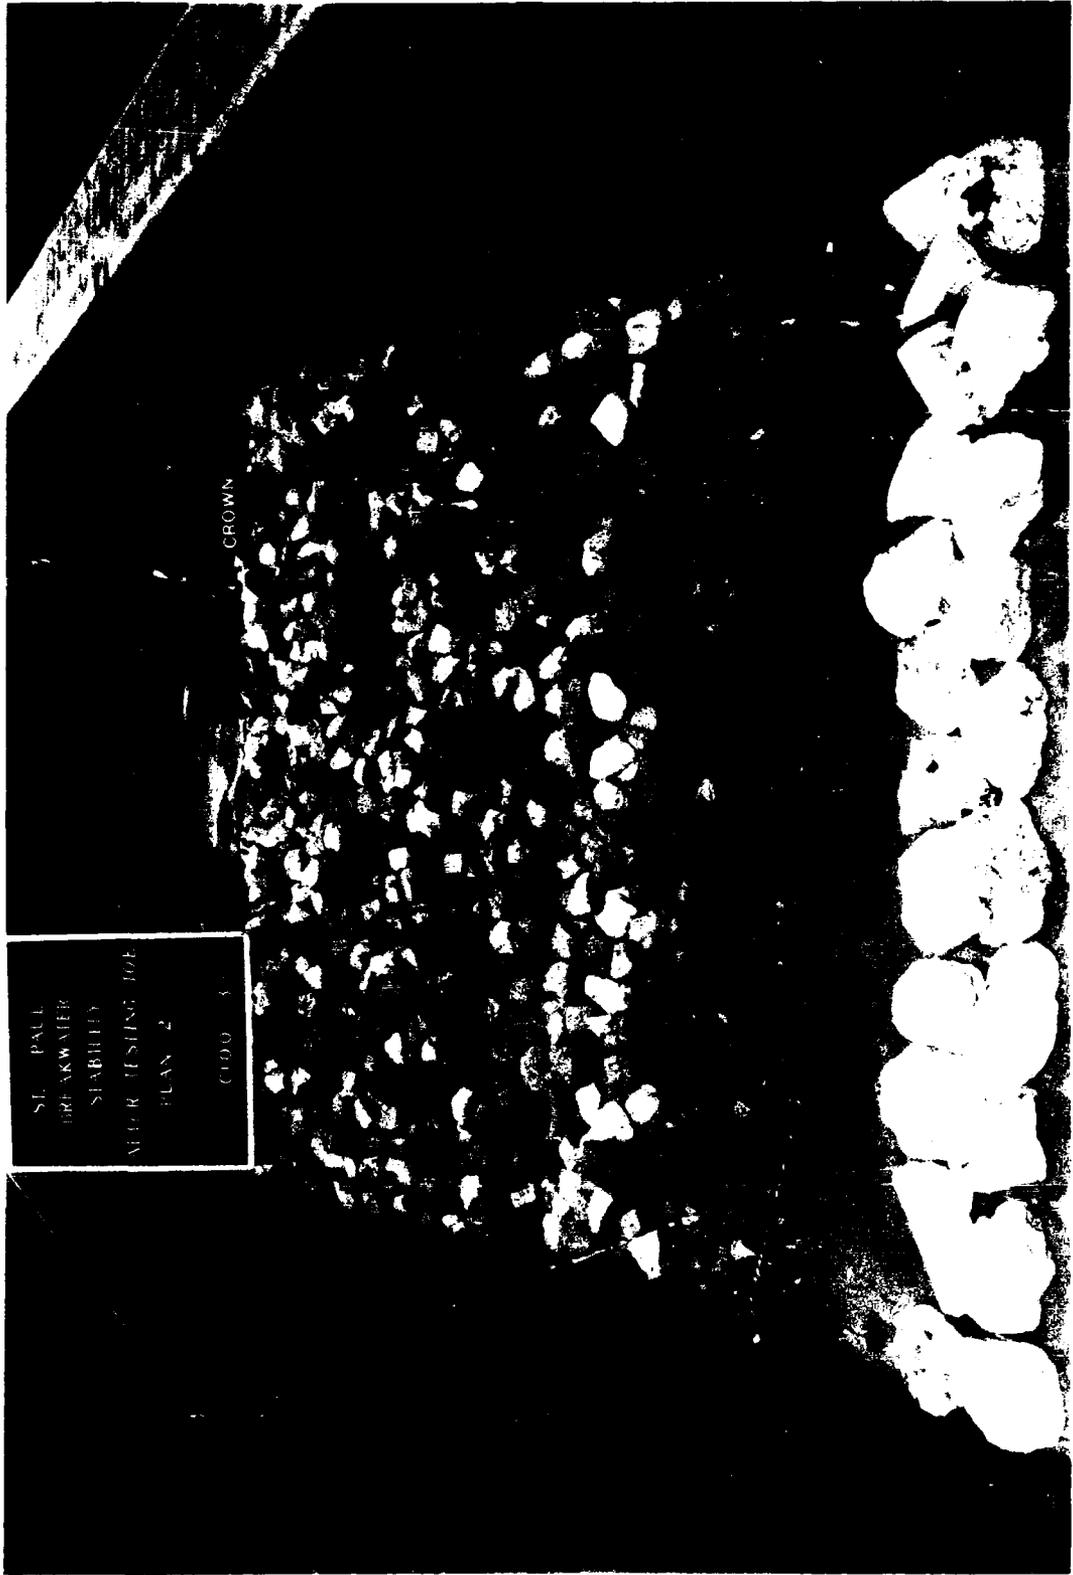
Photo 12. Plan 2, after Test 11, sea-side view; St. Paul Harbor breakwater stability study
