TECHNICAL REPORT CERC-88 10

ST. PAUL HARBOR BREAKWATER STABILITY STUDY ST. PAUL, ALASKA

Hydraulic Model Investigation

September 1988
Final Report

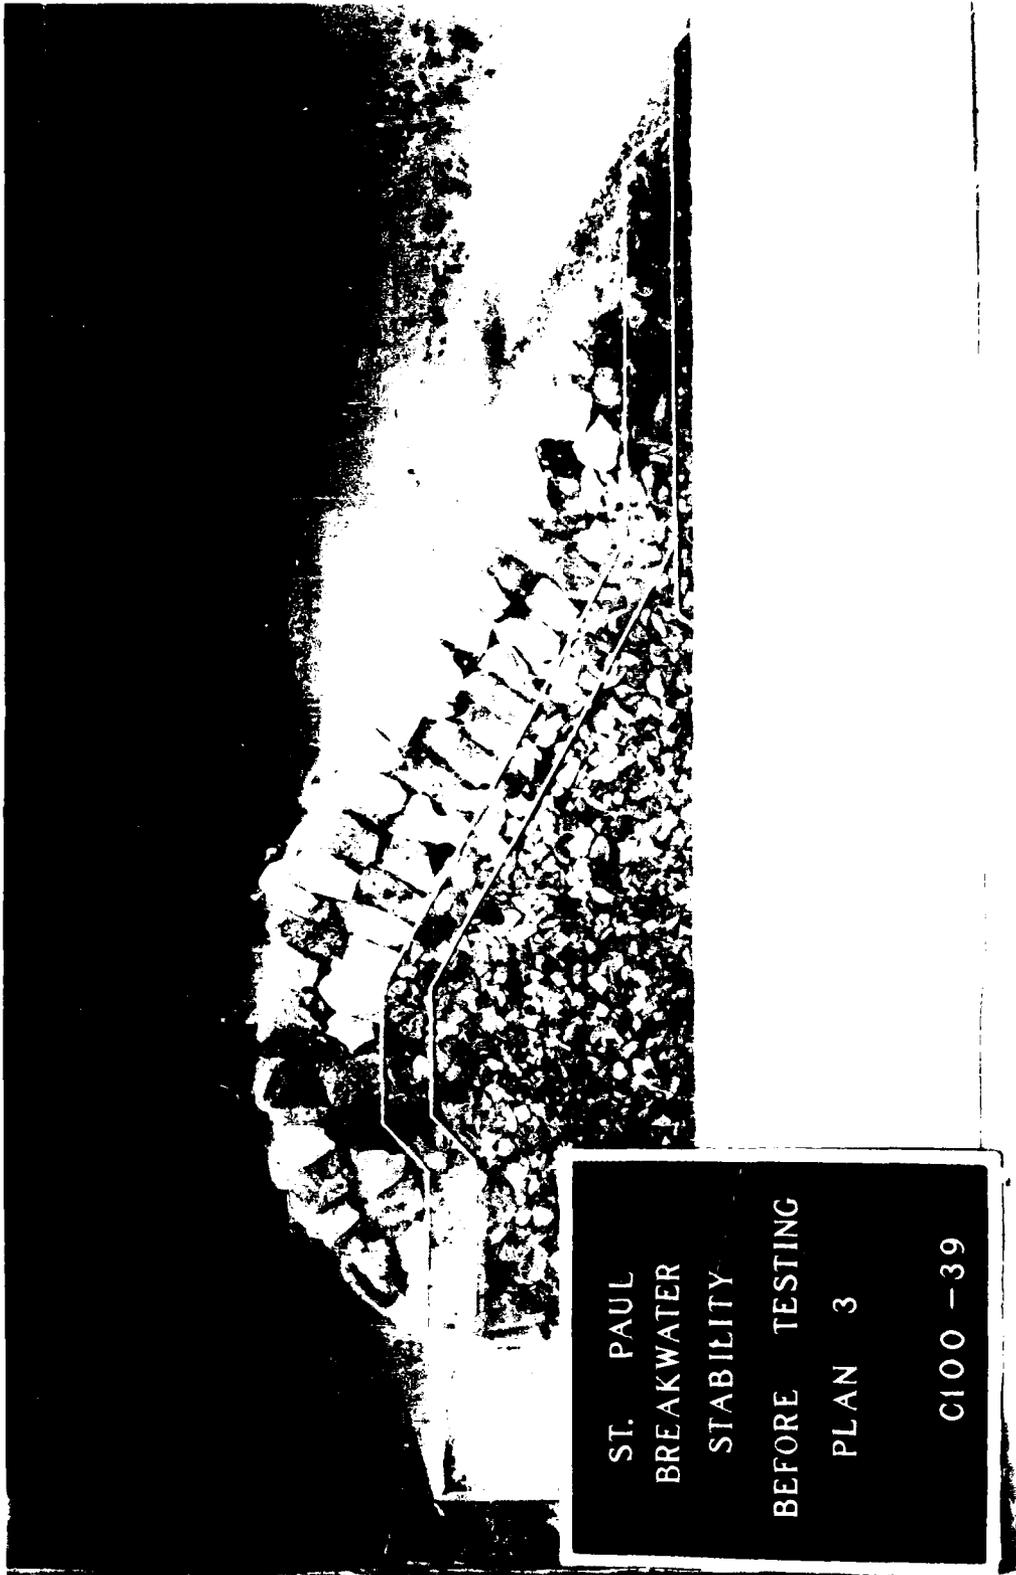
Photo 13. Plan 3, before Test 15, side view; St. Paul Harbor breakwater stability study

48. Table 6 summarizes the test conditions and wave runup, rundown, and overtopping results of the seven tests conducted on Plan 3. A stability test (Test 12) was followed by a survivability test (Test 13) and a high-water toe stability test (Test 14). The structure was then disassembled, rebuilt, and tested with a stability test (Test 15), survivability test (Test 16), low-water toe stability test (Test 17), and high-water toe stability test (Test 18). Plan 3 is shown before Test 15 in Photos 13 and 14, after Test 16 in Photos 15 and 16, and after Test 18 in Photos 17 and 18.

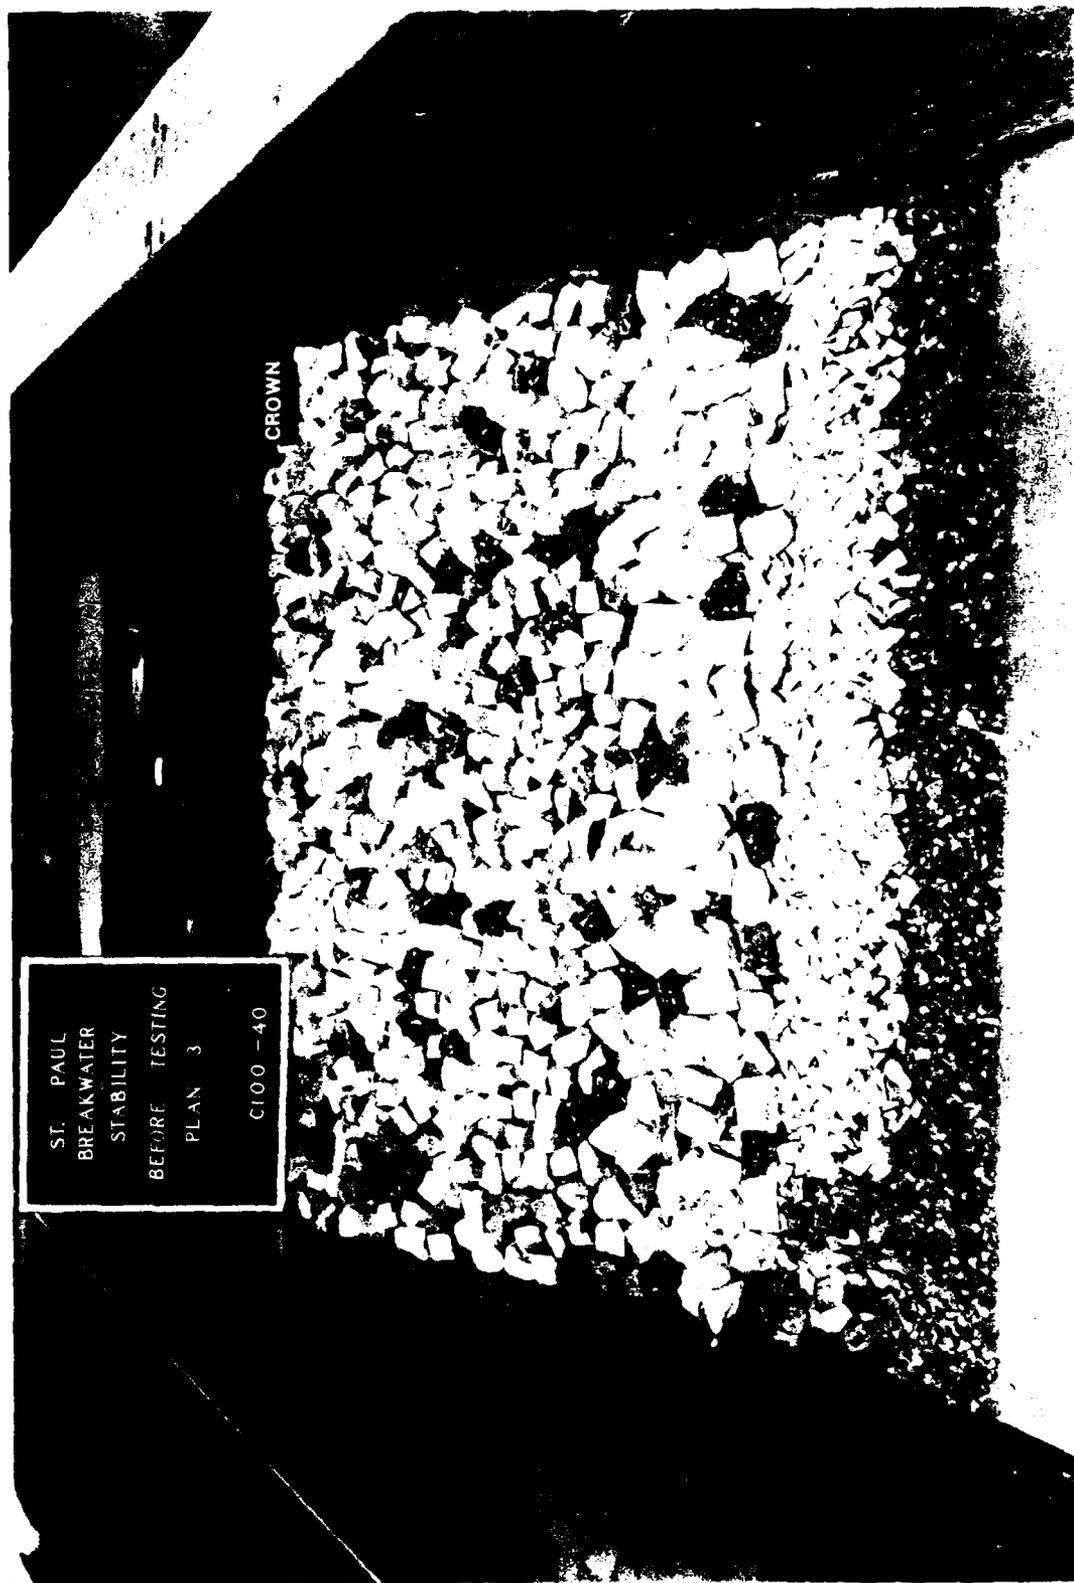
Photo 14. Plan 3, before Test 15, sea-side view; St. Paul Harbor breakwater stability study

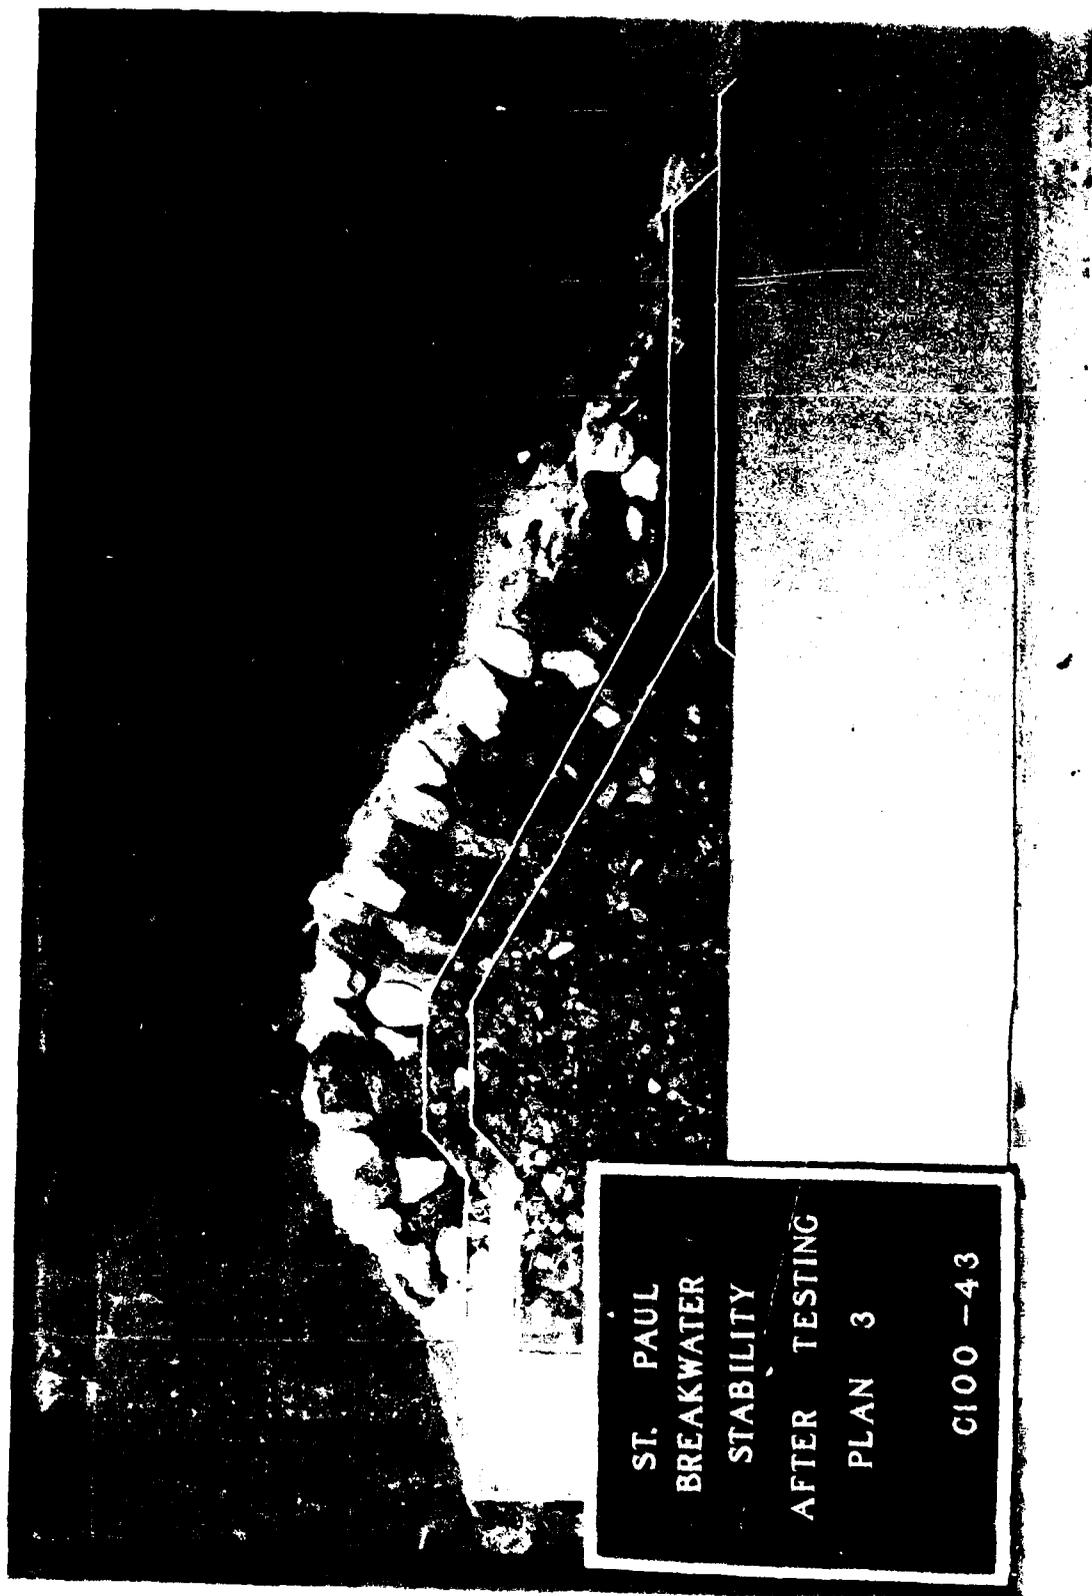
Photo 15. Plan 3, after Test 16, side view; St. Paul Harbor breakwater stability study

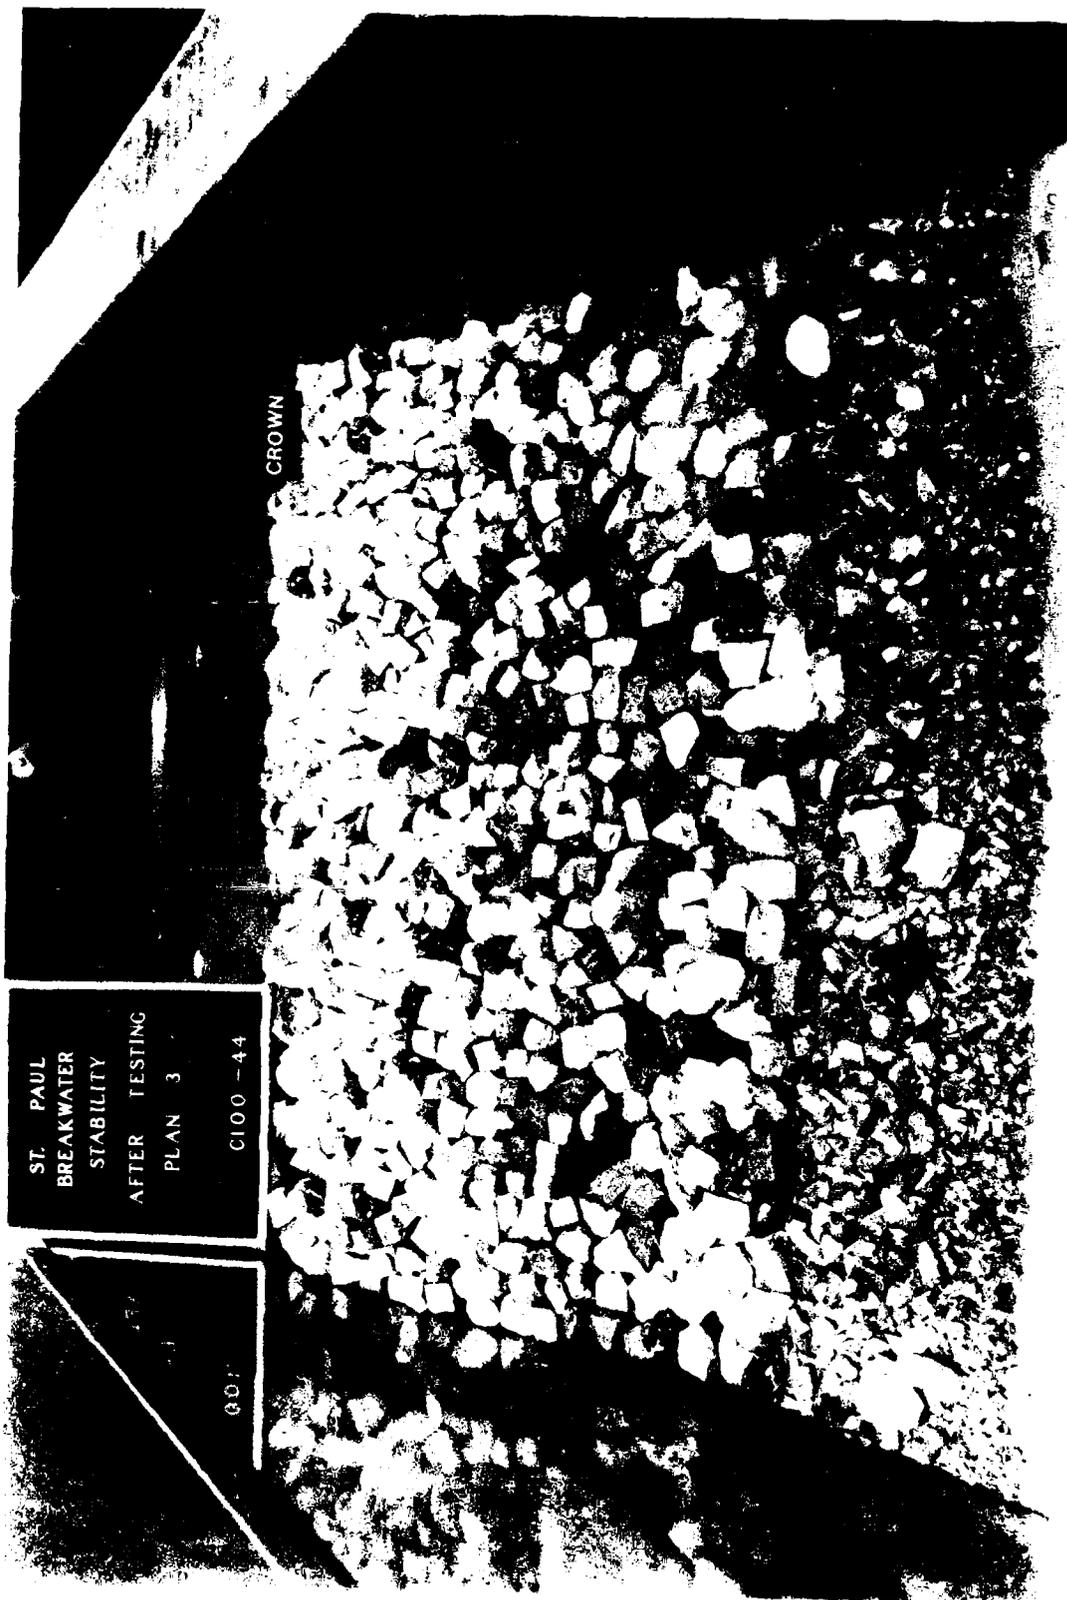
Photo 16. Plan 3. after Test 16, sea-side view; St. Paul Harbor breakwater stability study

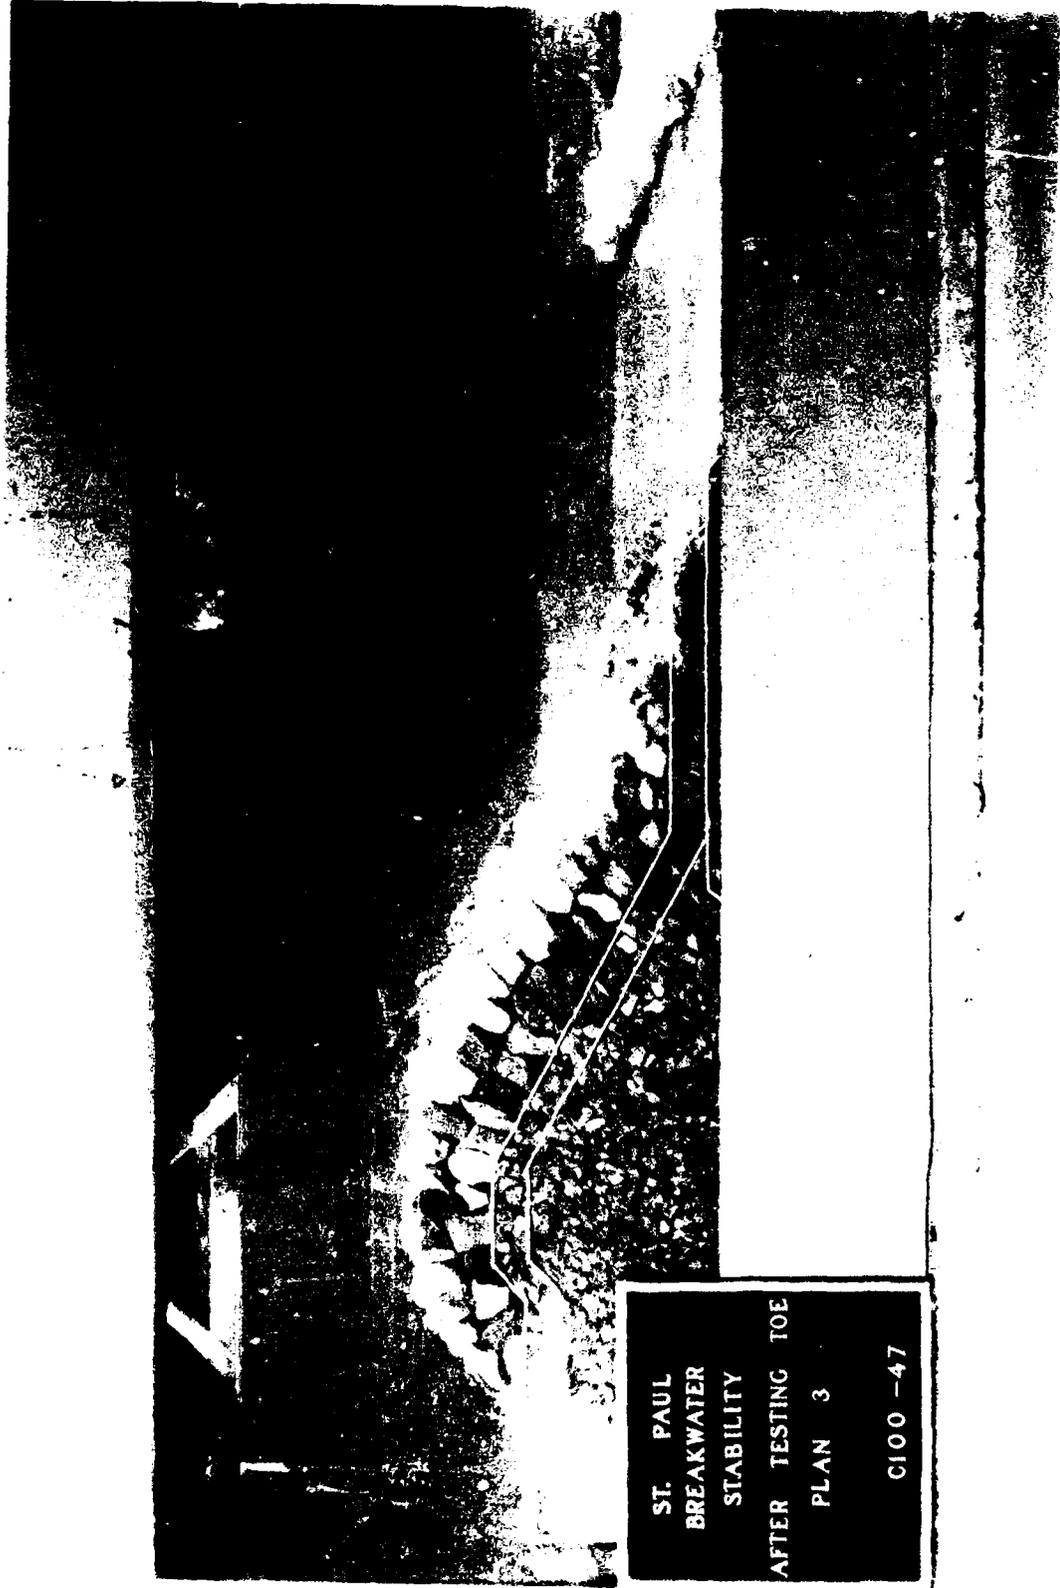
Photo 17. Plan 3, after Test 18, side view; St. Paul Harbor breakwater stability study

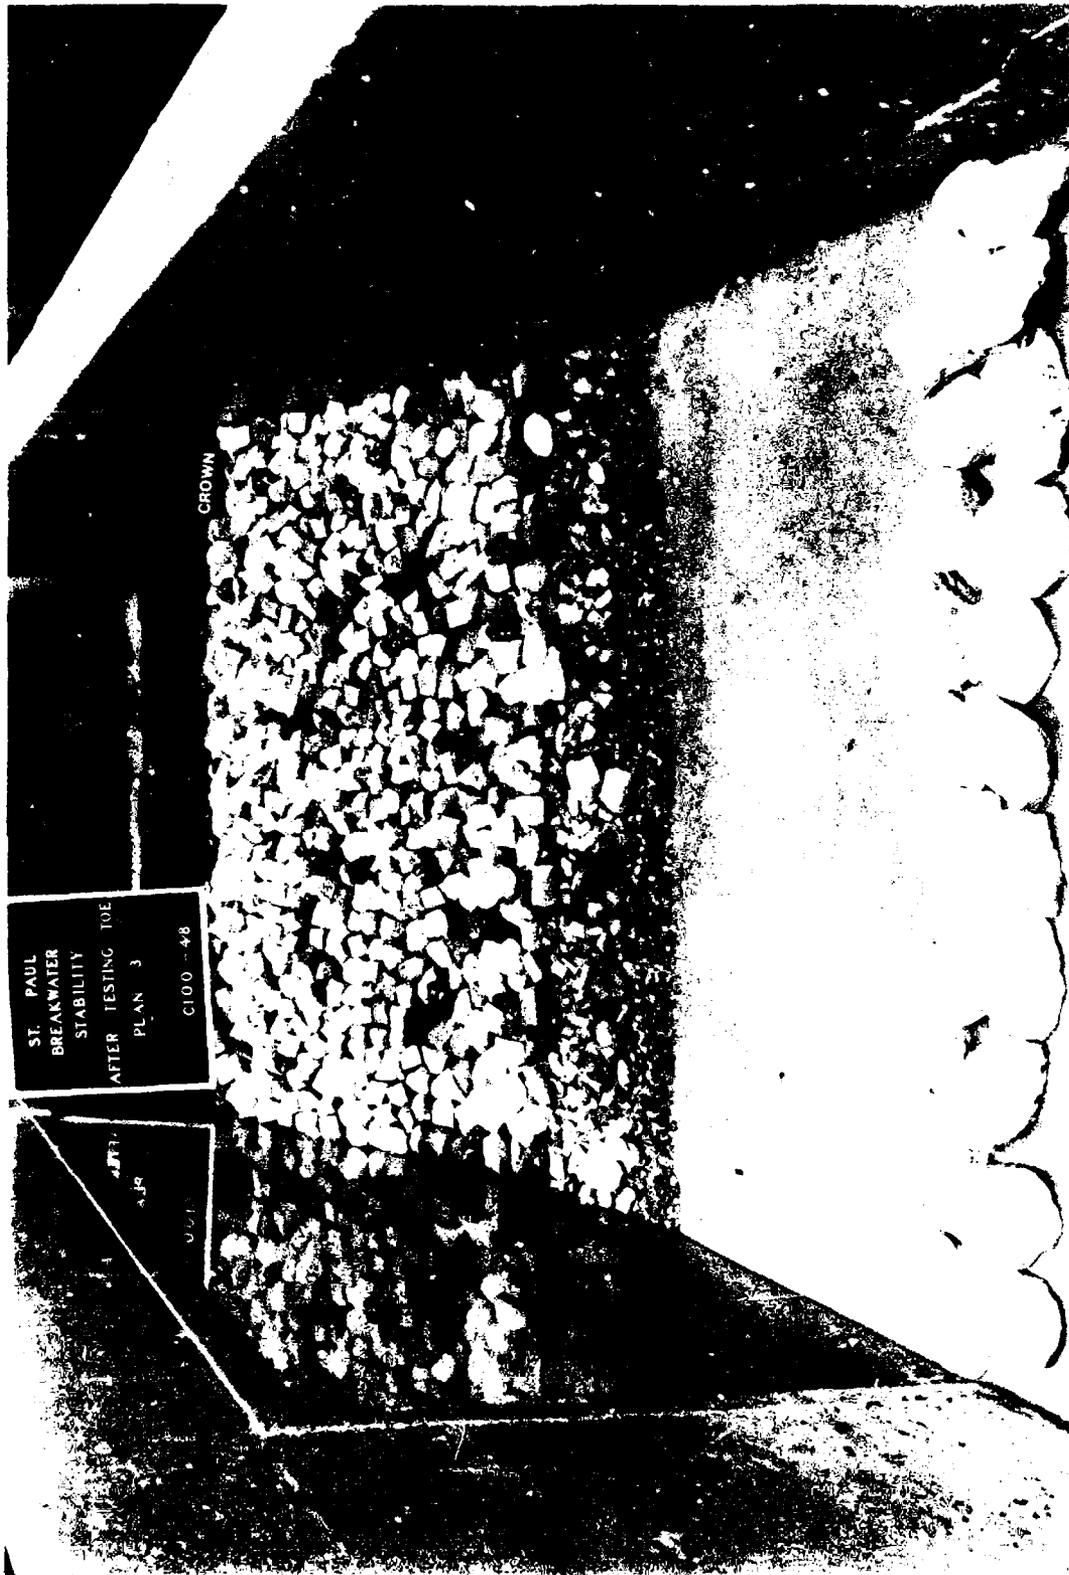
Photo 18. Plan 3, after test 18, sea-side view; St. Paul Harbor breakwater stability study

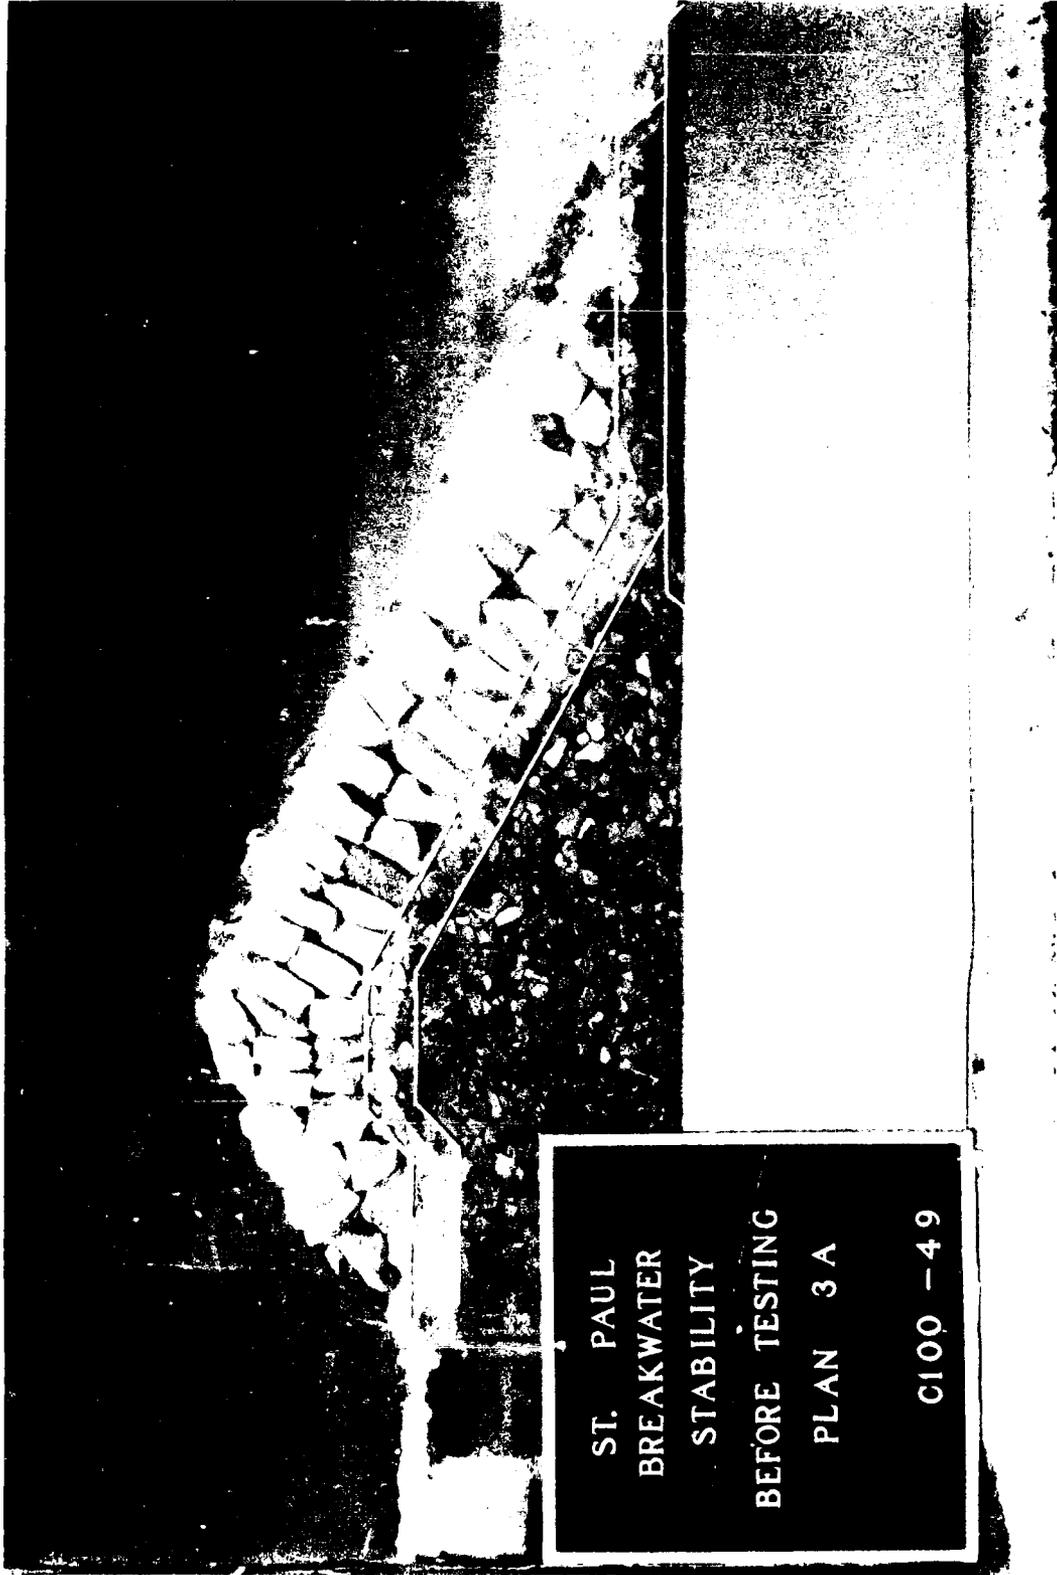
Photo 19. Plan 3.2, before Test 20, side view; St. Paul Harbor breakwater stability study

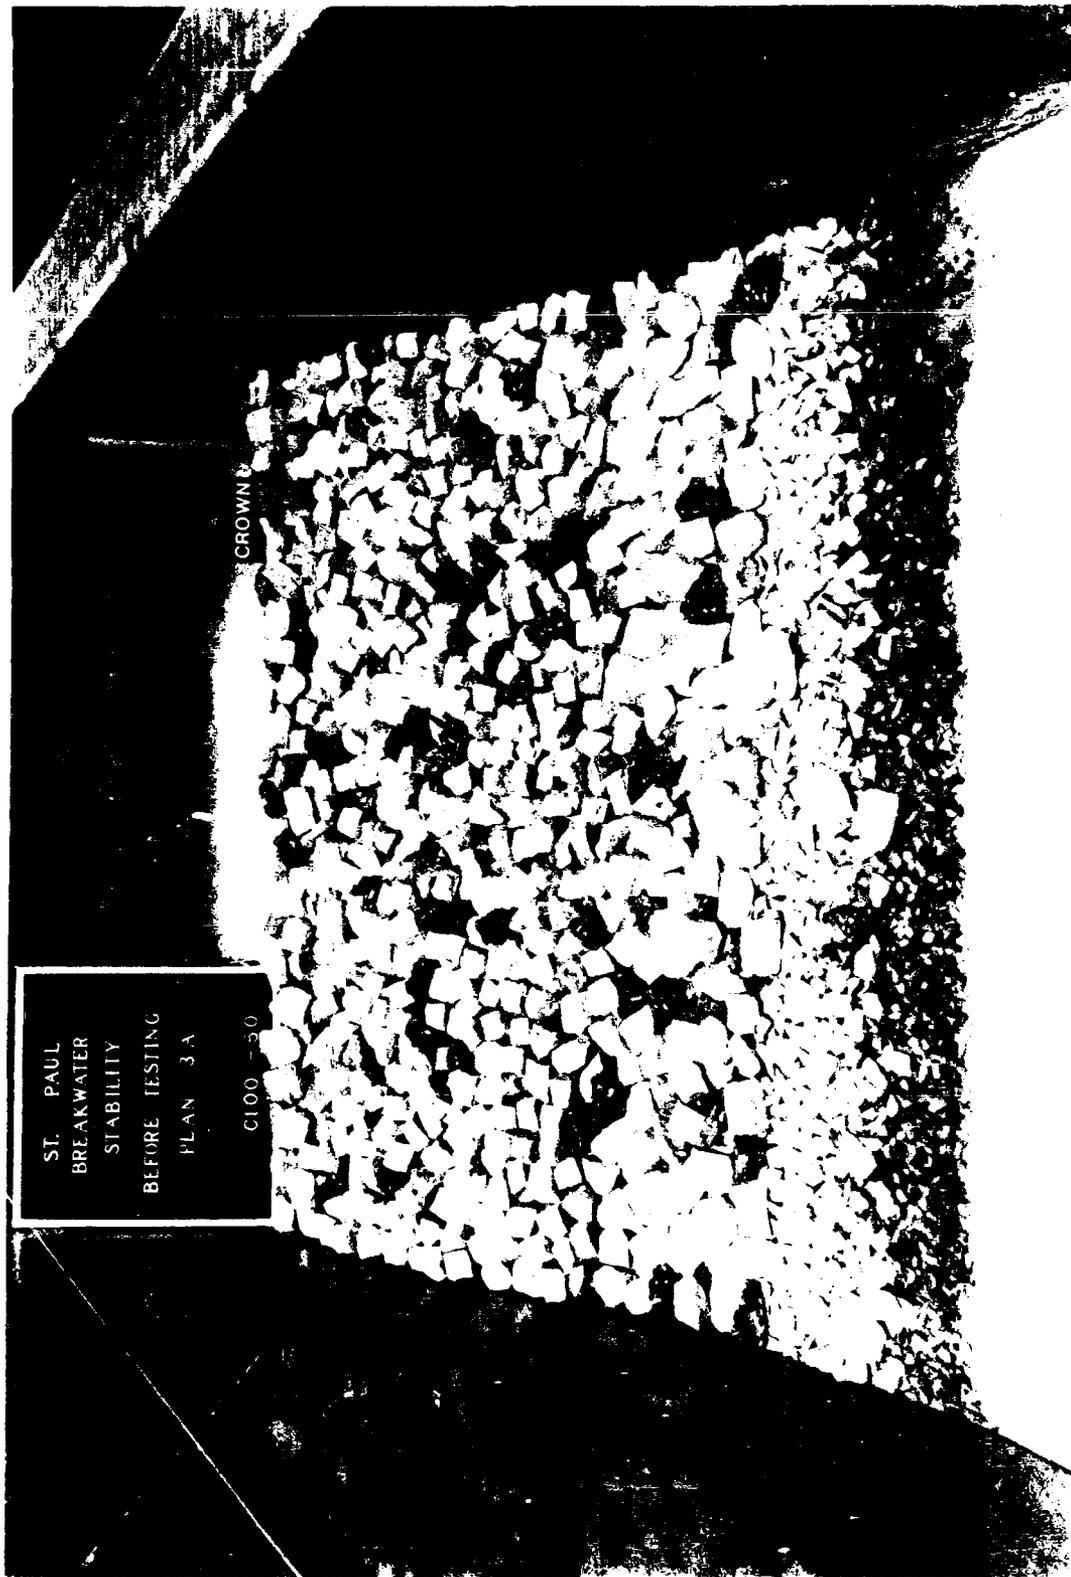
Photo 20. Plan 3.2, before Test 20, side view; St. Paul Harbor breakwater stability study
