NSWC TR 87-328

CORROSION BEHAVIOR OF SiC REINFORCED ALUMINUM ALLOYS

25 SEPTEMBER 1987

NAVAL SURFACE WARFARE CENTER

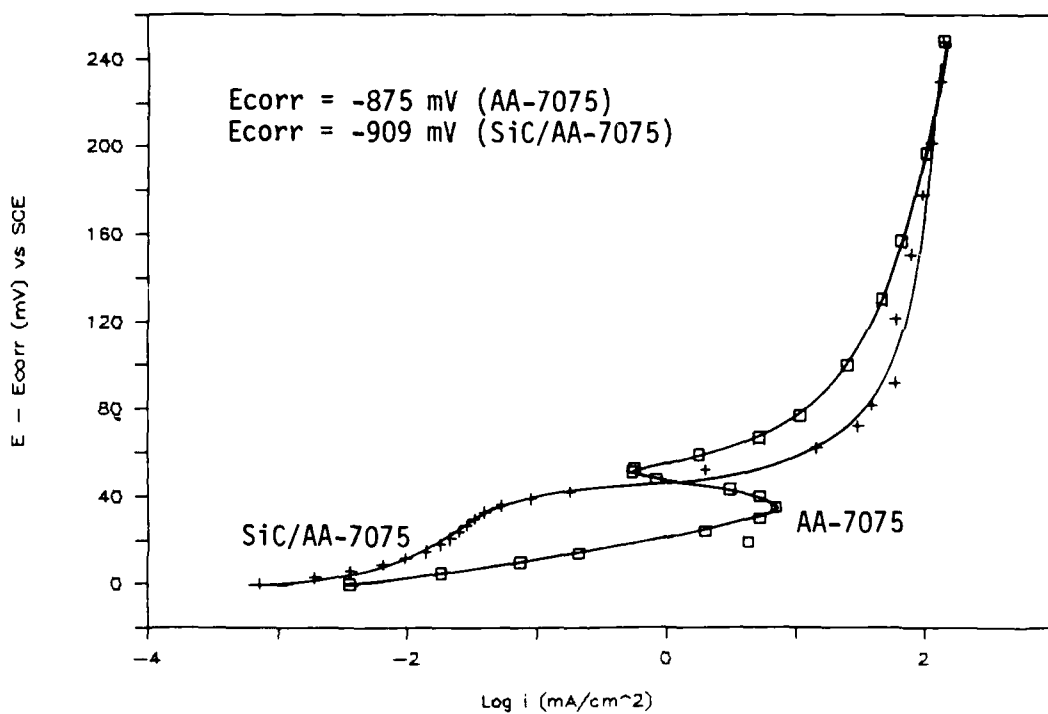
FIGURE 12. POTENTIODYNAMIC ANODIC POLARIZATION CURVES FOR SiC/AA-7075-T6 AND AA-7075-T6 IN 3.5% NaCl

The anodic behavior of SiC/AA-7075-T6 and AA-7075-T6 suggested that the MMC was less reactive and that the dissolution mechanisms were not the same. (See Figure 12.)* The MMC exhibited pseudo-passive behavior up to about 40 mV above E_{corr} , at which point the sample began to pit rapidly. The anodic current density on AA-7075-T6 increased rapidly from the start of the scan. For comparison, at 20 mV above E_{corr} for both samples the anodic current density was nearly two orders of magnitude higher for the wrought alloy. Microscopic examination showed that AA-7075-T6 was severely pitted, to so great of an extent that it had the appearance of uniform dissolution. SiC/AA-7075-T6 was not as severely pitted, and the pits were much smaller in diameter and not as deep as observed for AA-7075-T6. The MMC appeared to be covered with a corrosion product layer, which was not observed

for AA-7075-T6. The inflection in the curve for AA-7075-T6 further supports that the dissolution mechanisms were different. This inflection may be an active-passive transition but true passivation did not occur as indicated by the lack of a passive region and the recorded high current densities.

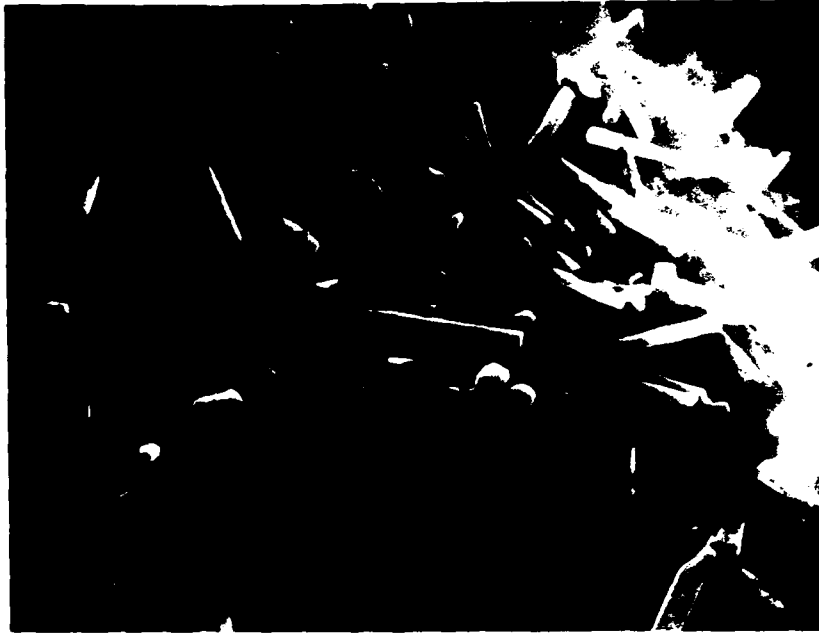
FIGURE 21. SiC WHISKERS FOUND AT THE BOTTOM OF A PIT
ON SiC/AA-2124-T6M (5,000 X)

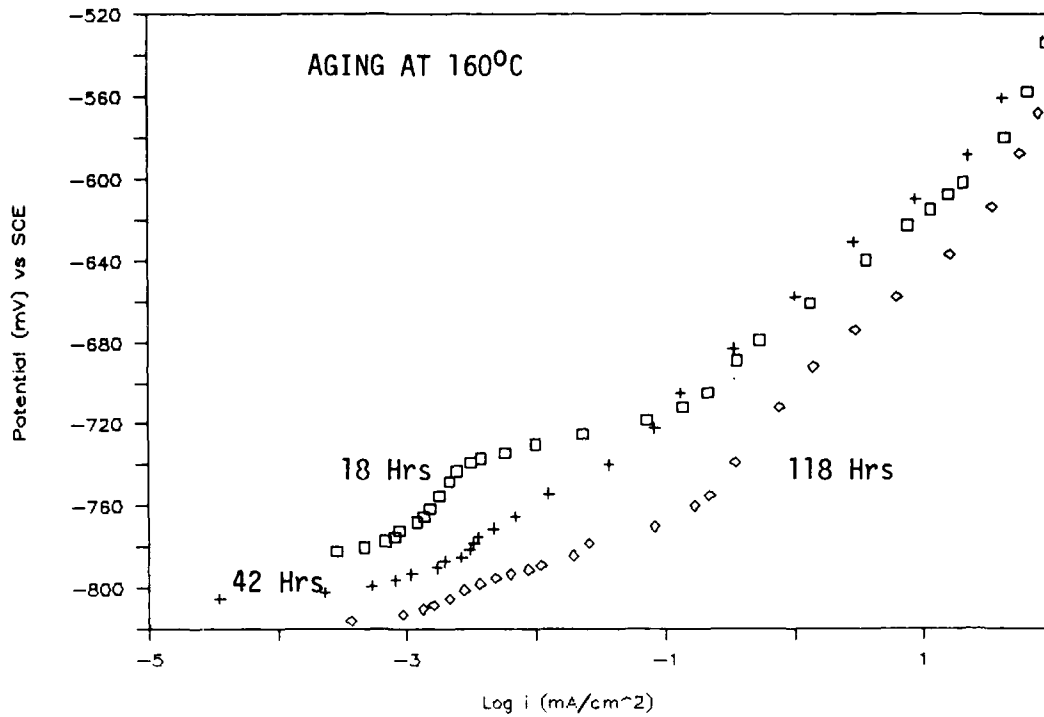
FIGURE 31. POTENTIODYNAMIC ANODIC POLARIZATION CURVES HEAT TREATED SiC/AA-2124 COMPOSITES IN 3.5% NaCl

The effect of heat treatment on the anodic dissolution behavior of SiC/AA-2124 can be seen in Figure 31. The E_{corr} of SiC/AA-2124 became more active with increasing aging time. This behavior was similar to that reported elsewhere.³⁰ In addition, the shapes of the anodic curves were different. The sample aged for 18 hours revealed a small passive region, which showed that the onset of pitting occurred at higher potentials as observed for cyclic pitting studies. However, at 42 and 118 hours pitting occurred near E_{corr} . Current densities around E_{corr} increased

with increased aging time and thus indicated that for lower aging times the MMC was less reactive. This behavior can be attributed to the presence of smaller intermetallics and less Mg segregation to the SiC whiskers. Large amounts of Cu and Mg in solid solution resulted in a more noble Ecorr and reduced the size and number of separate cathodic and anodic areas near the SiC whiskers. The presence of large Cu intermetallics and the depletion of Mg and Cu from grains caused by overaging results in a highly reactive SiC interphase region.
