TOOELE ARMY DEPOT  
PRELIMINARY ASSESSMENT/SITE INVESTIGATION  
FINAL REPORT

VOLUME II - SOUTH AREA

DECEMBER 1988

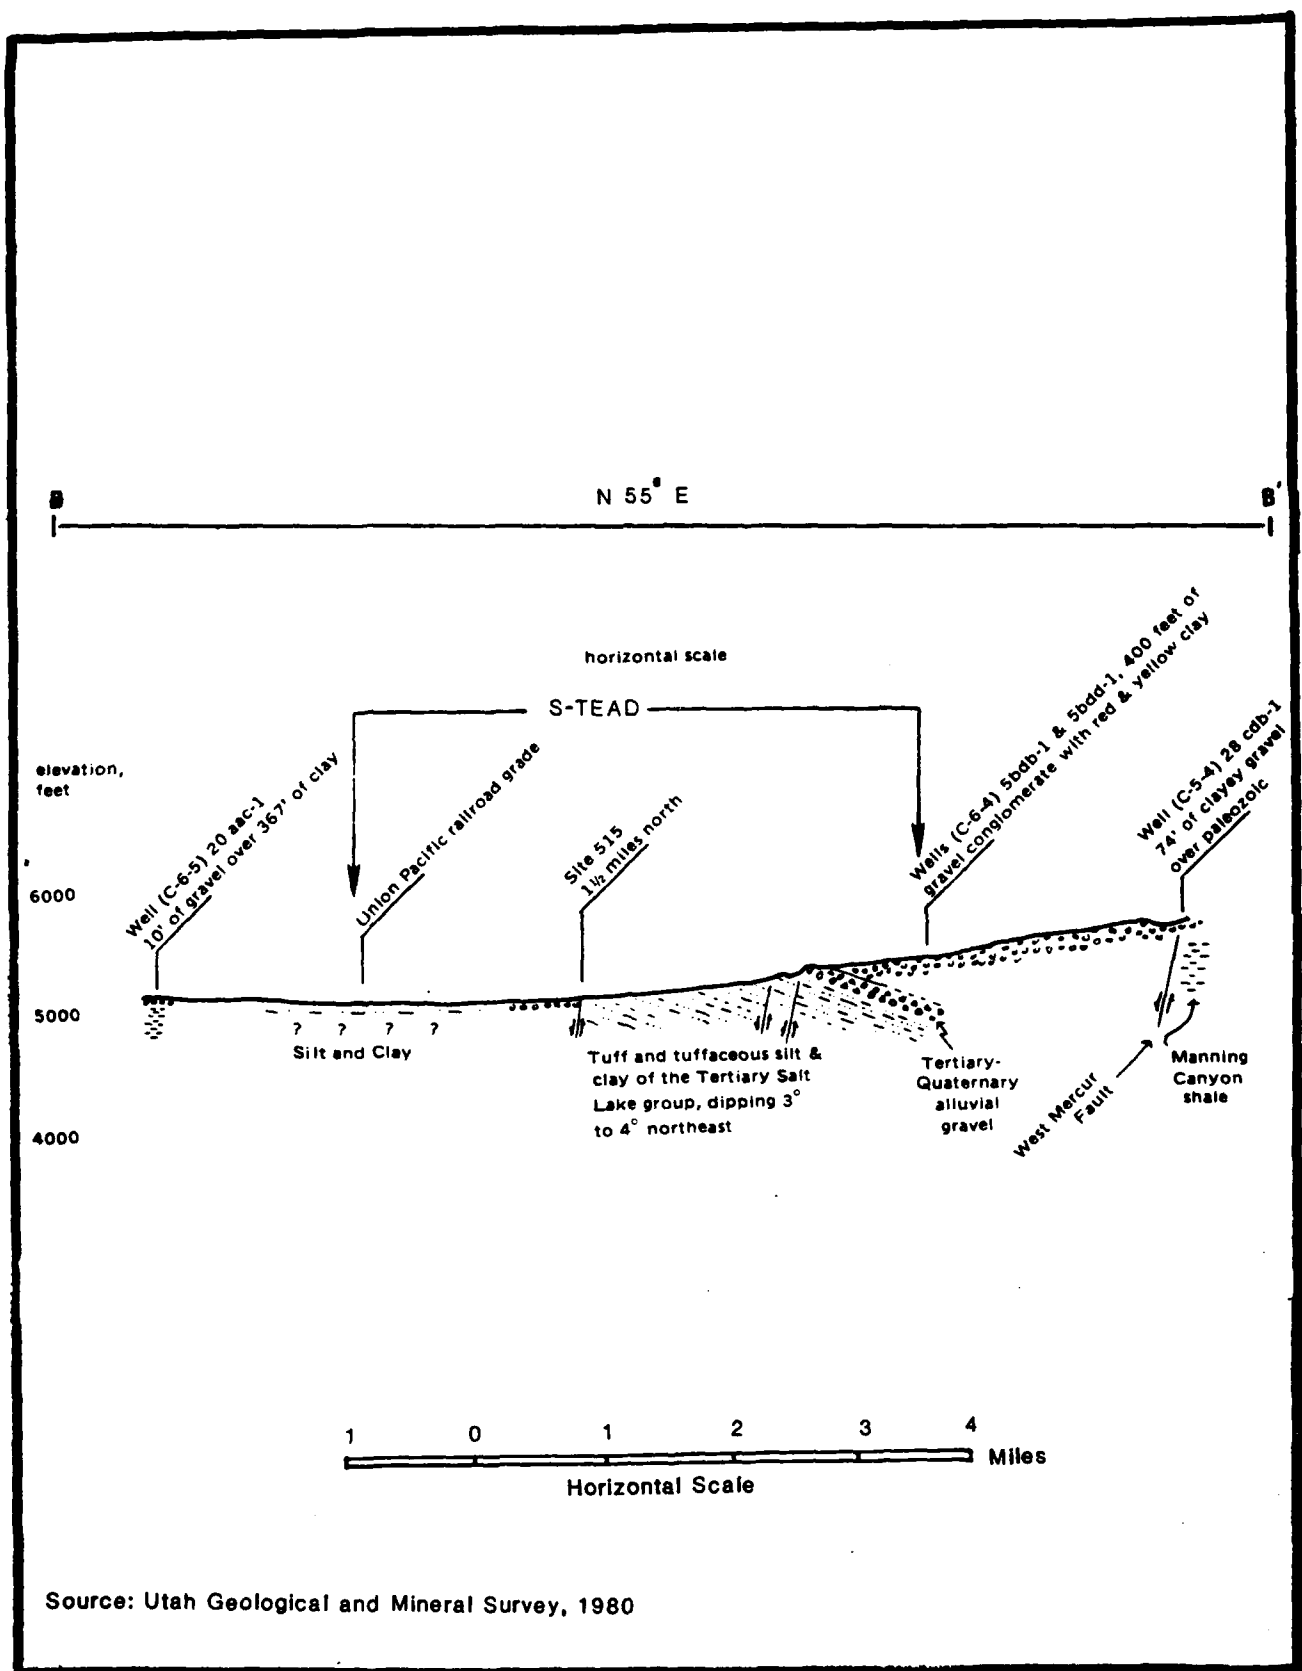
**Figure 3-4. Generalized geologic cross-section for S-TEAD.**

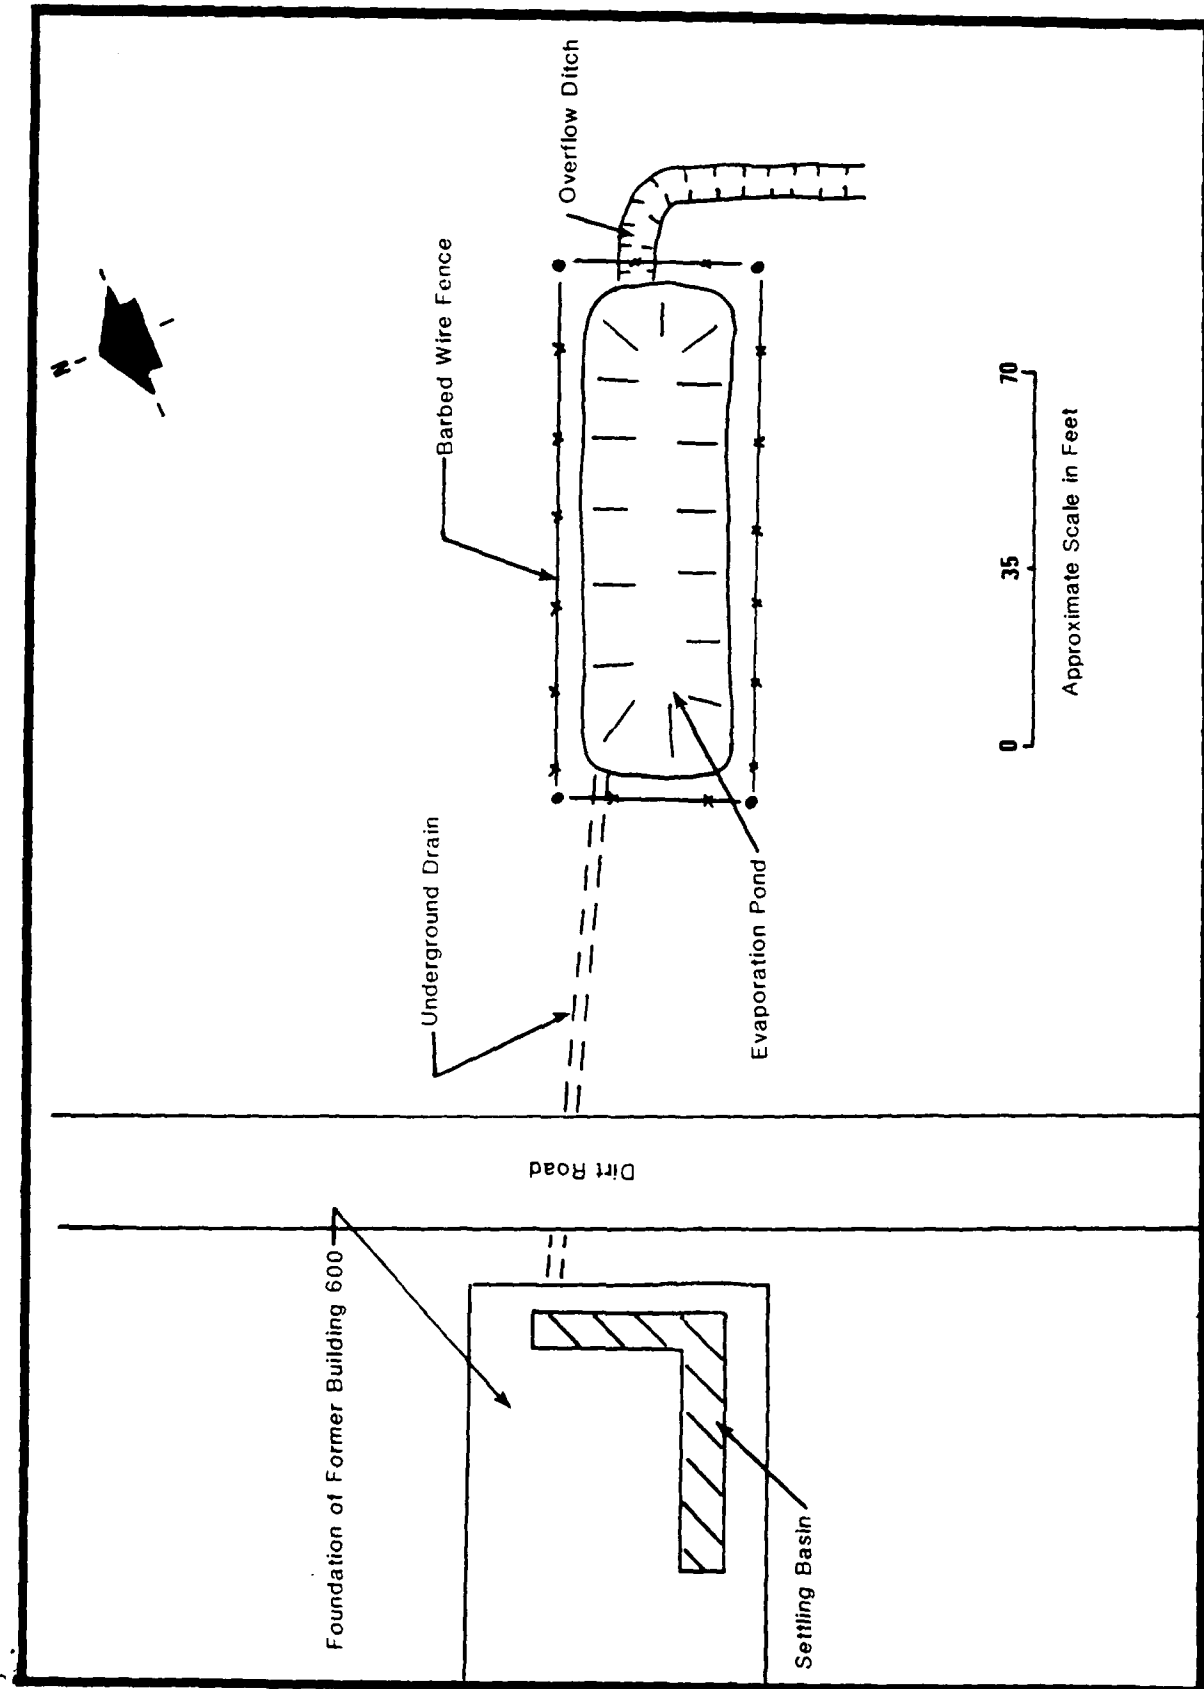
Figure 6-3. Site map of Bomb Washout Facility, S-TEAD.

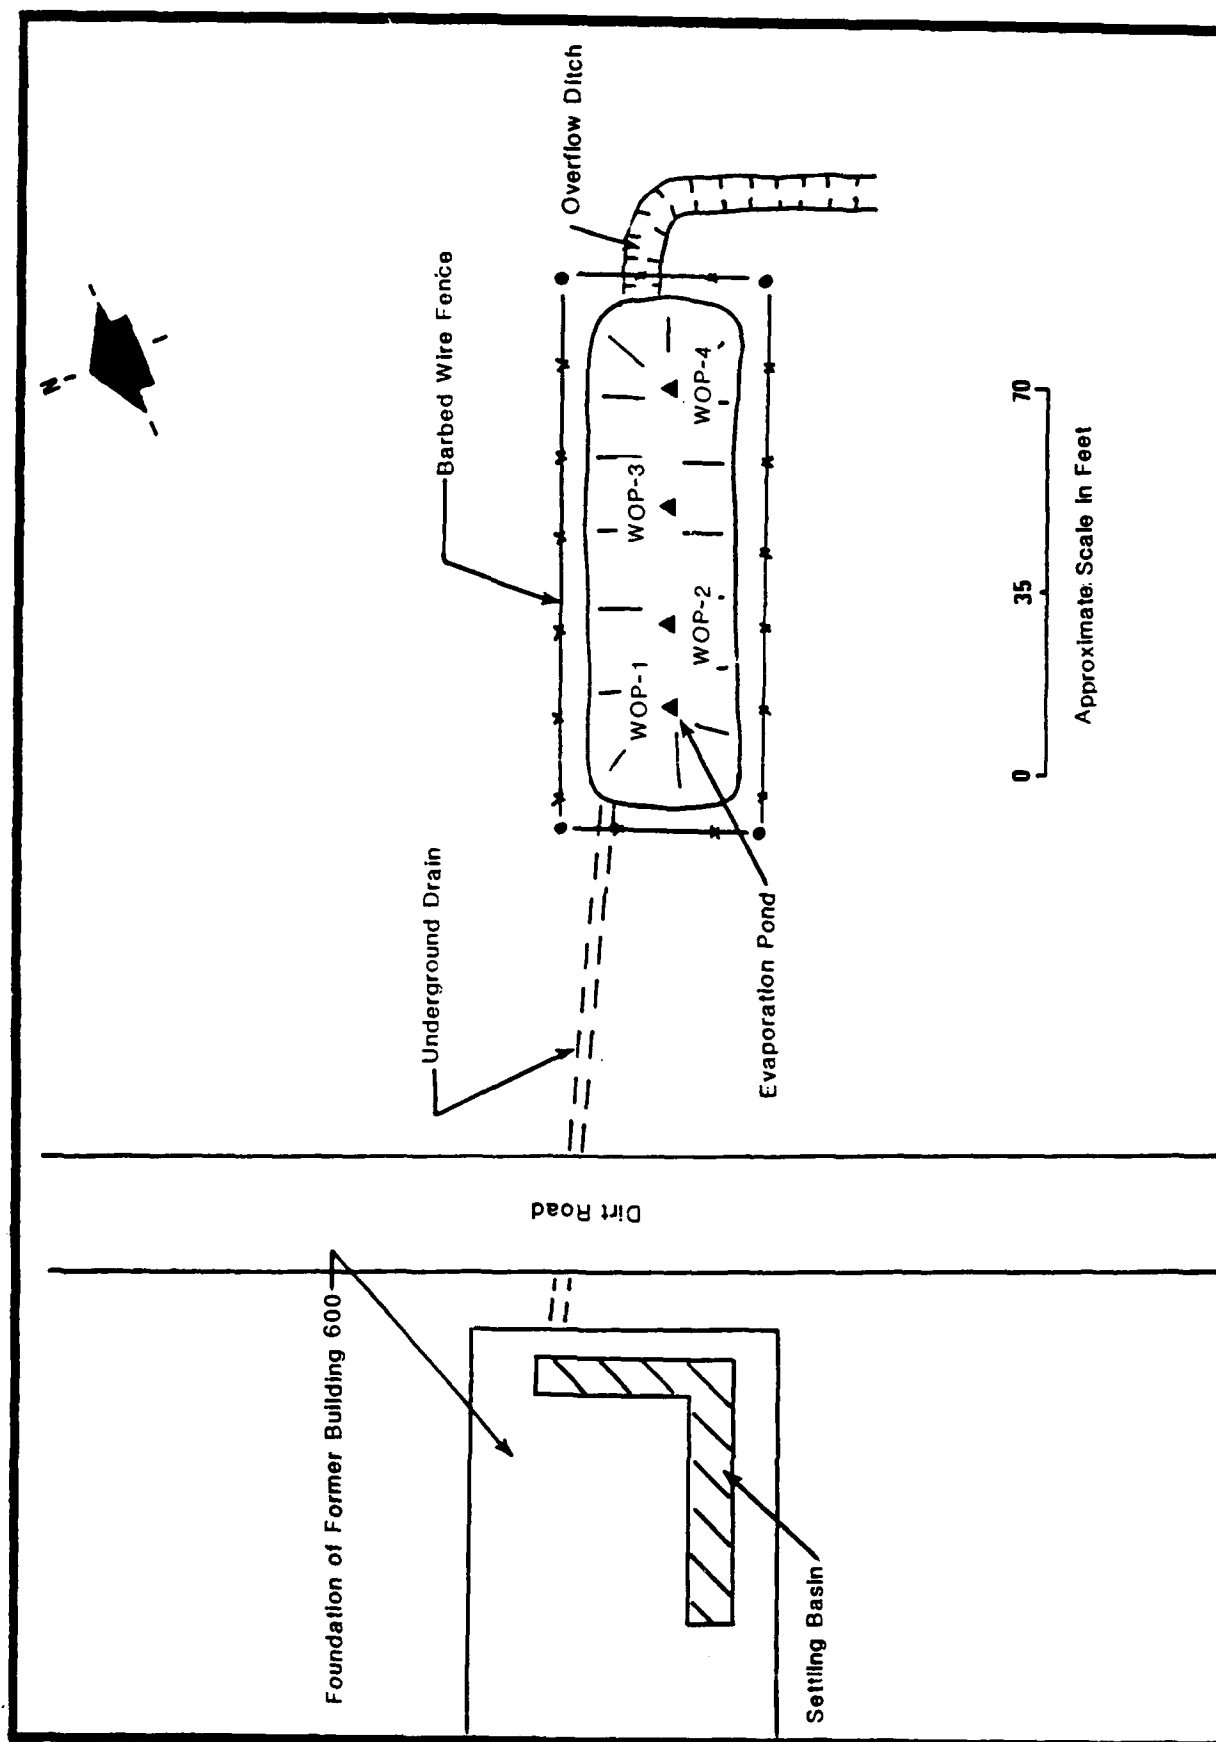
**Figure 8-2. Map of S-TEAD Bomb Washout Pond sampling locations.**

Monitoring Well S-2 is located approximately 500 feet west-southwest of the Bomb Washout Pond at a similar elevation. The boring log for this well shows a clayey silt extending from ground surface to a depth of 8.5 feet which is underlain by an 11 foot thick layer of gravelly sand (Ertec 1982). Alternating layers of silt, silty gravel, and sand occur to a depth of 86.5 feet (terminal depth of boring). Depth to groundwater, as measured in Well No. S-2 on 18 February 1987, is 56.58 feet BLS. The direction of groundwater movement in the vicinity of the site occurs in a general southerly direction. Well No. S-2 is not located directly downgradient of the site and may not intercept contaminants from the site.
