## TECHNICAL INFORMATION BULLETIN 88-3

# THE EFFECTS OF HIGH-ALTITUDE ELECTROMAGNETIC PULSE (HEMP) ON TELECOMMUNICATIONS ASSETS

JUNE 1988

OFFICE OF THE MANAGER  
NATIONAL COMMUNICATIONS SYSTEM  
WASHINGTON, D.C. 20305

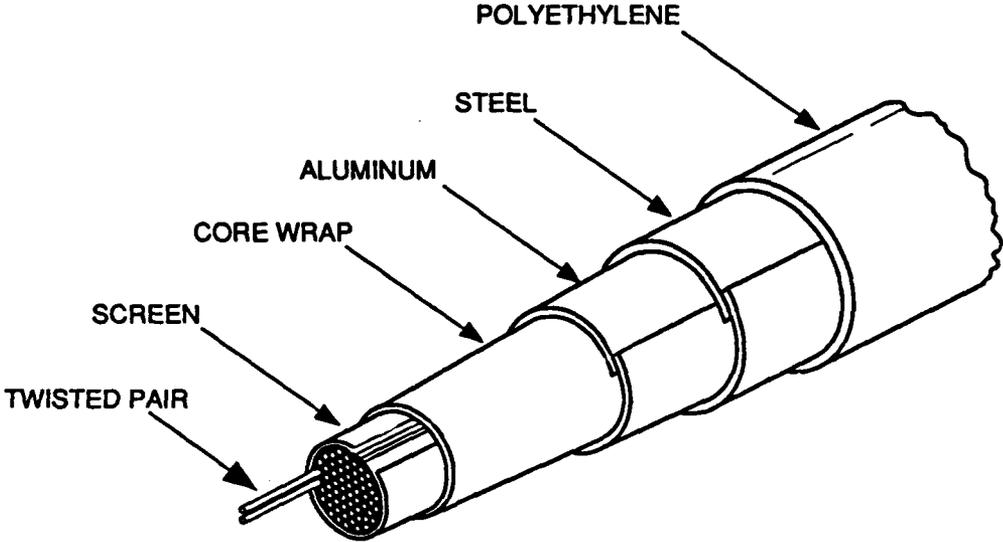
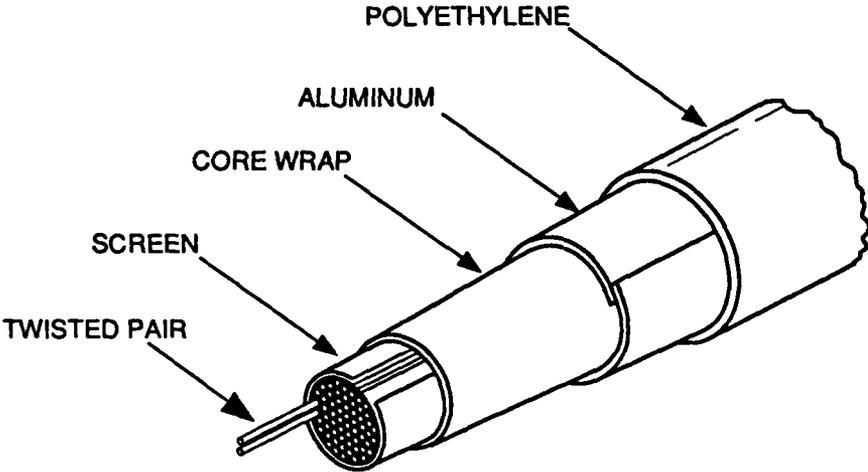
Exhibit 2-2  
T1 Carrier Twisted-Pair, Screened Cables

(a). Buried cable

(b). Aerial cable

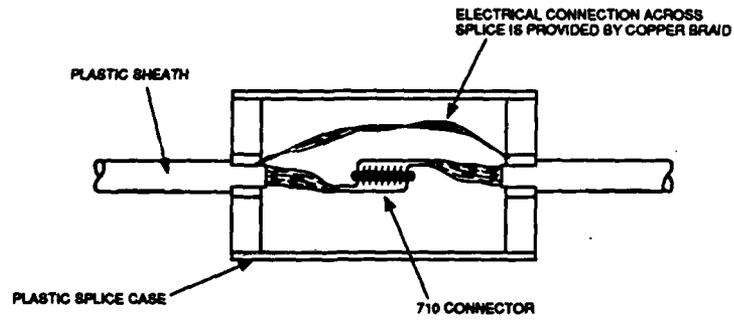
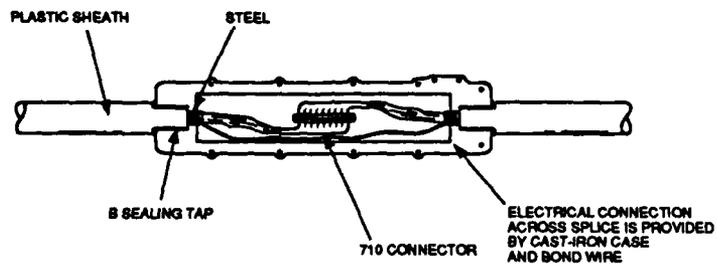
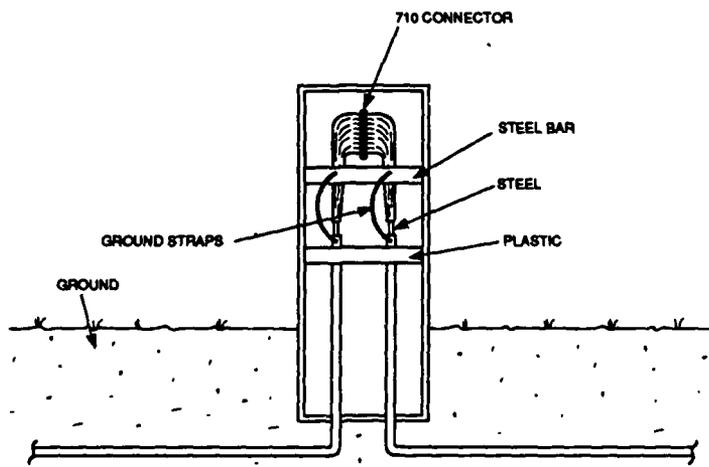
Exhibit 2-3  
T1 Carrier Splice Cases

(a). Plastic Splice Case

(b). Cast Iron Splice Case

(c). PC-12 Splice Case

In a typical T1 cable in the field, proper EMP cable shielding techniques are not always followed (i.e., the cable sheath is not always continuously bonded). The major violation occurs at cable splice points. In a typical plastic splice case, a copper braid makes a DC sheath-to-sheath connection for safety purposes; running alongside unshielded signal leads. Even when a steel splice case is used, a bonding jumper is carried inside the case. Three common splice cases are shown in Exhibit 2-3. Pigtails (bonding straps) are not usually well-bonded to sheaths, do not provide enough surface for conduction of large amplitude surges, and easily degrade over a period of years. The design of such splice cases allows significant coupling of the sheath current to the signal conductors.

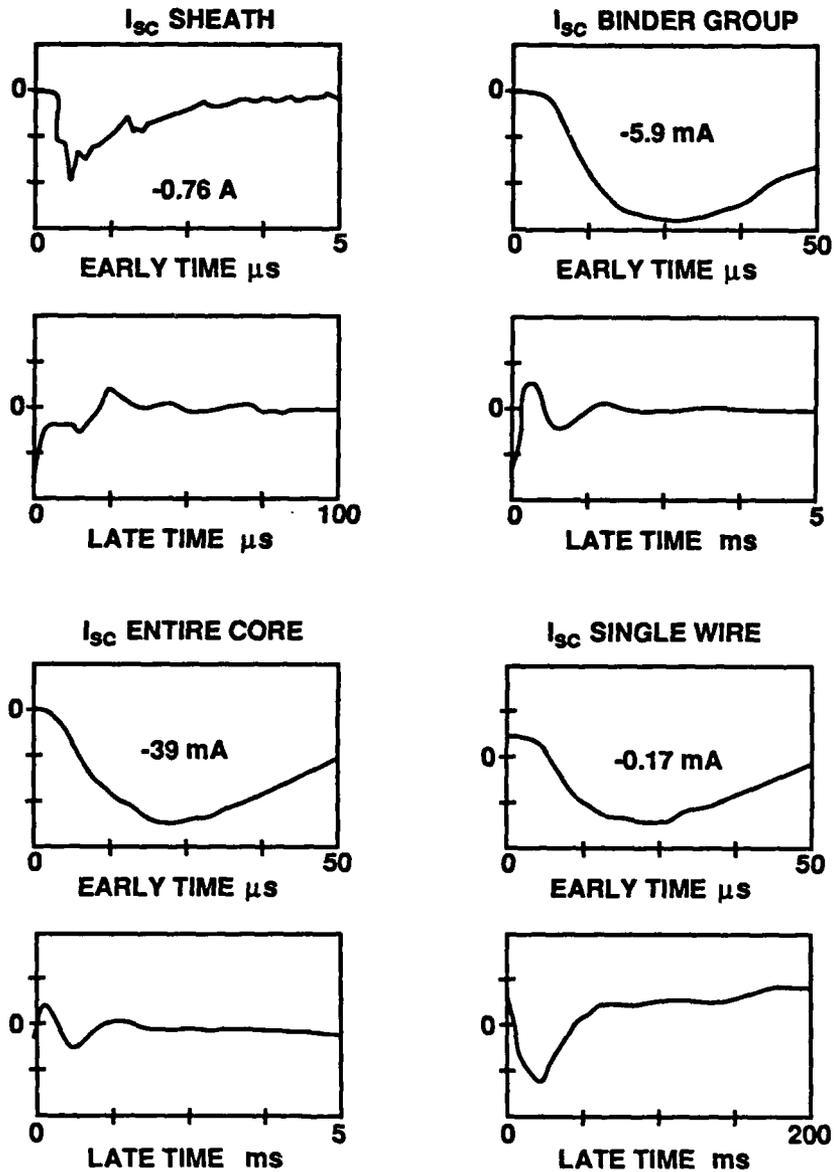
Exhibit 2-4  
HEMP-Induced Currents on Buried T1 Cables

SHEATH  $\Rightarrow$  CORE  $\Rightarrow$  BINDER GROUP  $\Rightarrow$  WIRE

760 mA  $\Rightarrow$  39 mA  $\Rightarrow$  5.9 mA  $\Rightarrow$  0.17 mA

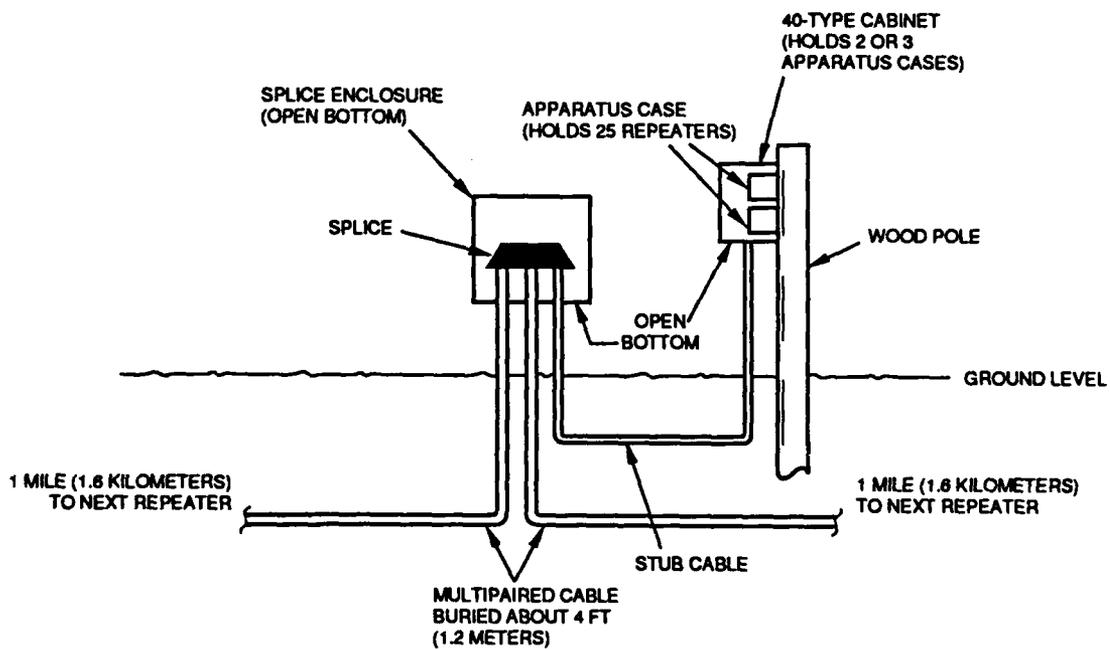
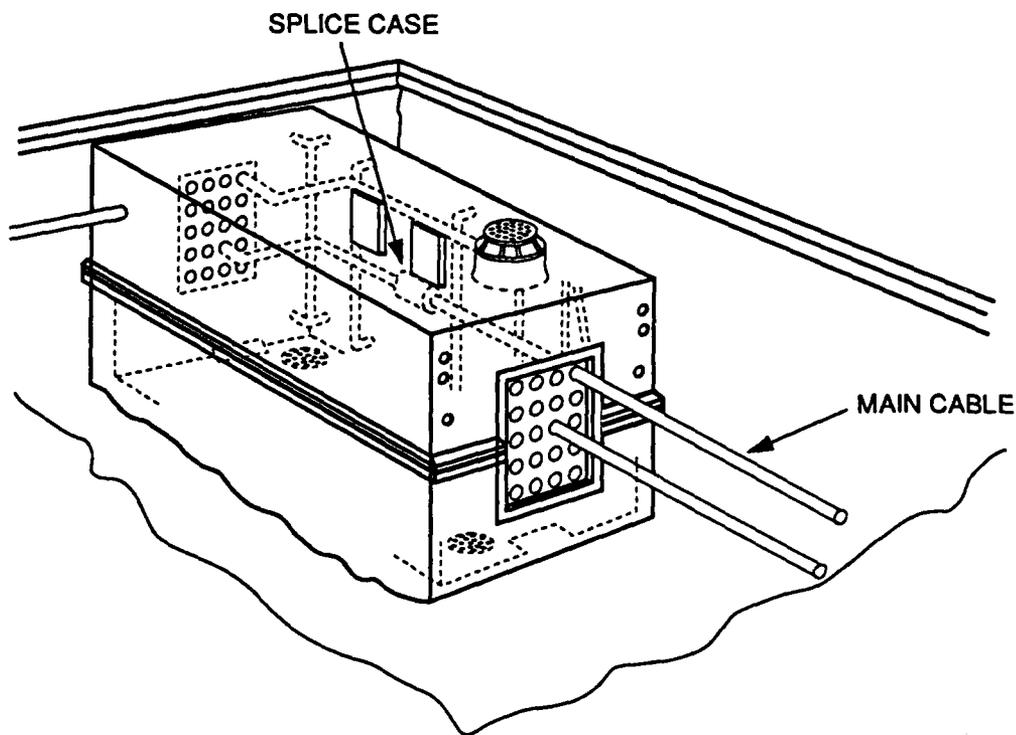
Exhibit 2-6  
Typical Buried T1 Repeater Installations

(a). Pole-Mounted Repeater

(b). Manhole-Installed Repeater

The typical repeater unit tested is an 800-type plastic case housing two 239 E/F 60 Hz protected repeaters with standard lightning protection devices (208A gas tubes) installed. The splice case is a typical PC-12 mounted above ground. During testing at several field levels up to threat level (about 50 kV/m), outages in equipment operation of 61  $\mu$ s to 256 ms were experienced, but no permanent failures were observed.

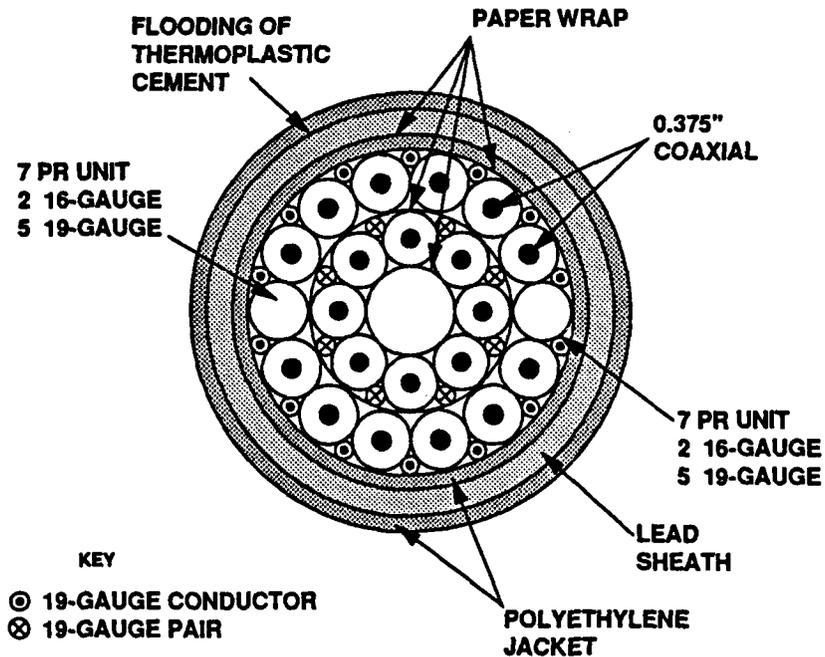
**Exhibit 2-26  
Typical L4 Cable Characteristics**

Trunk cable: WECO "COAX-20", buried, pressurized with dry air.

Standard coaxial line: 0.1" copper conductor insulated from 0.375" cylindrical conductor of 0.012" copper tape seamed lengthwise. Outer conductor wrapped in one or two 0.006" steel tapes for added strength and H-field shielding.

L4 trunks generally are 3-inch shielded cable carrying 20 coaxial tubes and 52 interstitial service pairs. Each coaxial tube carries six frequency-multiplexed master groups (3,600 one-way voice channels), while each pair carries 3,600 two-way (full-duplex) voice channels. Of the 20 tubes, one pair is spare and nine pairs are used, supplying 32,400 two-way message channels per sheath. Exhibit 2-26 shows a typical L4 cable.

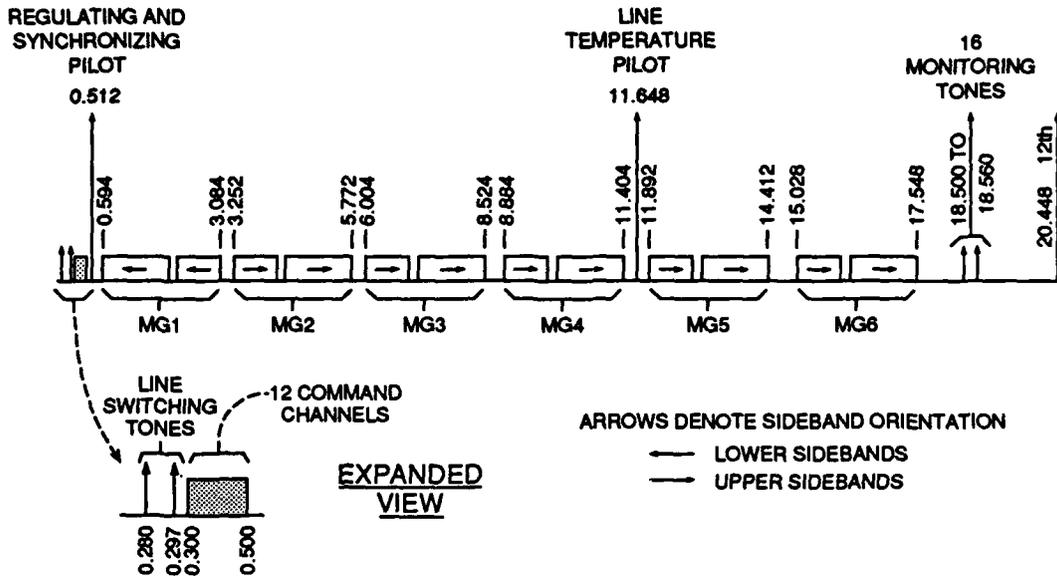
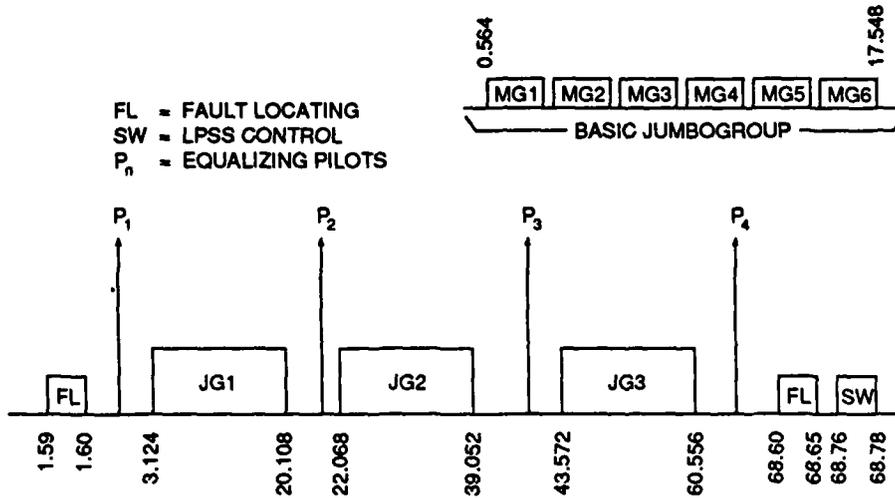
**Exhibit 2-27**  
**L System Frequency Allocation**

(a). L4 frequency allocation

(b). L5 frequency allocation

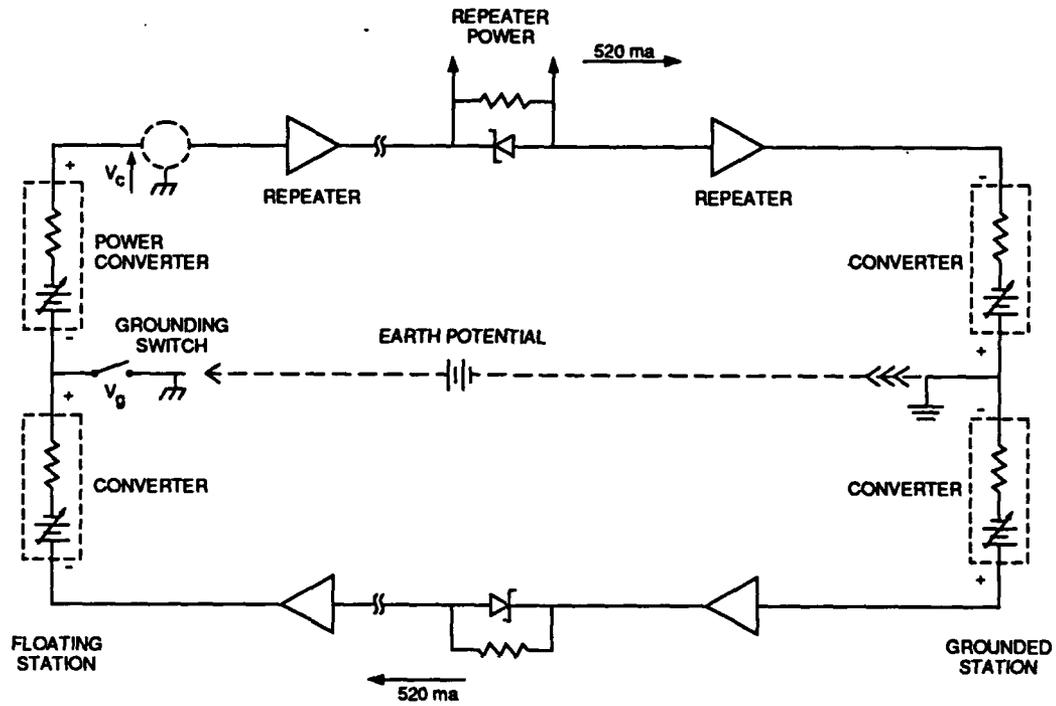
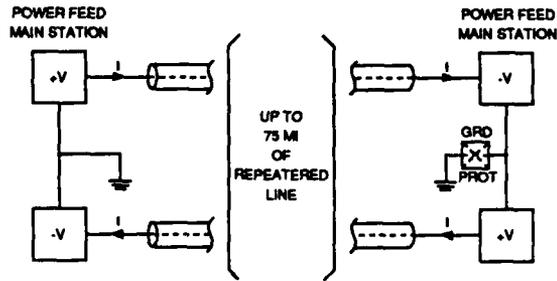
Exhibit 2-31  
L System Repeater Power Grounding Protection

(a). L4

(b). L5

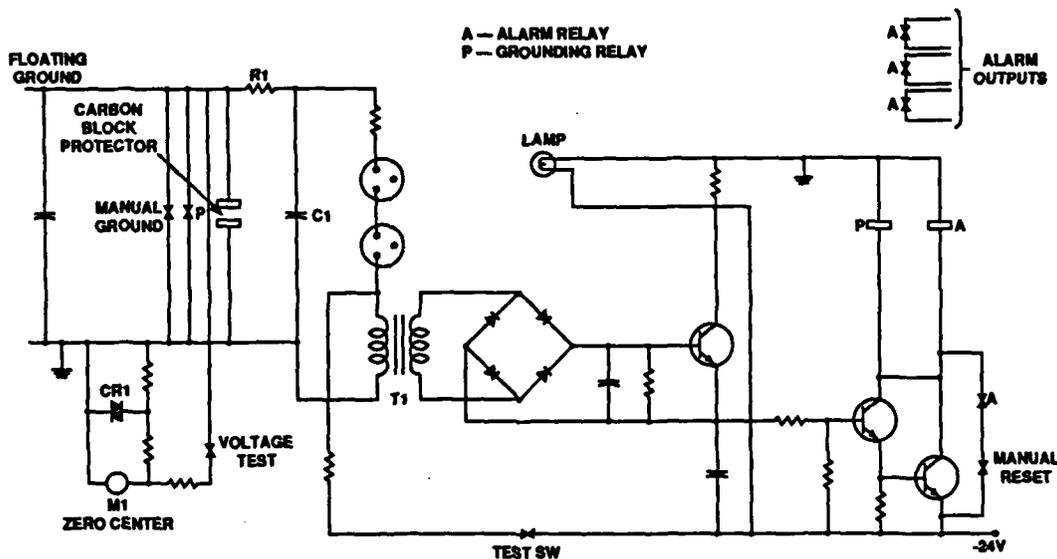
Exhibit 2-32  
Schematic of Power Loop Protective Grounding Circuit

Peak instantaneous limit:	2,600 V total
Peak floating ground voltage:	800 V maximum
Maximum steady-state over-voltage:	2,200 V total
Maximum steady-state floating ground voltage:	400 V maximum
Steady-state shutdown limit for floating ground voltage:	370 V
Delay time for steady-state shutdown:	20 ms

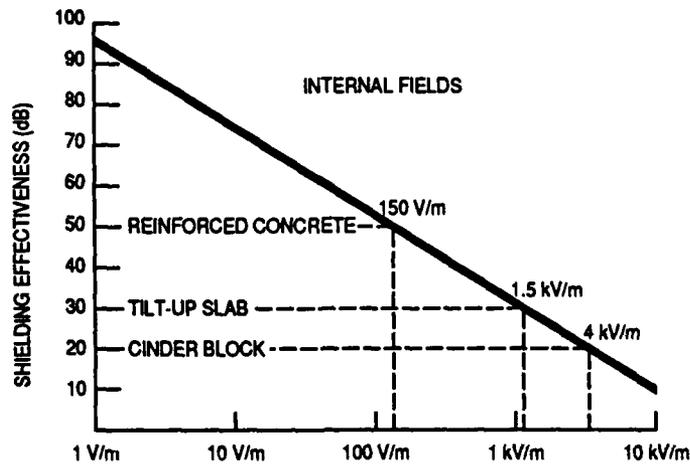
**Exhibit 3-1  
Building Shielding Effectiveness**

**NOMOGRAM FOR INTERNAL ELECTRIC  
FIELD ENVIRONMENTS (ZONE 1)**

$$\text{S.E.} = 20 \text{ Log} \left( \frac{E_{\text{ext}}}{E_{\text{int}}} \right)$$

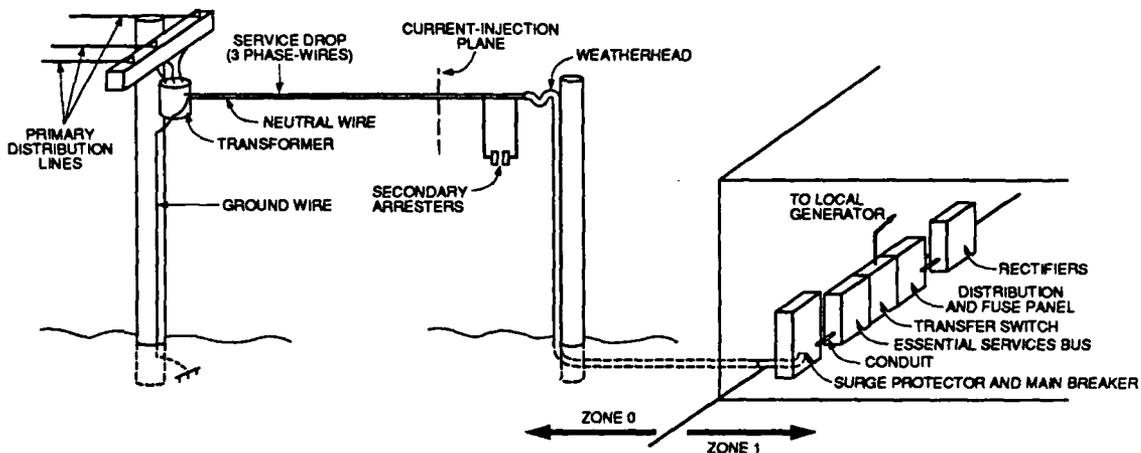
Exhibit 3-2  
Typical Power Line Termination

TYPICAL COMMERCIAL POWER FEED AND DISTRIBUTION  
BOUNDARY ONE AT THE MAIN BREAKER BOX

Inside the building, the power first passes through the main circuit breaker and then branches to essential and nonessential (i.e., lighting) service buses. From the essential service bus, the power goes to a transfer switch (actuated when power fails), then to a fuse panel and power distribution board (the rectifiers powering the facility are fed directly from this board). These circuits are almost always protected from lightning by the power company serving the physical plant. The power company places lightning arrestors (usually carbon block or gas tube) at the transformer on the load side of the power lines. Also, in virtually all physical plants, the telephone company places its own (secondary) lightning arrestors in the form of carbon

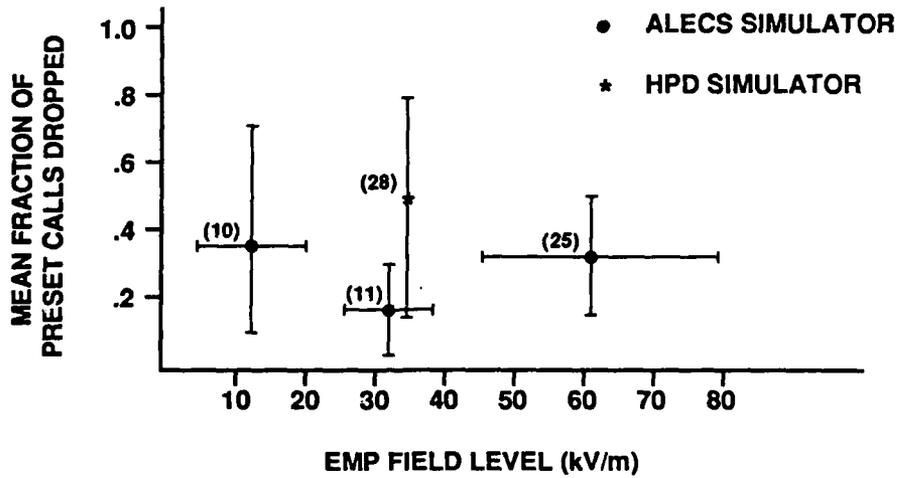
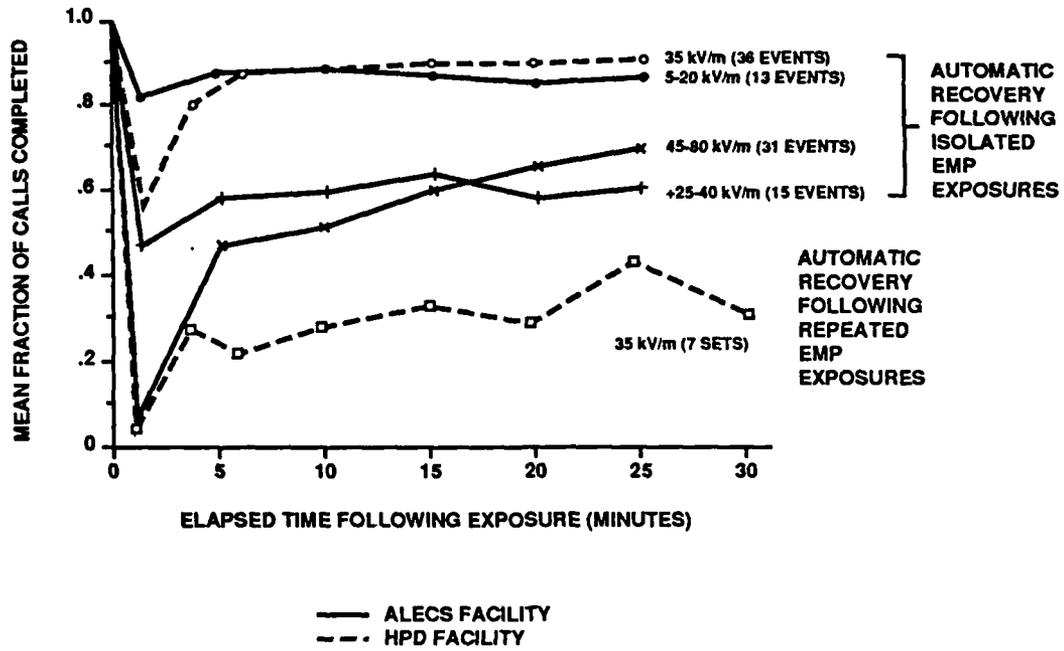
Exhibit 3-8  
 Transient-Induced Effects on Telecommunications Network

(a). Mean Fraction of Preset Calls Dropped Due to Induced Transients

(b). Automatic Recovery of Call Processing Following Simulator Exposure

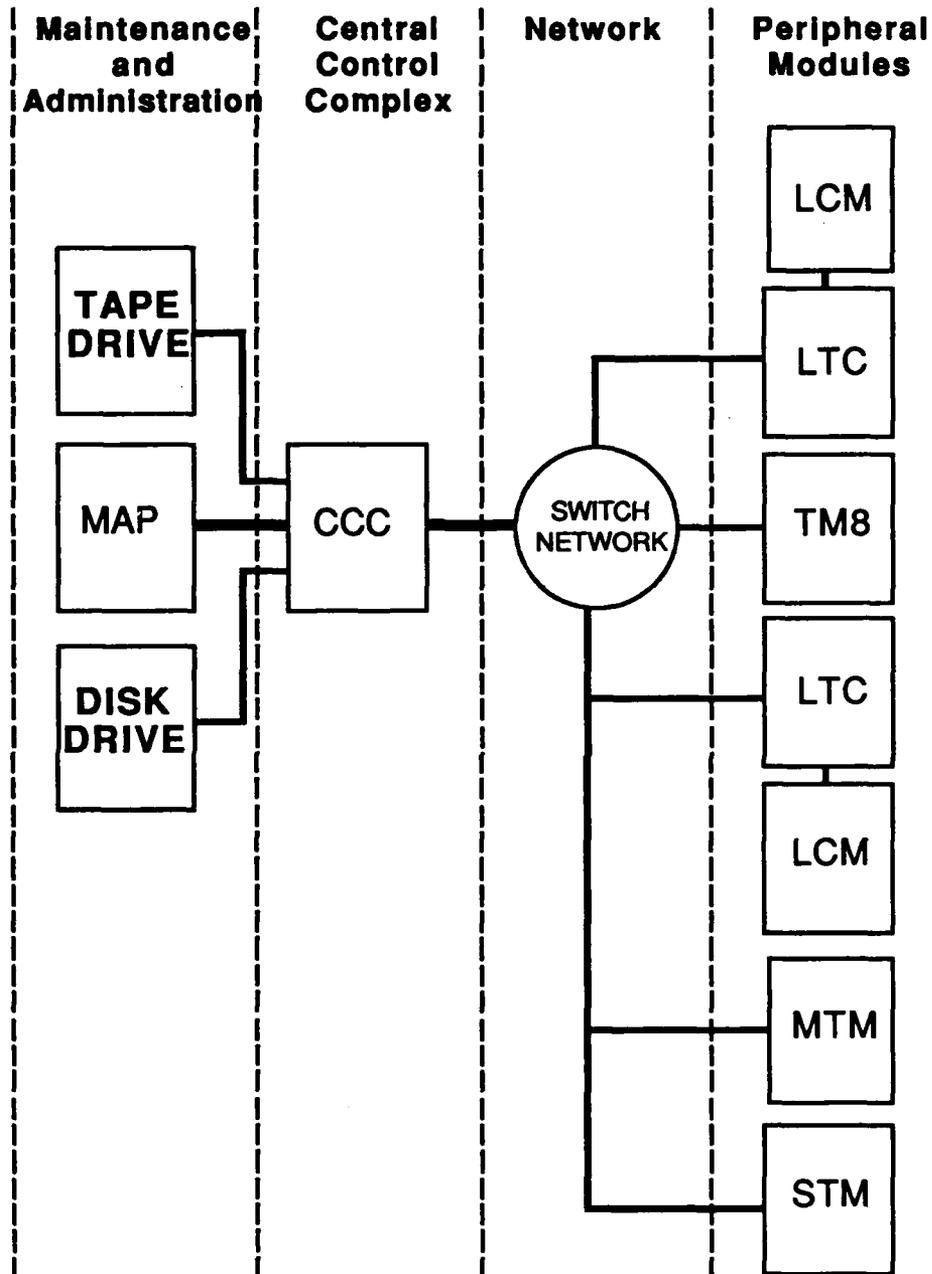
Exhibit 3-12  
Major DMS100 Component Interconnections

TM8 - Trunk Module, 8-wire  
 MTM - Maintenance Trunk Module  
 STM - Service Trunk Module

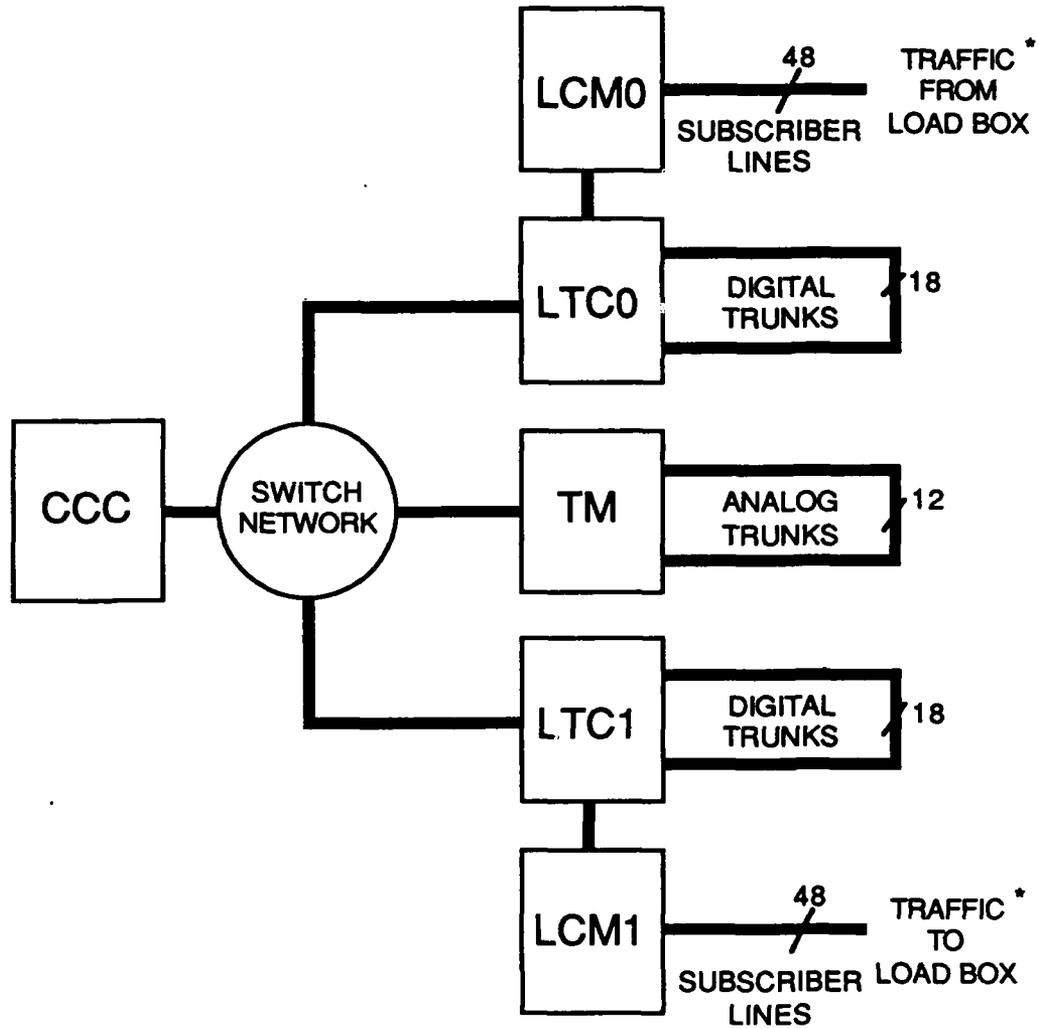
Exhibit 3-13  
 Traffic Link Distribution for the EMP test

LCM - Line Concentrating Module (Subscriber Line Interface)

Exhibit 3-15 graphically depicts the recovery time of switch call-processing capability following exposure to single simulator pulses of 30-50 kV/m. Exhibit 3-16 presents switch recovery time following exposure to single pulses of 50-70 kV/m. These exhibits include data taken from all the AESOP pulses for which recovery time data exist, with the switch in an unshielded configuration with modified and unmodified hardware. When one of the two LCMs (LCM0 or LCM1) returned on-line following a test pulse, the switch was said to be operating at 50 percent capability. When both LCMs returned on-line, the switch was said to be operating at 100 percent capability. This definition is entirely a function of the test architecture as described in Exhibit 3-13.
