Special Report 89-4

Radar profiling of Newton Airfield in Jackman, Maine

Carl R. Martinson

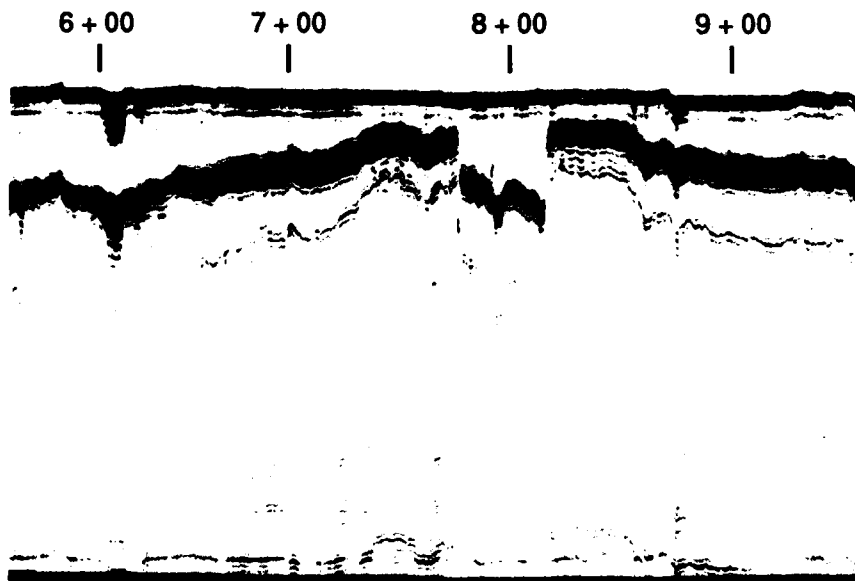
Figure 7. Survey parallel to the centerline and approximately 10 ft south of it, passing through station 8+00 where a discontinuity appears.

to either side of it on the centerline survey. Figure 7 shows a discontinuity approximately 40 ft long, with station 8+00 near the center of it. A cross-sectional survey at station 8+17, documented in Figure 5, shows the same discontinuity for a distance of about 10 ft. The subsurface observations correspond closely in size with the

patch seen at the surface. During a subsequent visit to the airport, we were informed that the insulation was too close to the surface in this area and that the area was excavated and the insulation placed at the "correct" level. We were also told that the repair extended to locations where the insulation was in its proper position.
