MISCELLANEOUS PAPER GL-89-5

# STUDY OF EMBANKMENT PERFORMANCE DURING OVERTOPPING AND THROUGHFLOW

Report 1  
FEASIBILITY STUDY

by  
Hon-Yim Ko, R. Jeffrey Dunn, Ebrahim Simantob

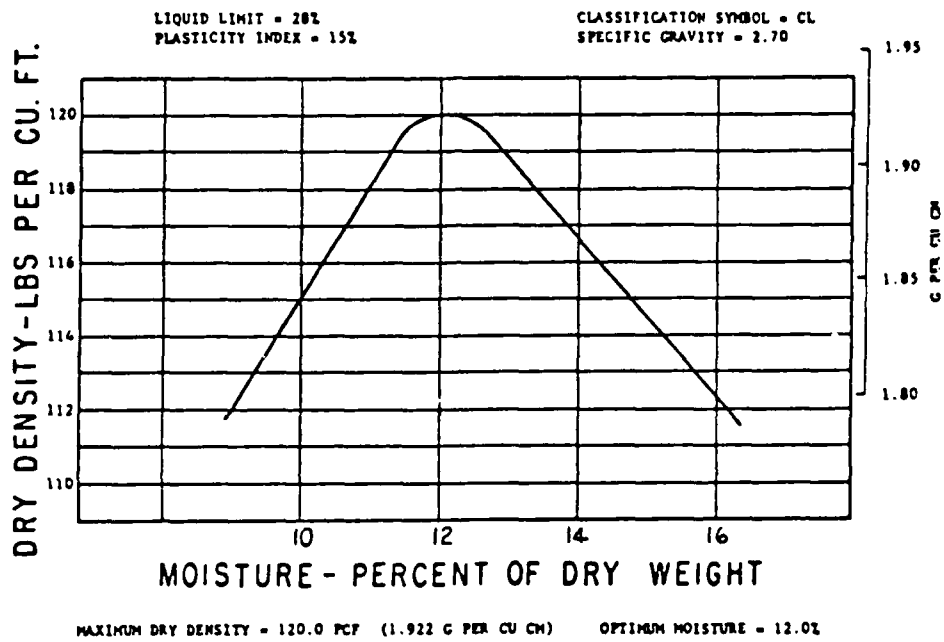
Fig.III.4 Compaction test results for clay material (ASTM D 698)

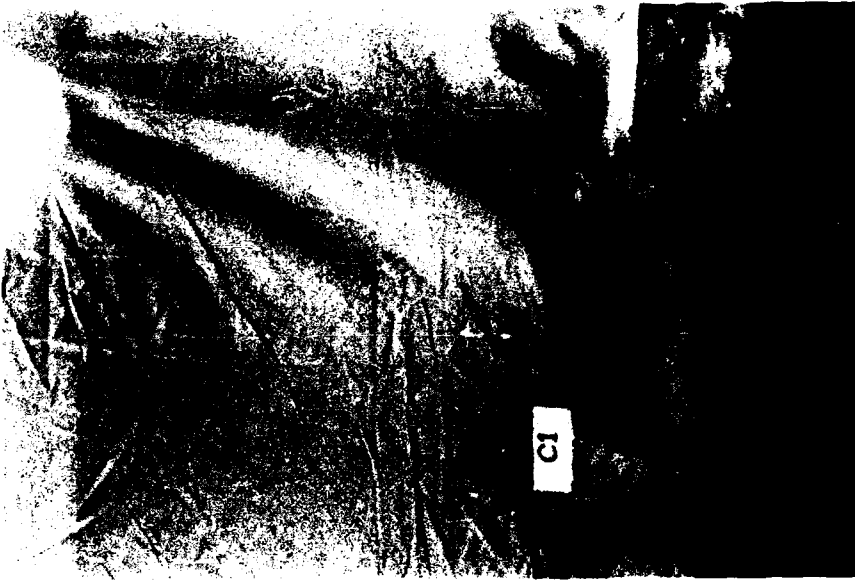
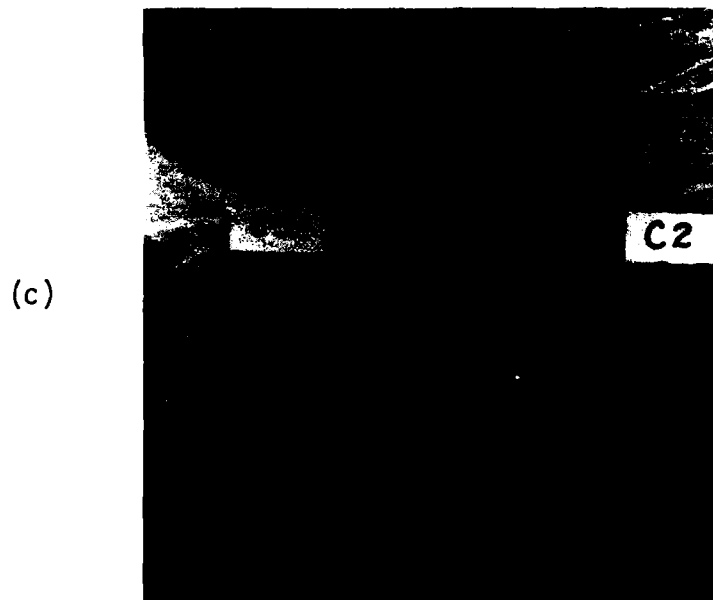
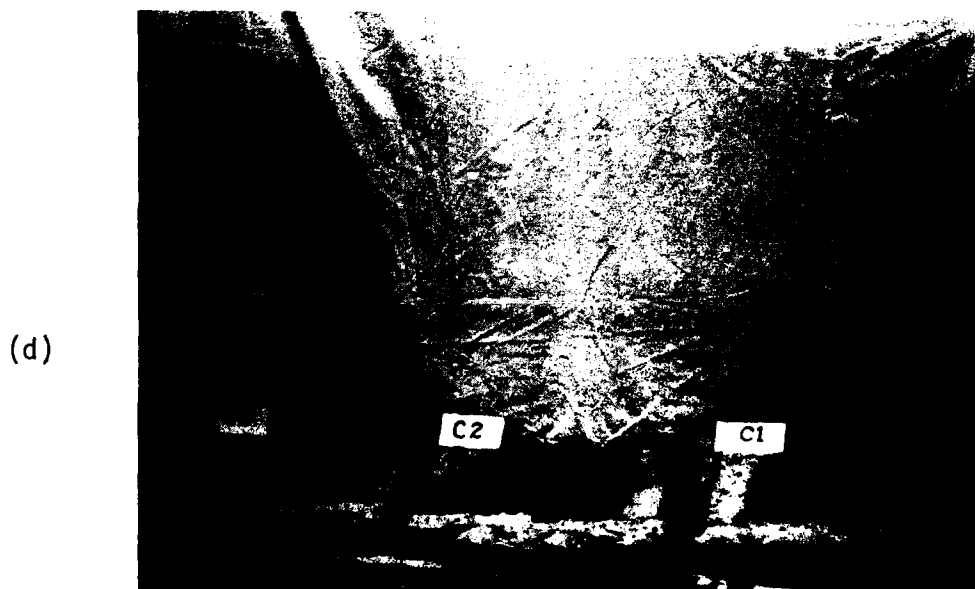
Fig. V.6 Photographs of clay embankments after completion of 16 minutes of overtopping, (a) Embankment C-1, (b) Embankment C-2

Fig.V.6 Photographs of clay embankments after completion of 16 minutes of overtopping, (c) Embankment C-3, (d) Embankments C-1, C-2, C-3

40. As indicated previously, the clay embankments did not fail after 16 minutes of overtopping flow. In Figure V-5 stereophotos of Sample C-1, taken at successive 4 minute intervals, are presented. The photos indicate that erosion occurred over the entire area below the spillway. The erosion profile was a wide U-shaped, moderately sloped channel, containing several ridges. This erosion profile agrees with the discussion of erosion gully shapes in different soil types presented by Winterkorn and Fang (1975). Photographs of the three clay embankments after completion of the tests are shown in Figure V-6 and show the similarity of the erosion profile between the tests.
