Aircraft Structures Technical Memorandum 506

A REVIEW OF AUSTRALIAN AND NEW ZEALAND  
INVESTIGATIONS ON AERONAUTICAL FATIGUE DURING THE  
PERIOD APRIL 1987 TO MARCH 1989 (U)

A REVIEW OF AUSTRALIAN AND NEW ZEALAND INVESTIGATIONS ON  
AERONAUTICAL FATIGUE DURING THE PERIOD  
APRIL 1987 TO MARCH 1989

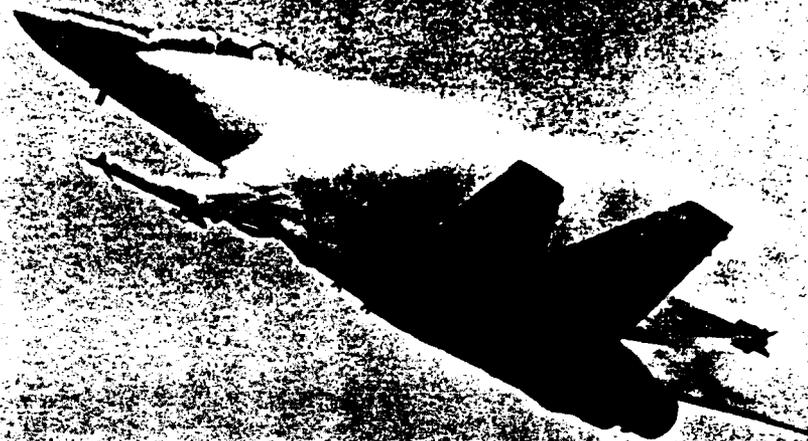
FIG. 3 VORTICES FROM LEADING EDGE OF F/A-18

LEADING EDGE EXTENSION (LEX) CREATES VORTEX

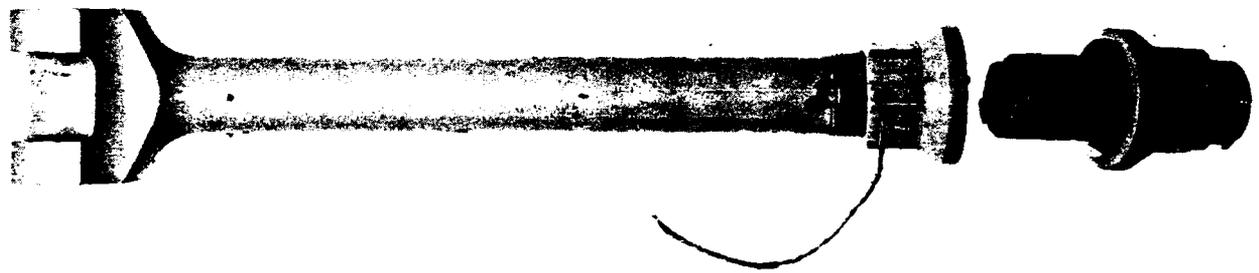
FIG. 14 BELL 214ST DRAG BRACE FAILURE AND FRACTURE SURFACE

When the wreck was recovered after 6 weeks in 30 fathoms, it was found that one main rotor blade drag brace had failed in fatigue [10]. The failure had occurred in the 1.25-inch diameter threaded portion of the rod, under the innermost of two nuts which clamp the blade attachment yoke at the outer end of the brace. The assembly is shown in Fig. 13, the broken drag brace and the fracture surface after cleaning in Fig. 14.

The plane of the fracture was located three threads in from the face of the nut and was normal to the axis of the brace. A secondary fatigue crack had propagated from the thread adjacent to the face of the nut and had intersected the primary crack, releasing a small wedge shaped section which was not recovered. Cracks were also evident in two threads inboard from the primary crack.
