ENVIRONMENTAL IMPACT
RESEARCH PROGRAM

CONTRACT REPORT EL-89-3

RESERVOIR BANK EROSION AND CULTURAL
RESOURCES: EXPERIMENTS IN MAPPING AND
PREDICTING THE EROSION OF ARCHEOLOGICAL
SEDIMENTS AT RESERVOIRS ALONG THE
MIDDLE MISSOURI RIVER WITH SEQUENTIAL
HISTORICAL AERIAL PHOTOGRAPHS

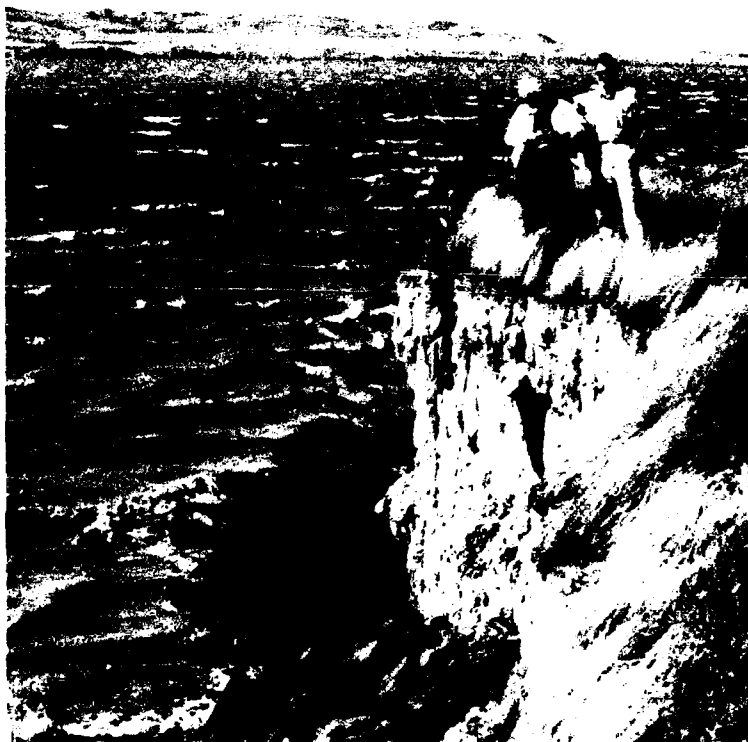
Figure 7. Sediments recently collapsed probably due to topple or cantilever failure of jointed silty sediments at the Jones Village Site, 39CA1

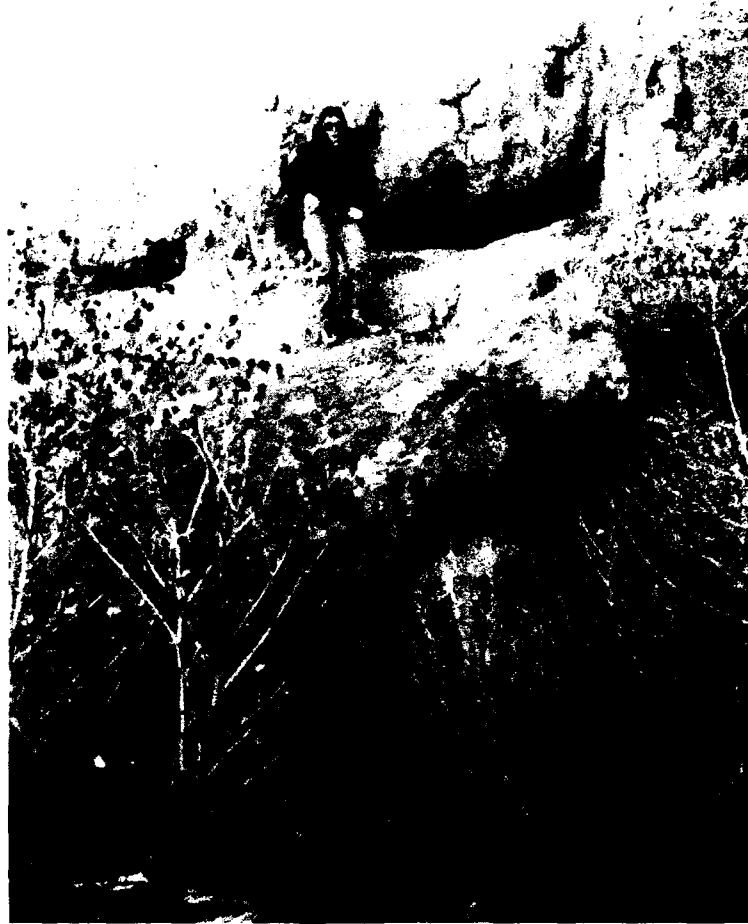
Figure 12. Systematic and widespread undermining of banks during illegal looting activities may be a major factor facilitating bank collapse and erosion at some sites

(Figure 12). Looters remove astonishingly large amounts of sediment and undermine banks very effectively at some sites, and this activity occurs year after year. Illegal artifact collecting, then, poses a double threat to cultural resources. This is one cause of bank erosion that would be relatively easy to combat and control (Site 39C06).

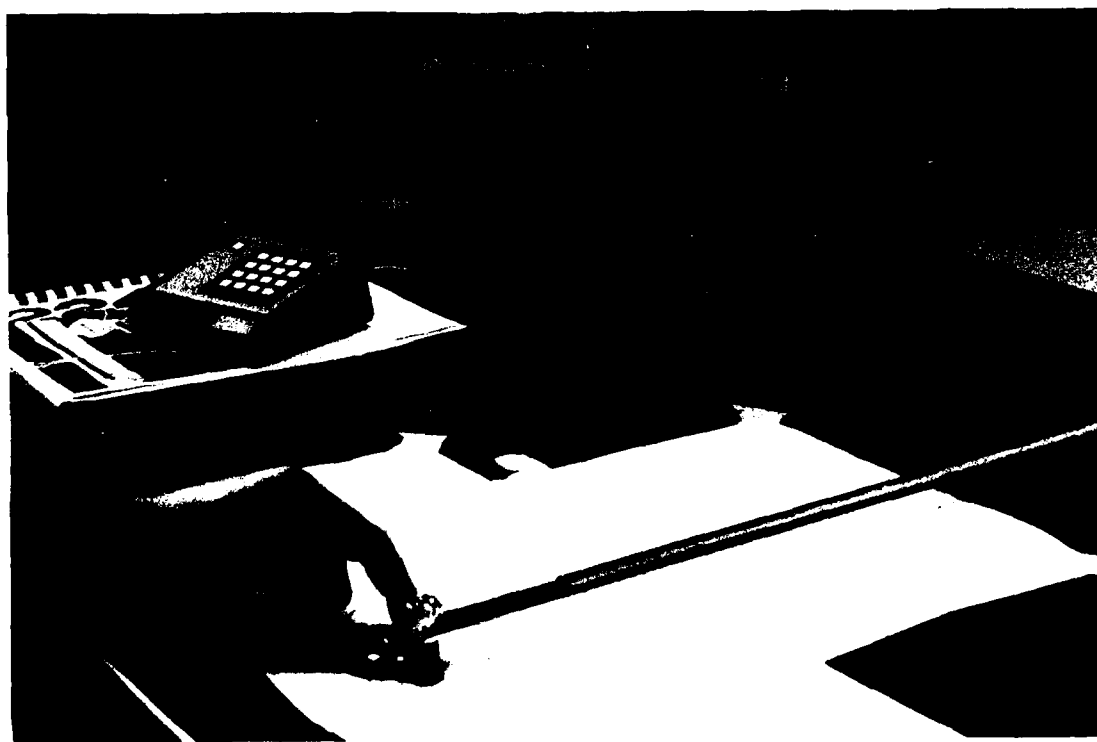
Figure 30. Measurement of areas of sites lost using a Numonics digital planimeter

190. A digital planimeter was used to measure the areas of the sites as they were prior to reservoir filling, and the successive amounts of site area lost due to bank recession at later dates (Figure 30). It should be mentioned here that defining the boundaries of a site is, in almost all cases, a rather arbitrary exercise, whether it is done using evidence visible on aerial photographs or through survey or excavation on the ground. In the three experimental cases illustrated here, site boundaries were defined on the basis of cultural features that could be cumulatively photointerpreted from the aerial photographs--the maximum extent of fortification ditches and housepits, for
