Advanced Tribological
Coatings For High Specific
Strength Alloys,
R&D 5876-MS-01

5th Interim Report

National Centre of Tribology

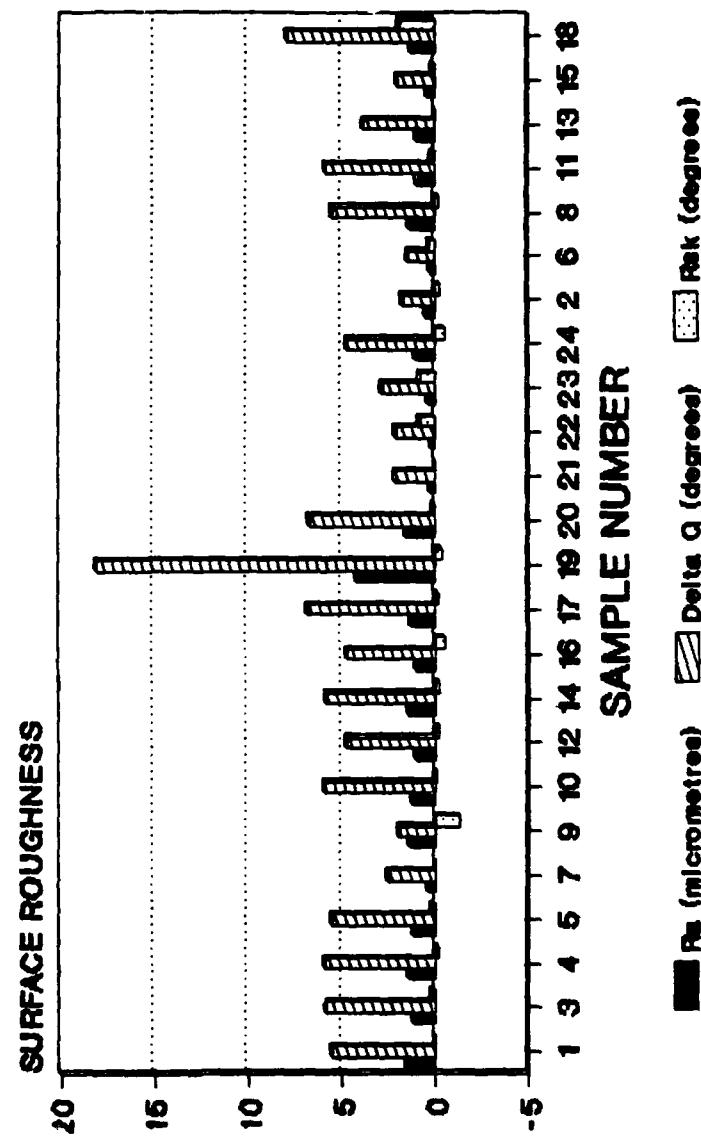
SURFACE ROUGHNESS MEASUREMENTS

The surface roughness measurements for the samples are summarised in Figure 1. This figure has been arranged with the samples that were originally solution heat treated grouped first, followed by those which were originally hardened and ground. Essentially only pack aluminising (HSSA19) causes any detriment to the surface roughness, all other treatments either cause no change or a small improvement in the surface roughness.

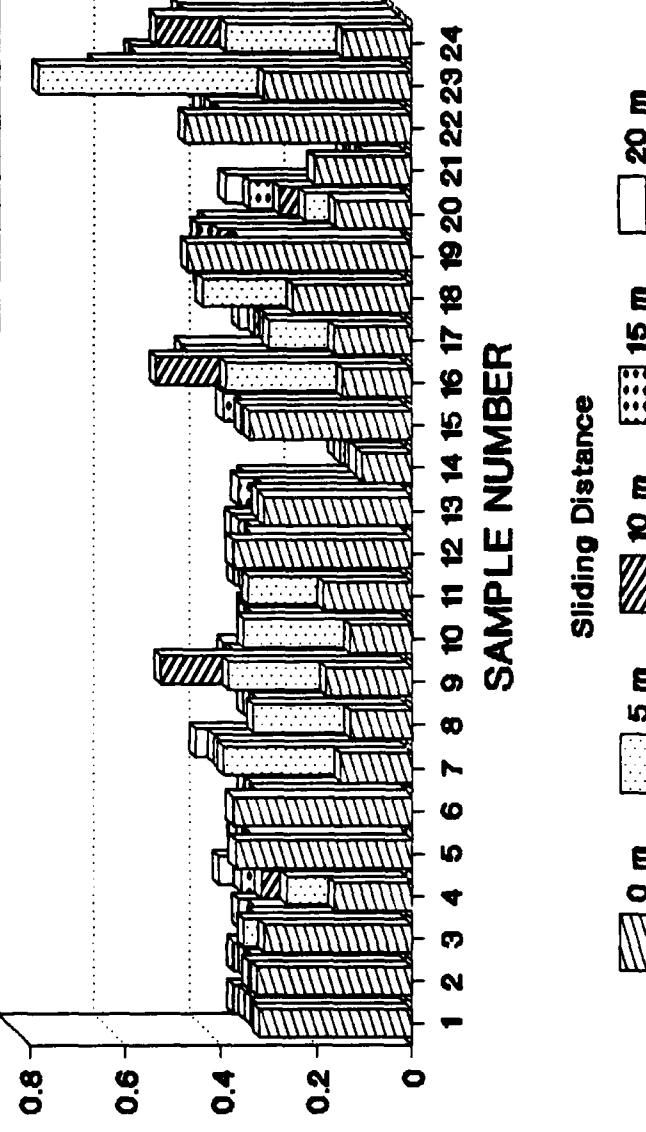
FRICITION COEFFICIENT

Figures 2 and 3 summarise the friction (at various test intervals) and the measured wear rates. The wear profiles, with attached SEM micrographs of the central region of the scars, with the exception of HSSA16, are contained in Appendix 4.

Samples HSSA1 & HSSA2 can be regarded as the baseline performance, any coating exhibiting high friction or wear can be rejected from further study. At this load samples HSSA4, HSSA10, HSSA11, HSSA14, HSSA20 to HSSA 23 show 'good' performance. The extent of the wear on HSSA4, HSSA20 and HSSA24 is not readily apparent in the micrographs attached to the wear profiles. The scars show up more clearly when viewed in back

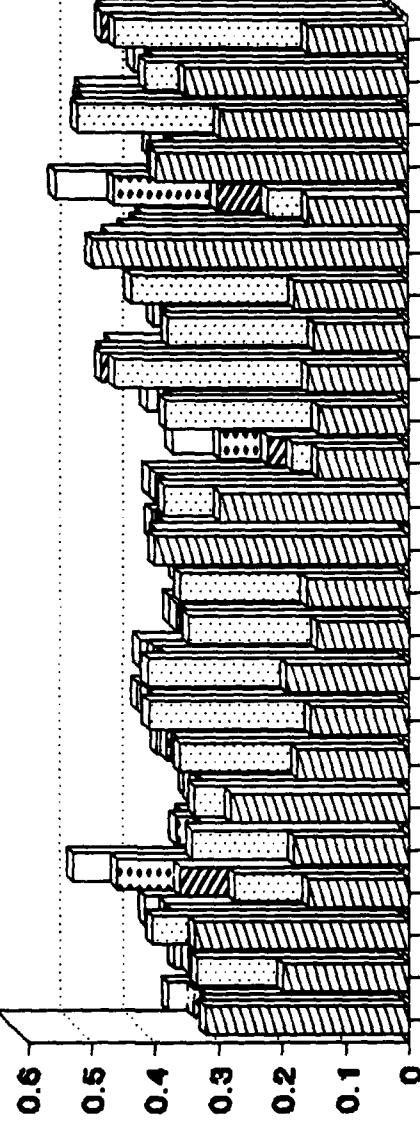
FRICITION COEFFICIENT

Figures 6 and 7 show the friction (at various test intervals) and the measured wear rates. The wear profiles, with attached SEM micrographs of the central region of the scars, with the exception of HSSA16, are contained in Appendix 5.

Samples HSSA4, HSSA14, HSSA20 & HSSA 22 give low wear rates and reasonable friction coefficients. SEM analysis revealed metal transfer from the En 31 ball to the plate occurred during the test on HSSA4 (Figure 8). A small hole can be seen in the coating of sample HSSA 22 which may indicate that the coating is starting to break up (Figure 9).

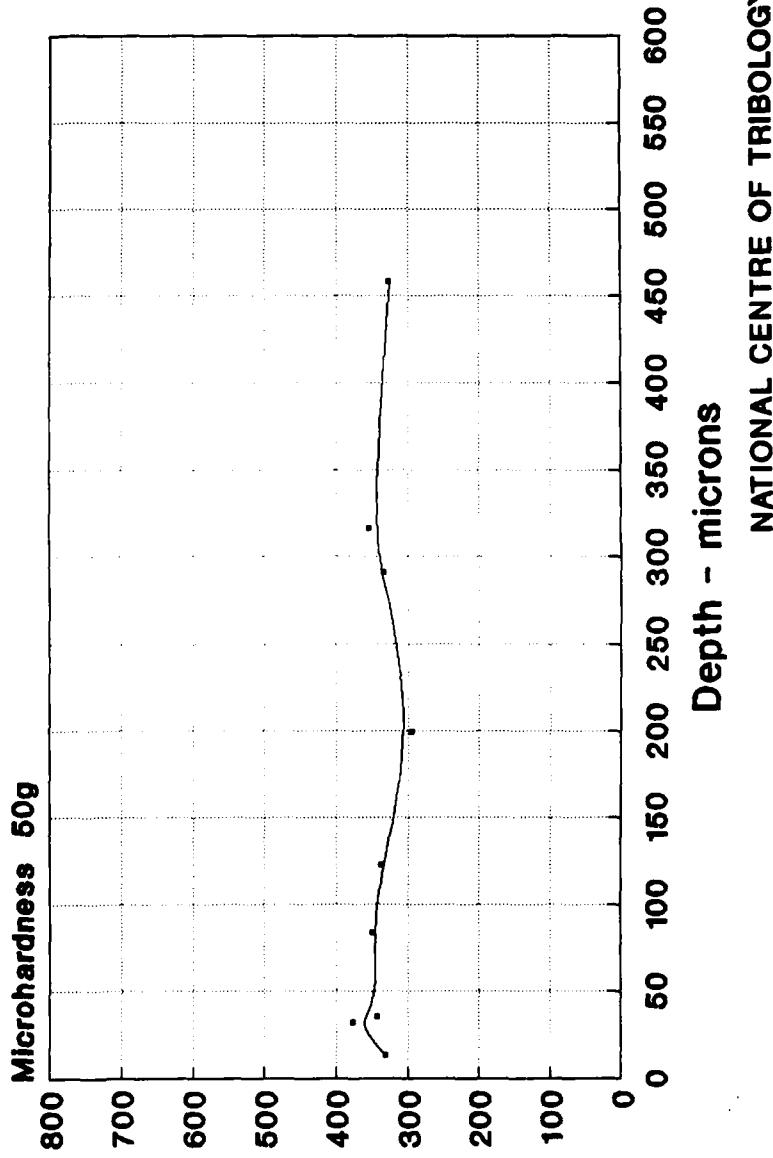
MICROHARDNESS DEPTH PROFILE
HSSA 3 / PLASMA NITROCARBURIZED #1

Microhardness depth profiles were produced by measuring the Vickers microhardness at increasing depth into the sample on the metallographic specimens. The hardness was measured by applying a load of 50N for 15 seconds. The microhardness profiles are summarised in Appendix 3.

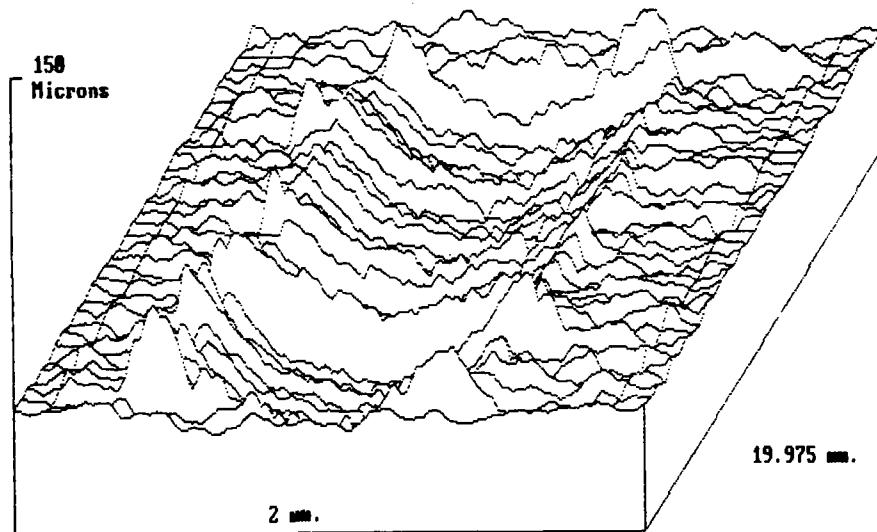
HSSA1: Solution Heat Treated

Wear volume in cubic millimetres
Above datum Below datum Net loss
.0456357 .2335793 .1879436

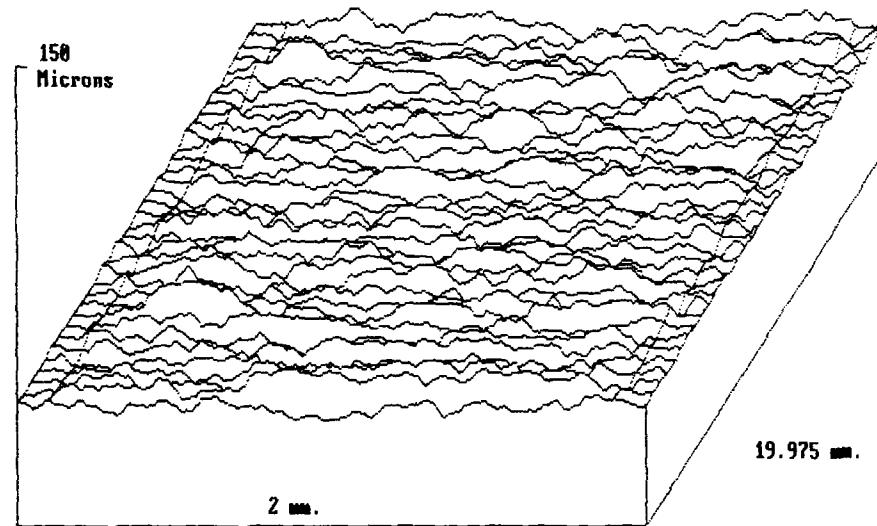
HSSA4: Beta Nitrocarburized 1

Wear volume in cubic millimetres
Above datum Below datum Net loss
3.921508E-02 3.531782E-02 -3.897257E-03

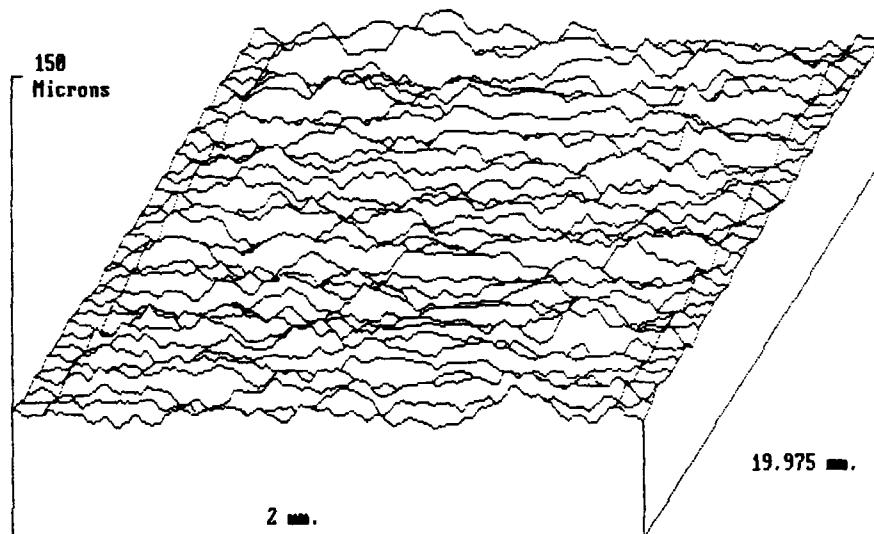
HSSA14: High Temperature Nitrocarburized 1

Above datum	Below datum	Net loss
4.902035E-02	4.254118E-02	-6.47917E-03

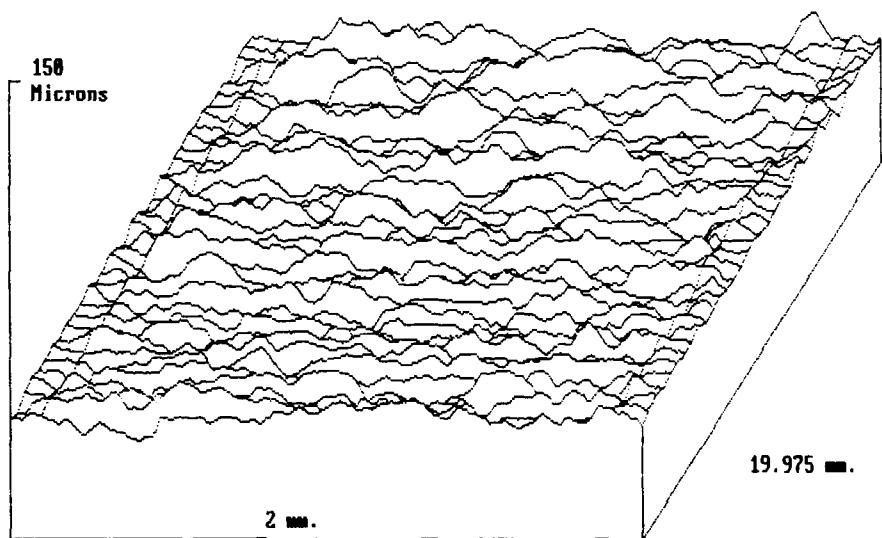
HSSA 20: Gas Carbonitriding 1

Above datum	Below datum	Net loss
4.566613E-02	5.848346E-02	1.281733E-02

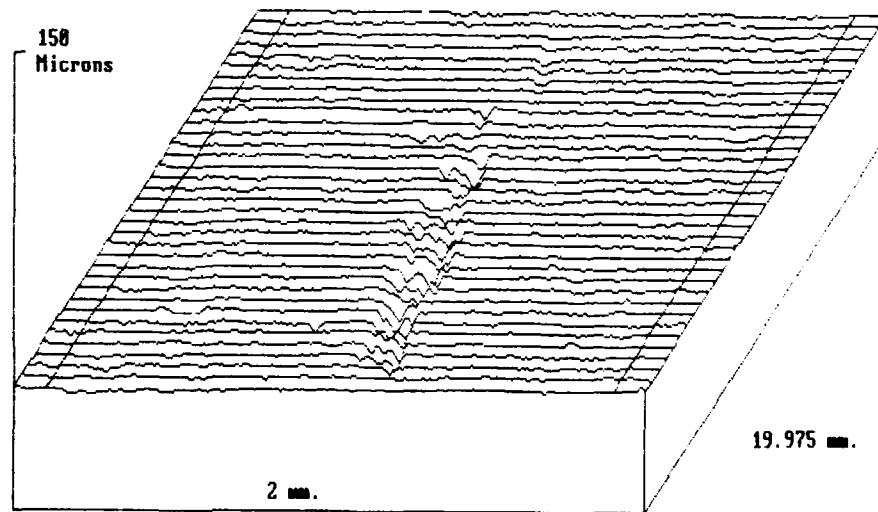
HSSA 22: TiN Reactive Sputter

Above datum	Below datum	Net loss
3.728391E-03	1.470531E-02	1.097691E-02

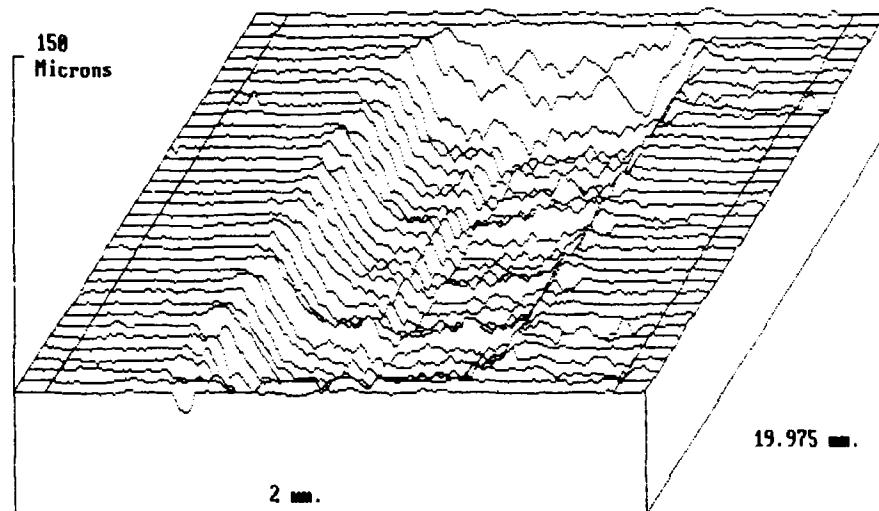
HSSA 23: TiN/HfN Multilayer

Wear volume in cubic millimetres
Above datum Below datum Net loss
4.79215E-03 .3629499 .3581578

Analysis of the plasma nitrided samples (HSSA12 and HSSA13) has revealed poor processing, further samples are being prepared with a different supplier. The TiN/HfN multilayer (HSSA23) probably failed at 50N because substrate could not support the coating (cf ice on mud). The wear rate for this treatment is greater than that for uncoated titanium because of the presence of TiN and HfN particles in the wear debris. These are very hard and effectively improve the cutting properties of the En30 ball. Multi-treatment (e.g. Nitrocarburize then TiN/HfN multilayer) would result in support for the film and improved results. This approach is being evaluated.
