Enhanced Preliminary Assessment Report:

Croom Army Housing Units Croom, Maryland

October 1989

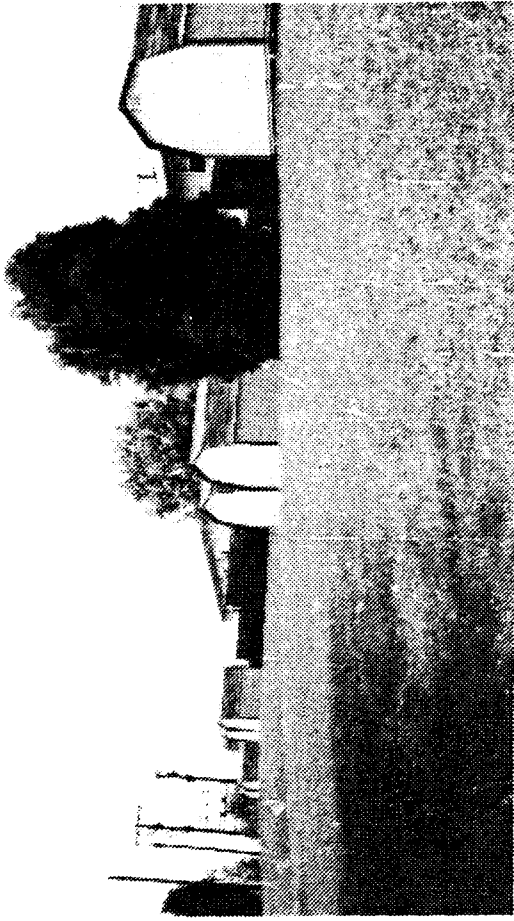
2

1. One of the three apartment buildings; a pole-mounted transformer at top right (transformers maintained by the local utility).
2. Storage barns behind the buildings.
3. Vent or riser for underground storage tanks. The tanks are located underneath the sidewalk.
4. A view (left to right) of the pump house, storage shed, and elevated water storage tank; structures are adjacent to the building on the west side of the street.
5. and 6. Inside views of the pump house, showing the motor, plumbing, and other accessories for pumping water from the well.
7. The sewage-treatment system; part of the sand-bed filter system (72 feet x 70 feet) is seen in the foreground, with chlorinator house for the treatment of effluent water from the filter bed in the background. Septic tanks, which form part of the treatment system, are underground. The disinfection of wastewater is inadequate.
