**Enhanced Preliminary
Assessment Report:**

**Woodbridge Army Housing Units
Woodbridge, Virginia**

October 1989

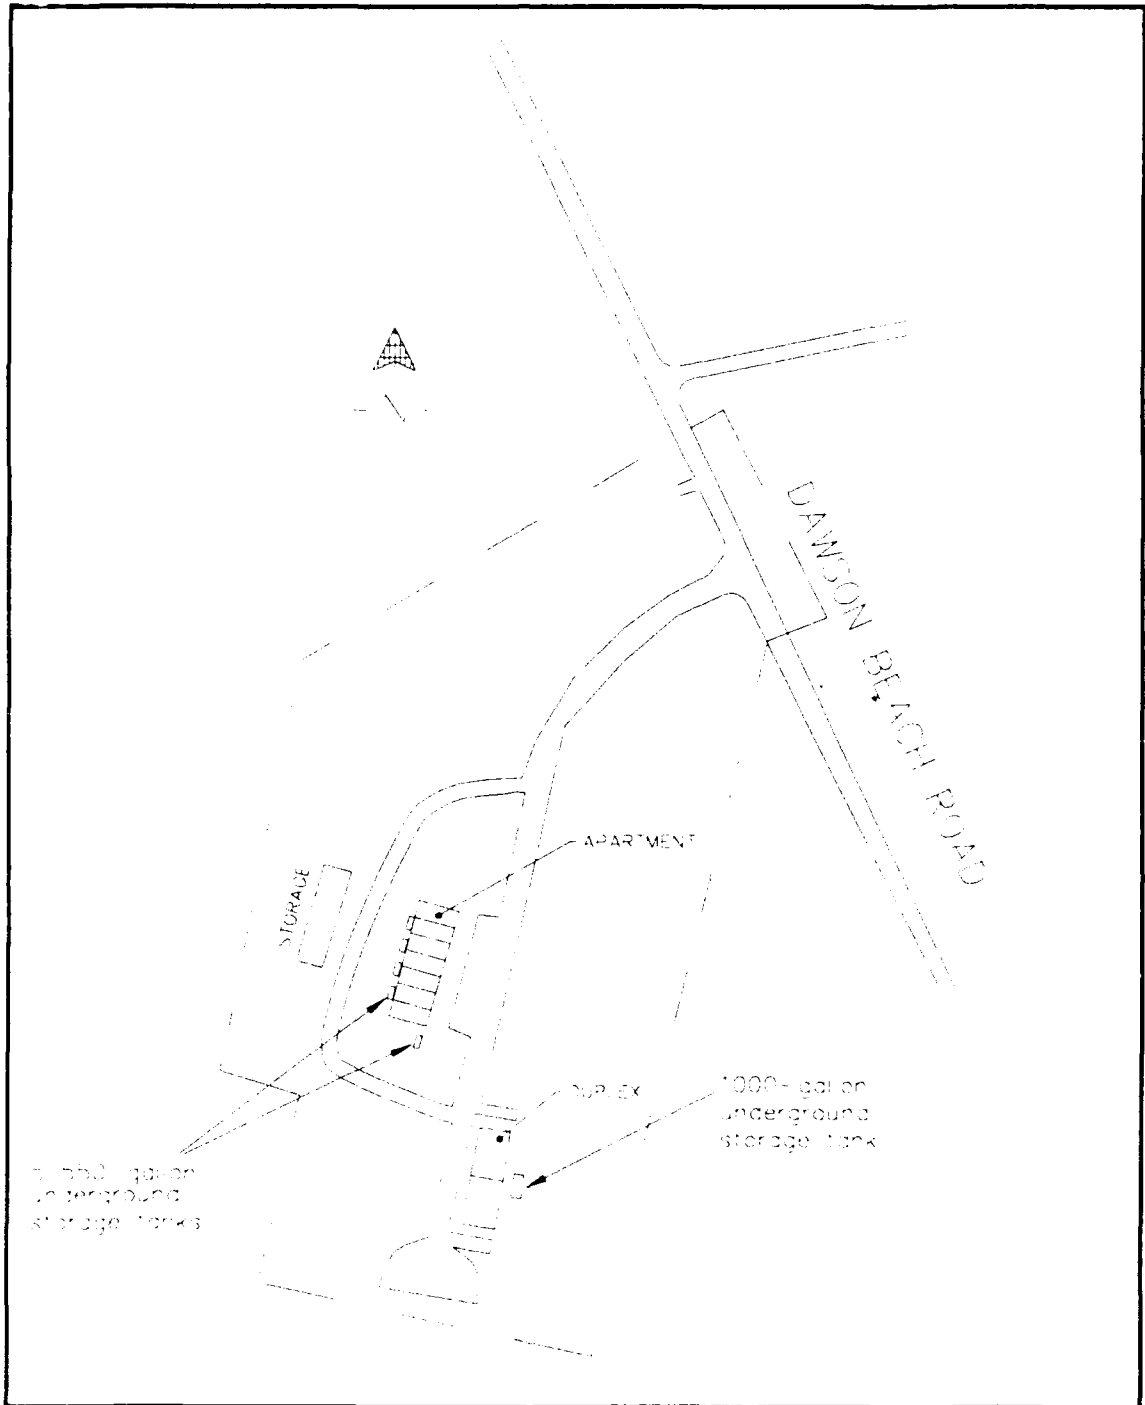
FIGURE 2 Site Plan Map of Woodbridge Army Housing Units

Figure 2 presents the site plan of the housing property.

The 7-acre area has nine housing units in two apartment buildings. One building is a duplex with two units, one with two bedrooms and one with three bedrooms. The other apartment building has seven units; four of these have two bedrooms each, and three have three bedrooms each.
