**AIRFIELD PAVEMENT EVALUATION
OF
BOLIVIAN AIRFIELDS**

**PREPARED FOR
TACTICAL AIR COMMAND (TAC)**

**BY
HQ AFESC PAVEMENT EVALUATION TEAM**

**HQ AIR FORCE ENGINEERING AND SERVICES CENTER
TYNDALL AIR FORCE BASE
FLORIDA 32403-6001**

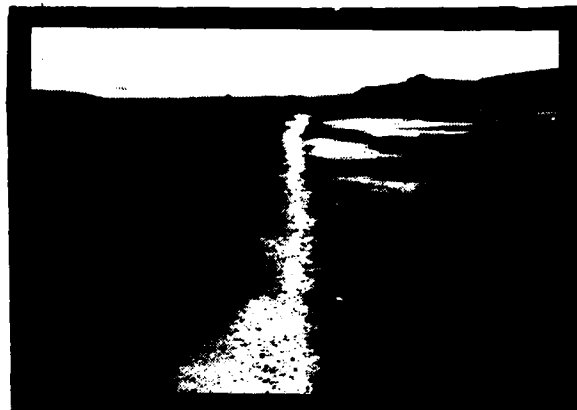
PHOTO 15: Intersection of taxiway and runway. POC and debris are present. Recommend the area be swept clean of loose debris.

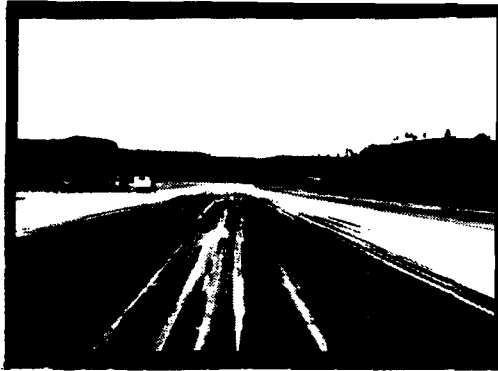
PHOTO 1: 05 end of the runway showing hill which causes a steep glide slope for approaching aircraft.

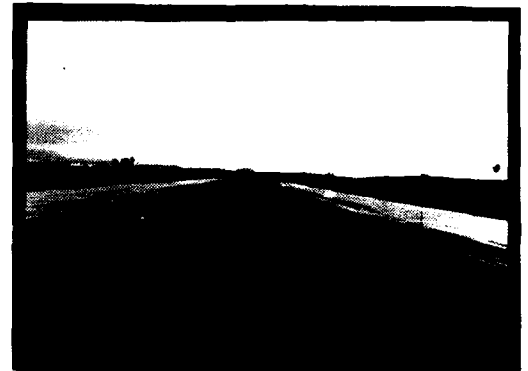
PHOTO 3: Runway 05/23, facing the 23 end. Photo is presented to depict the significant elevation drop of the 23 end of the runway.

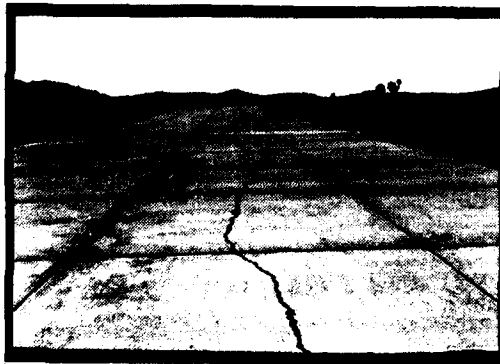
PHOTO 7: Sealed longitudinal crack on Feature T02A.

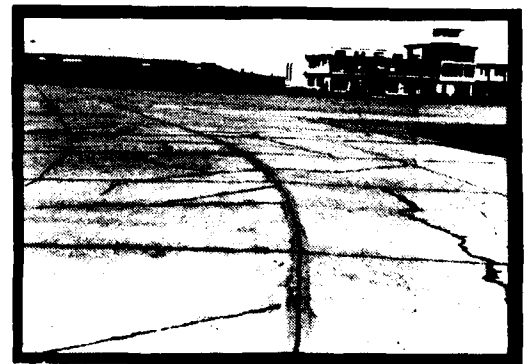
PHOTO 8: Load related cracks that have been well maintained. Traffic is concentrated in this area.

Runway pavement conditions are generally VERY GOOD with few pavement distresses. There are only isolated signs of structural distresses. For example, in the concentrated touchdown areas are low severity longitudinal and transverse cracks that have been well-maintained. The predominant

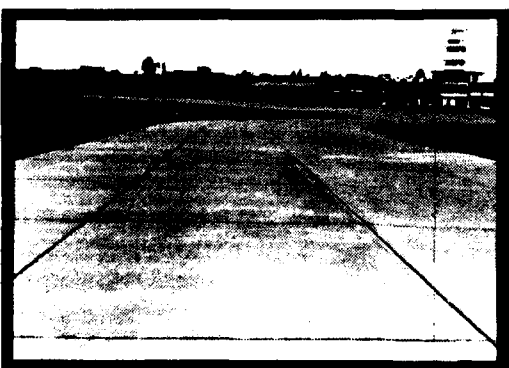
PHOTO 5: Excellent condition PCC typical of many pavements throughout the airfield.
