Final Report
on
Program to Study the
Oxidation of Carbon-Carbon Composites
and Coatings on these Materials

by
J. Cullinan, J. Schaeffer, E. A. Gulbransen
G. H. Meier and F. S. Pettit

Materials Science and Engineering Department
University of Pittsburgh
Pittsburgh, PA 15261

September 30, 1989

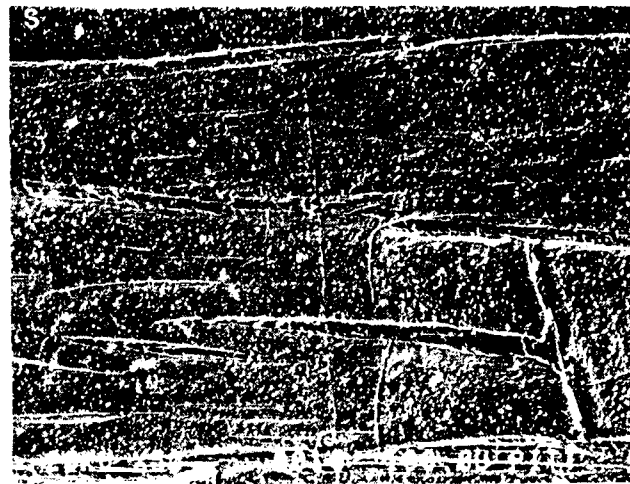
Figure 4. Initial microstructure of uninhibited carbon-carbon composite (HITCO CC139E). The top shows the surface, the middle shows a transverse cross section, and the bottom shows a planar cross section.

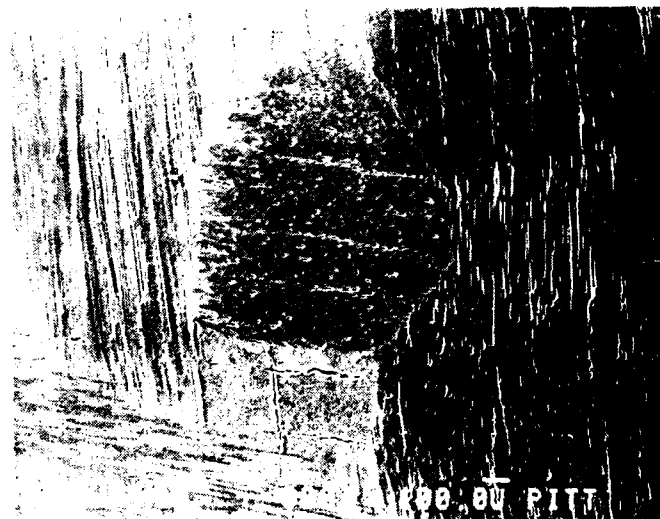
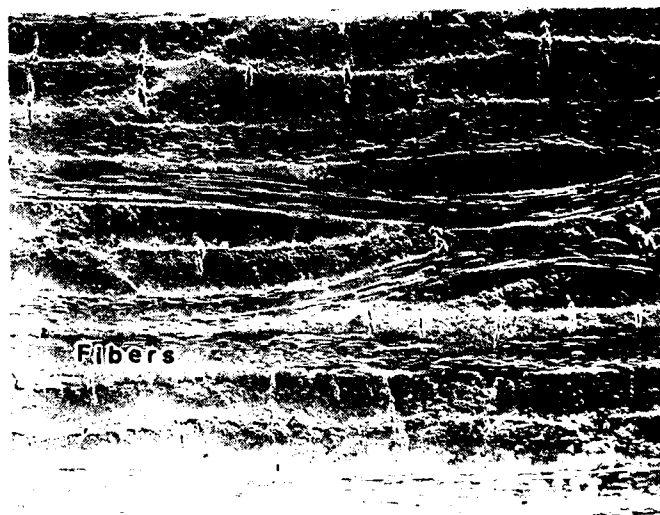
Figure 7. Initial microstructure of inhibited CC137E. Top shows surface, middle shows transverse cross section and bottom shows a planar cross section.

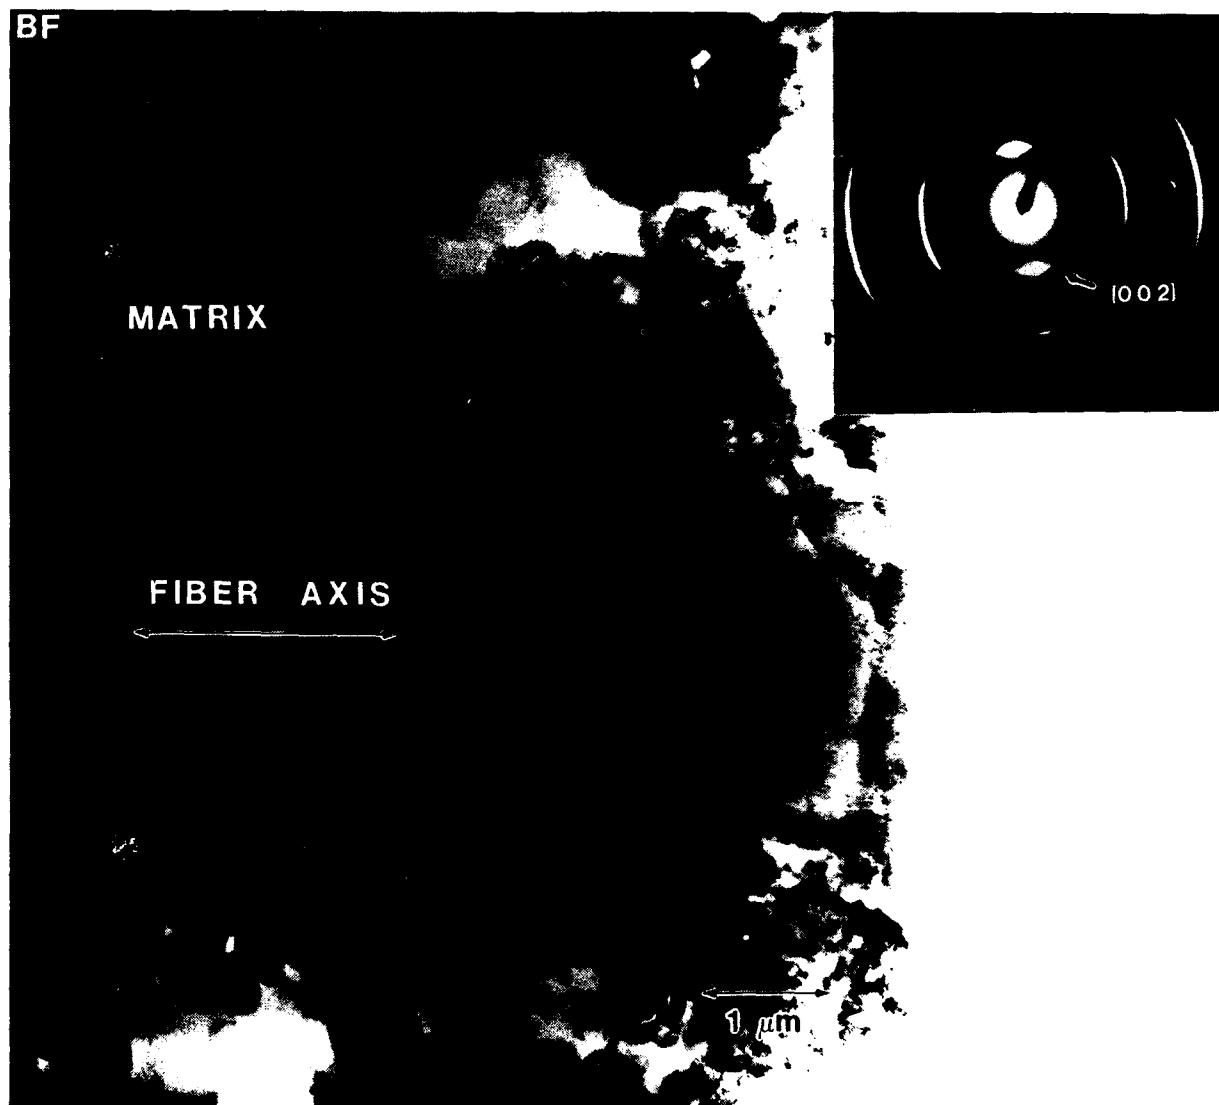
Figure 8. Bright field TEM image of a fiber and matrix in CC137E. SAD shows preferential orientation of (002) basal planes.

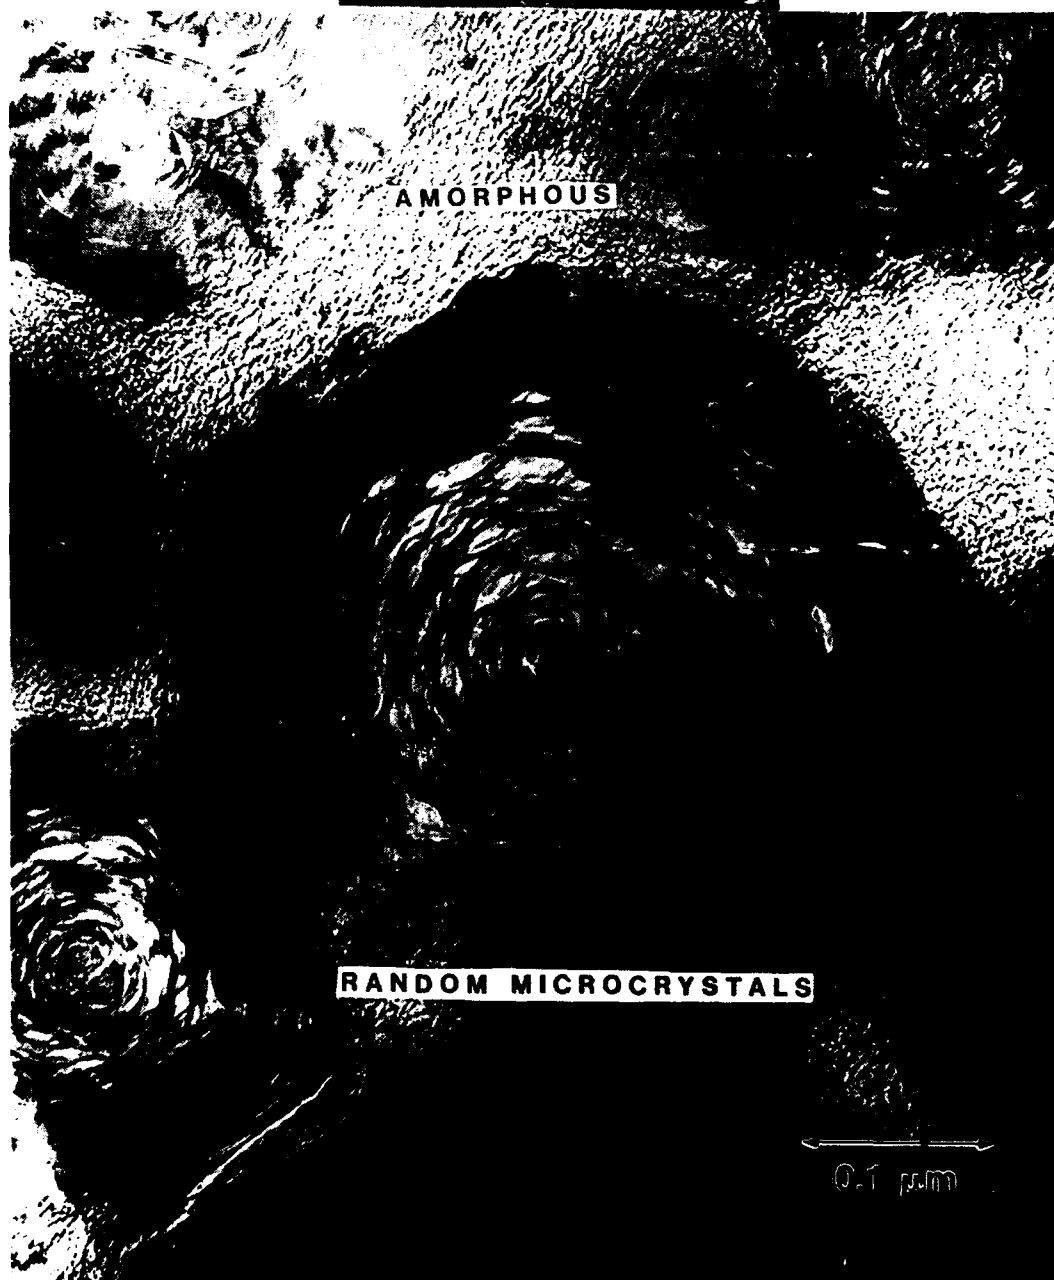
Figure 11. Bright field TEM micrograph shows the matrix carbon in as-received CC137E. The matrix is composed of microcrystalline rosettes and amorphous or glassy carbon.

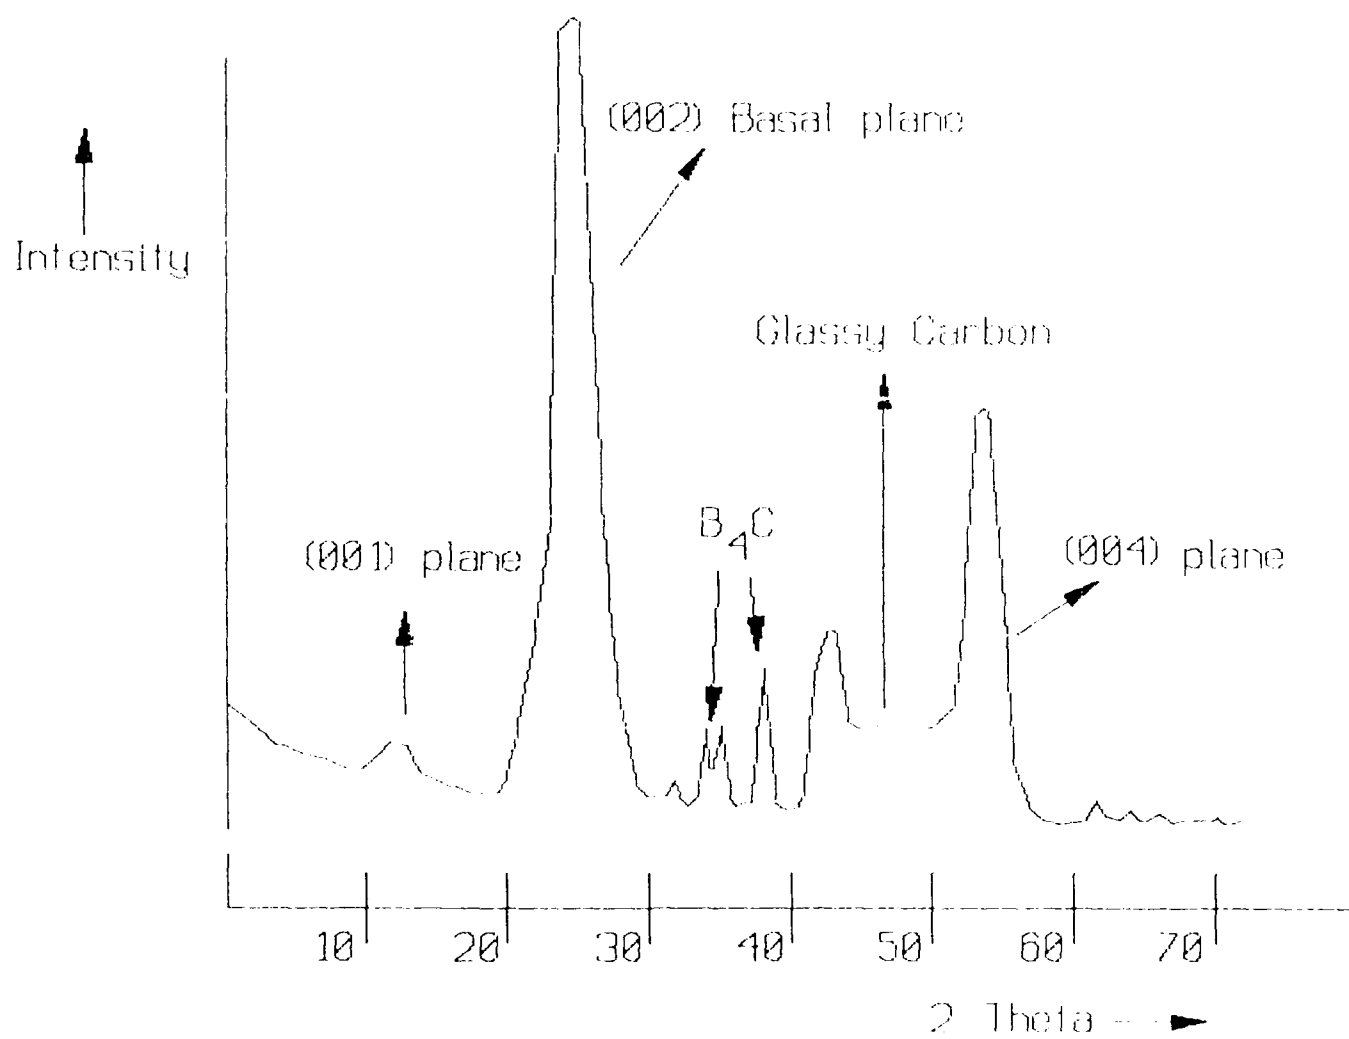
Figure 12. Schematic of an XRD pattern from as-received CC137E sample. The (001) plane for a graphite structure indicates a carbon with missing atoms.

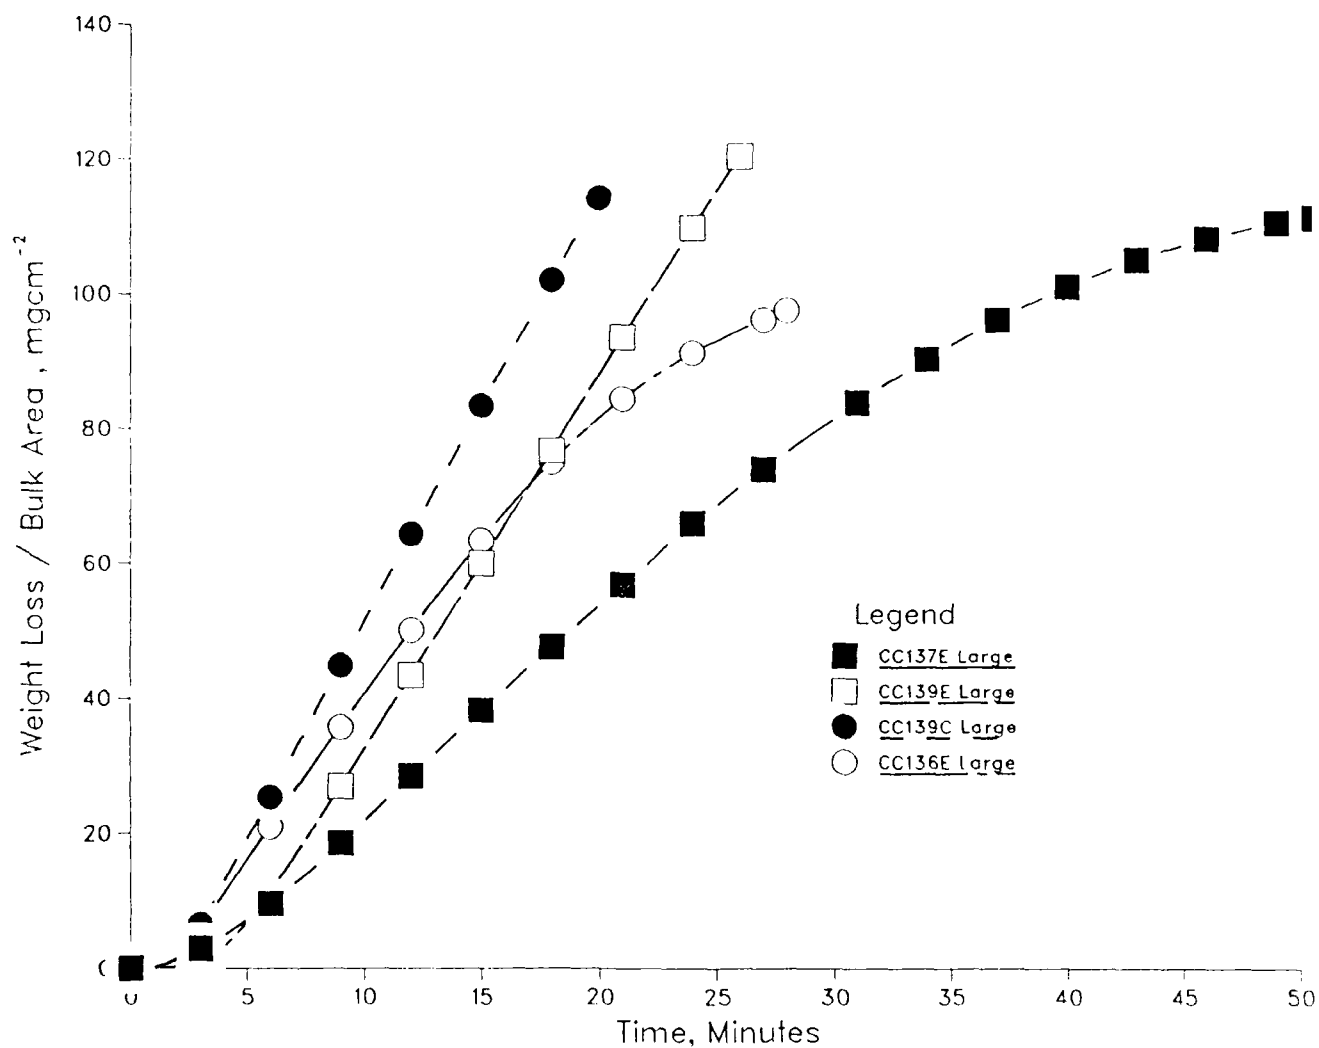
Figure 13. Isothermal oxidation kinetics for uncoated CCC at 800°C in O₂ flowing at 100 cc/min.

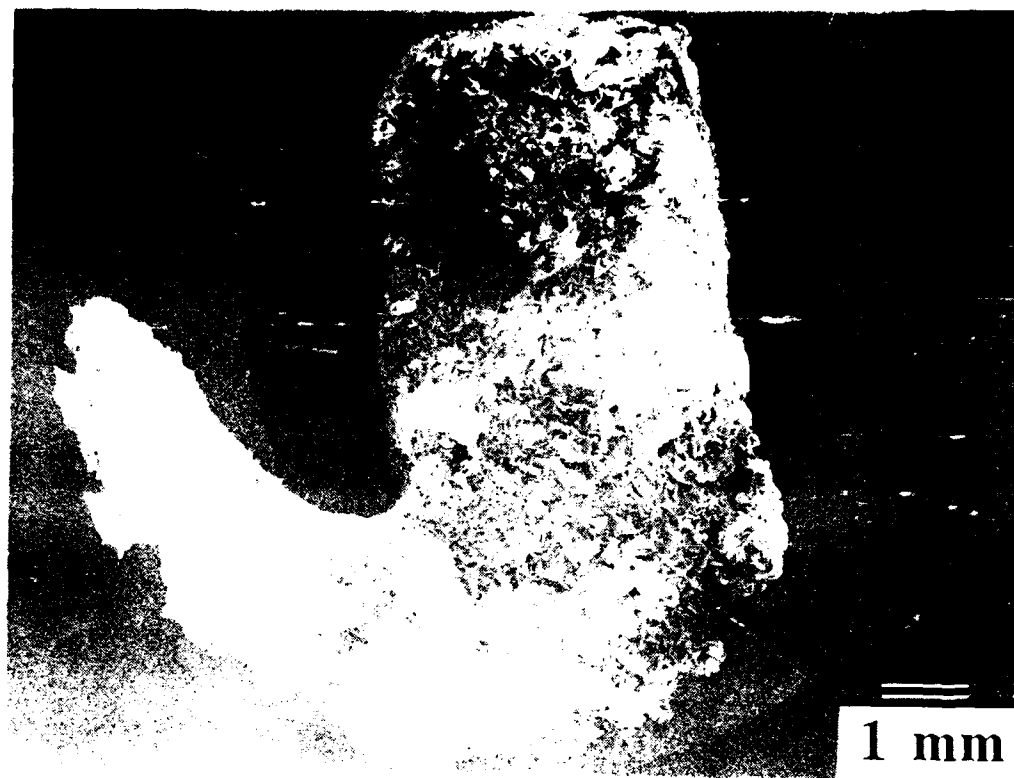
Figure 29. Micrographs show the coating of an inhibited sample by B_2O_3 after large oxidative weight loss. B_2O_3 plates cover the surface of the remaining CCC (bottom).

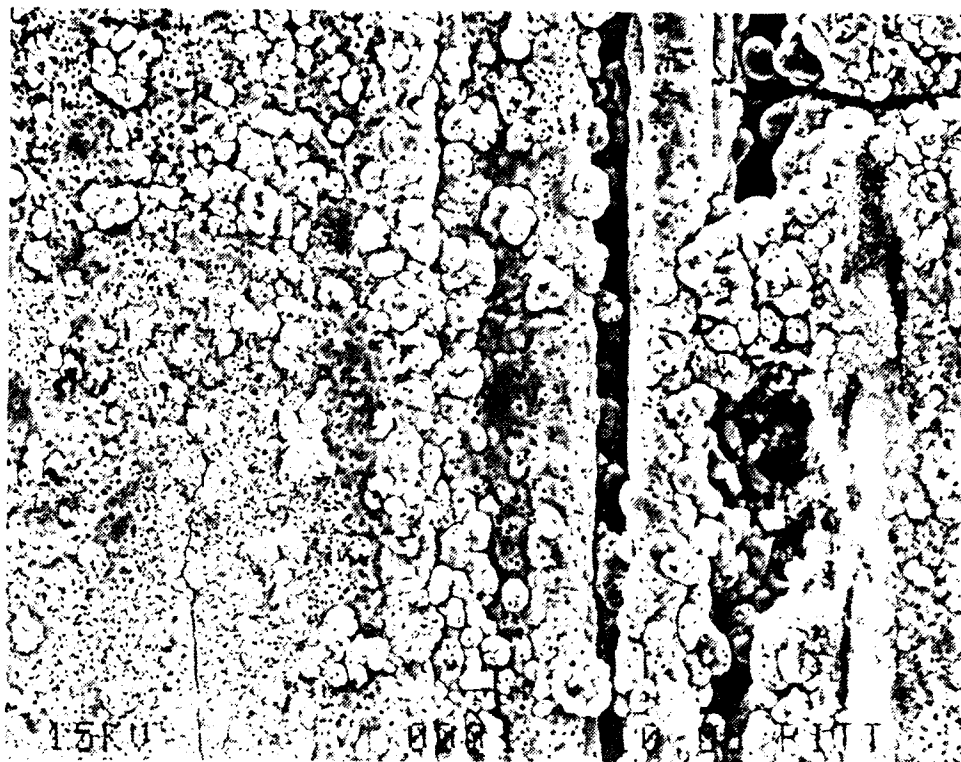
Figure 32. Mature pitted morphology on CC139E after isothermal oxidation at 600°C in O₂ flowing at 100 cc/min.

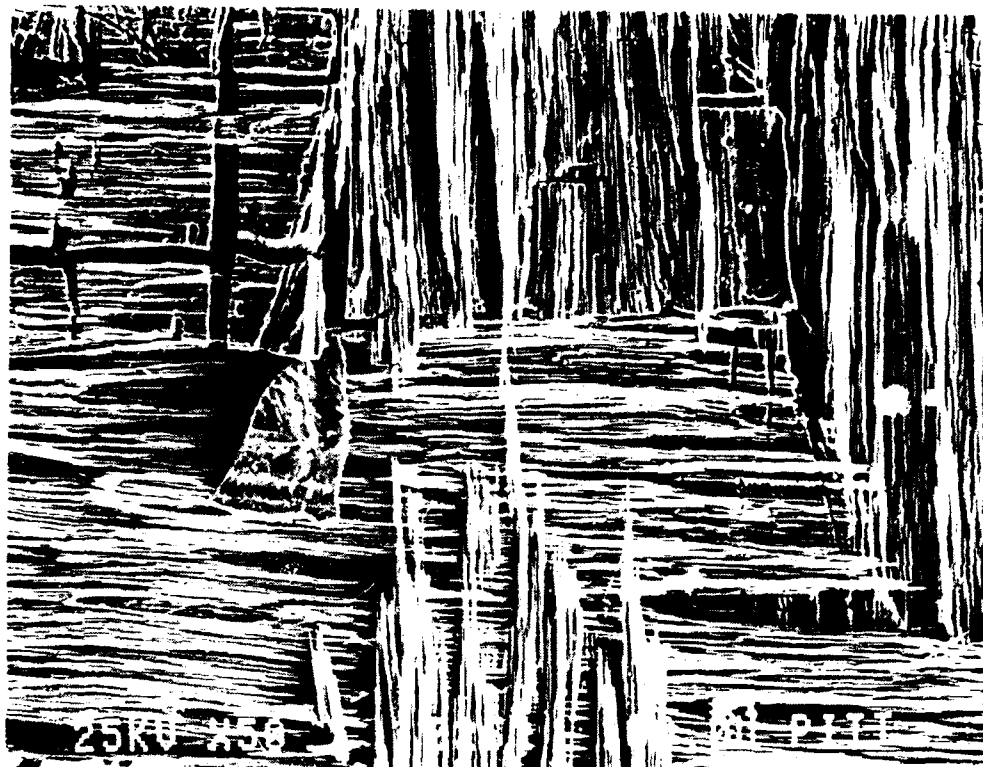
Figure 34. Micrographs of CC139E after oxidation at 950°C in O₂ flowing at 14 cc/min.

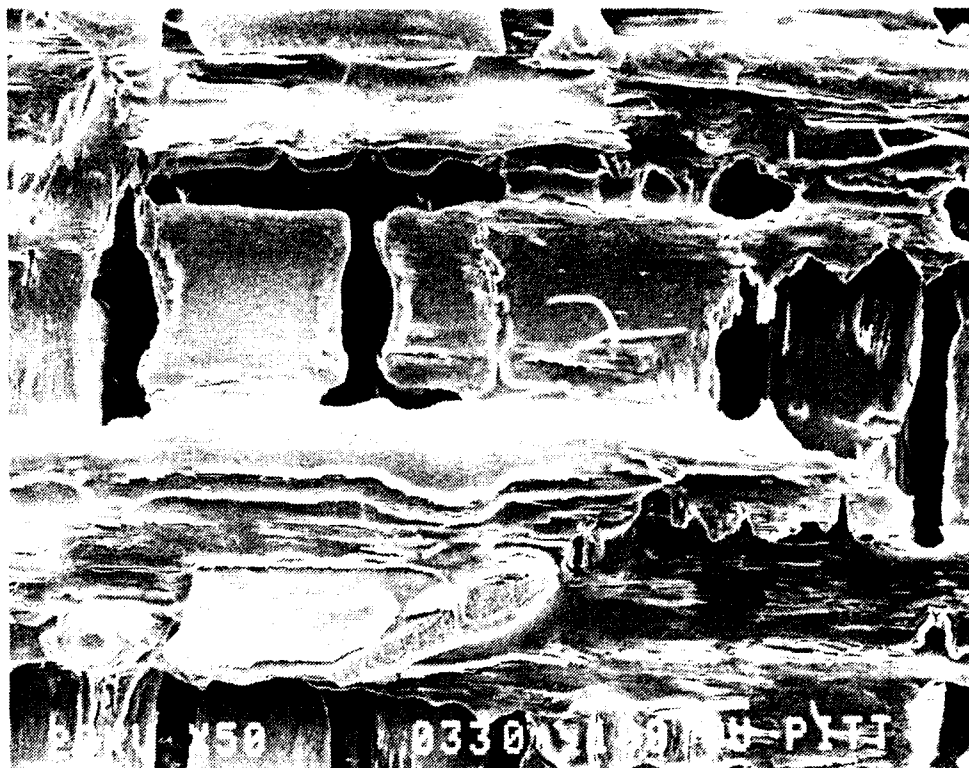
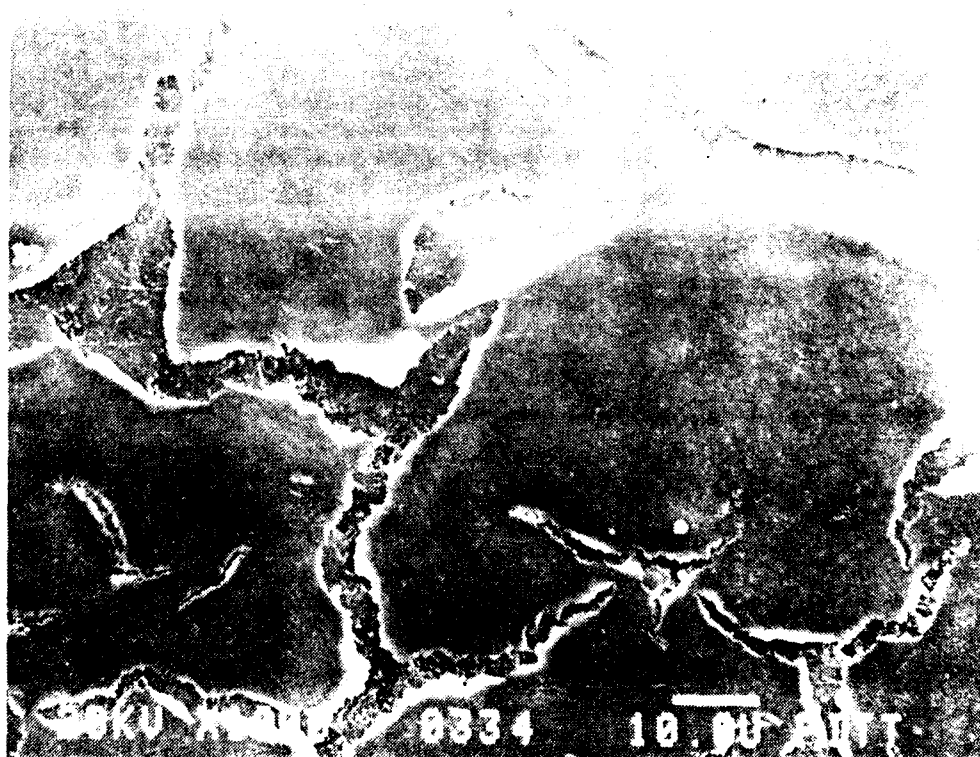
Figure 37. Boron oxide coats fiber regions of CC136E after isothermal oxidation at 1100°C in O₂ flowing at 100 cc/min. The bottom shows cracking of the B₂O₃ after cool down to room temperature.

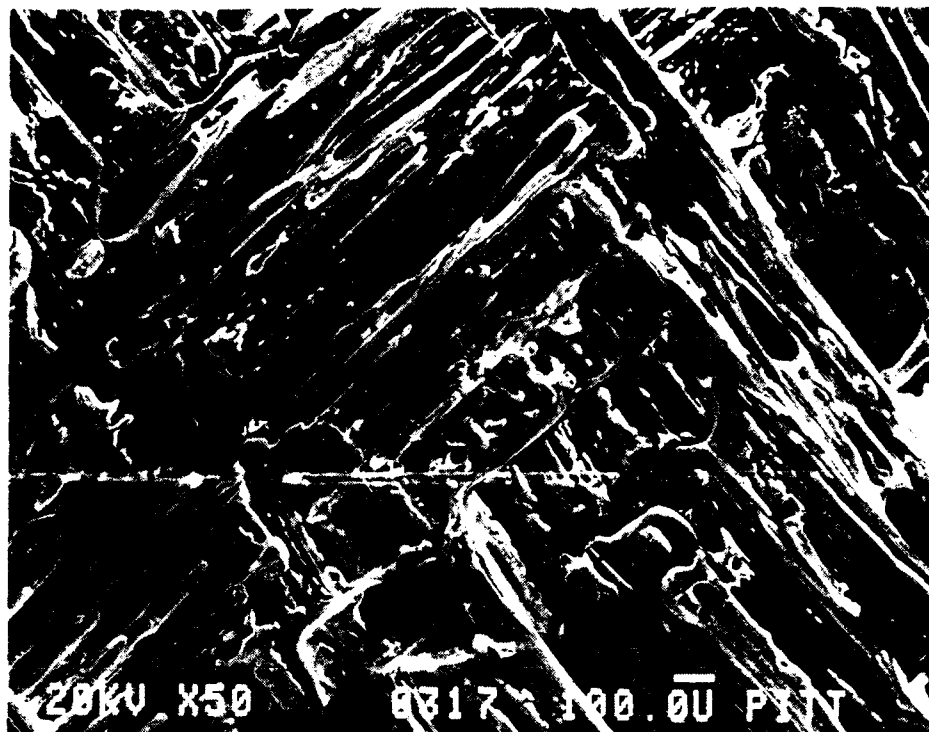
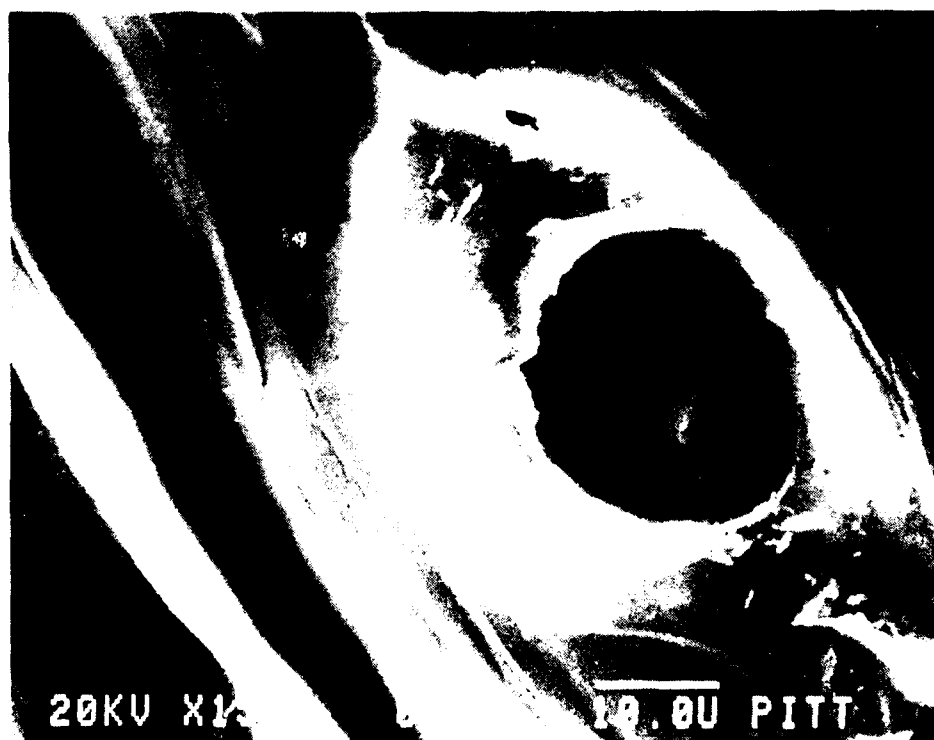
Figure 38. Micrographs of CC137E after isothermal oxidation at 1100°C in O₂ at 100 cc/min. The top shows boron oxide coating the CCC, while the bottom shows a B₂O₃ globule.

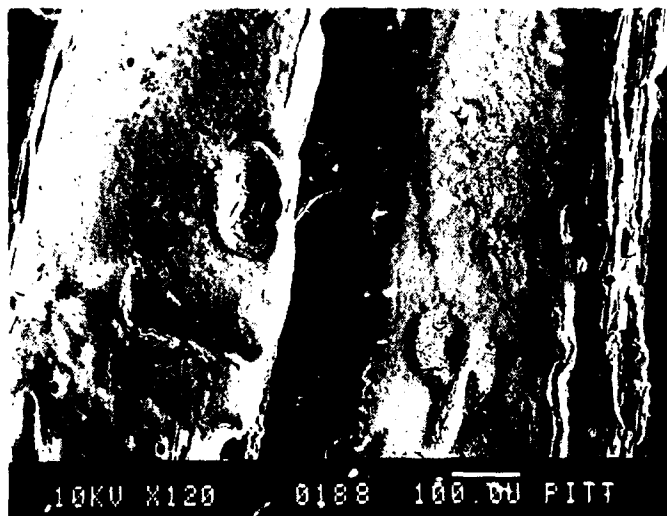
Figure 45. Surface morphologies of inhibited CCC after 12 hours of oxidation at 600°C in a) dry oxygen and b) oxygen-water vapor. Minor pitting is seen in the top micrograph.

Weight change versus time measurements obtained for the oxidation of inhibited carbon-carbon composites in dry oxygen and in oxygen containing water vapor are compared in Figures 39 through 44 for temperatures between 400 and 900°C. Typical surface morphologies that were observed upon specimens after exposure are presented in Figures 45 through 47. At the lower temperatures, such as 600°C, there was not a significant difference in surface morphologies between oxidation in wet and dry oxygen, Figure 45. At higher temperatures much more B_2O_3 was evident upon the specimens oxidized in dry oxygen than in wet oxygen. In some experiments in

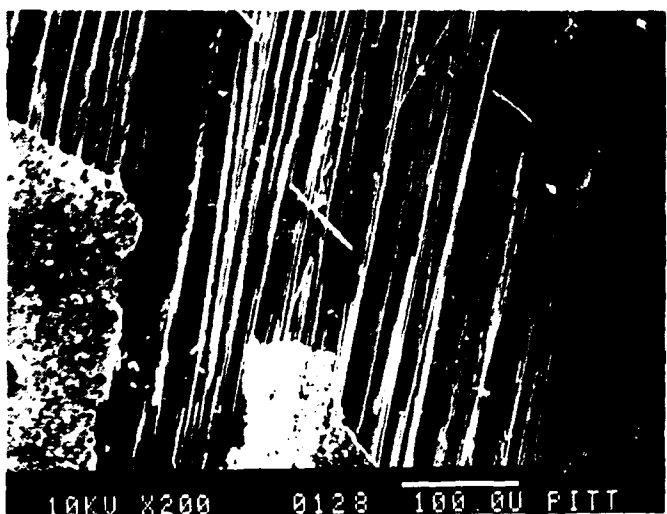
Figure 46. Surface morphologies and accompanying WDS boron maps of inhibited CCC after exposure at 700°C to a) dry oxygen (6 hours) and b) oxygen-water vapor (3 hours). Large scale boron oxide loss is observed after longer exposures to oxygen-water vapor at $T > 700^{\circ}\text{C}$.

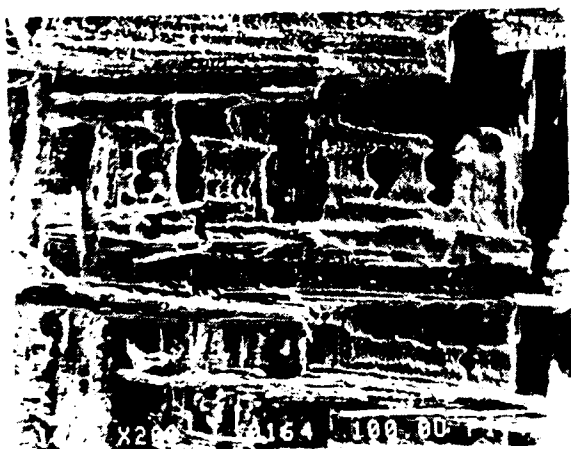
Figure 47. Surface morphologies and accompanying WDS boron maps of inhibited CCC after exposure at 900°C to a) dry oxygen (68 min.) and b) oxygen-water vapor (68 min.). Shorter exposures to oxygen-water atmospheres result in larger amounts of boron oxide being retained on the surface.

wet oxygen, it appeared that all the B_2O_3 had been removed, Figure 46, while in others some B_2O_3 remained, Figure 47.

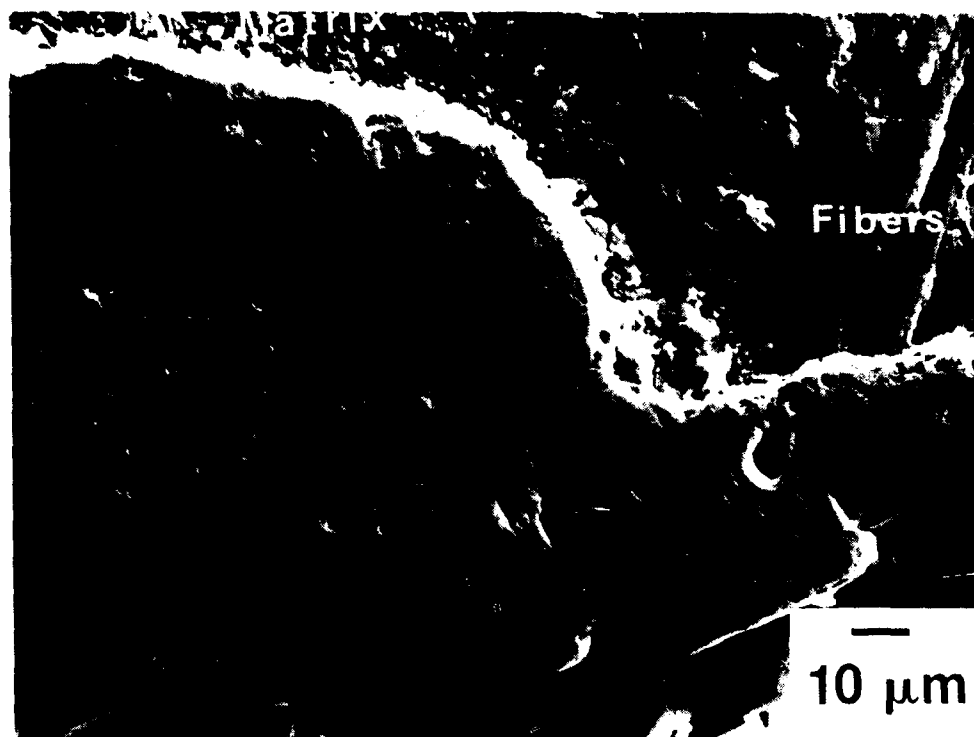
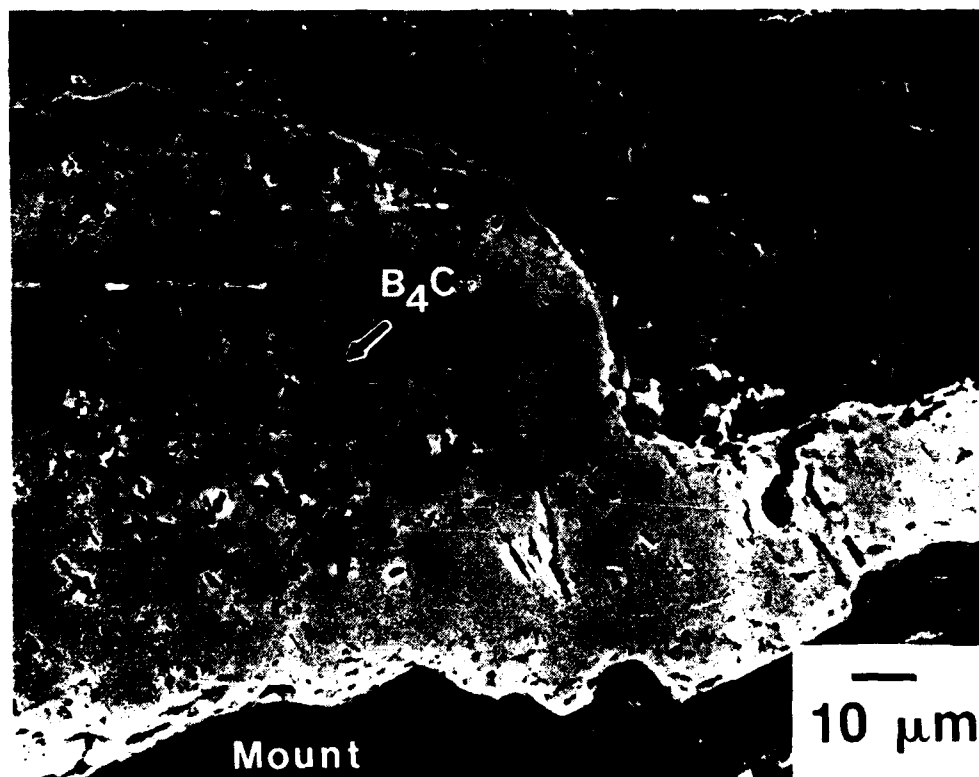
Figure 55. Microstructure (as-received) of thin HP24 coating on CC137E used for Chromalloy processes. The top is a SEI and the bottom is BEI. The thickness of the coating is less than that in Figure 54. A thicker coating with more B₄C develops over the matrix.

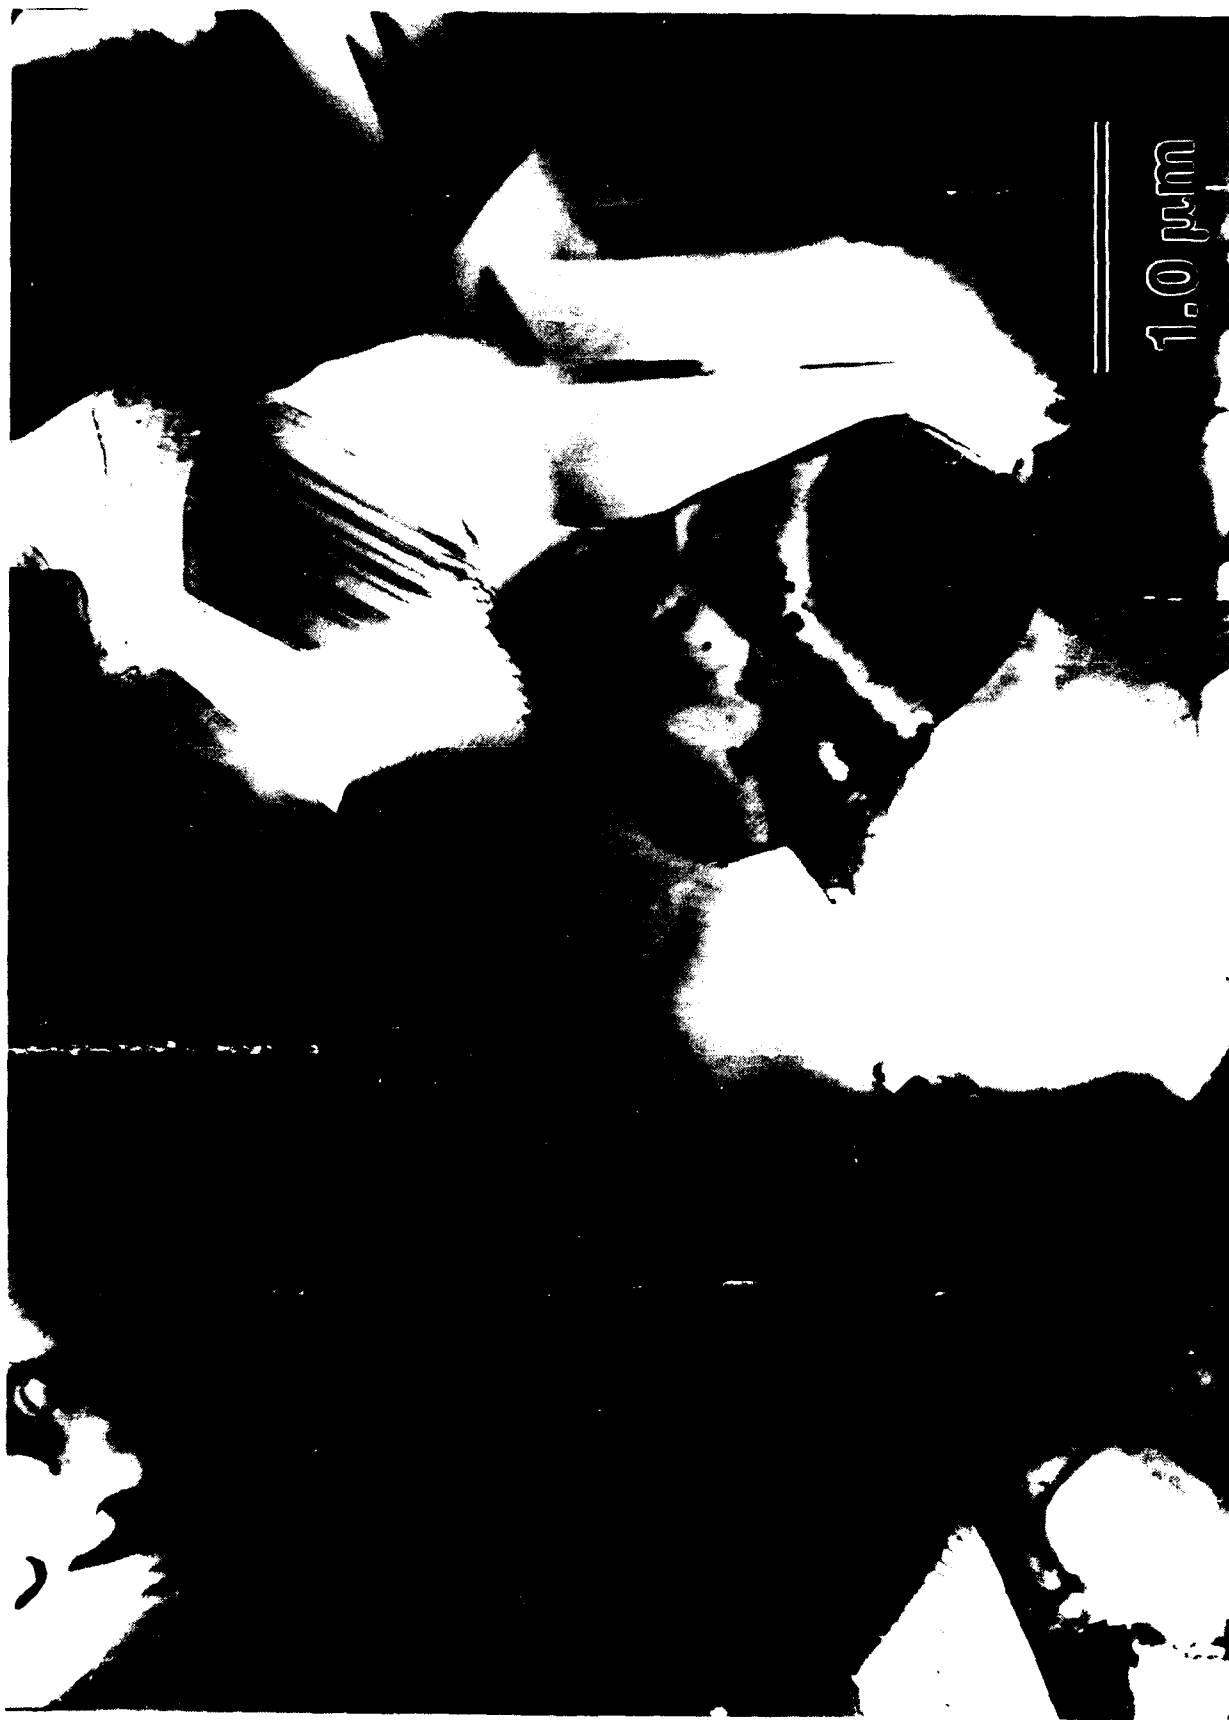
Figure 56. TEM micrograph of β -SiC grains in the as-received HP24 coating.

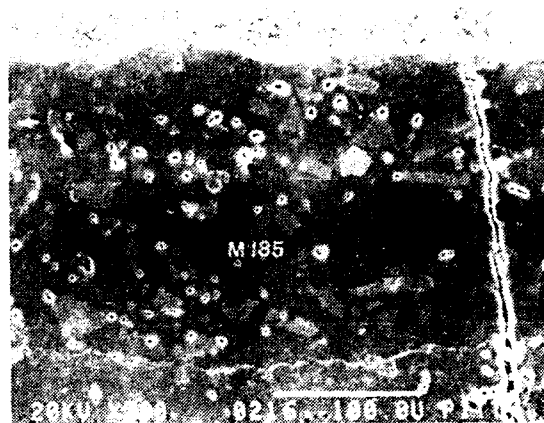
Figure 58. Micrographs showing the surface and cross section of the as-received M185.

The M185 coating produced by HITCO is directed at adding a glaze to the HP24 coating layer to seal the cracks. Figure 58 shows the surface and a transverse cross section of this coating. The M185 is 200 μm thick and is composed of vitreous silica and a dispersion of particles. The additives are present presumably to alter the viscosity of the silica in critical temperature ranges where cracking occurs. Cracks are seen on the surface and through the cross section.

Cracking was prevalent in the M185 sample. The cracks on the surface are about 0.5 to 1.0 mm apart and often had a star-like morphology. The star burst morphology was linked with the presence of Al and possibly occurred at intersections between the surface and the Al-rich particles. Cracking in the transverse cross section is seen to extend from the coating/gas interface to the substrate. These cracks are about 400 μm apart. Figure 58 shows that some of the cracks in the M185 extend through the HP24. This observation and the similar crack spacing and distribution of M185 and HP24 indicate that the existing cracks in the HP 24 have propagated into the M185.

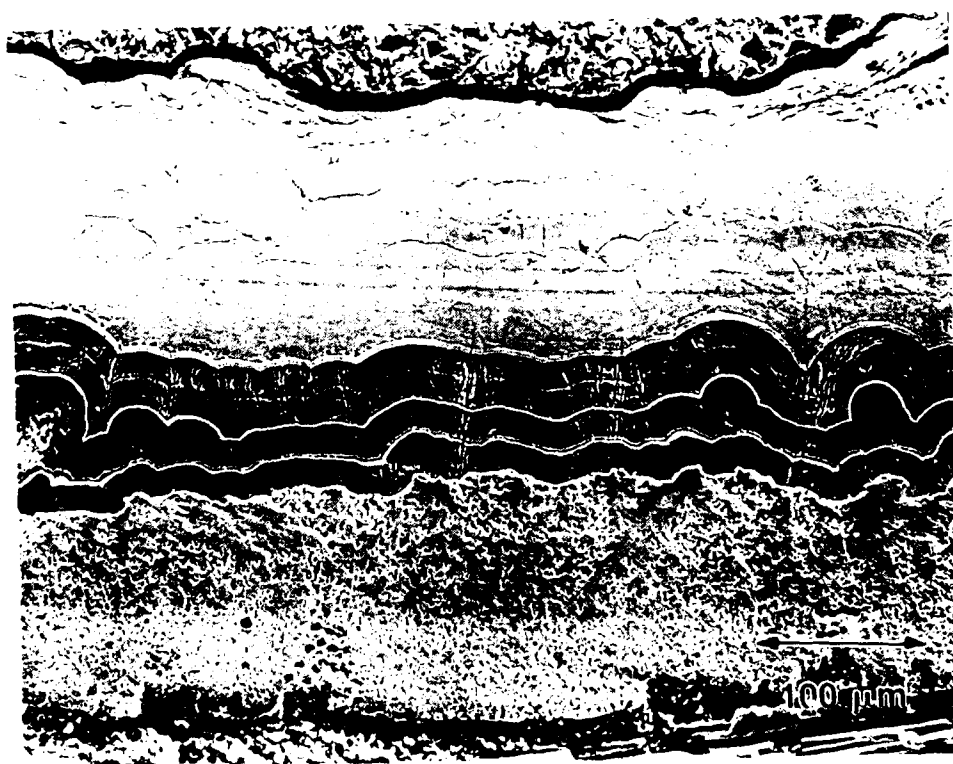
Figure 60. Etched cross sections of the Chromalloy Glaze (top) and Chromalloy No Glaze (bottom) coatings.

The other complex coating used in this study was fabricated by Chromalloy and is designated HP24/BXC/RT42A/Glaze. This coating is shown with and without the glaze in Figure 60. The coating is 350 μm thick, and the glaze only about 15 μm thick. Some regions are noticeably thicker than others so the coating is nonuniform.

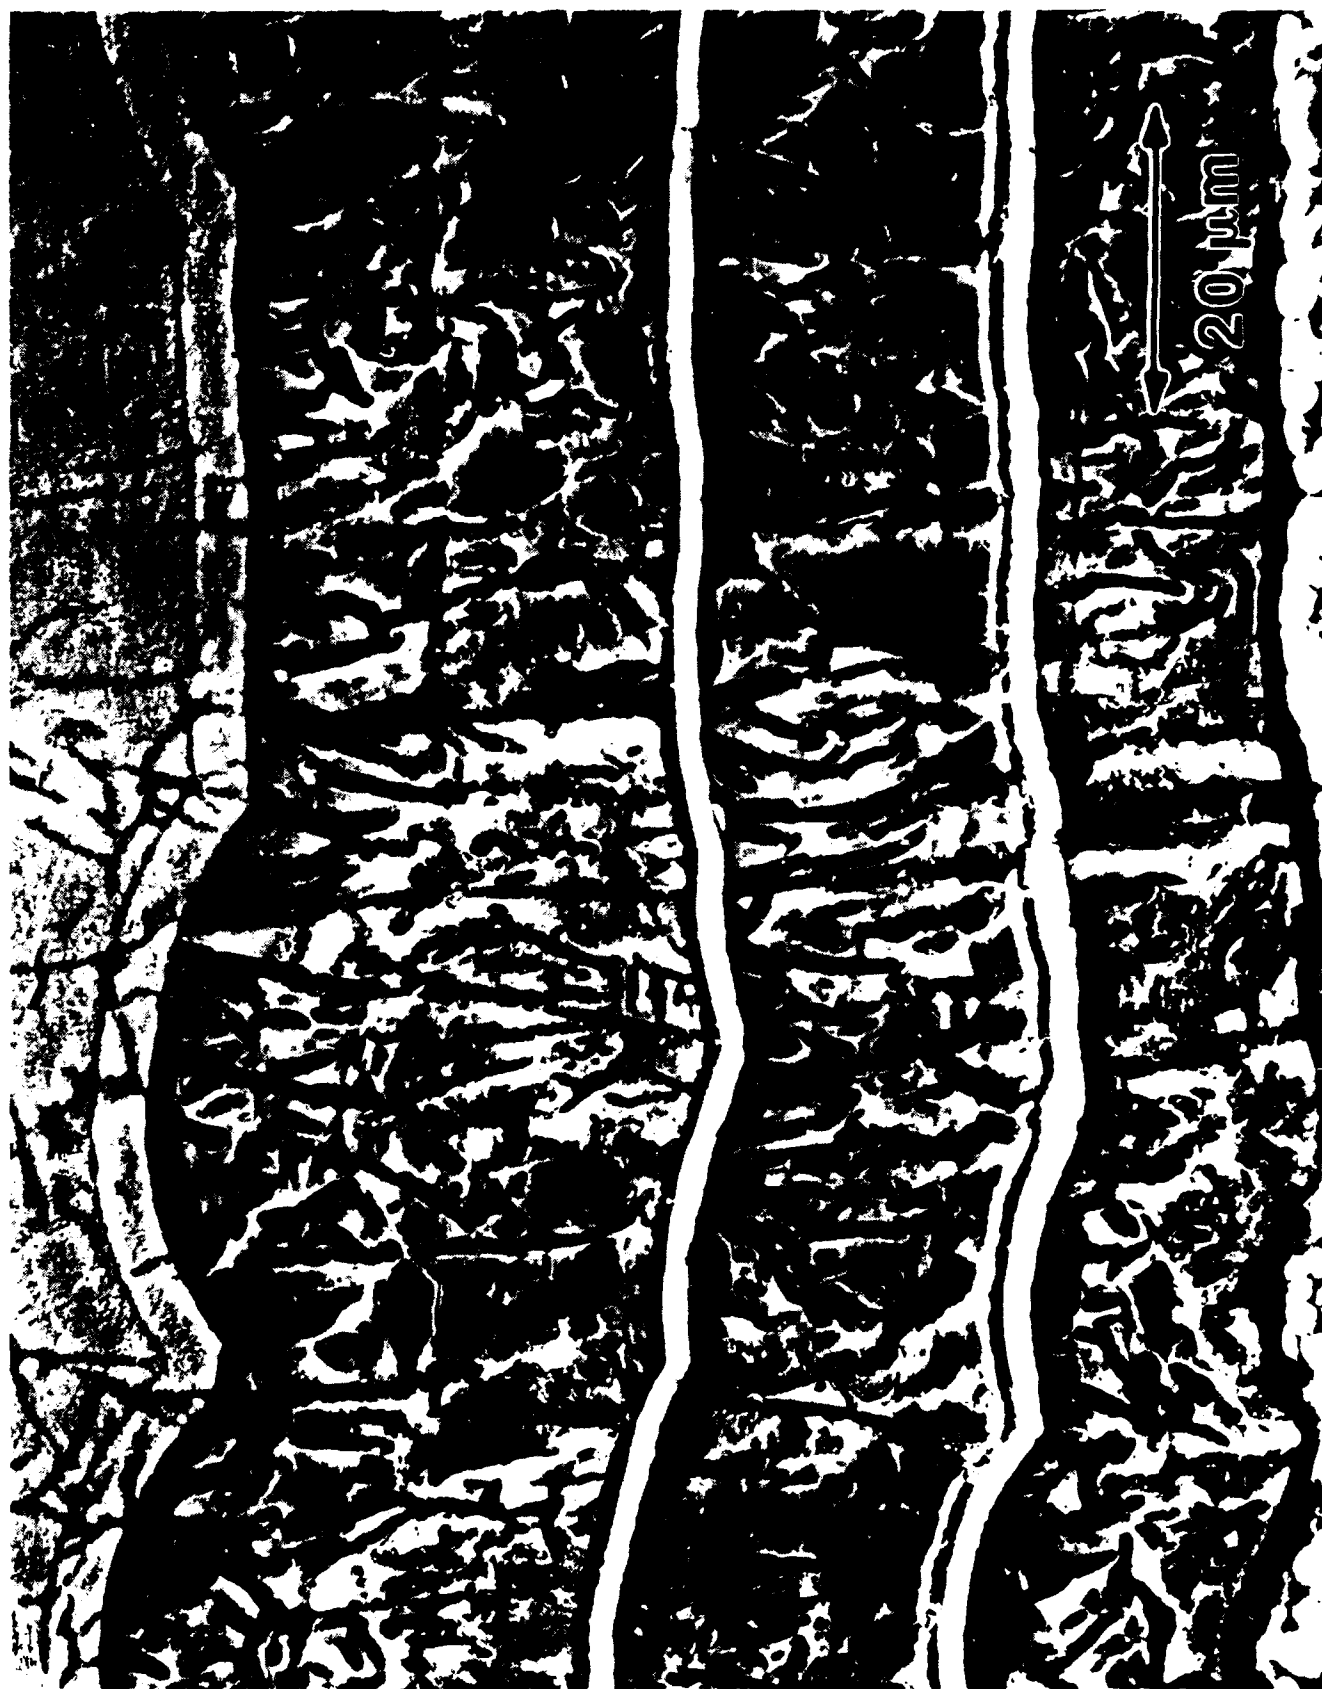
Figure 61. SEM micrograph of the BXC (B₄C) intermediate layers in the Chromalloy coating.

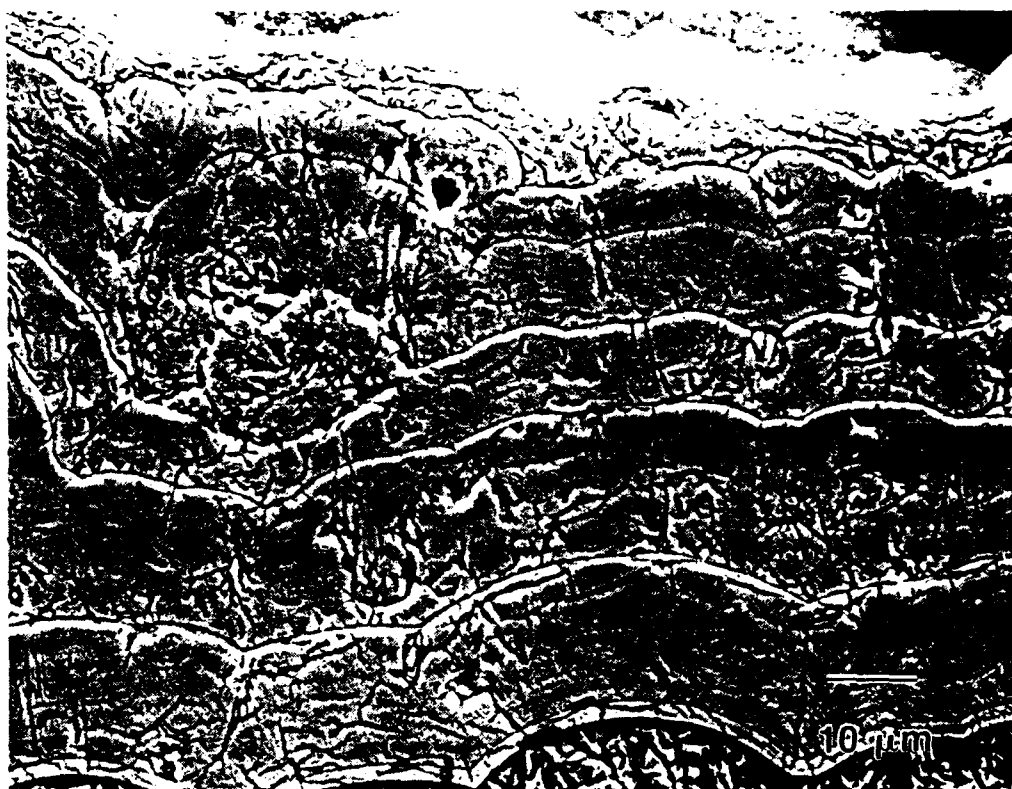
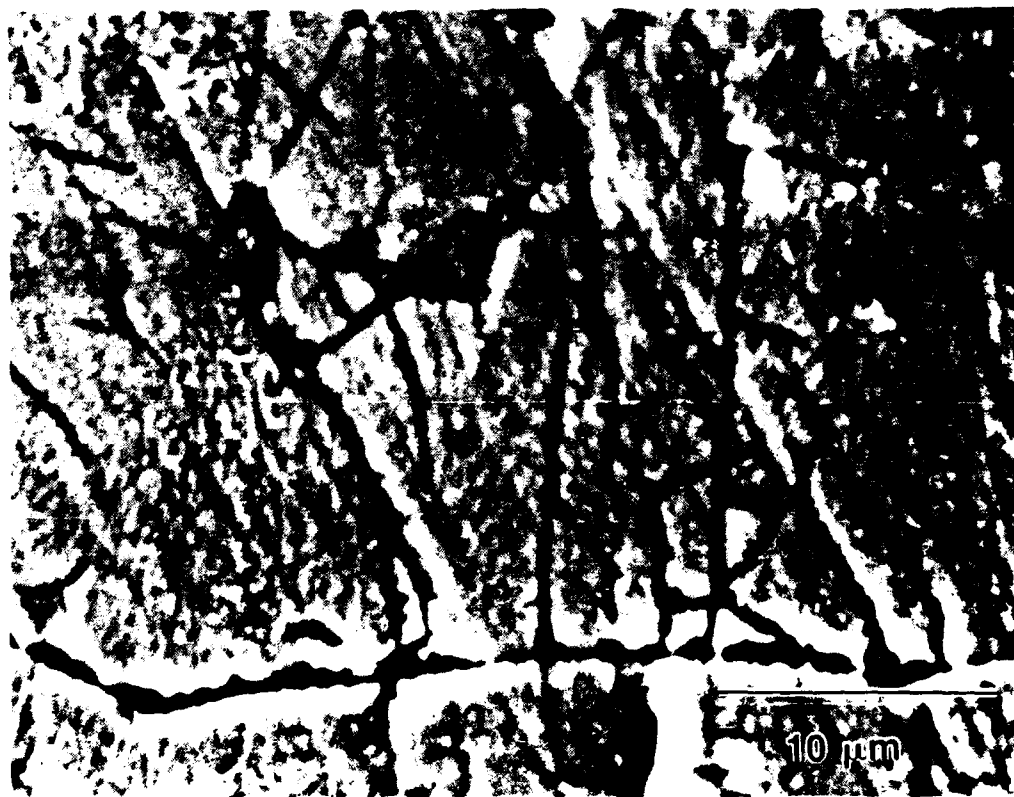
Figure 62. SEM micrographs of the RT42A (CVD SiC) layers on the Chromalloy coating.

On top of the B_4C intermediate layers are C.V.D. SiC layers. A high magnification micrograph of the C.V.D. layers is seen in Figure 62. The C.V.D. SiC is cubic with a lattice parameter of 4.37 Å. The deposition conditions are such that Si is in excess since diamond cubic Si is detected in these layers with XRD. The free Si is also seen at the interfaces between successive SiC layers. The individual β -SiC layers are about 30 μm thick. Six to seven of these SiC layers (10 μm total thickness) are deposited
