Final Report
on
Program to Study the
Oxidation of Carbon-Carbon Composites
and Coatings on these Materials

by
J. Cullinan, J. Schaeffer, E. A. Gulbransen
G. H. Meier and F. S. Pettit

Materials Science and Engineering Department
University of Pittsburgh
Pittsburgh, PA 15261

September 30, 1989

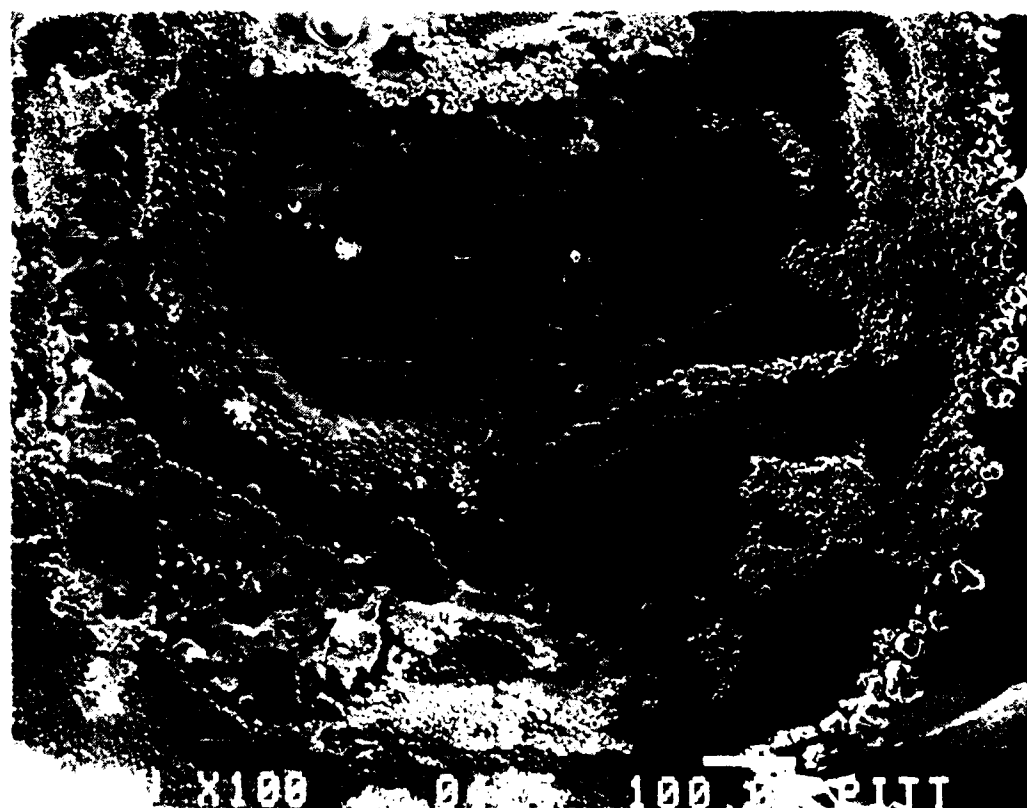
Figure 67. Micrographs of the defects that form on the surface of the HP24 samples after isothermal oxidation at 1100°C.

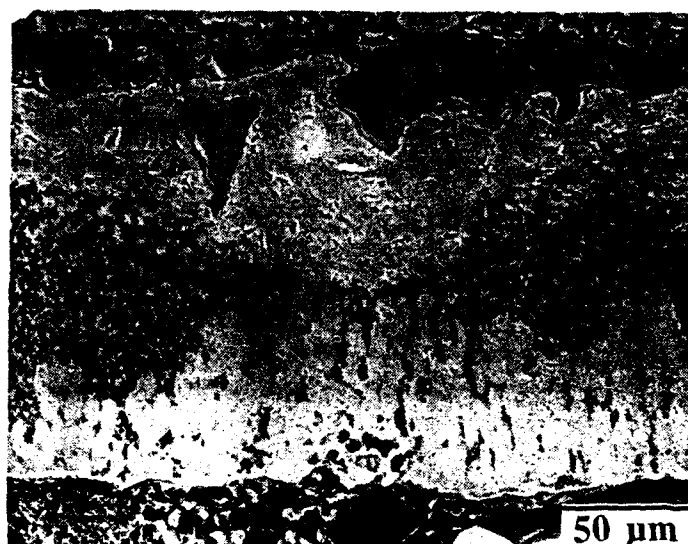
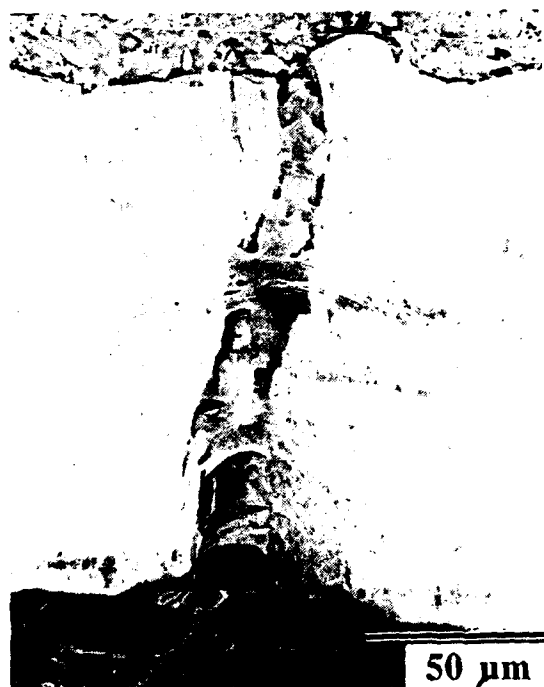
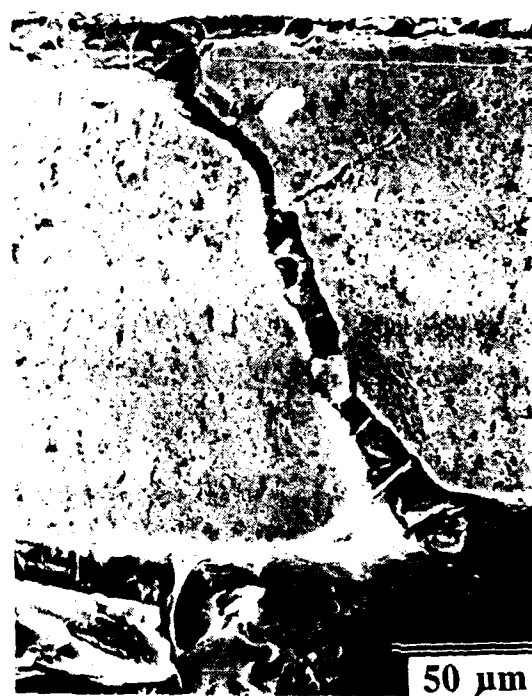
Figure 68. Cross sections of HP24 after isothermal oxidation at 1200°C. The top micrograph shows B₄C stringers in the coating. The bottom micrographs show bubbling in the reaction products in cracks.

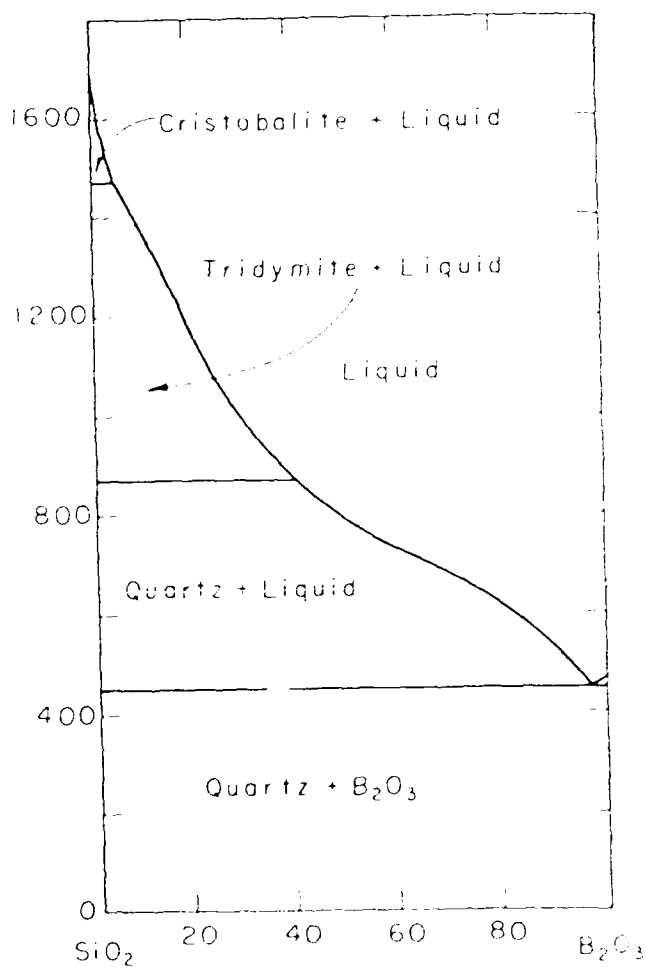
Figure 69. Phase diagram of the B_2O_3 - SiO_2 system.

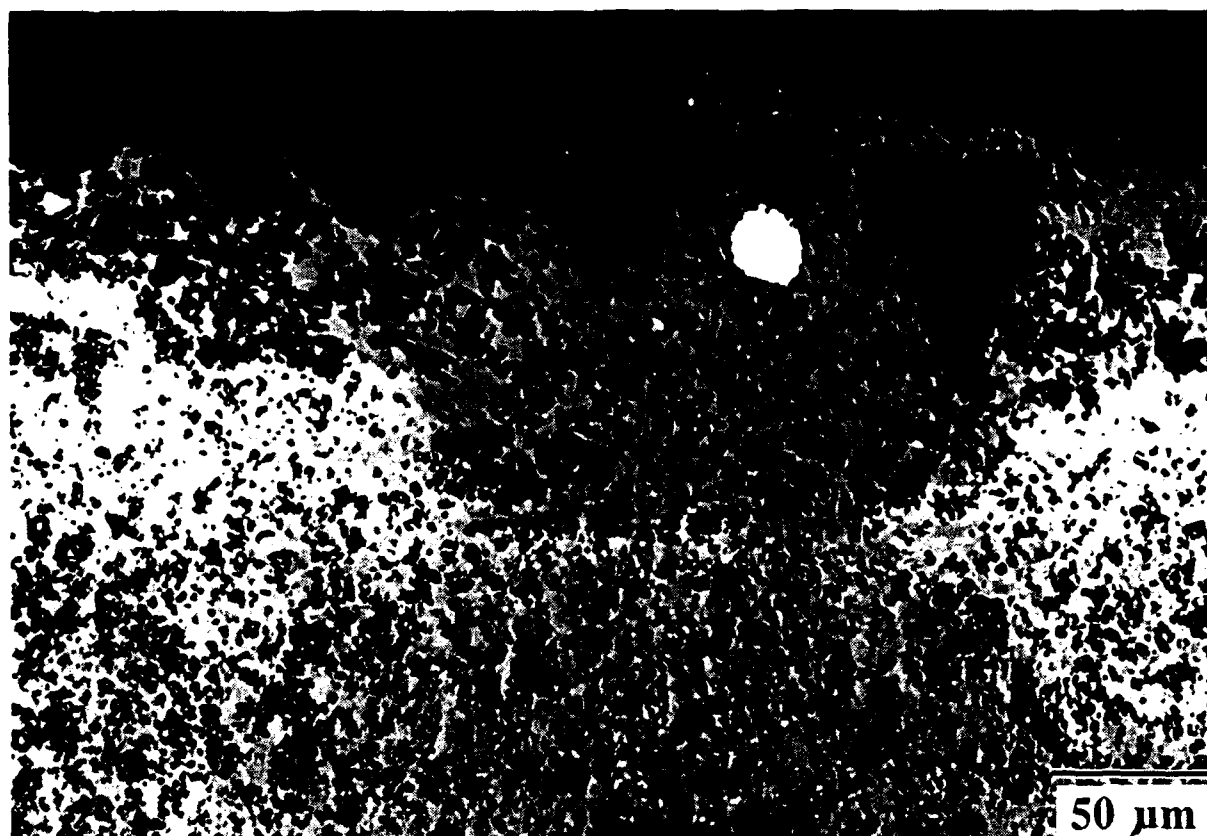
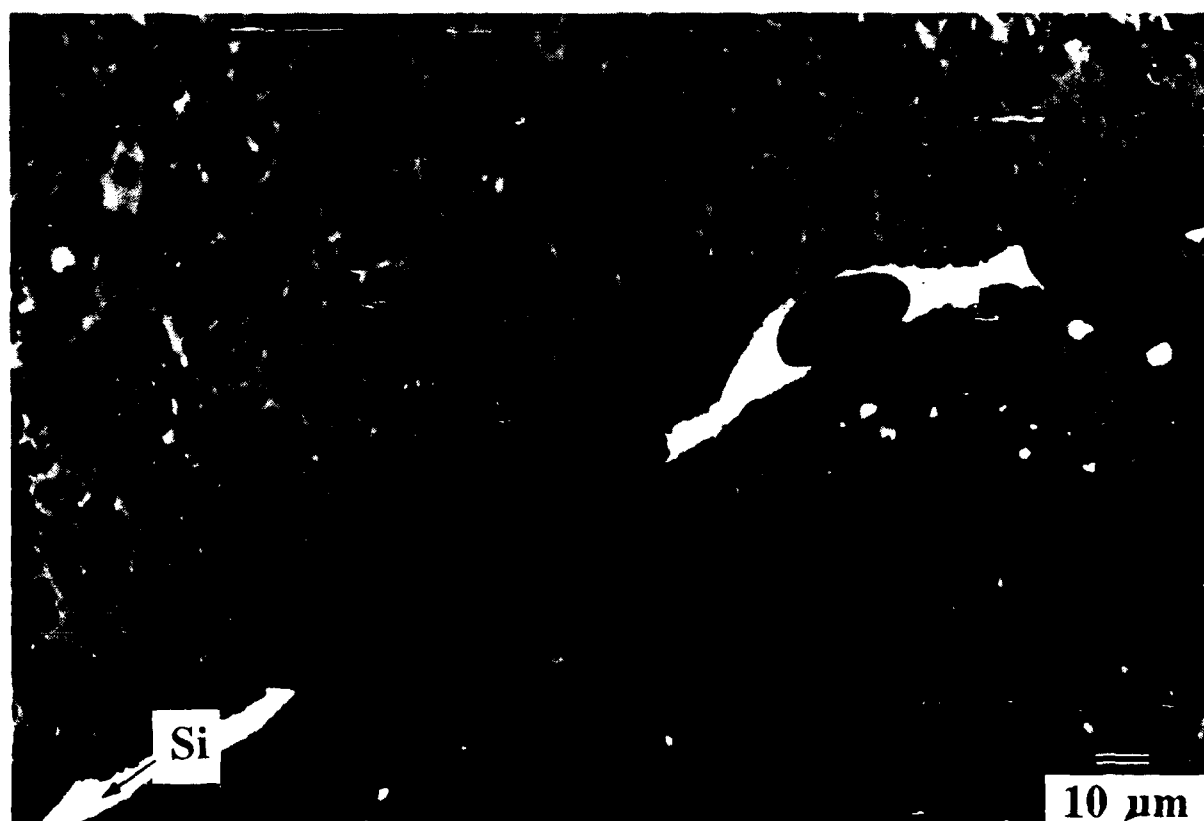
Figure 70. Optical micrographs show HP24 after oxidation in oxygen at 1100°C for 20 hours. Preferential attack of the bright free Si is observed in each micrograph. Dark particles are B_4C .

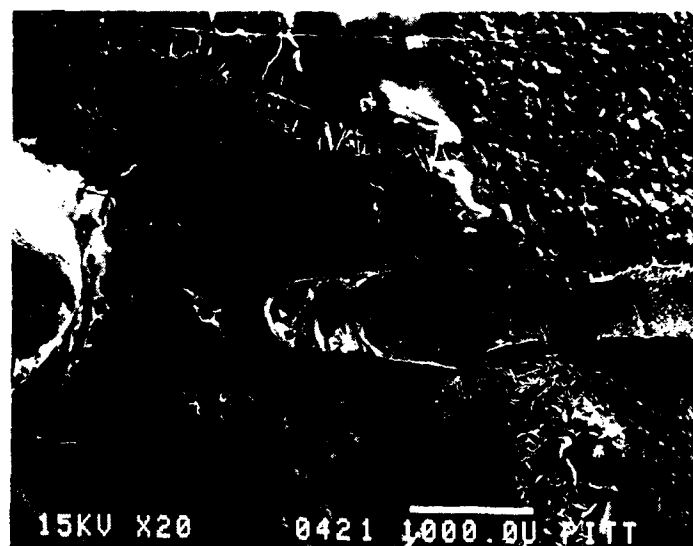
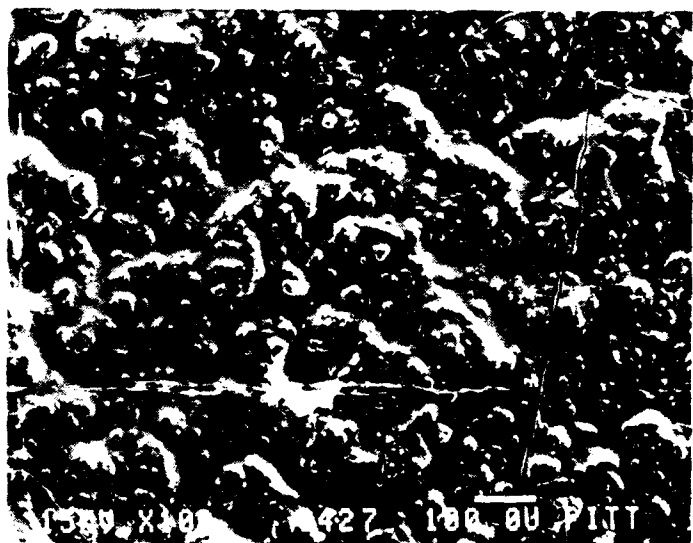
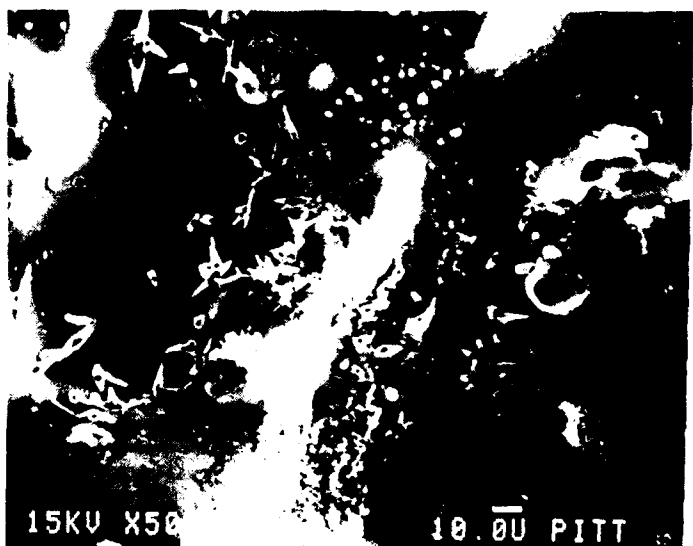
Figure 72. Surface micrographs of the M185 after isothermal oxidation at 1100°C. The top shows a large mound/hole defect, while the other two micrographs show typical surface morphologies.

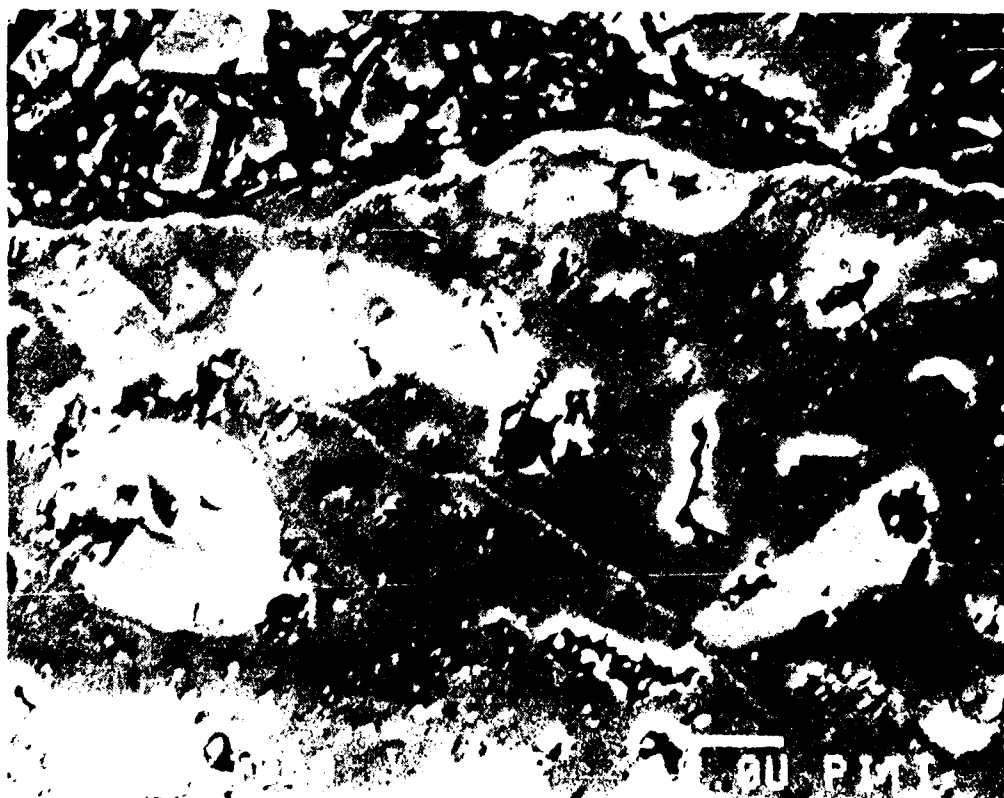
Figure 73. Micrographs of the M185 sample after isothermal oxidation at 1100°C. The top micrograph is a cross section of the coating and the other micrograph shows the coating/scale interface.

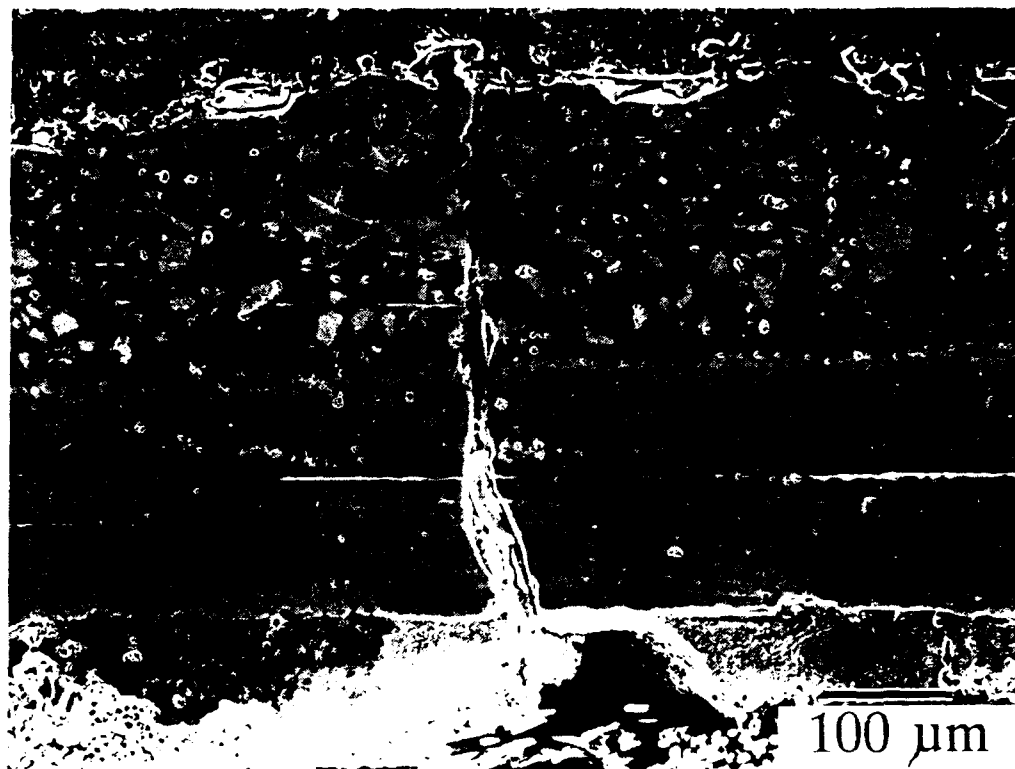
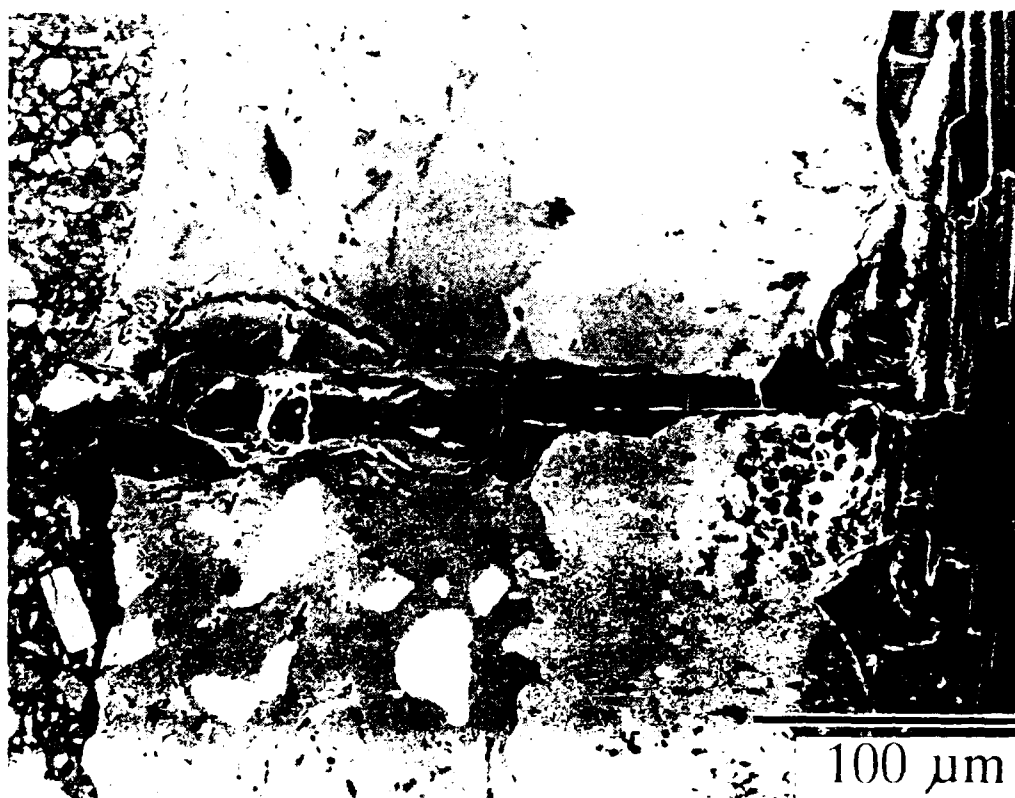
Figure 75. Cross section of the M185 sample after isothermal oxidation in oxygen at 1100°C. The crack is sealed in the top micrograph. The bottom shows a porous crack that is not sealed. The porous crack leads to a mound.

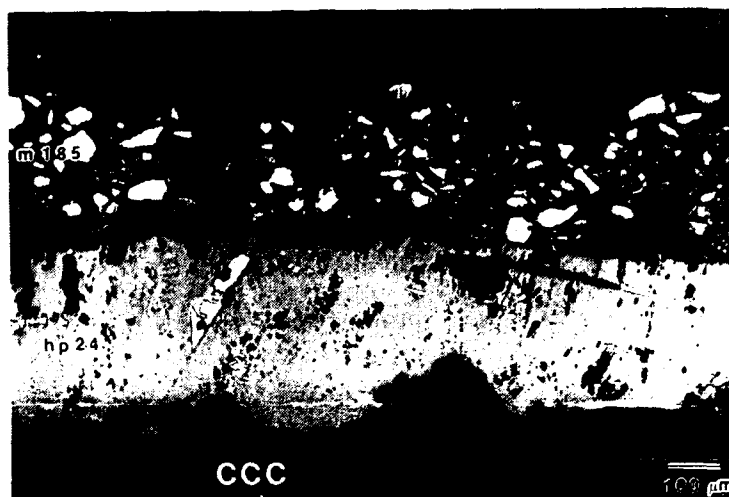
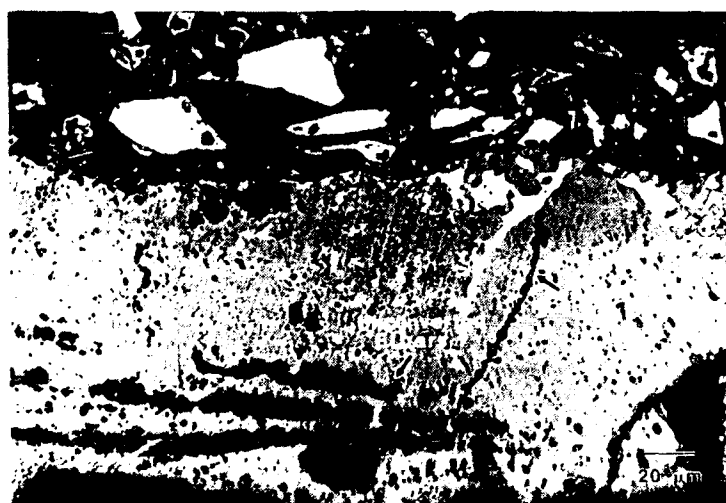
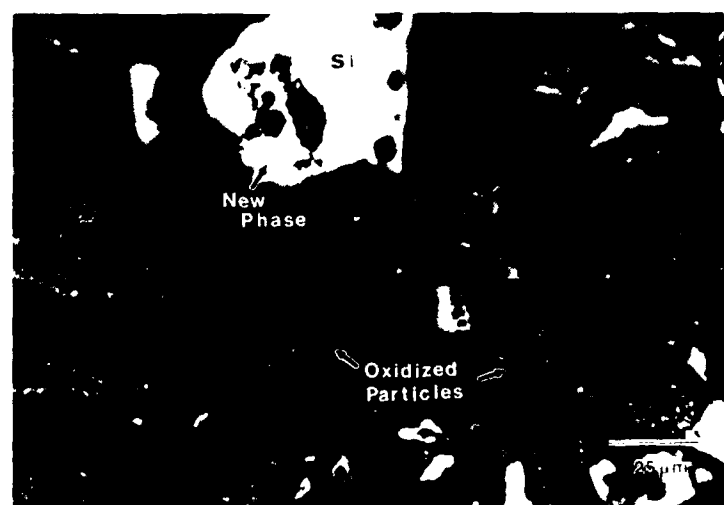
Figure 76. Optical micrographs of the cross section of the M185 coating after oxidation at 1300°C. Particle attack in the M185 glaze and preferential attack of Si in the HP24 are observed.

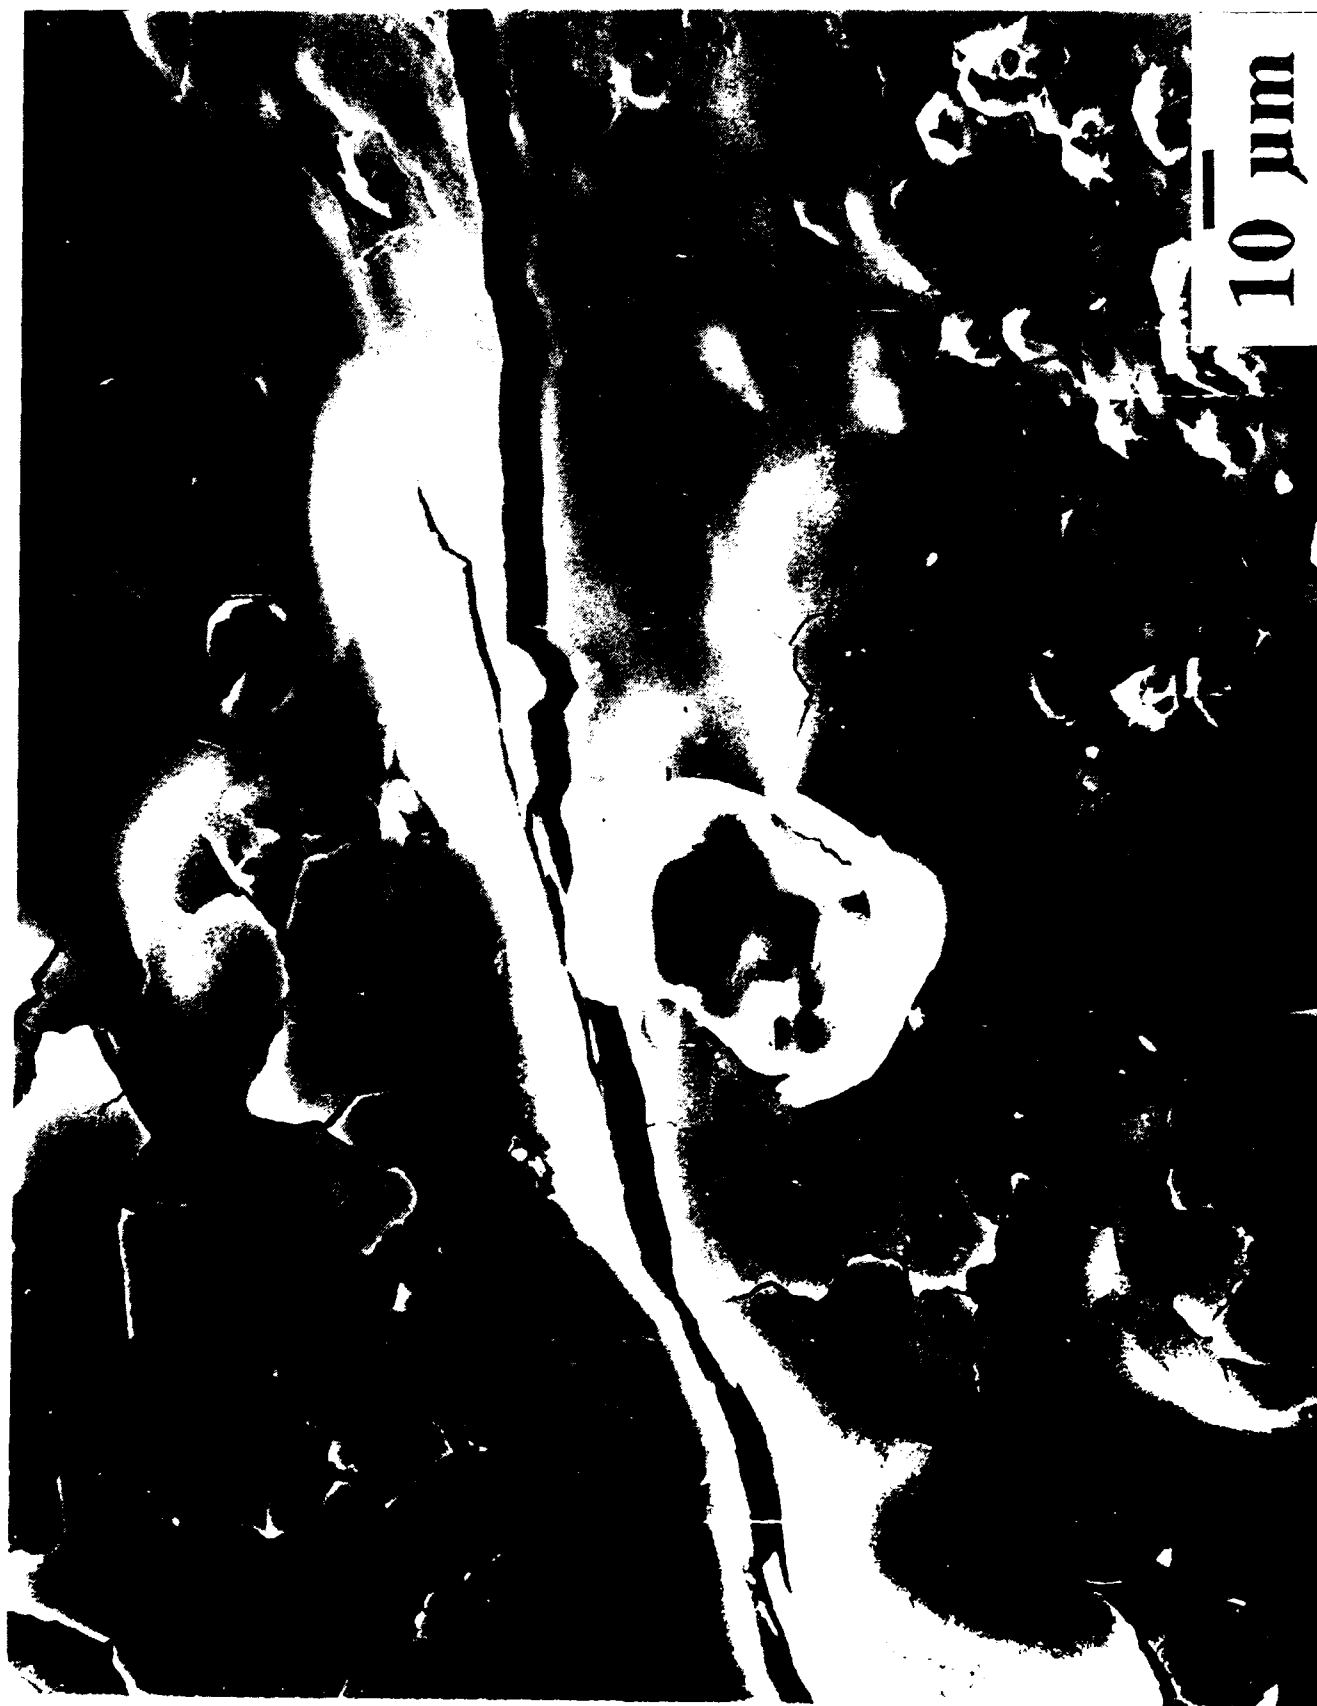
Figure 77. Surface micrograph of the No Glaze after isothermal oxidation in oxygen at 1100°C. The surface shows cracking and spalling of the silica scale.

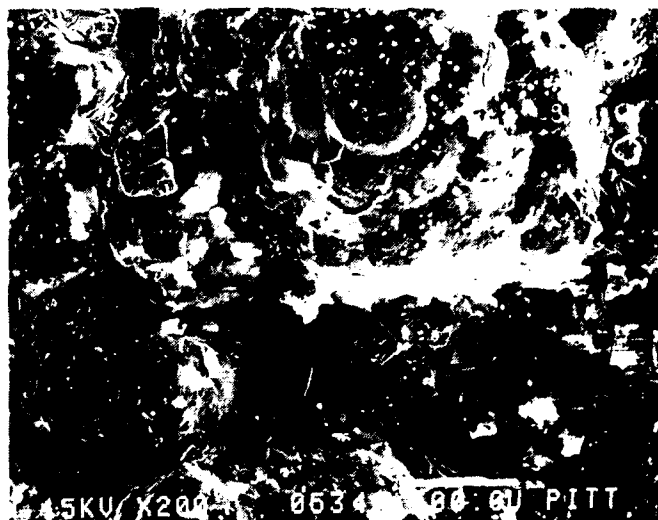
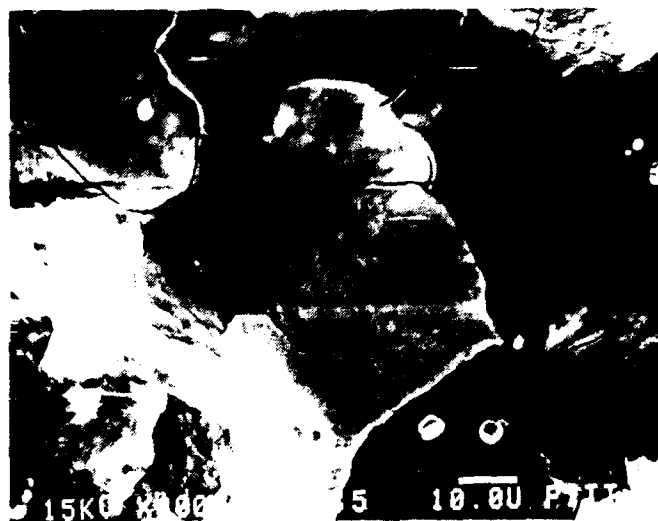
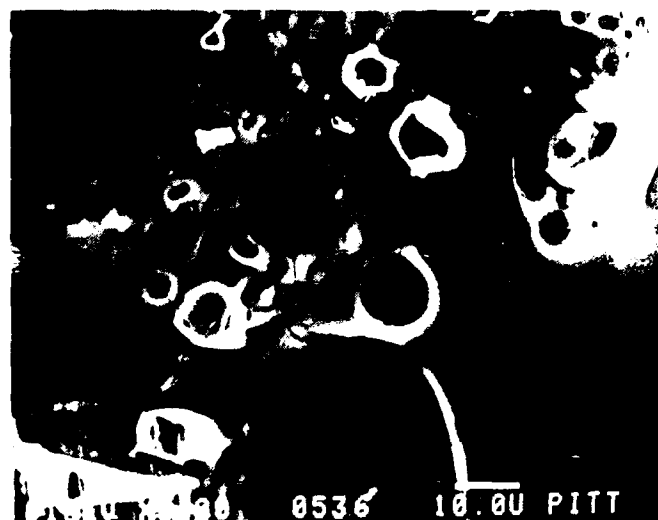
Figure 78. Surface of the No Glaze coating after isothermal oxidation testing at 1300°C.

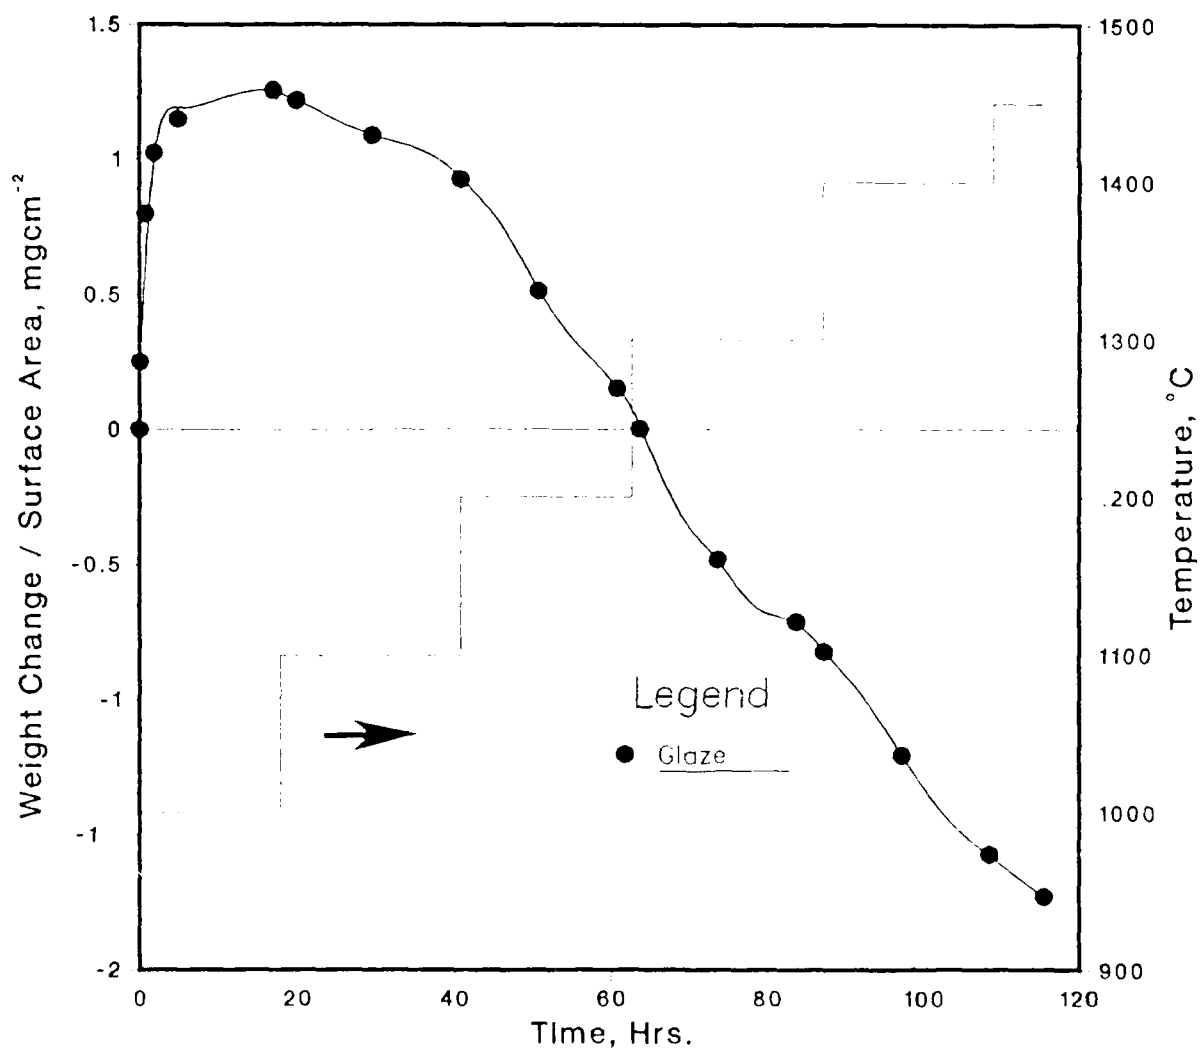
Figure 79. Oxidation kinetics for the Glaze sample when incrementally heated from 1000 to 1450°C in oxygen. No thermal shock of the sample was observed.

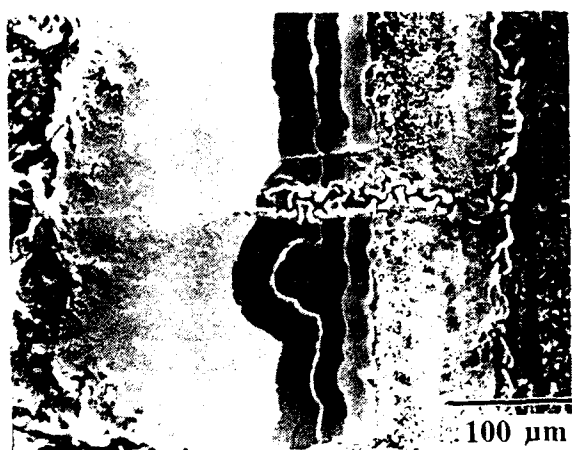
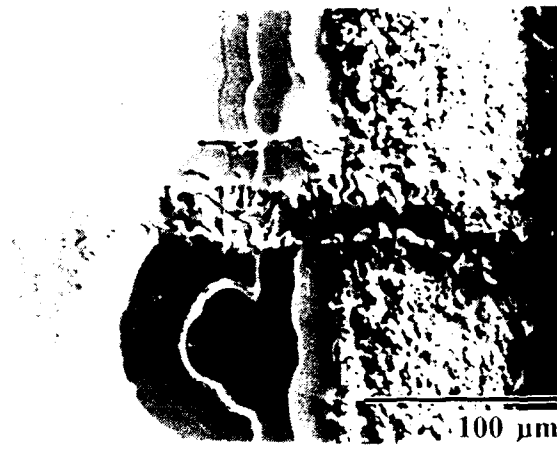
Figure 80. Micrographs and WDS analyses of the glaze sample cross section after oxidation test at 1000 to 1450°C.

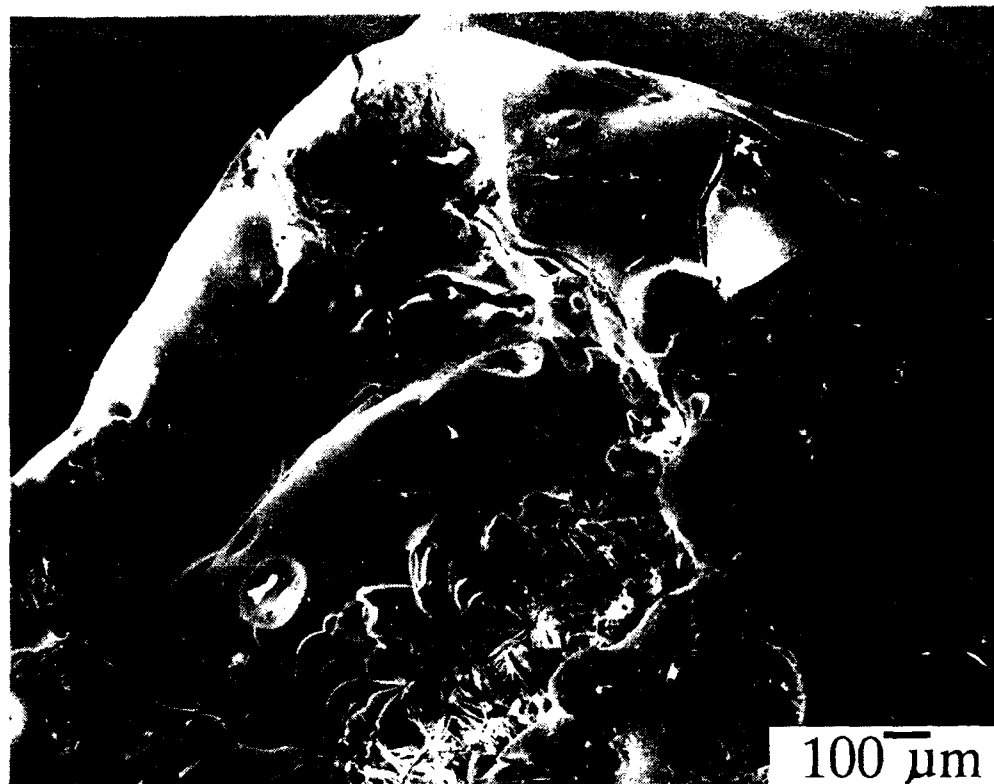
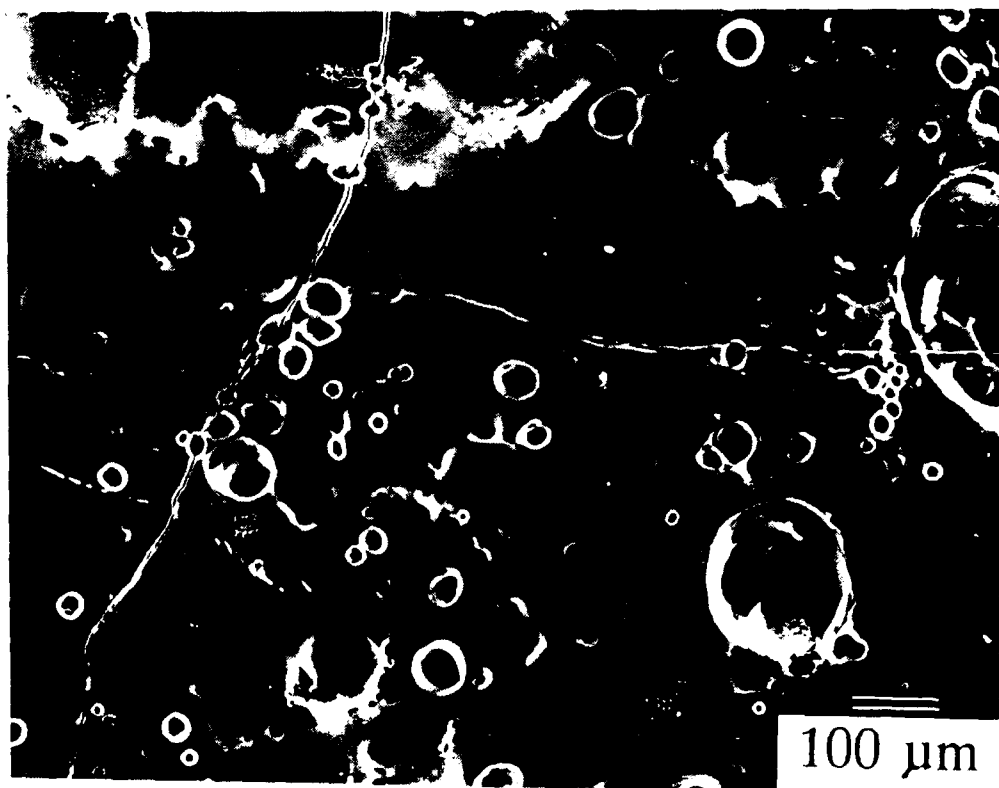
Figure 85. Micrographs showing the surface of the glaze sample after 100 cycles in oxygen at 1125°C. The top micrograph shows a typical large crack at the corner of the sample. The micrograph shows cracks and bubbles near the center of the sample.

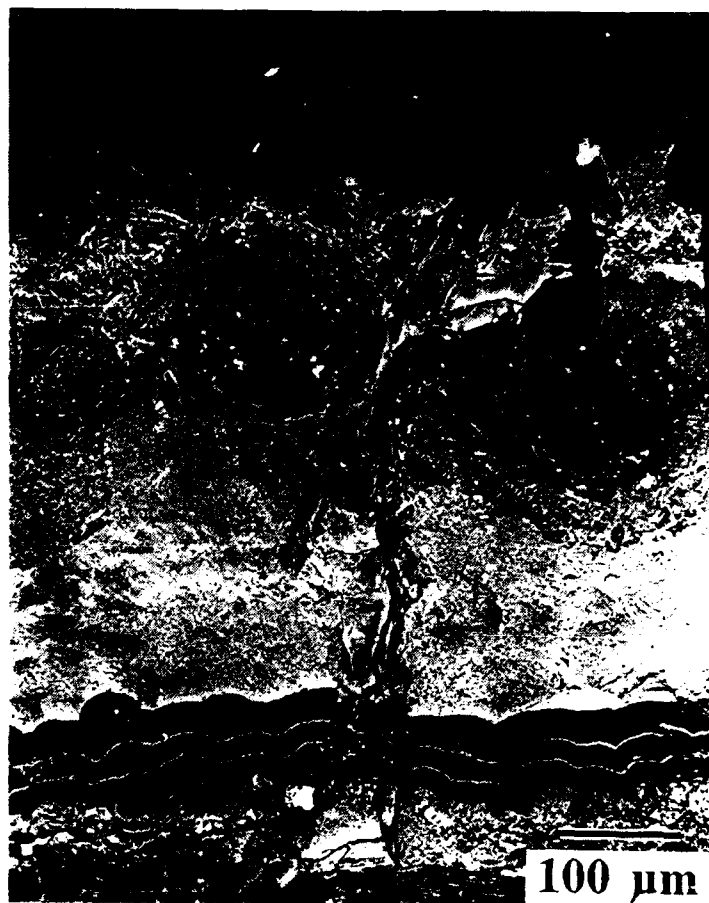
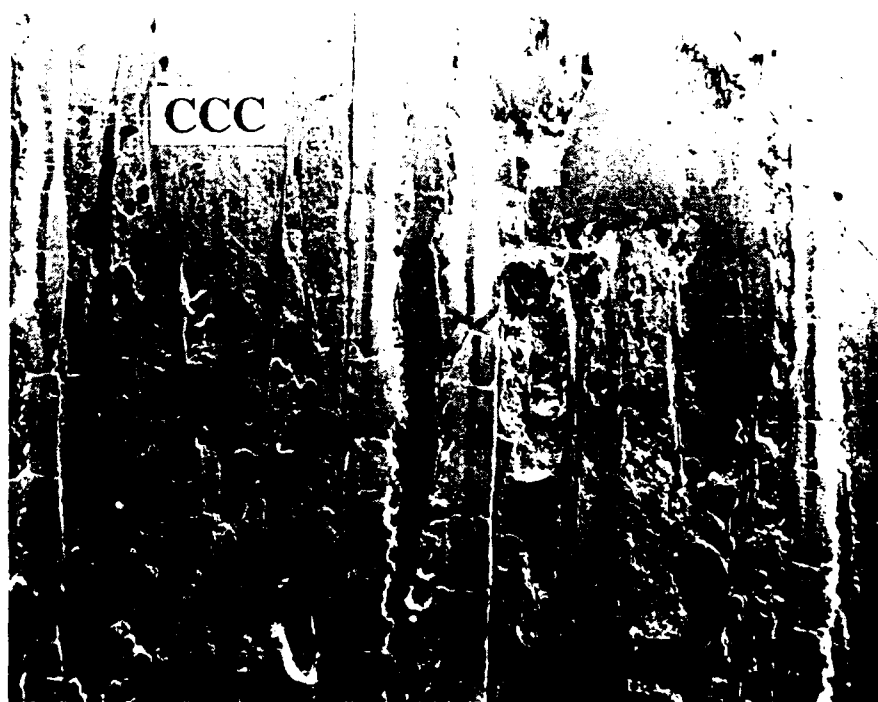
Figure 86. Micrographs of the glaze sample after 100 cycles in oxygen at 1125°C. The top micrograph shows a sealed crack. The bottom micrograph shows a cross section of the penetrated coating.

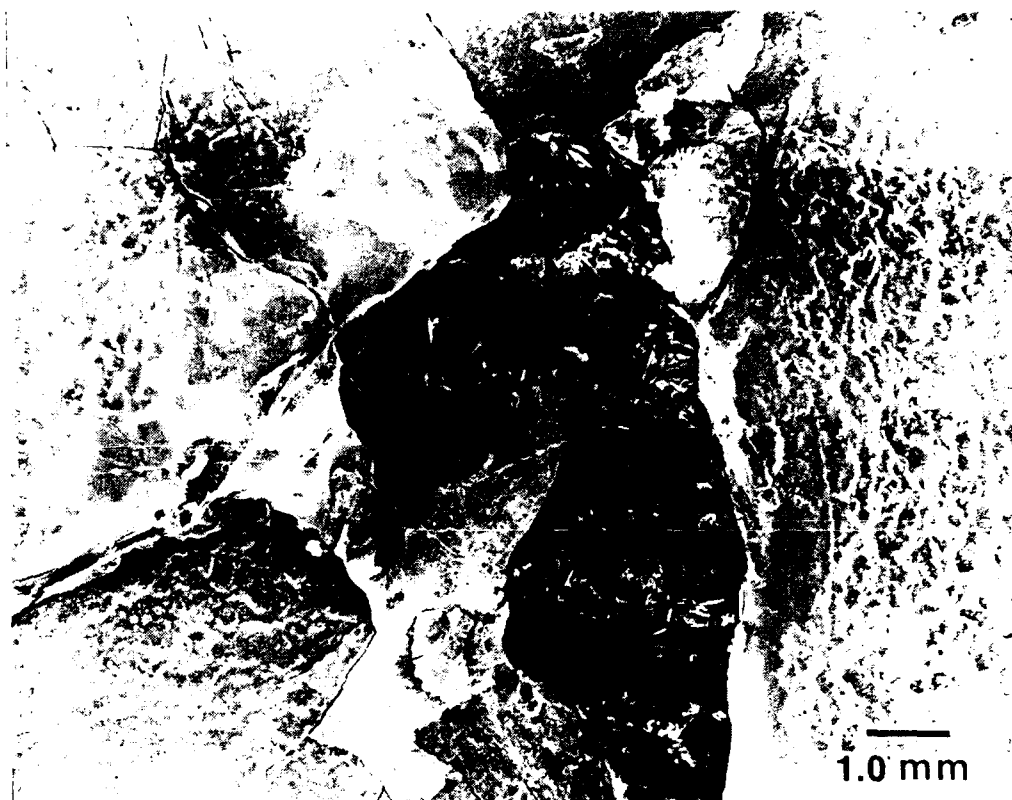
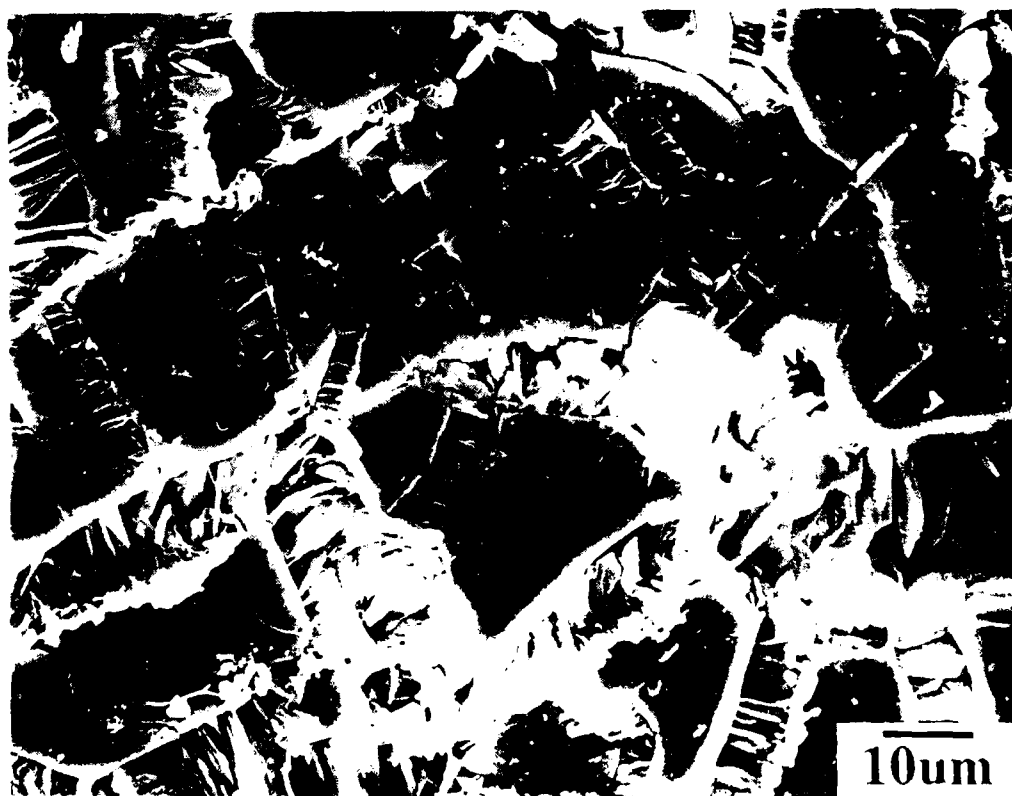
Figure 87. Surface micrograph showing the buckled failure observed in the M185 sample after 975 cycles in air at 900°C. Boron is detected at the rim of the hole. The lower micrograph shows fracturing of the glaze near the hole.

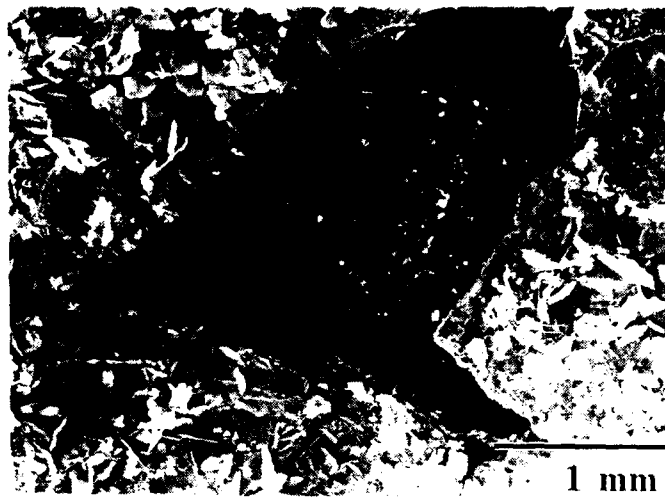
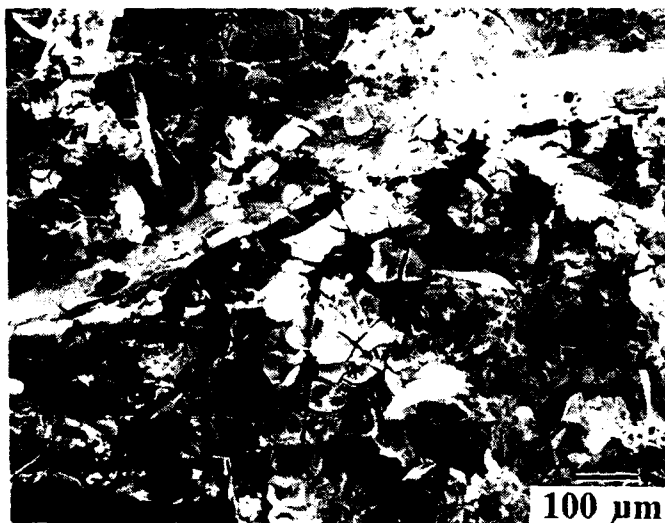
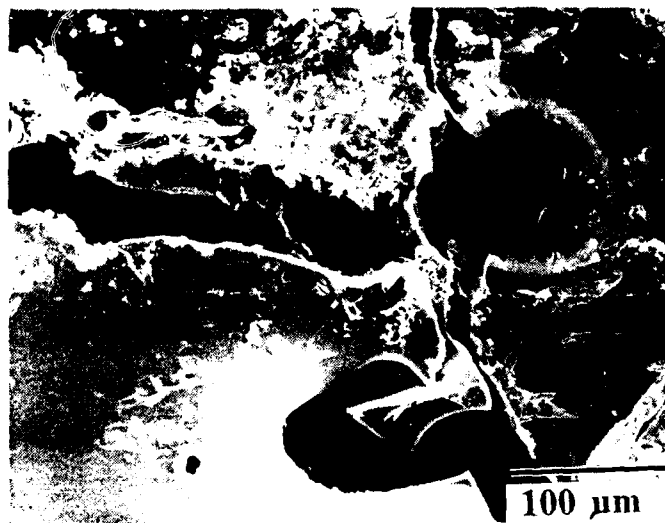
Figure 88. Surface micrographs of the glaze sample after cyclic oxidation at 900°C. The top shows a large failure site. Some boron oxide surrounds the failure site. The other micrographs show cracking and spalling on the surface.

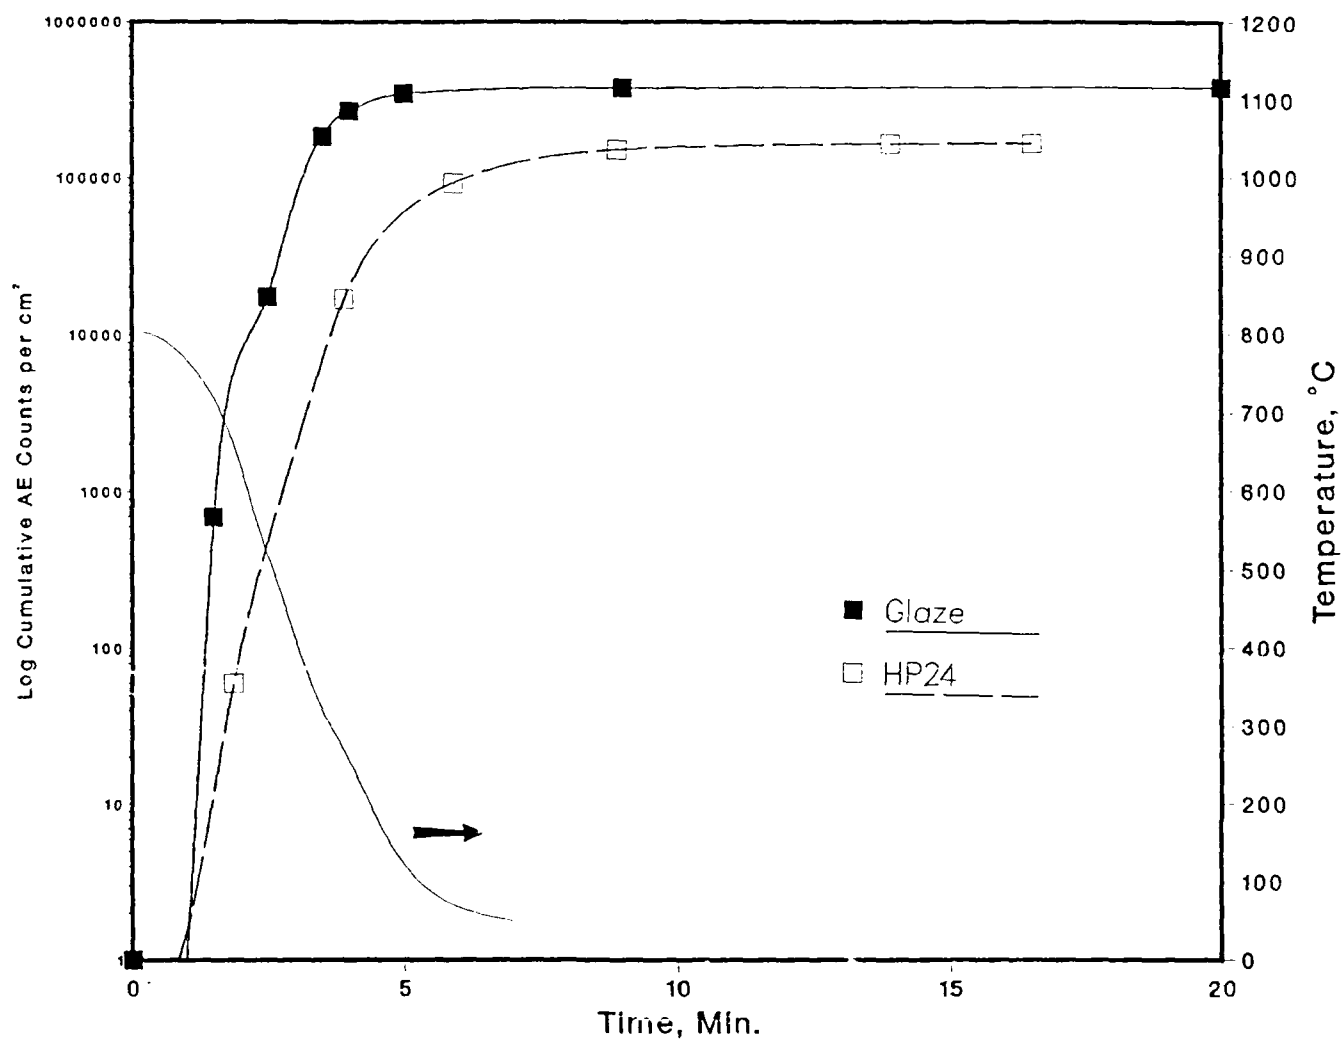
Figure 89. Log cumulative acoustic emission counts vs. time during cool down from 800°C in air.
