Final Report
on
Program to Study the
Oxidation of Carbon-Carbon Composites
and Coatings on these Materials

by
J. Cullinan, J. Schaeffer, E. A. Gulbransen
G. H. Meier and F. S. Pettit

Materials Science and Engineering Department
University of Pittsburgh
Pittsburgh, PA 15261

September 30, 1989

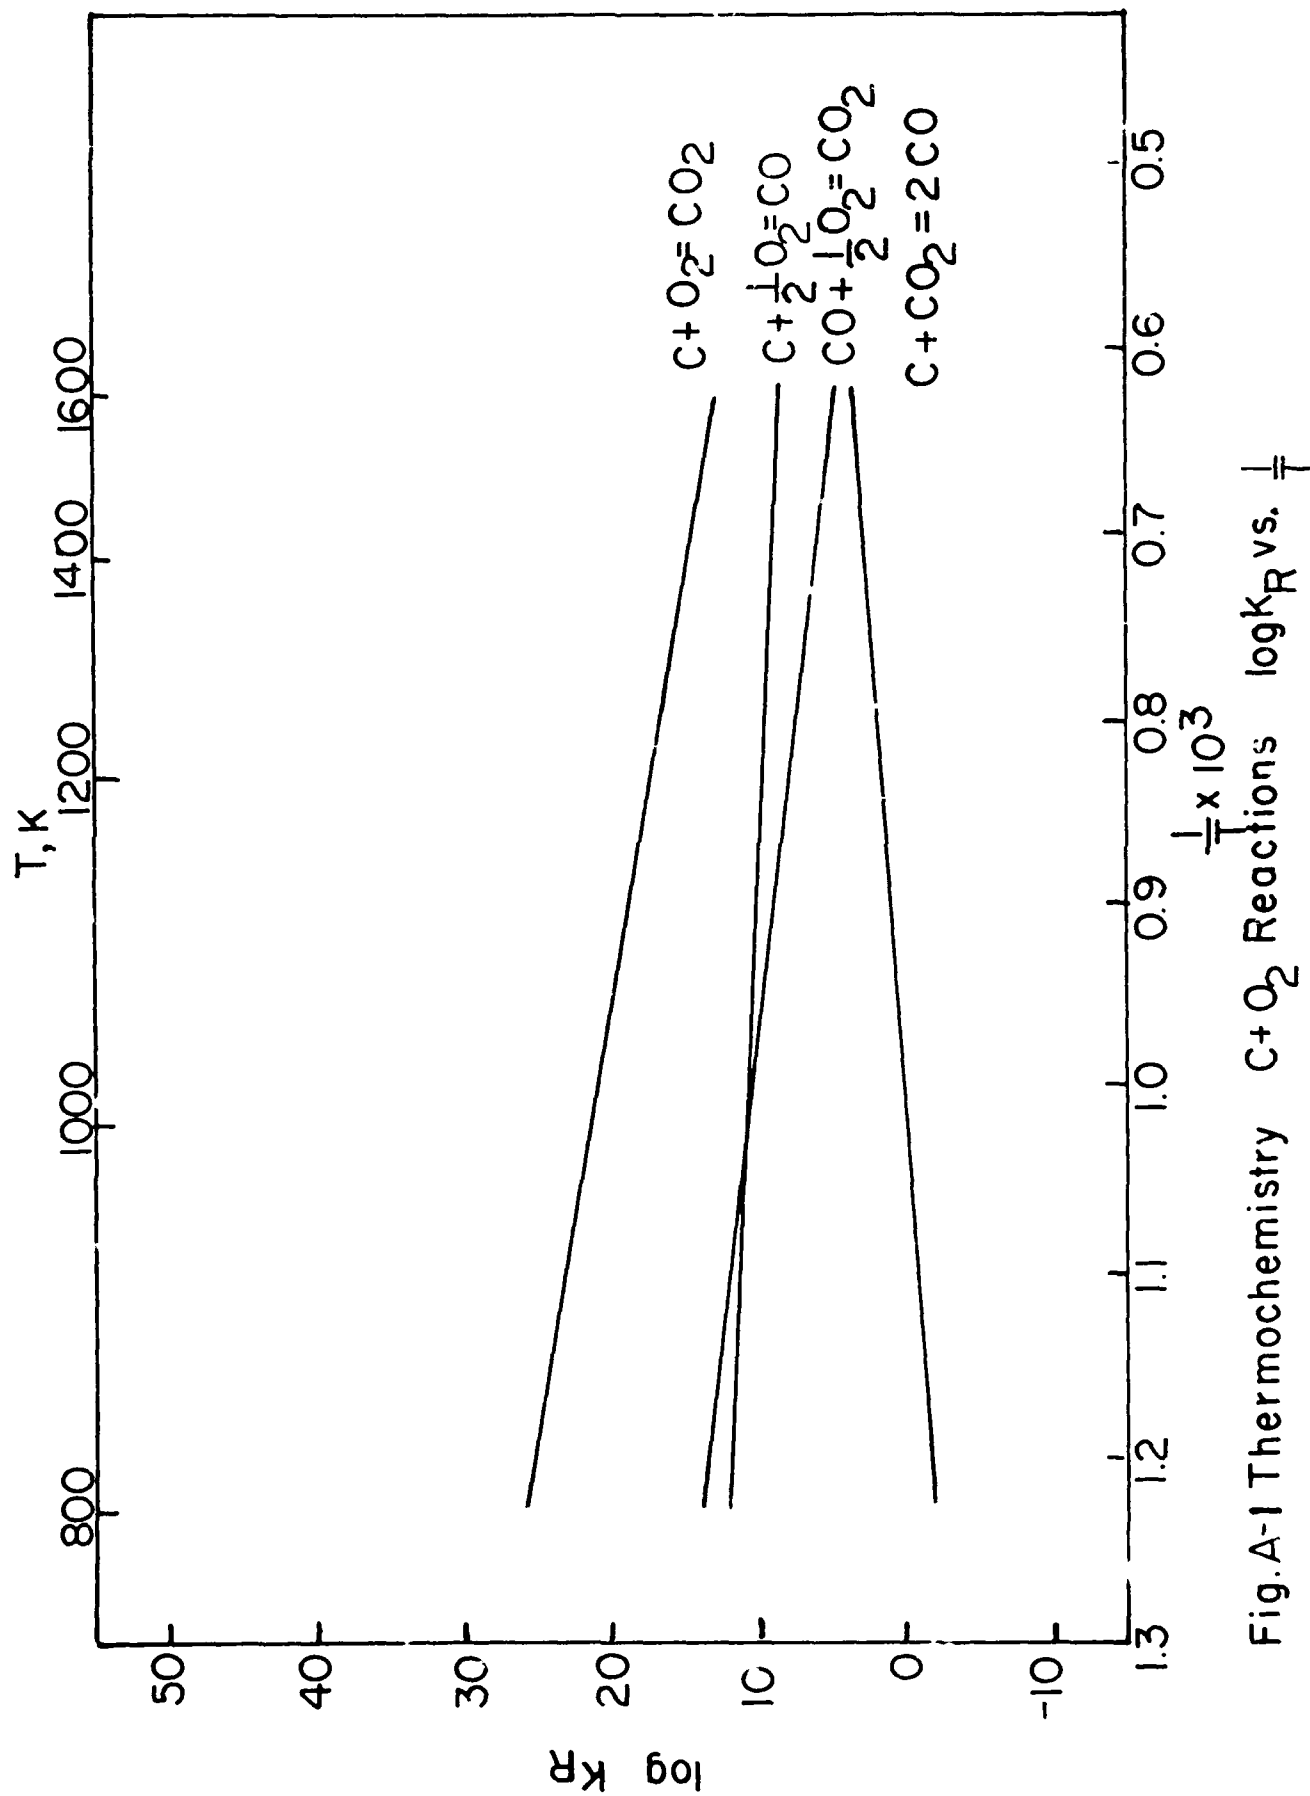
Fig.A-1 Thermochemistry $C + O_2$ Reactions $\log K_R$ vs. $\frac{1}{T}$

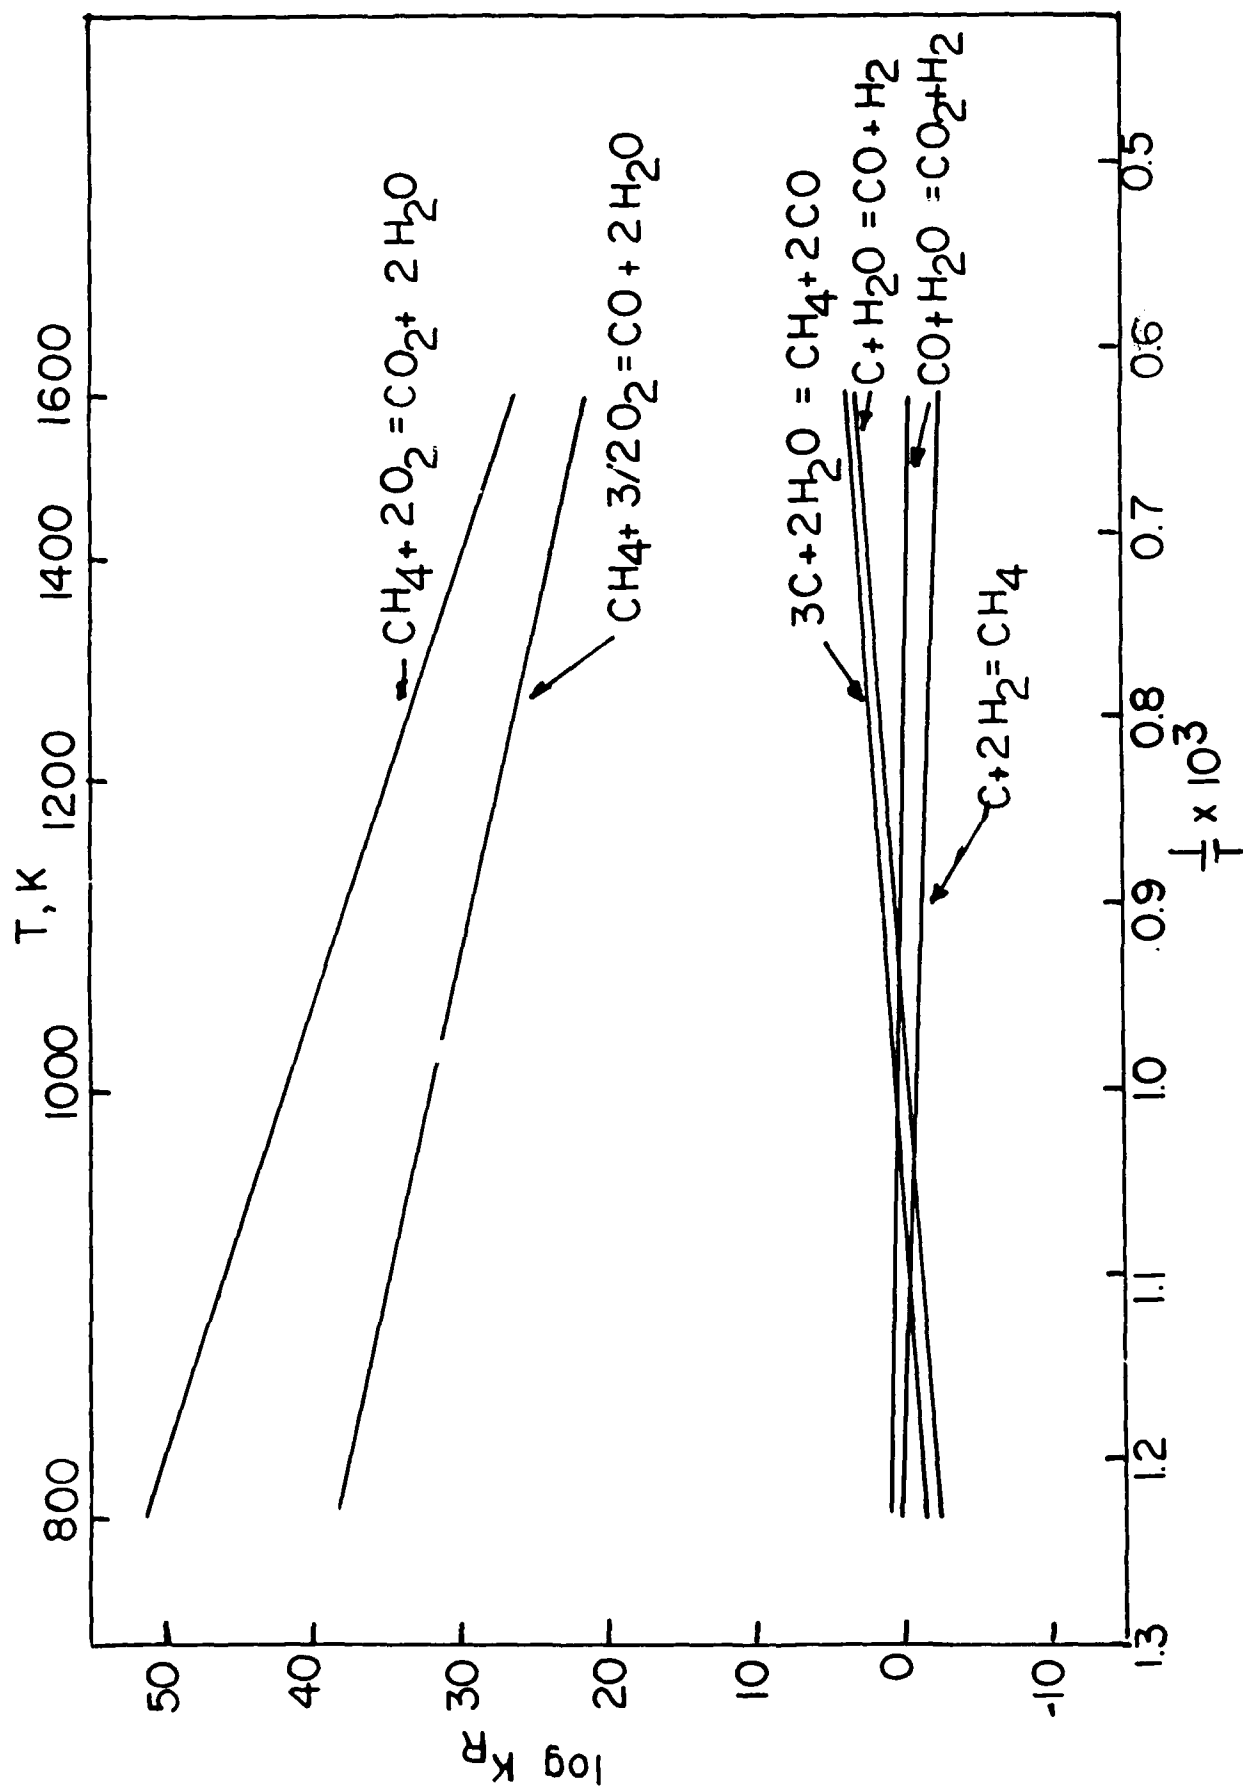
Fig. A-2 Thermochemistry $\text{C} + \text{H}_2\text{O}$ Reactions $\log K_R$ vs. $1/T$

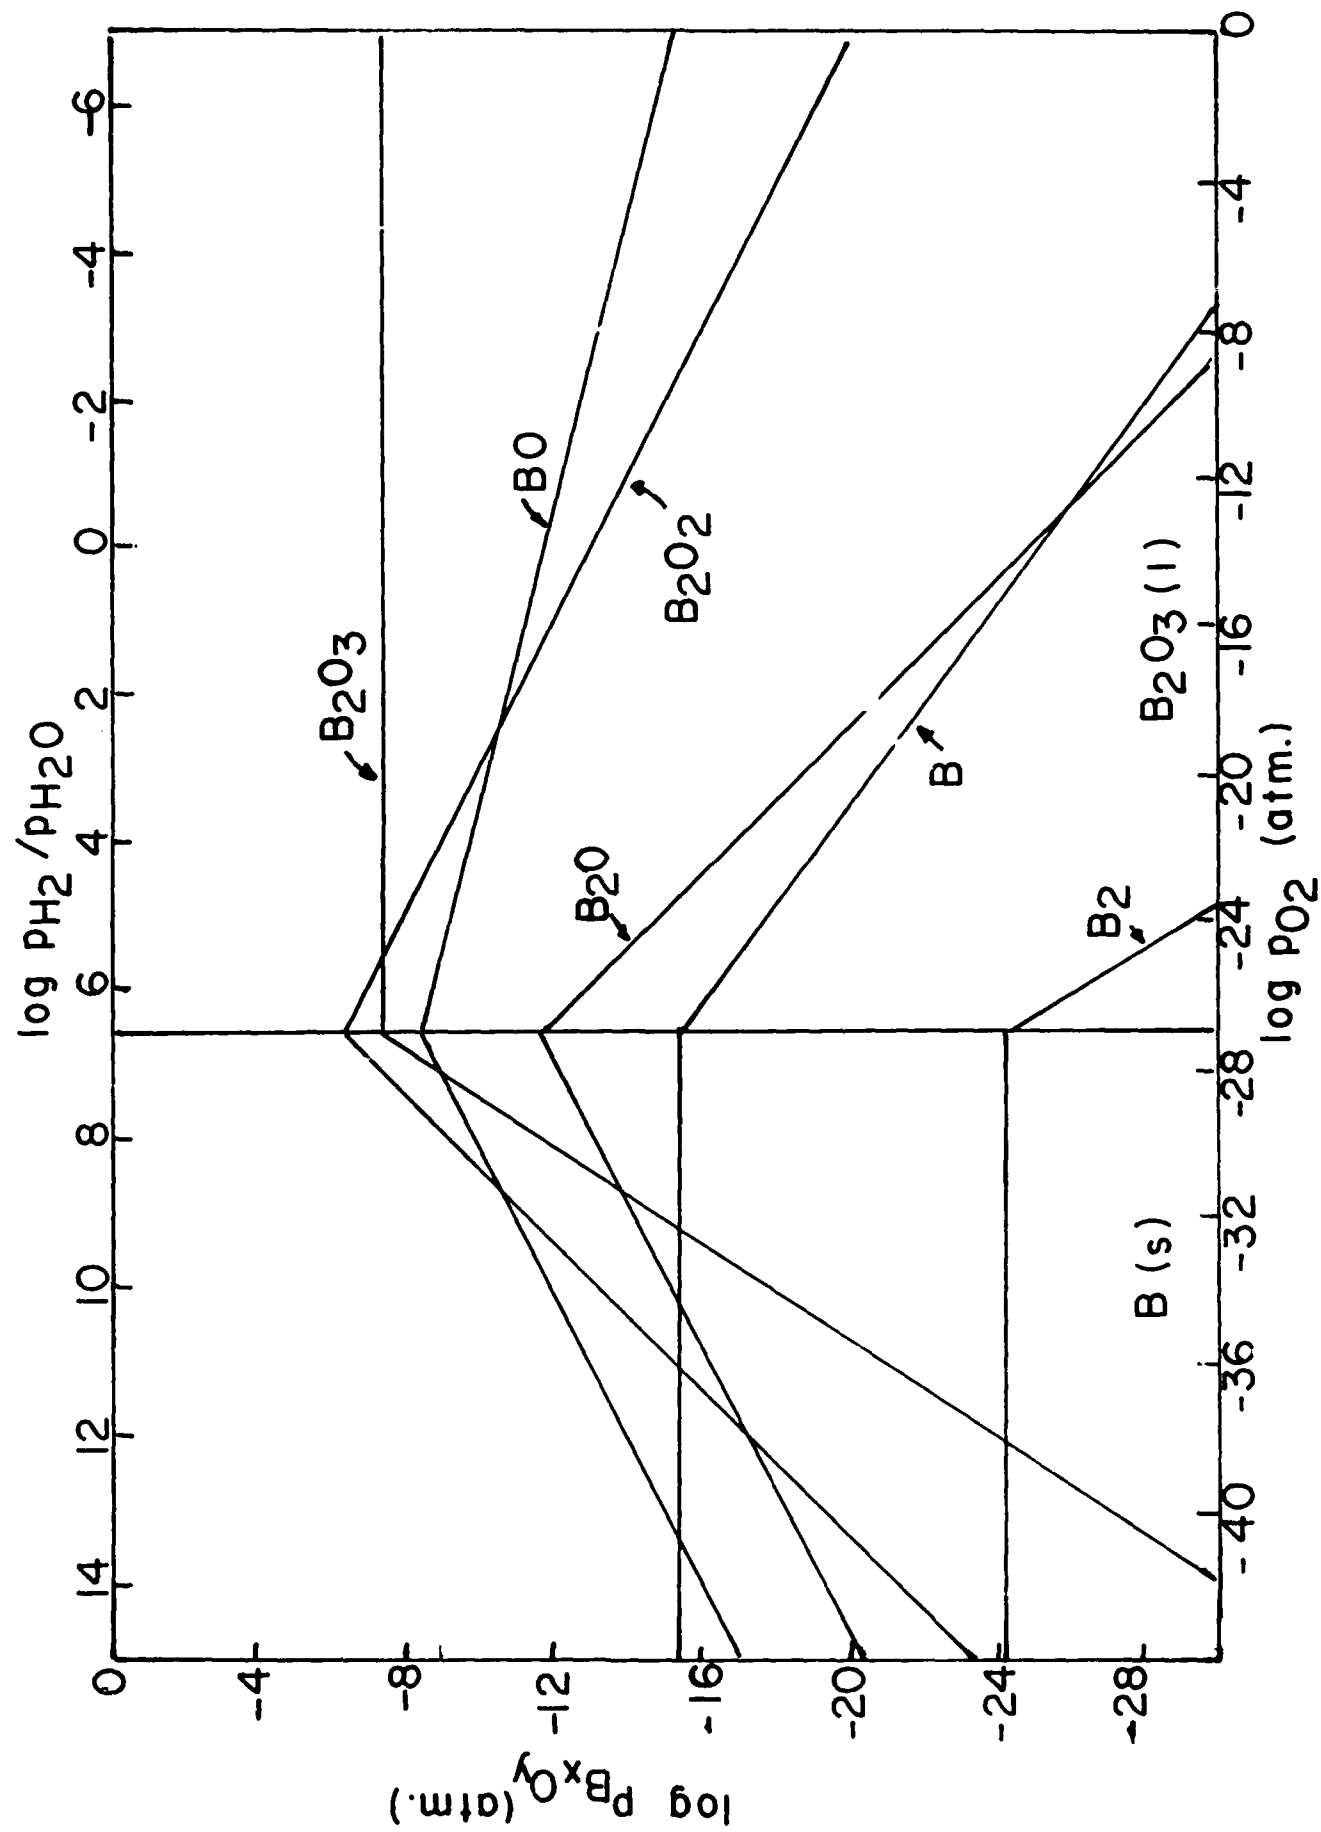
Fig.A3 Volatile Species B-O System 1250 K

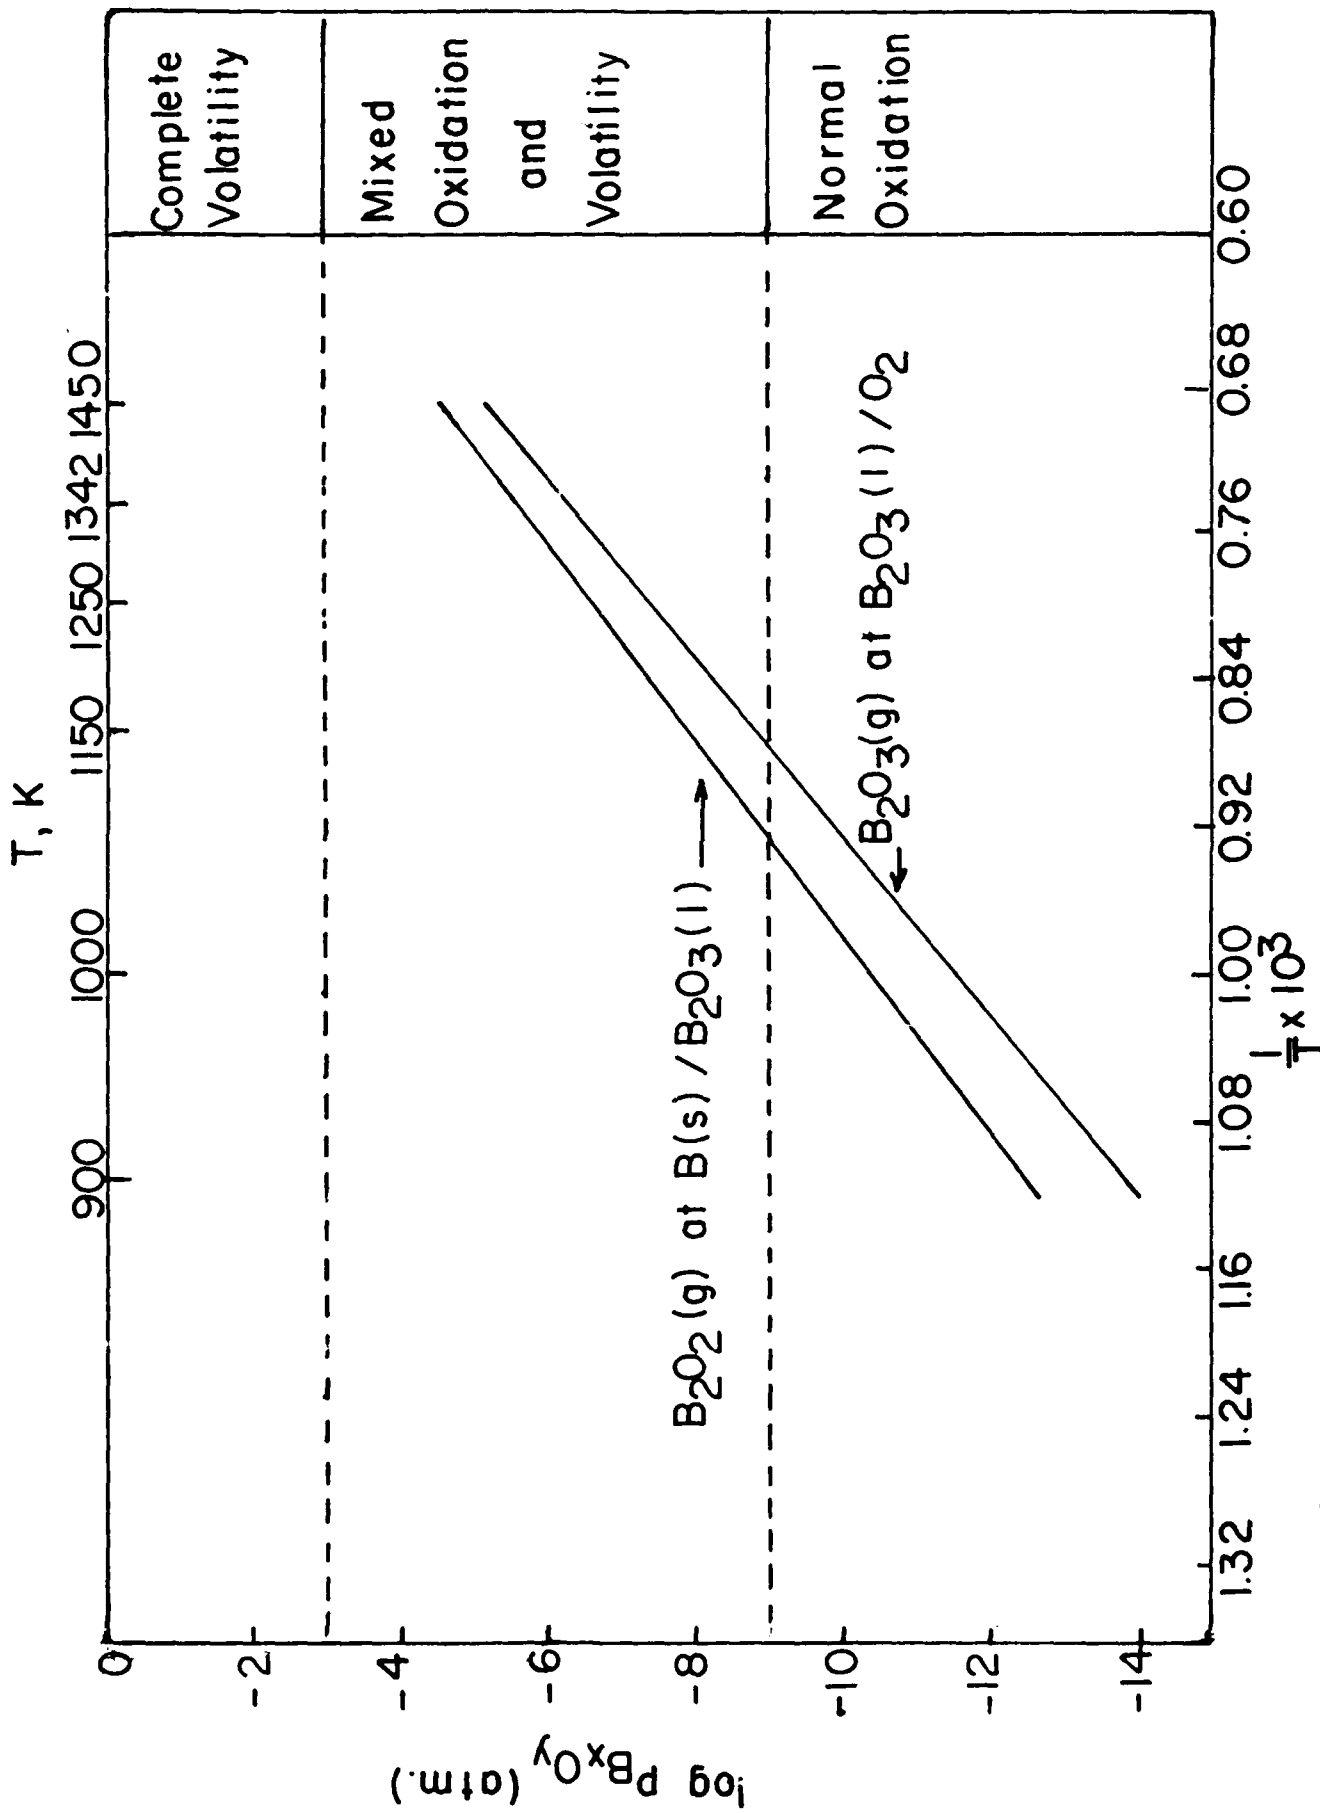
Fig.A4B-O System Volatile Species vs. Temperature

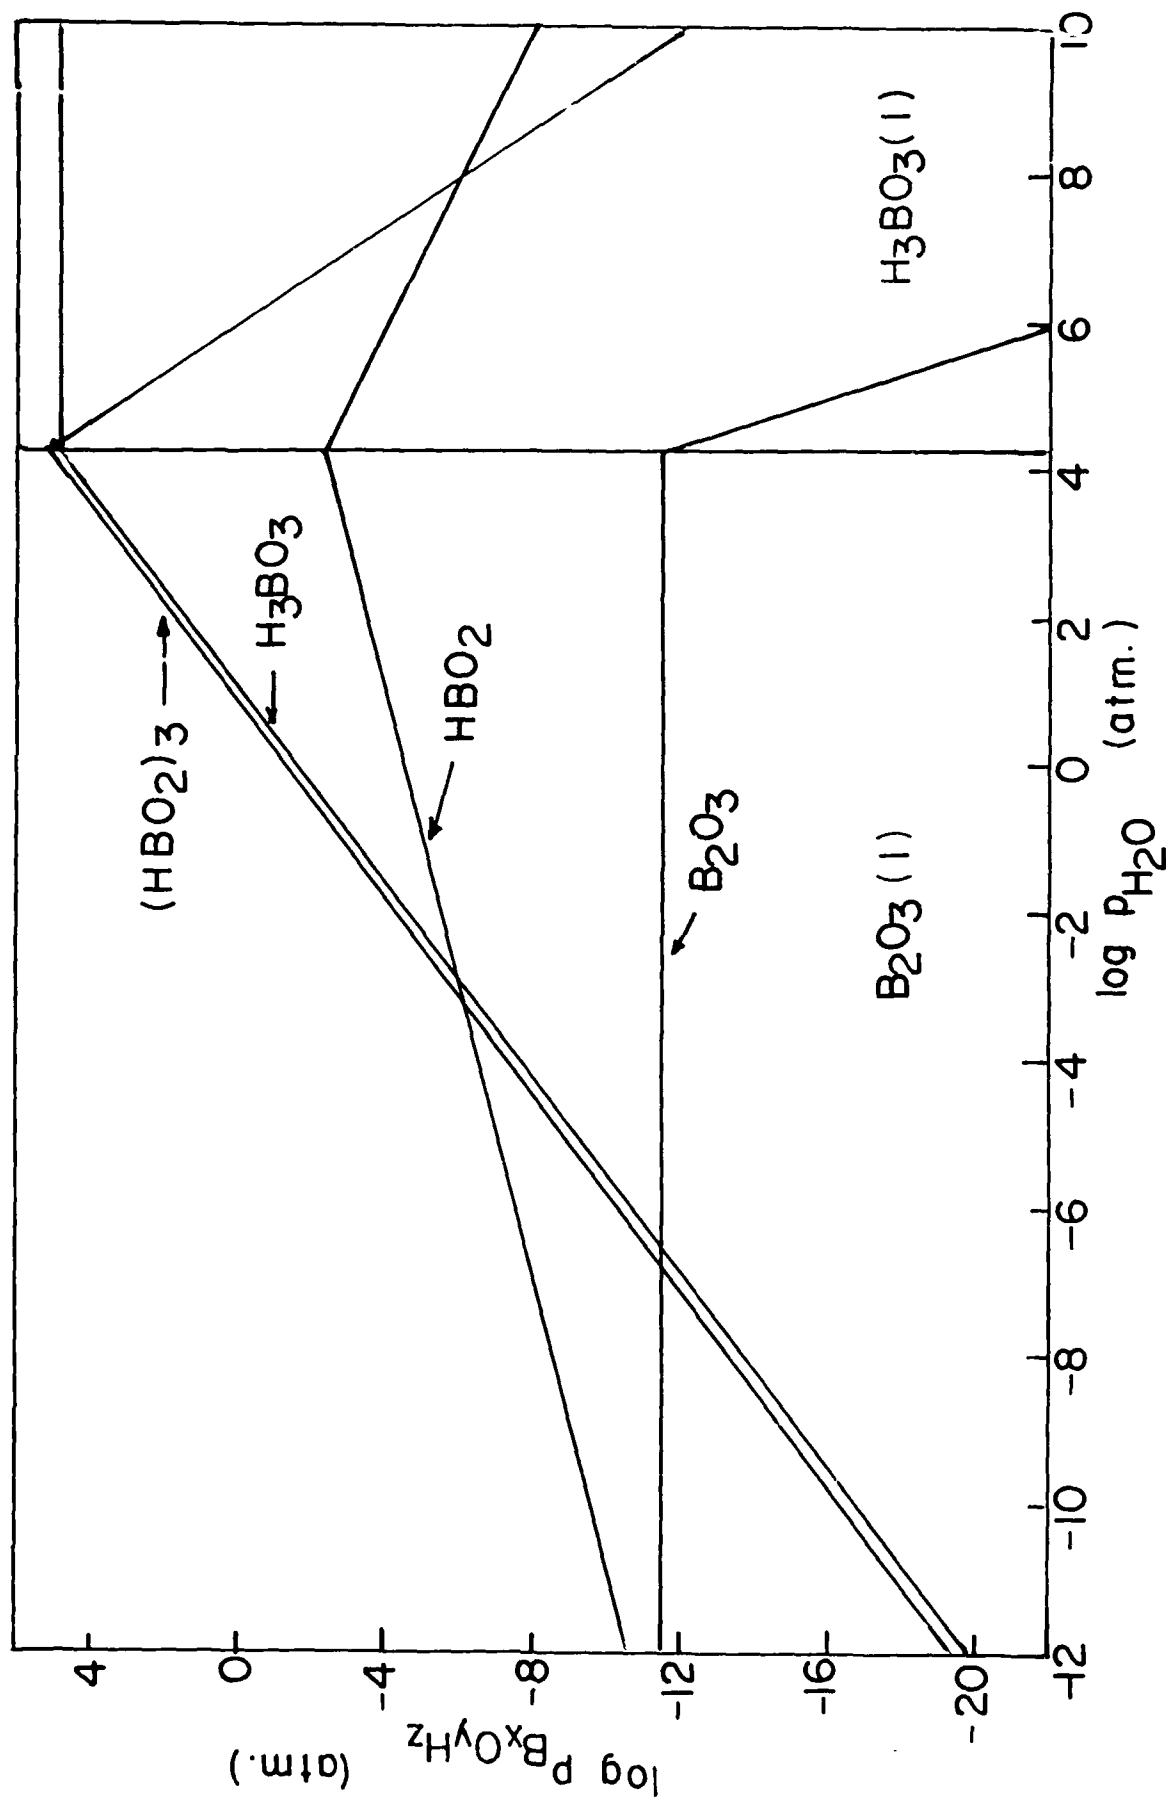
Fig.A-5 B-O-H System Volatile Species 1000 K

Table A-3 shows the reactions for the boron - water system. Figure A-5 shows a plot of $\log p_{B_xO_yH_z}$ vs $\log p_{H_2O}$ where p is in atmospheres. $B_2O_3(l)$ is the condensed phase at 1250K for $\log p_{H_2O} = 0$. Here $\log p_{(HBO_2)_3} = -1.3$, $\log p_{H_3BO_3} = -1.7$ and $\log p_{HBO_2} = -4.5$. $H_3BO_3(l)$ is only formed for $\log p_{H_2O} > 4.5$. The volatile species $(HBO_2)_3$ and H_3BO_3 are very important in the oxidation of B(s) in $H_2O(g)$ atmospheres.

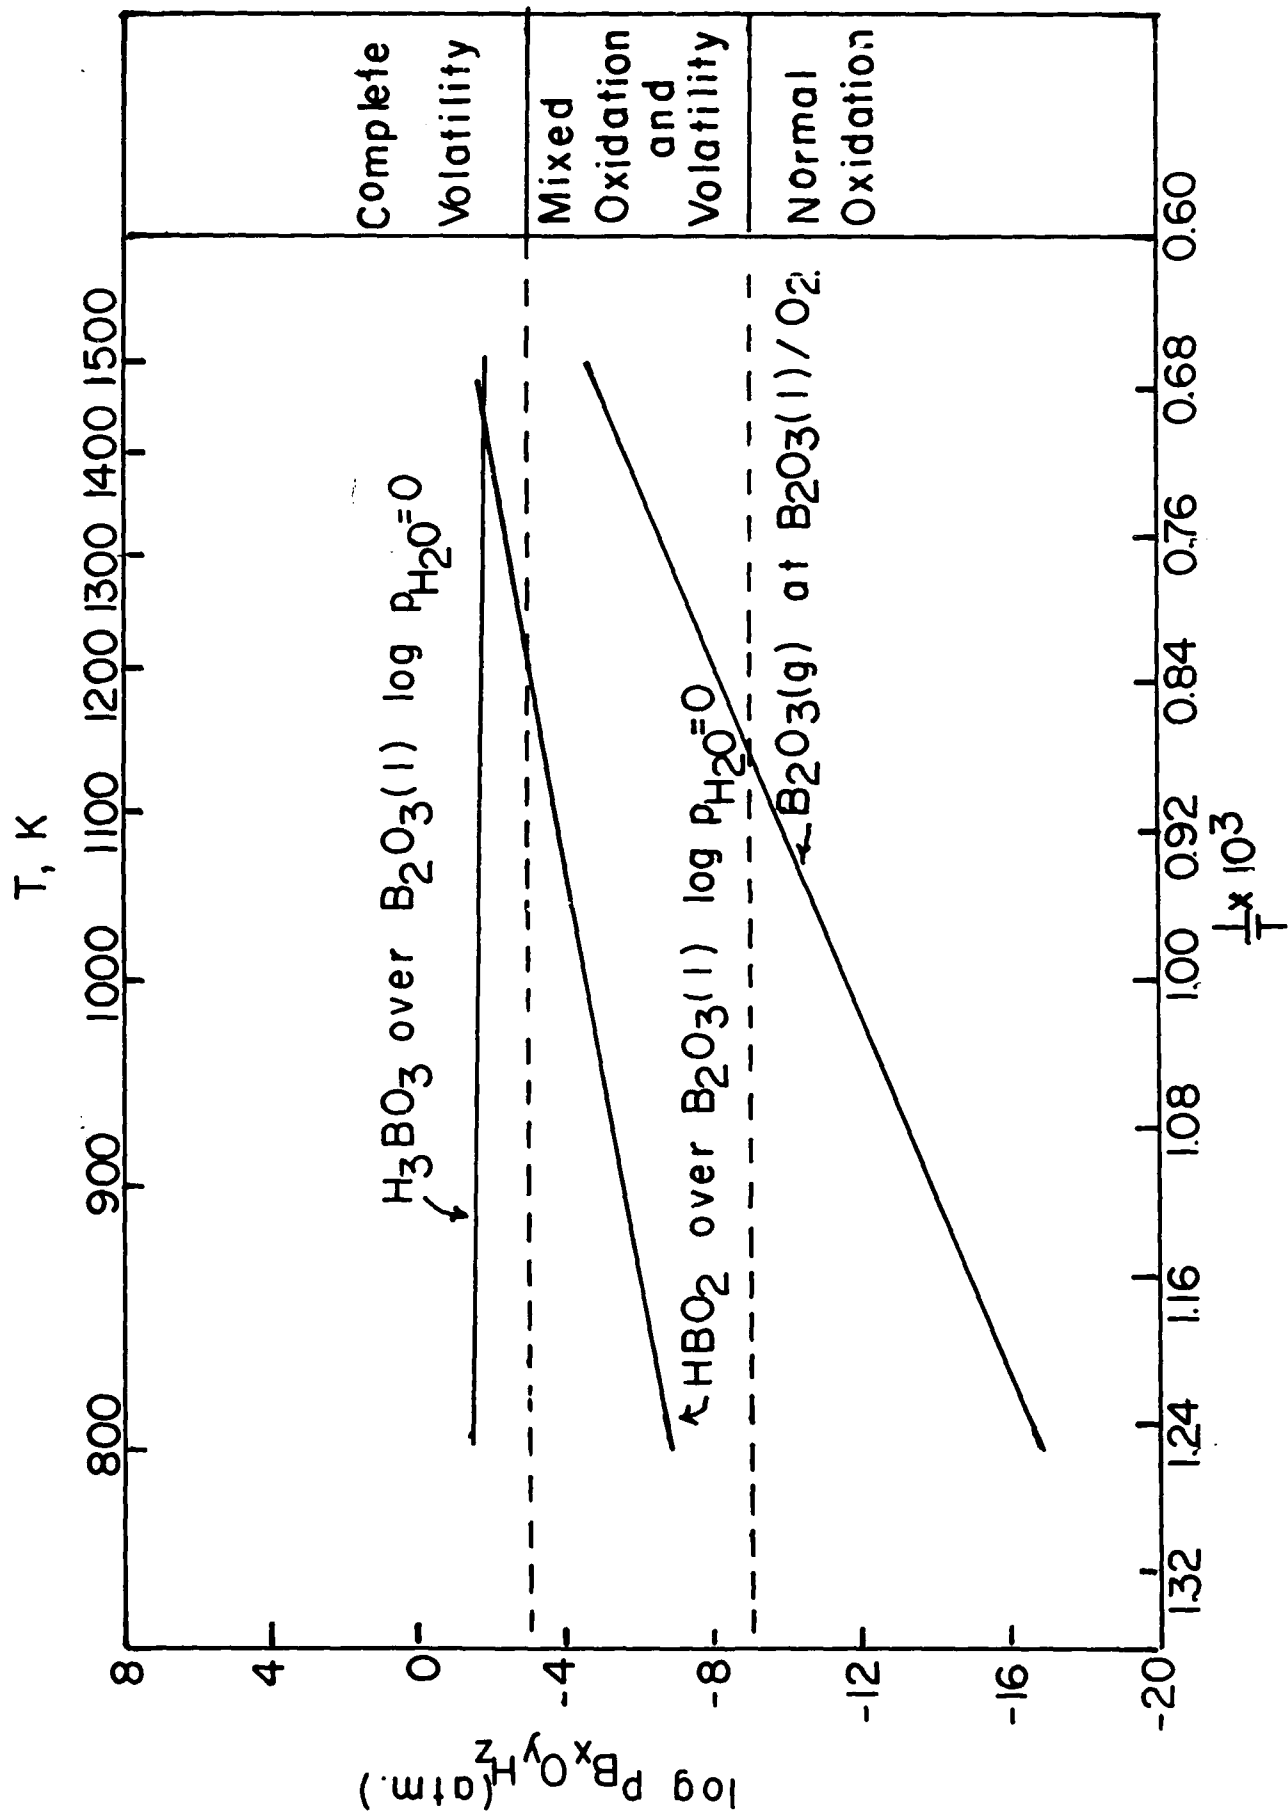
Fig. A6 B-O-H System Volatile Species vs. Temperature

Figure A-6 shows a $\log p_{B_xO_yH_z}$ vs. $1/T$ plot for the temperature range of 800 to 1500K. Since high pressures of the species $(HBO_2)_3(g)$ and $H_3BO_3(g)$ occur gas flow can greatly influence the kinetics of the water-boron reactions.
