Task Order 2 Enhanced Preliminary Assessment

FORT HOLABIRD
CRIME RECORDS CENTER
BALTIMORE, MARYLAND

USATHAMA Task Order 2
ENHANCED PRELIMINARY ASSESSMENT REPORT
FORT HOLABIRD
CRIME RECORDS CENTER
CITY OF BALTIMORE, MARYLAND
Contract No. DAAA15-88-D-0007

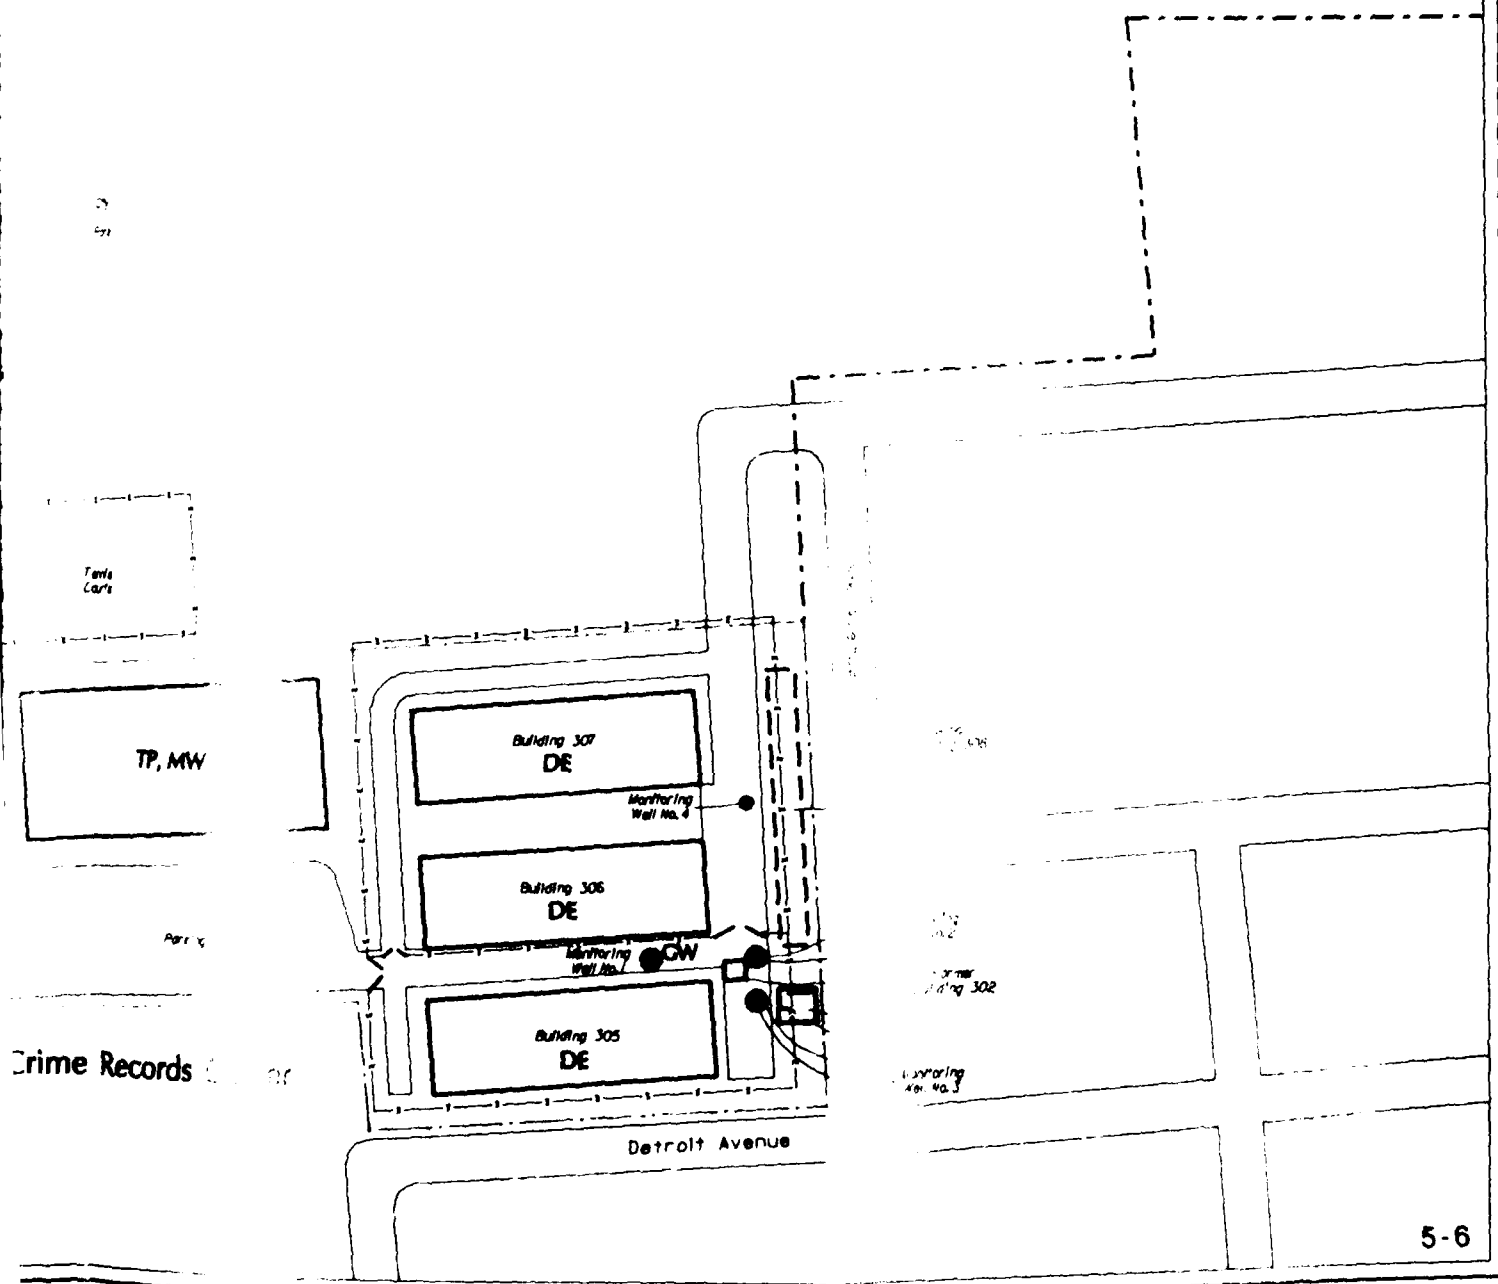
Table ES-1 outlines recommended actions for the ESOs located on the CRC property. Figure ES-1 shows proposed sampling locations. Recommendations are discussed in the following subsections.

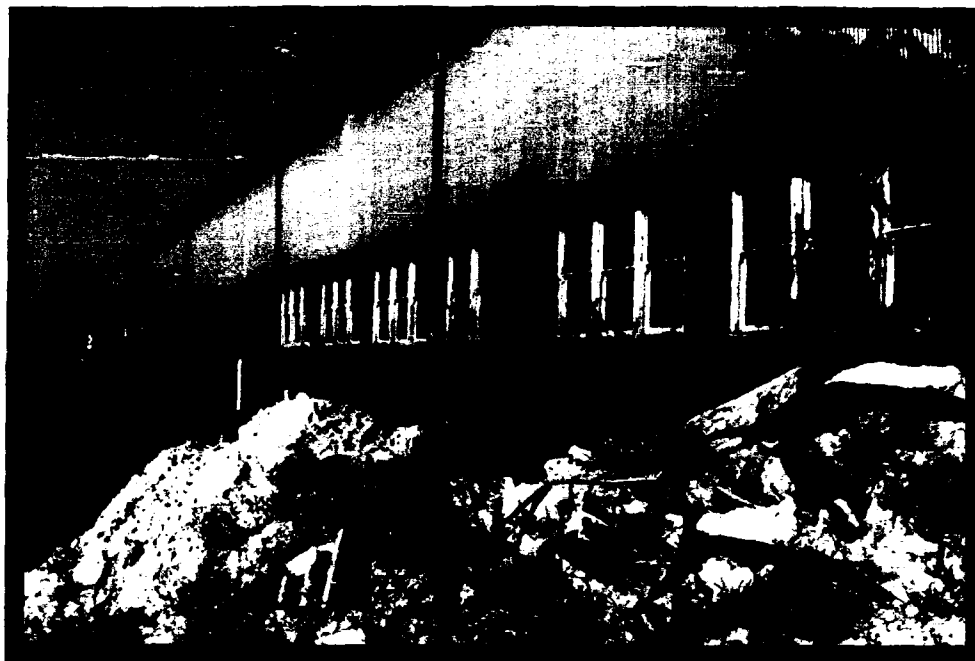
4. BUILDING 307

Building 307 became a Prisoner of War (POW) processing and records center after World War II, but was later converted to a bowling alley [T-5]. This building is now in poor condition and is not currently occupied. It has been gutted and usable non-structural components have been salvaged. Parts of the eastern and northern side walls also have been removed, exposing the interior to natural elements, and some vandalism has occurred. However, the structural conditions of a particular building is not within the scope or intent of this enhanced PA report. Therefore, the structural integrity of Building 307 is not an environmental concern.

Access to Buildings 306 and 307 should be immediately restricted. Signs warning of the possible presence of asbestos should be posted on the fenced area surrounding these buildings. In addition, the entrance to the boiler room should be locked and similar warning signs posted. Finally, entry to within the fenced area should be restricted to the warehouse activities in Building 306.
