TECHNICAL REPORT ARCCB-TR-90008

**BRITTLE TORSIONAL FATIGUE  
CRACK INITIATION IN AN  
OTHERWISE DUCTILE ENVIRONMENT**

**US ARMY ARMAMENT RESEARCH,  
DEVELOPMENT AND ENGINEERING CENTER  
CLOSE COMBAT ARMAMENTS CENTER  
BENÉT LABORATORIES  
WATERVLIET, N.Y. 12189-4050**

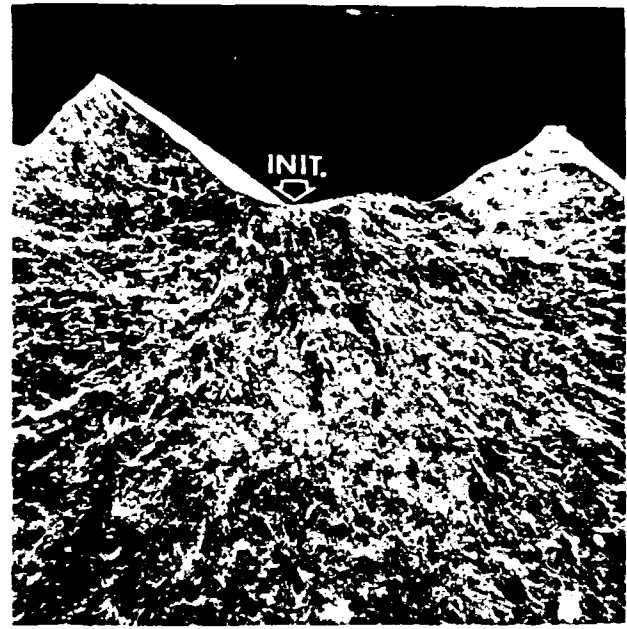
(b) Fatigue crack initiation site, magnification 100x.

(c) Fatigue crack initiation site, magnification 500x.

Figure 2a shows the entire 45-degree crack (area surrounded by ABC) at 10x. Figures 2b, 2c, and 2d show the single initiation site at progressively higher magnifications. Figure 2d at 10,000x shows what appears to be a defect at the initiation site. However, the defect could not be identified.
