SPECIAL REPORT 90-7

Surface Changes in Well Casing Pipe Exposed to High Concentrations of Organics in Aqueous Solution

Susan Taylor and Louise Parker

March 1990

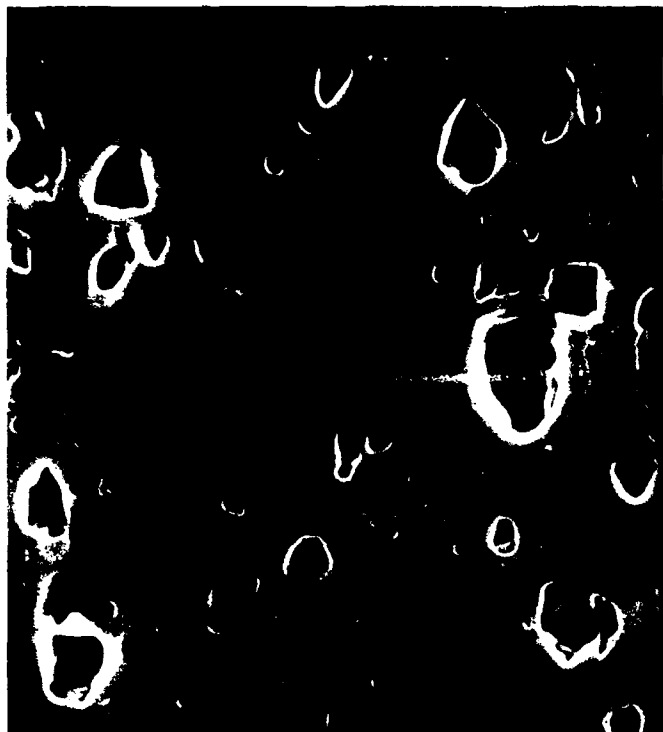
Figure 2. SEM micrograph of untreated PVC (2000x).

Examination of the untreated PVC casings with the SEM shows them to have smooth, slightly lined surfaces marred by an even distribution of irregularly shaped holes (Fig. 2). These holes are approximately 5 μ m along their longest dimension. The surface between the holes had dimples that appeared to have the same geometry as the larger holes. No change in surface structure was observed between the 1 week, 1 month, 6 month test samples (Fig. 3), the untreated samples (Fig. 2) and the control samples (Fig. 4). The bright particles in the holes and on the surface in Figure 4 are particulates that were present in the well water.

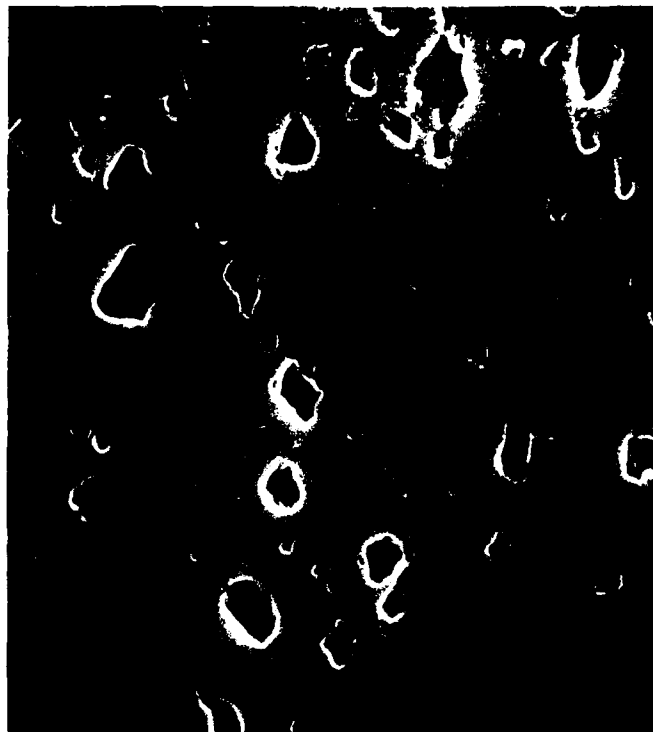
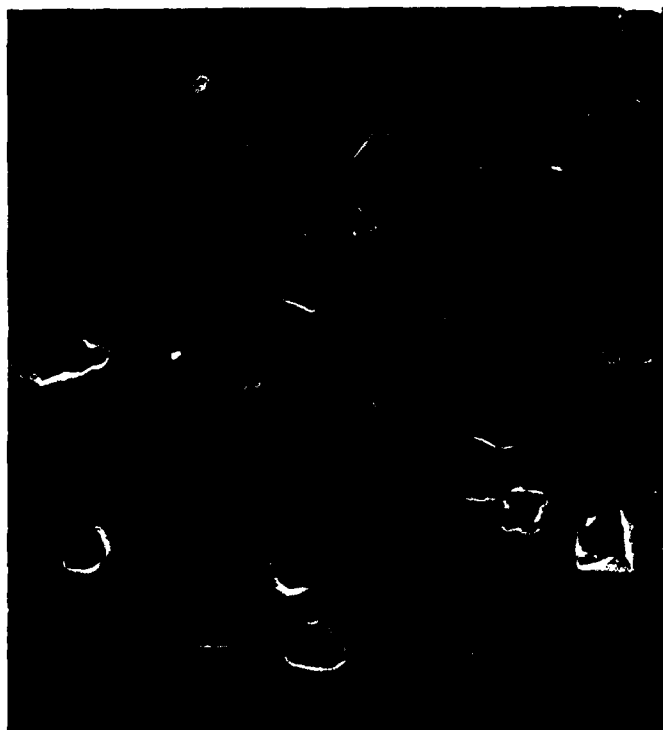
a. Soaked for 1 week.

Figure 3. Micrographs of PVC soaked in the test solution (2000x).

b. Soaked for 1 month.

c. Soaked for 6 months.

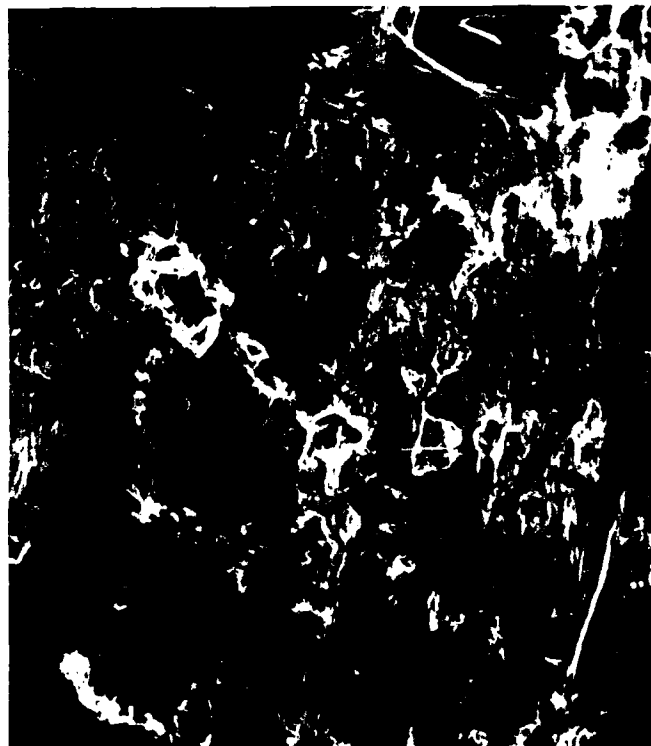
Figure 5. Micrograph of untreated PTFE (200 \times).

Untreated PTFE casings have smooth areas interrupted by patches of pulled-out fibrous strands paralleling the length of the tube (Fig. 5). The surface characteristics of the PTFE varied from sample to sample, with large changes in both the size and the number of fibrous patches. Test samples (Fig. 6) could not be distinguished from control samples (Fig. 7); however, the lack of regular features makes it difficult to identify any alterations which might have been caused by immersion in the test solution.

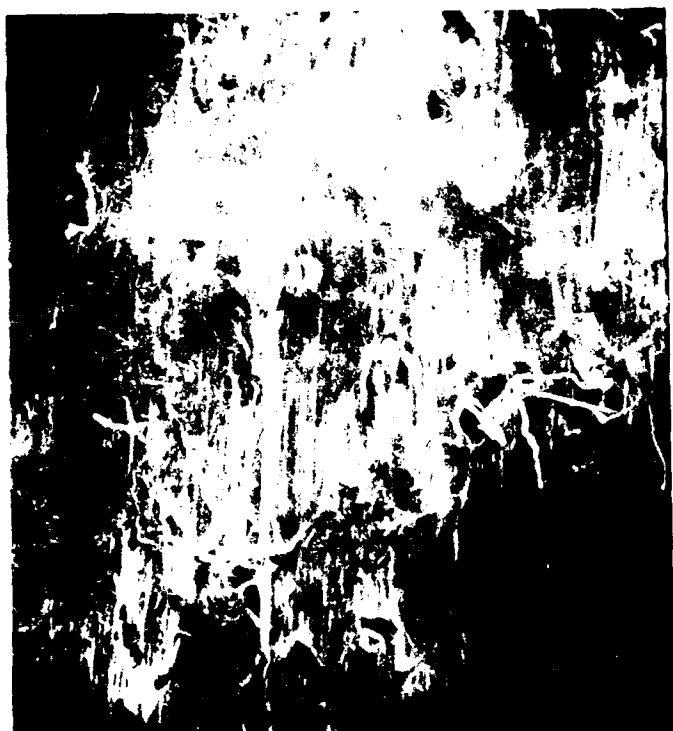
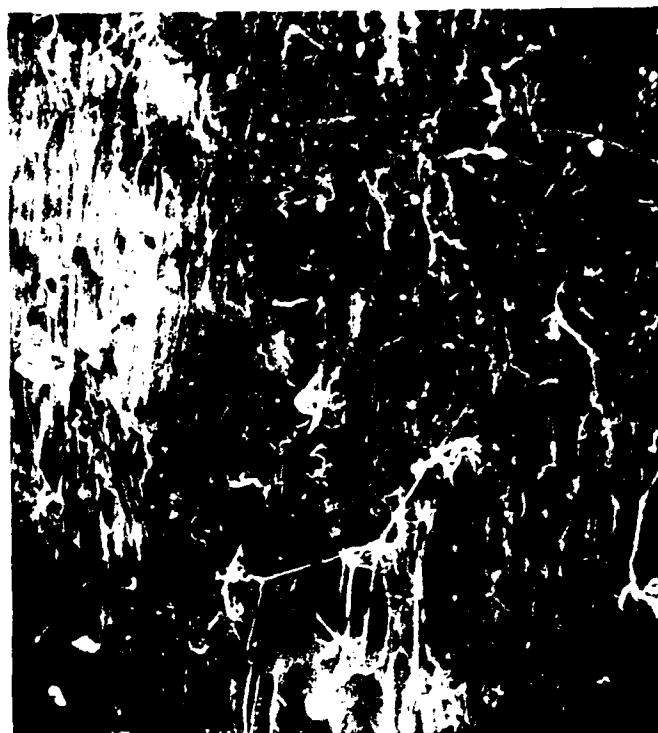
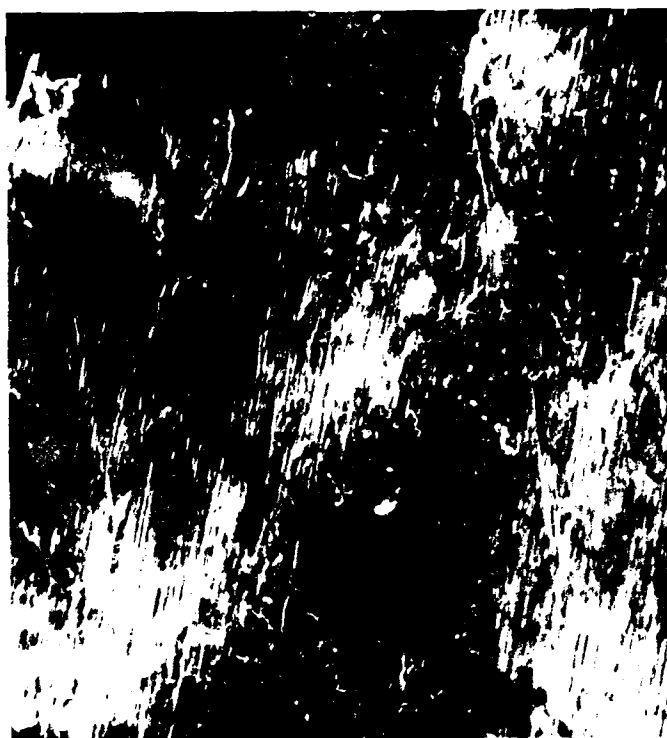
a. Soaked for 1 week.

b. Soaked for 1 month.

c. Soaked for 6 months.

Figure 6. Micrographs of PTFE soaked in the test solution (200 \times).

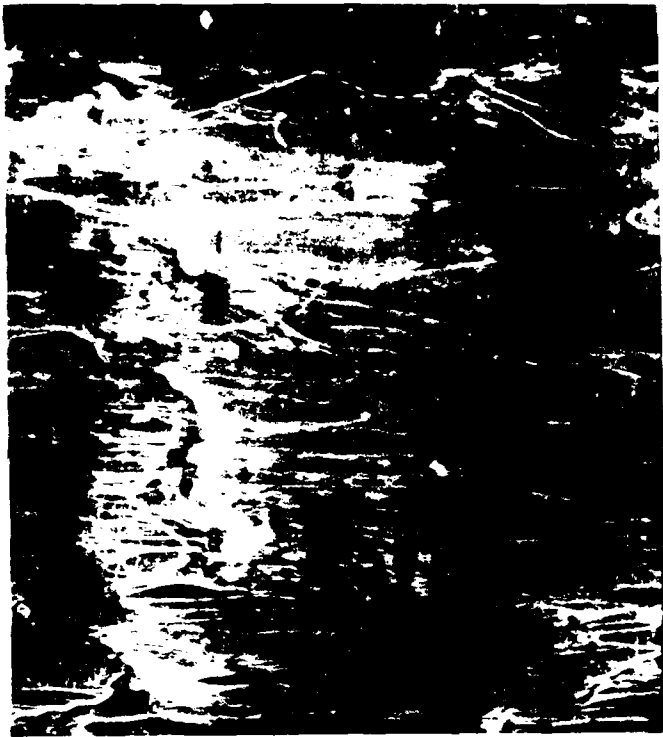
a. Soaked for 1 week.

b. Soaked for 1 month.

c. Soaked for 6 months.

Figure 7. Micrographs of PTFE soaked in well water (200 \times).

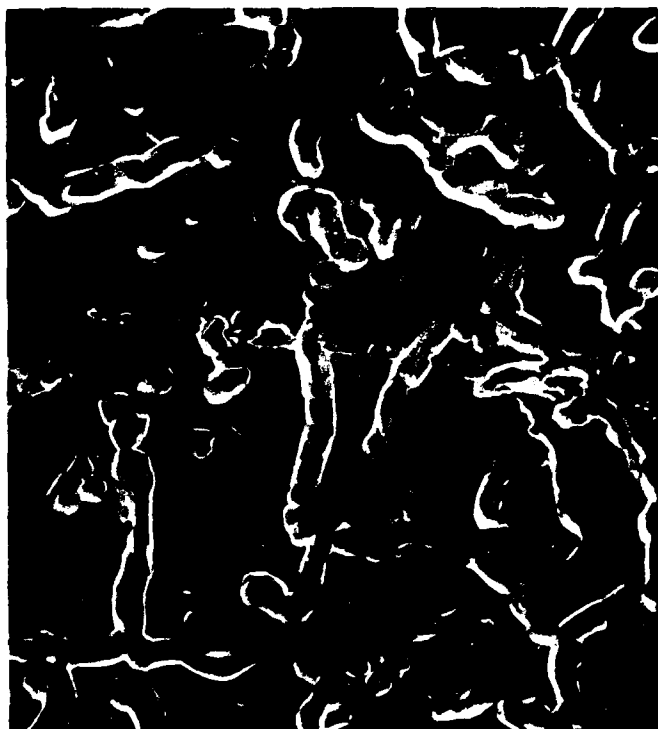
Figure 8. Micrograph of untreated SS316 (200x).

SS316 casings have a rough surface, with finger-like protrusions sticking out from the surface (Fig. 8). The surface area of these samples should be greater than that of the SS304, and Hewitt (1989) found that it rusted more rapidly than SS304. Magnifications higher than 200 \times showed no detail in the areas between the protrusions, so lower magnifications were used to characterize the surface. At a magnifications of 35 \times and 200 \times , no changes were seen between the 1 week, 1 month and 6 month test samples (Fig. 9) and the control samples (Fig. 10).

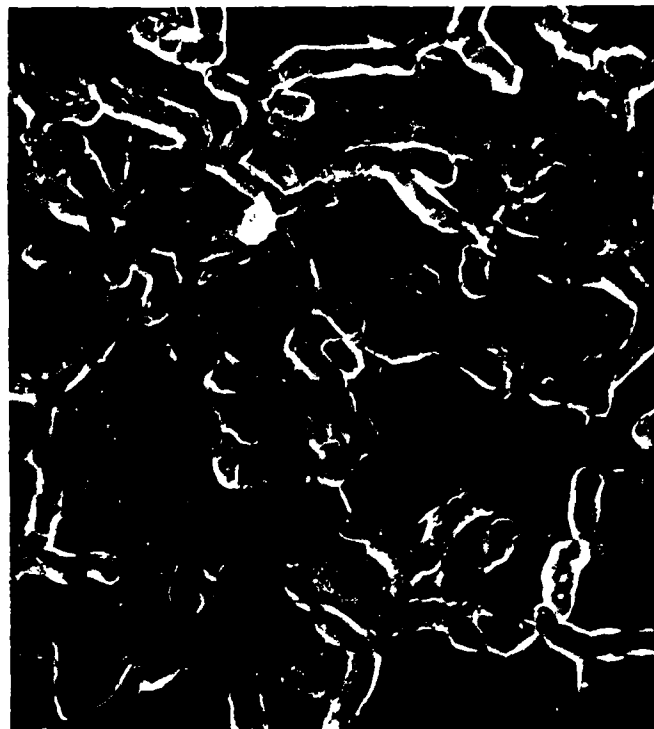
a. Soaked for 1 week.

Figure 9. Micrographs of SS316 soaked in the test solution (200x).

b. Soaked for 1 month.

c. Soaked for 6 months.

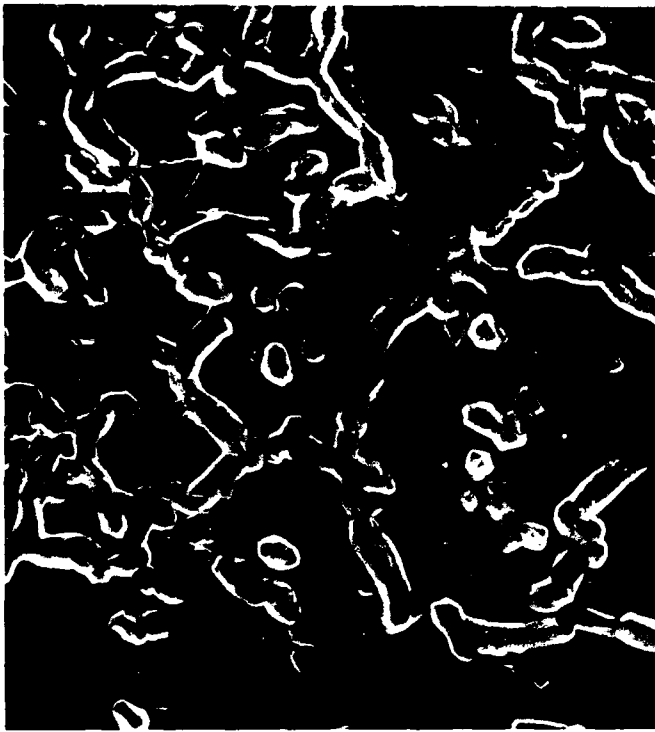
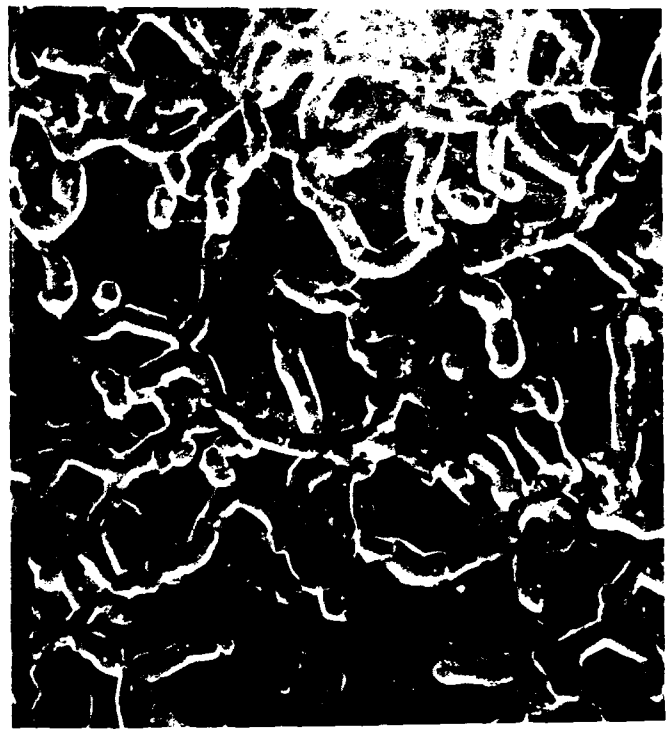
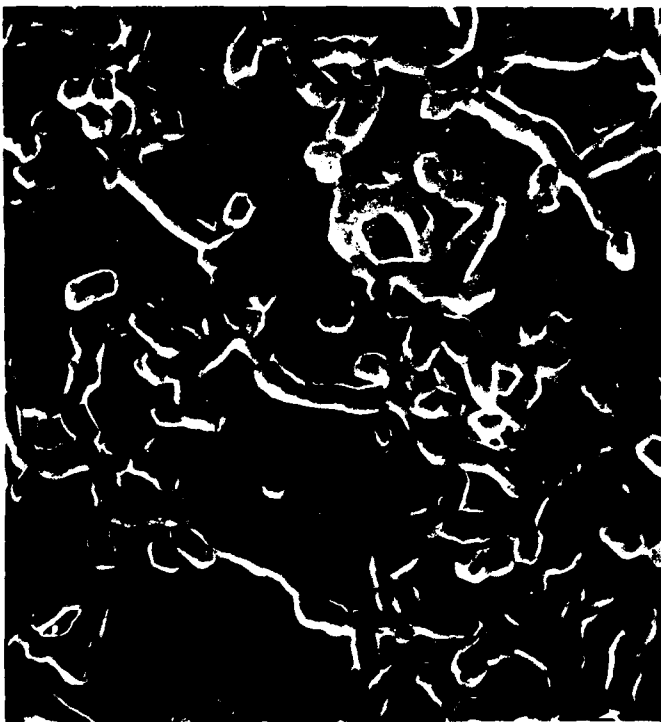
a. Soaked for 1 week.

b. Soaked for 1 month.

Figure 10. Micrographs of SS316 soaked in well water (200×).

c. Soaked for 6 months.
