WRDC-TR-90-4006

**An Evaluation of the Effects of "Hand" Sanding  
and Plastic Media Blasting (PMB) Paint Removal Methods  
on Graphite/Epoxy Composite Materials**

March 1990

Final Report for The Period October 1986 to October 1989

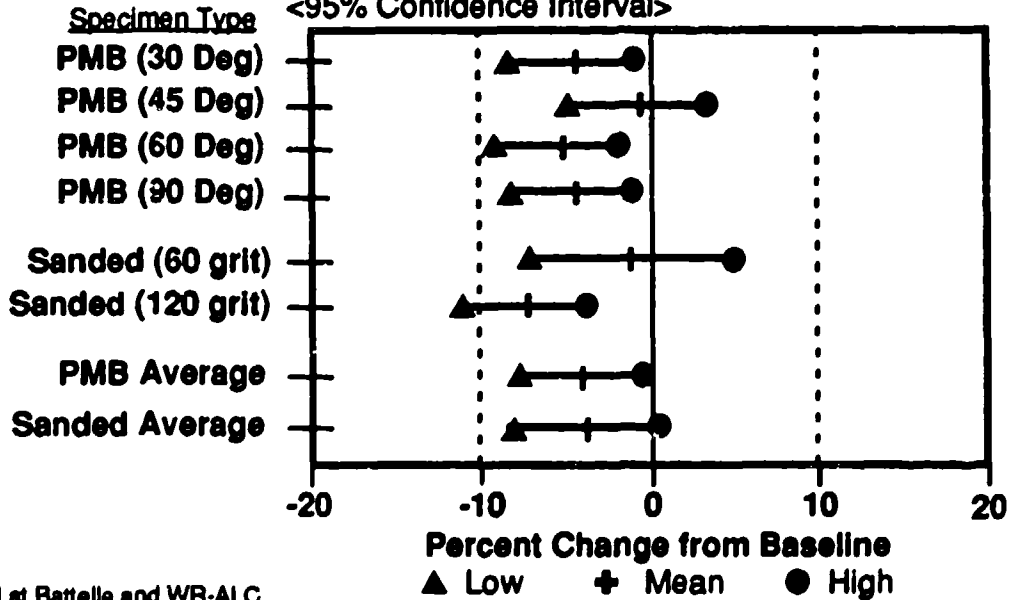
Figure 27.

PMB vs. "Hand" Sanding of Graphite/Epoxy

<95% Confidence Interval>

- Performed at Battelle and WR-ALC
- PMB Parameters: 60 psi, 30/40 Mesh, 3.0 mohs  
12 in. standoff, various angles

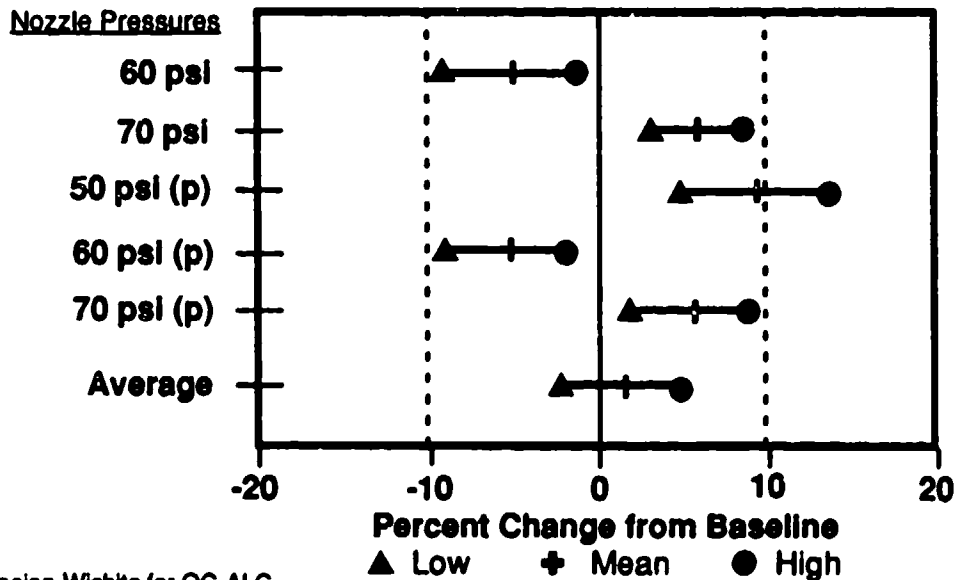
Figure 31.

PMB'd Quasi-Isotropic Graphite/Epoxy

<95% Confidence Interval>

- Performed at Boeing-Wichita for OC-ALC
- PMB Parameters: 30/40 Mesh, 3.0 mohs, 12-18 in. standoff, 70 degree angle
- (p) indicates primer used as a "flag"

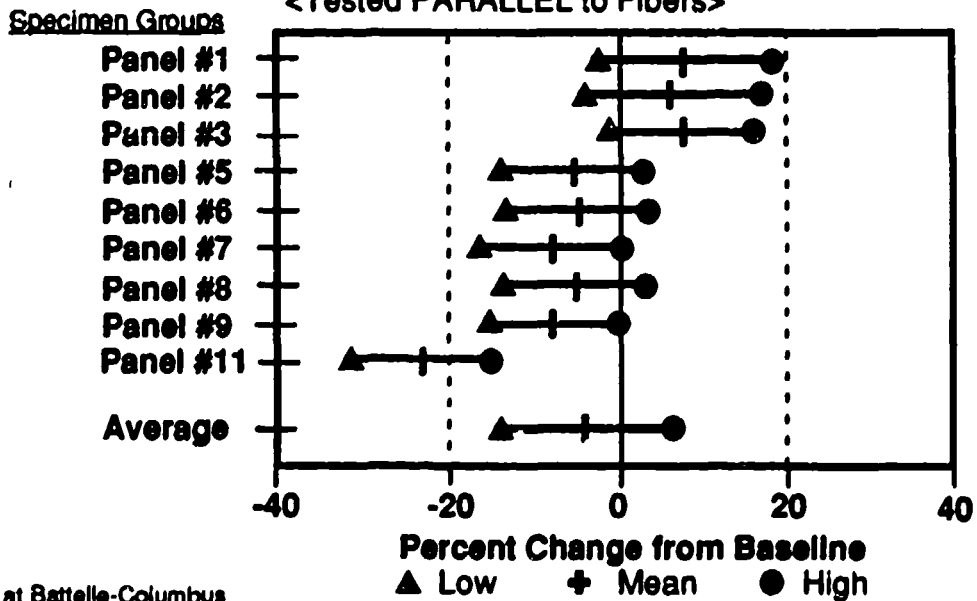
Figure 34.

# WRDC/MLSE Tensile Moduli Variation

PMB'd Unidirectional Graphite/Epoxy  
 <Tested PARALLEL to Fibers>

- Performed at Battelle-Columbus  
 - 95% Confidence Interval

On the average, no statistical variation was noted between the tensile modulus values of the stripped and baseline sections of the panels in the WRDC/MLSE program. However, the stripped section of Panel 7 experienced a 9.1% mean loss in parallel tensile modulus, the stripped section of Panel 9 exhibited an 11.3% mean loss, and the stripped section of Panel 11 exhibited an 23.9% mean loss.

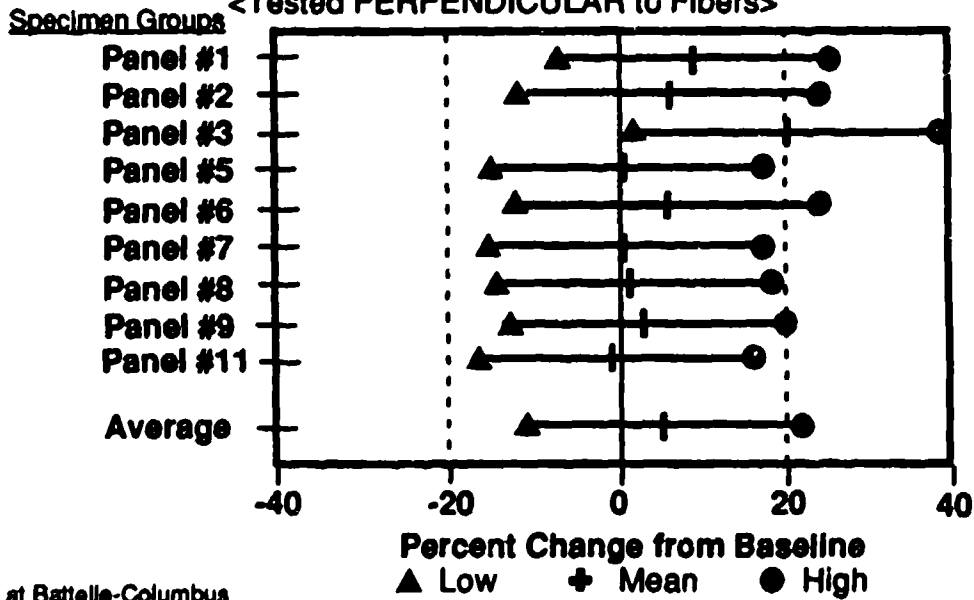
Figure 35.

PMB'd Unidirectional Graphite/Epoxy

<Tested PERPENDICULAR to Fibers>

- Performed at Battelle-Columbus  
 - 95% Confidence Interval

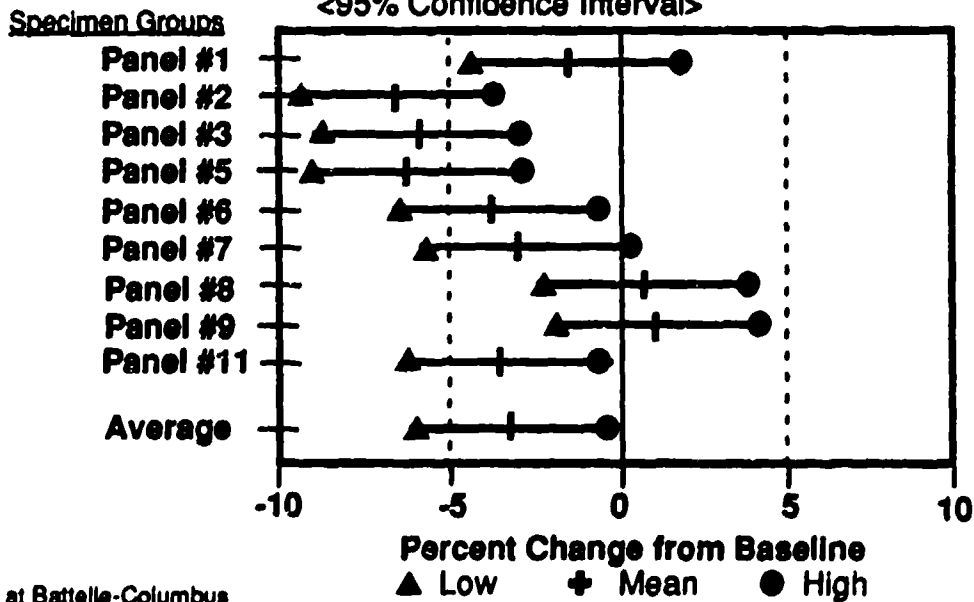
Figure 36.

PMB'd Unidirectional Graphite/Epoxy

<95% Confidence Interval>

- Performed at Battelle-Columbus

On the average, the ILS values for the stripped sections of the panels in the WRDC/MLSE Program showed a 2.9% statistical degradation when compared with the baseline ILS values. Degradations as high as 6.4% were noted.

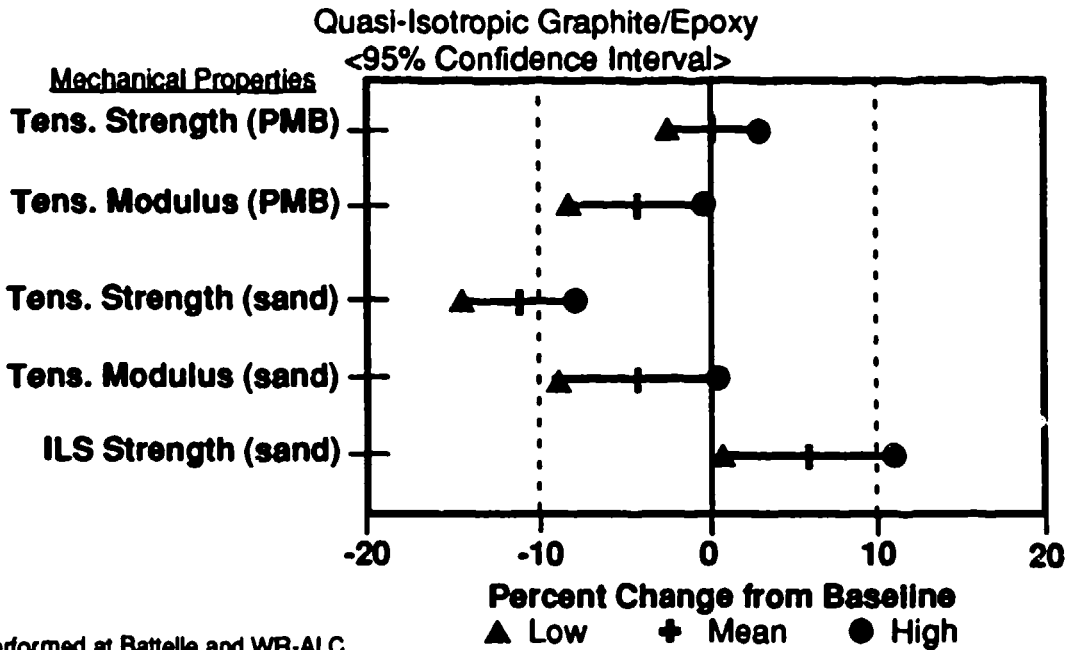
Figure 39.

## Variations Shown by WR-ALC Program

- Performed at Battelle and WR-ALC
- PMB Parameters: 60 psi, 30/40 Mesh, 3.0 mohs  
12 in. standoff, various angles

Summarizing variation analysis charts can be found in Figures 39-42.
