4. TITLE (and Subtitle) Surface and Interface Characterization for High-Temperature Adhesive Systems		5. TYPE OF REPORT & PERIOD COVERED Annual Report Sept. 1, 1985 - Aug. 31, 1986

MML TR 86-76c

SURFACE AND INTERFACE CHARACTERIZATION FOR HIGH-TEMPERATURE
ADHESIVE SYSTEMS

Annual Report

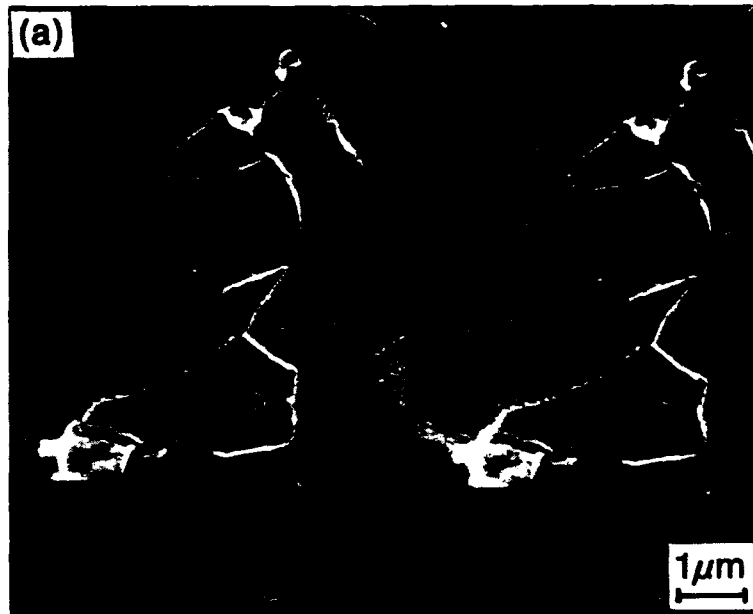
Vacuum Exposure 400°C 165 hr

Figure 3. CAA oxide at (a) low and (b) high magnification, after heating in vacuum maintained at 400°C for 165 hours.

Samples that were exposed to vacuum at 400°C for as long as 160 hr (Fig. 3) showed no change in morphology when examined by SEM, i.e., the porous, honeycomb morphology was retained. However, for a sample exposed to air at 320°C for 1200 hr, Fig. 4, although the honeycomb structure is still evident, the cell walls have thickened slightly. Additionally, some peeling of the oxide seems to have occurred at the grain boundaries.
