**DREDGING OPERATIONS TECHNICAL  
SUPPORT PROGRAM**

TECHNICAL REPORT D-90-13

**GUIDELINES FOR VEGETATIVE EROSION  
CONTROL ON WAVE-IMPACTED COASTAL  
DREDGED MATERIAL SITES**

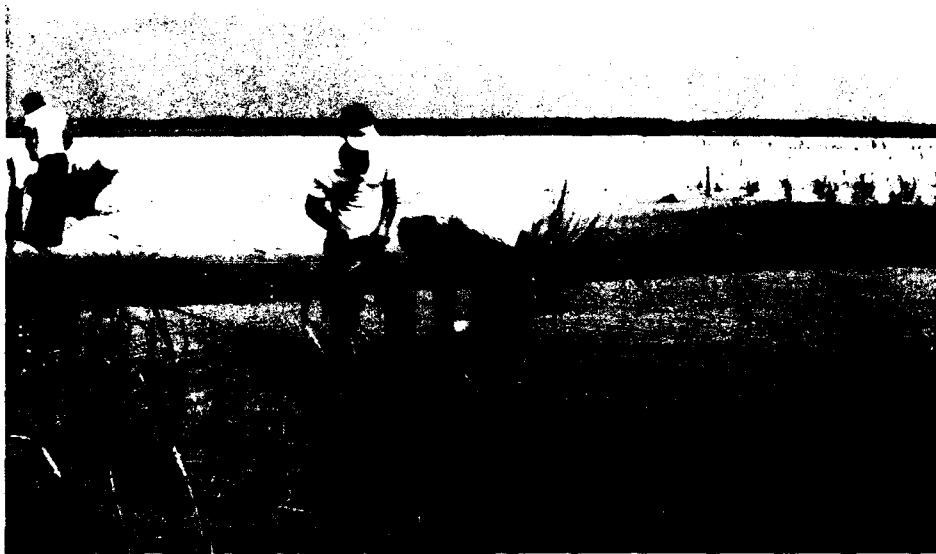
Figure 16. Hand-planting sprigs (photo courtesy of W. W. Woodhouse, Jr., E. D. Seneca, and S. W. Broome, North Carolina State University at Raleigh)

52. Hand planting can be very satisfactory if adequate attention is given to details, particularly planting depth and soil firming after planting; this is usually the most practical method for small-scale plantings. Opening of planting holes is readily done with dibbles, spades, and shovels in loose, sandy soils. Portable power-driven augers work well in the more difficult cohesive or compact soils. Normally, planting crews work in pairs, one worker opening holes and the other inserting the plant and closing the hole. A third worker is used if fertilizer is added in the planting hole; this worker drops in a measured amount of material just after the hole is opened and before the plant is inserted.

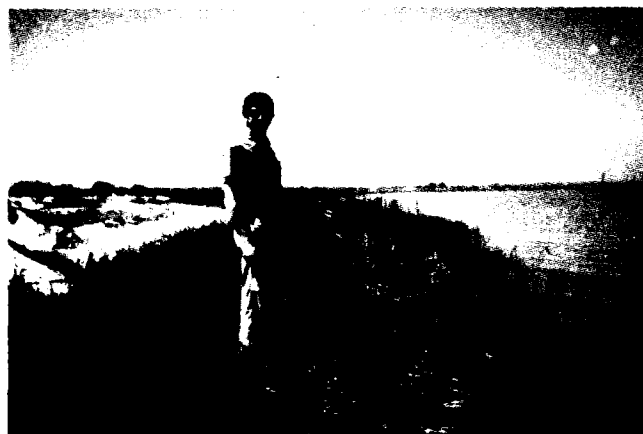
a. Photo taken 3 months after planting  
(note plant rolls seaward of single-  
stemmed plants)

b. Photo taken after 18 months after  
planting

Figure 20. Coffee Island marsh development site

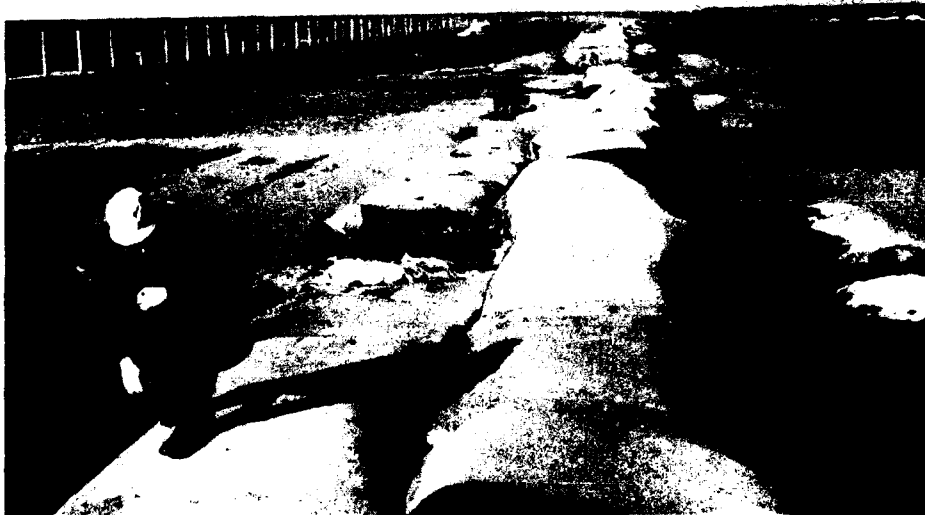
a. Empty cloth bags placed  
on filter cloth

b. Bags filled with a sand  
slurry in-place

Figure 23. Construction of sandbag breakwater (Continued)

c. Newly completed dike

d. Dike after exposure to the elements for  
2 years

74. Any container filled with sand, sand-cement, or concrete that is used as building block material for a breakwater will be considered a sandbag breakwater for purposes of this discussion. In construction projects, nylon fabric bags are typically used because of their durability. Sandbag breakwater life expectancy is 2 to 5 years, depending upon site accessibility to humans and subsequent vandalism, exposure to sunlight (ultraviolet rays degrade fabric), and energy forces exerted against the dike. Bags can be filled onsite with hydraulic pumps (sand/water slurry) until inflated and then sealed. Bag breakwaters must be underlain with filter cloth to prevent scour and resultant subsidence of the structure. While intact, sandbag breakwaters provide nearly total protection from wave attack. One consequence of this protection is that sediment deposition may initially be quite high in the protected area. To avoid burial of the new plantings, the planting operation should be delayed several weeks until a measure of stability has been achieved.

76. Before this project, no natural marsh existed on this side of Galveston Bay because of the high-energy conditions. The sandbag breakwater provided enough initial protection of the transplants to permit marsh establishment (Newling and Landin 1985, Landin 1986). Despite the eventual degradation of the breakwater structure, the marsh has continued.

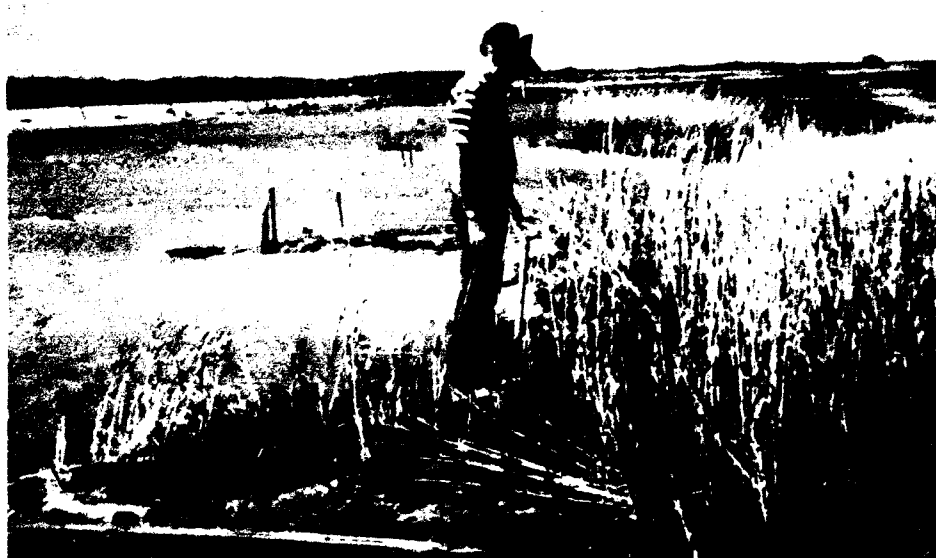
Figure B6. Erosion control mat plot in November 1985, about 1.5 years after planting
