US Army Corps
of Engineers

TECHNICAL REPORT REMR-CS-34

LABORATORY EVALUATION OF CONCRETE MIXTURES AND TECHNIQUES FOR UNDERWATER REPAIRS

November 1990

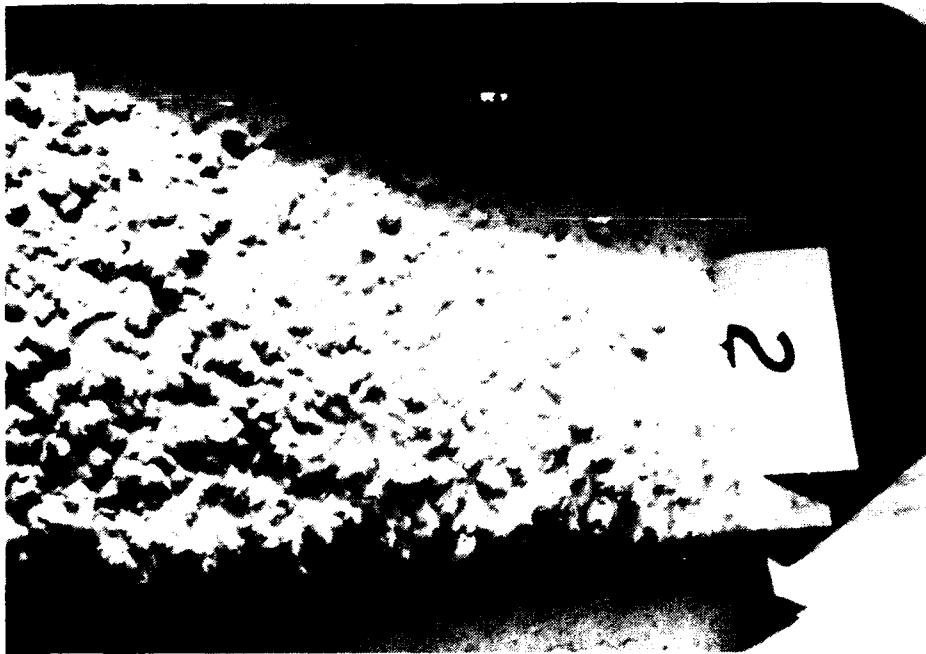
Figure 12. Concrete beam after hardening, trial 2

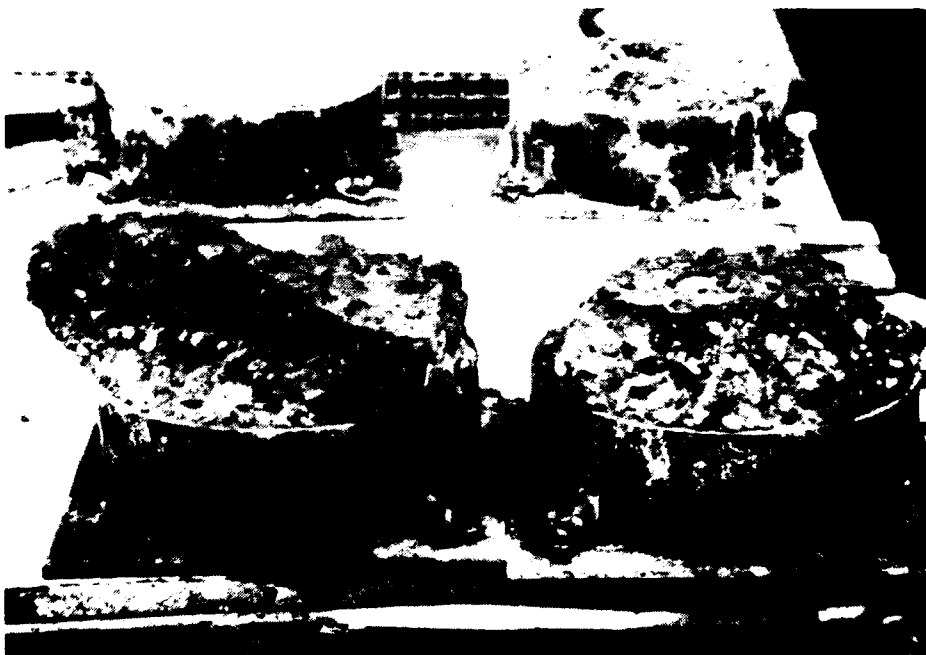
Figure 13. Hardened abrasion specimens, trial 2

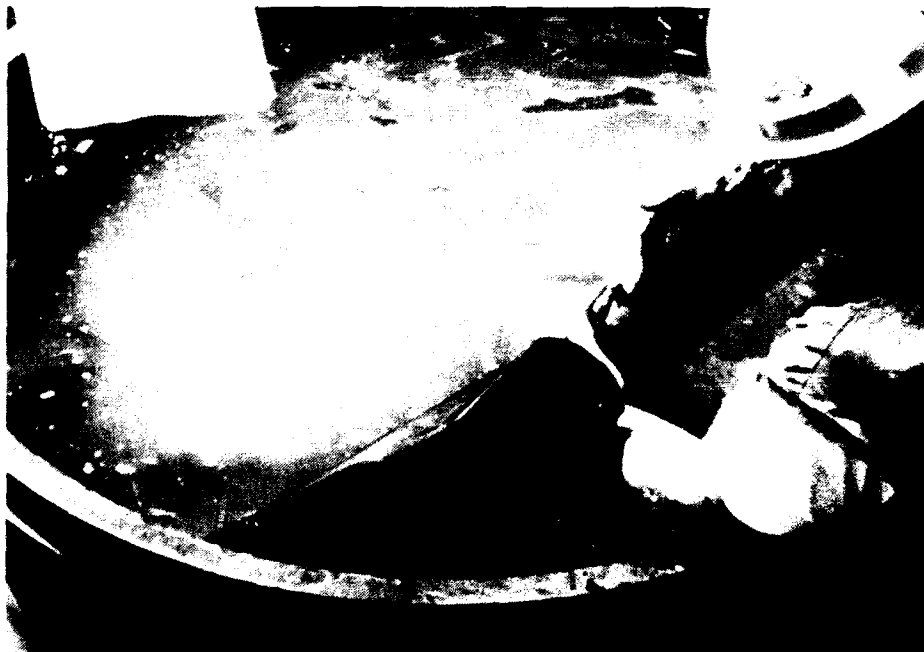
Figure 17. Concrete pumped into steel tank, trial 4
