MTL TR 90-57

# A PROPOSED STANDARD PRACTICE FOR FRACTOGRAPHIC ANALYSIS OF MONOLITHIC ADVANCED CERAMICS

GEORGE D. QUINN, JEFFREY J. SWAB, and MICHAEL J. SLAVIN  
CERAMICS RESEARCH BRANCH

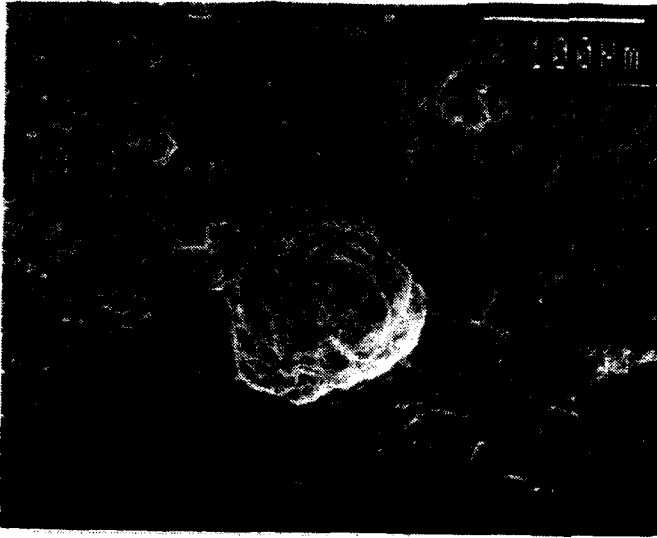
**FLAW:** PORE

**MATERIAL:** Sintered Yttria-Tetragonal Zirconia Polycrystal, as-machined.

**COMMENTS:**  $\sigma = 544$  MPa.

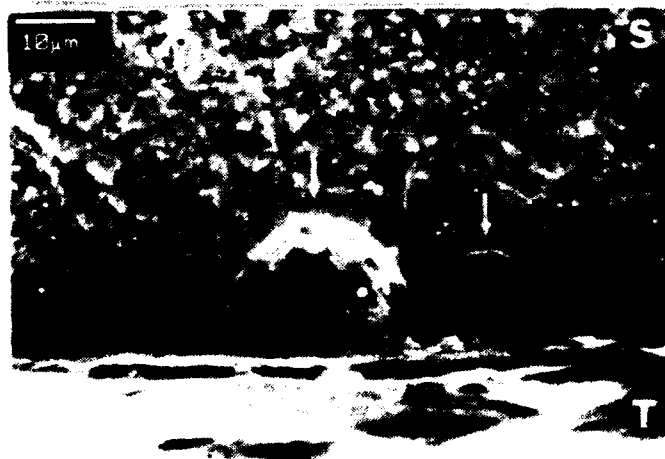
**FLAW:** PIT

**MATERIAL:** Hot pressed Silicon Nitride with Magnesia additions, as-machined.

**COMMENTS:**  $\sigma = 598$  MPa;  
 -Pits formed due to oxidation.
