NASA
Technical Memorandum 103688

Mechanical Behavior of Fiber Reinforced SiC/RBSN Ceramic Matrix Composites: Theory and Experiment

Prepared for the
36th International Gas Turbine and Aeroengine Congress and Exposition
sponsored by the American Society of Mechanical Engineers
Orlando, Florida, June 3-6, 1991

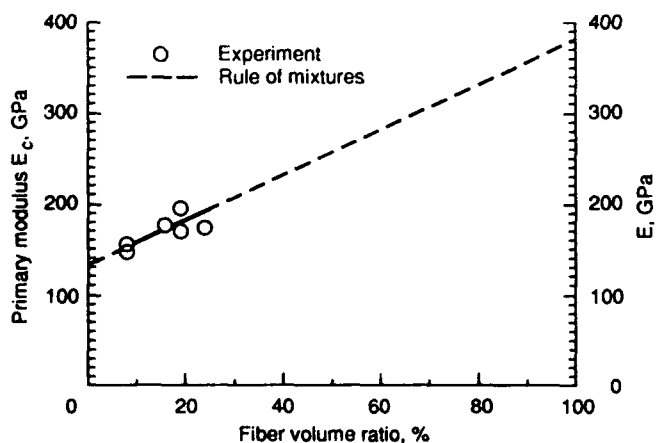
Figure 5.—Primary modulus of SiC/RBSN composite from experiment and the rule of mixtures.

SiC/RBSN composites with four different fiber volume ratios were tested. Results are shown in table I. The effect of fiber content on mechanical properties and failure behavior is evident from the listed data. The composite primary modulus, E_c , obtained from initial linear portions of the stress-strain curves, increased with increasing fiber volume ratio, f (fig. 5). These data points were best-fitted with a straight line which then was extrapolated to all f values, using the rule of mixtures, $E_c = fE_f + (1 - f)E_m$, where the fiber elastic modulus, E_f , and the average matrix elastic modulus, E_m , were estimated to be 381 and 133 GPa, respectively. This fiber modulus was about 2 percent less than the measured value of 390 GPa (DiCarlo and Williams, 1980) while the matrix modulus was 21 percent more than the average value of 110±10 GPa (Bhatt, 1988). The difference in the matrix modulus is rather high but it could be due to the matrix densities being higher in the low fiber fraction (1- and 3-ply) specimens than in the high fiber fraction (5- and 8-ply) specimens. In addition, in-situ properties do not necessarily agree with individual constituent measurements. The calculated composite primary moduli based on the rule of mixtures were in reasonable agreement with the experimental primary moduli as shown in table I.

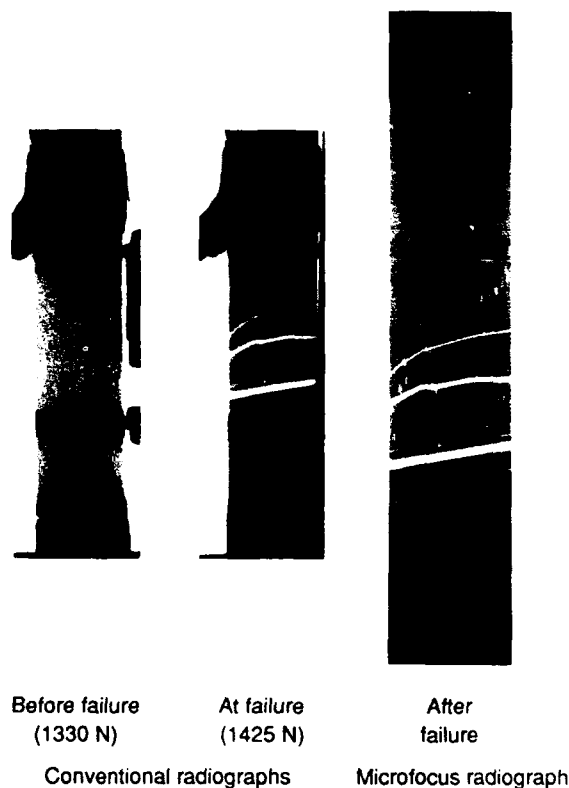
Figure 6.—X-radiographic results for specimen S1A.

Specimens S1A, S1B, and M3A were tested under tension and failed catastrophically. For S1A, x-radiographs taken at increasing loads up to 1330 N showed no evidence of any failure. Radiographs taken after ultimate failure (fig. 6) showed transverse matrix cracking, fiber fracture, and minimal fiber pull-out. Fiber fractures occurred throughout the gauge length, sometimes twice in the same fiber, due to the statistical behavior of fiber strength and the gauge length being greater than the effective fiber length. Fiber/matrix interface debonding (splitting) and transverse matrix cracking can be observed in the optical photomicrographs (fig. 7). It should be noted that these transverse matrix cracks were not through-the-thickness cracks. It is also evident from the listed loads in figure 6 that the fiber pull-out mechanism occurred only at the very end of the rupture process. As expected, when the fiber content is small, even though the interface is weak, fiber pull-out can not guarantee graceful failure.

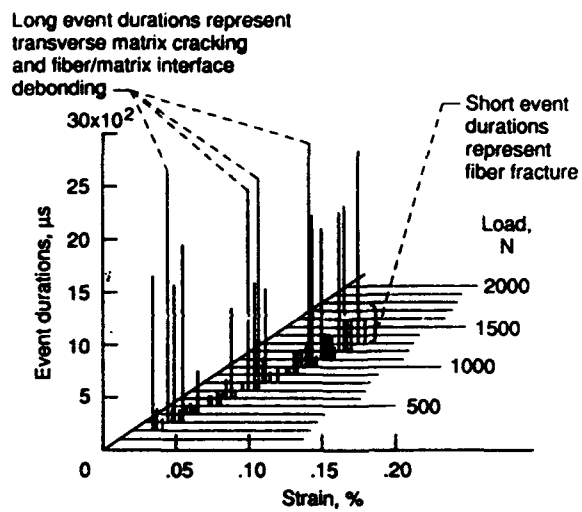
Figure 8.—Three-dimensional plot of event durations, load and strain for specimen S1A.

The linear stress-strain curve for these specimens and x-ray results taken alone gave no indication of any failure events before the proportional limit or, in this case, the ultimate strength. By contrast, AE results clearly indicated the occurrence of fiber breakage, transverse matrix cracking and fiber/matrix interface debonding throughout the loading history as shown in figure 8. These major failure mechanisms were identified via three AE parameters: event duration, peak amplitude, and energy (Chulya et al., 1990). The energy parameter was used to separate microscopic events from macroscopic events. A transverse matrix crack was defined as an event with long duration ($>400 \mu\text{S}$) and medium peak amplitude (51 to 70 dB) while a fiber fracture event was characterized as short duration ($<400 \mu\text{S}$) and high peak amplitude ($>70 \text{ dB}$). For an interfacial debonding event, high peak amplitude ($>70 \text{ dB}$) and long event duration ($>400 \mu\text{S}$) were detected.

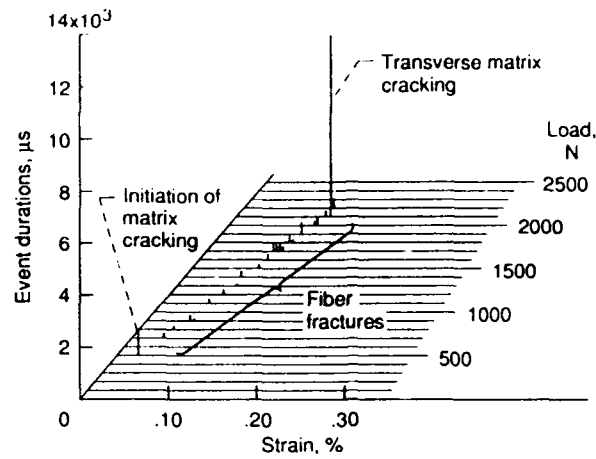
Figure 9.—Three-dimensional plot of event durations, load and strain for specimen S1B.

For specimen S1B, which had a strong fiber/matrix interface, the failure mode was also catastrophic but with only one single transverse through-the-thickness matrix crack. X-radiography showed no sign of fiber breakage scattered throughout the gauge length. Photomicrography showed no evidence of fiber/matrix interface debonding. Transverse matrix cracking and fiber fracture were the only major failure mechanisms observed. These results were confirmed by the AE analysis. As shown in figure 9 by means of a three-dimensional AE plot, a small single matrix crack occurred first followed by a series of fiber breaks near the crack location until the load reached 2100 N. At this load the small matrix crack propagated all the way through the specimen and catastrophic fiber fractures followed.

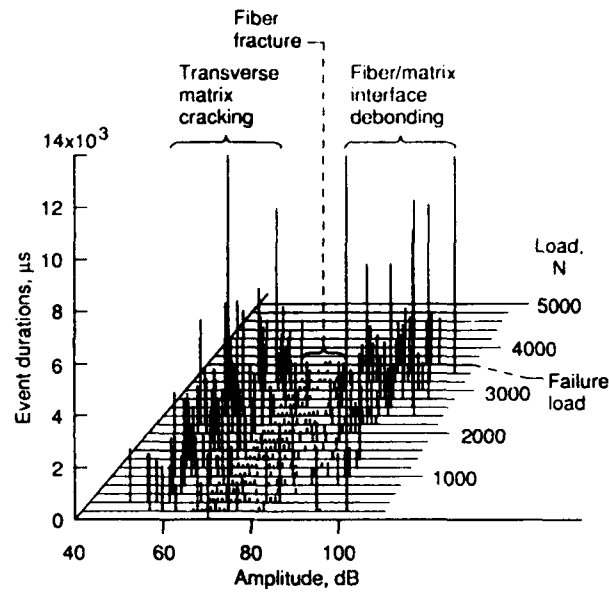
Figure 10.—Three-dimensional plot of event durations, amplitude, and load for specimen M3A.

The 3-ply SiC/RBSN specimen (M3A) with weak interfaces and 16 percent fiber content also failed catastrophically in tension. Optical photomicrography showed multiple transverse matrix cracks (not through-the-thickness but initiating from both sides of the specimen) and multiple fiber/matrix interface debonding. X-radiographic results again showed fiber fracture scattered throughout the gauge length. The plot of AE event duration and amplitude versus the applied load shown in figure 10 shows that transverse matrix cracking and fiber fracture occurred early in the loading stage and continued throughout the loading history while fiber/matrix interface debonding occurred only after approximately two-thirds of the failure load. The stress-strain curve is linear and does not have the ability or resolution to reflect these failure events. Apparently, the 16-percent fiber content improved the ultimate strength, but still could not prevent catastrophic failure.

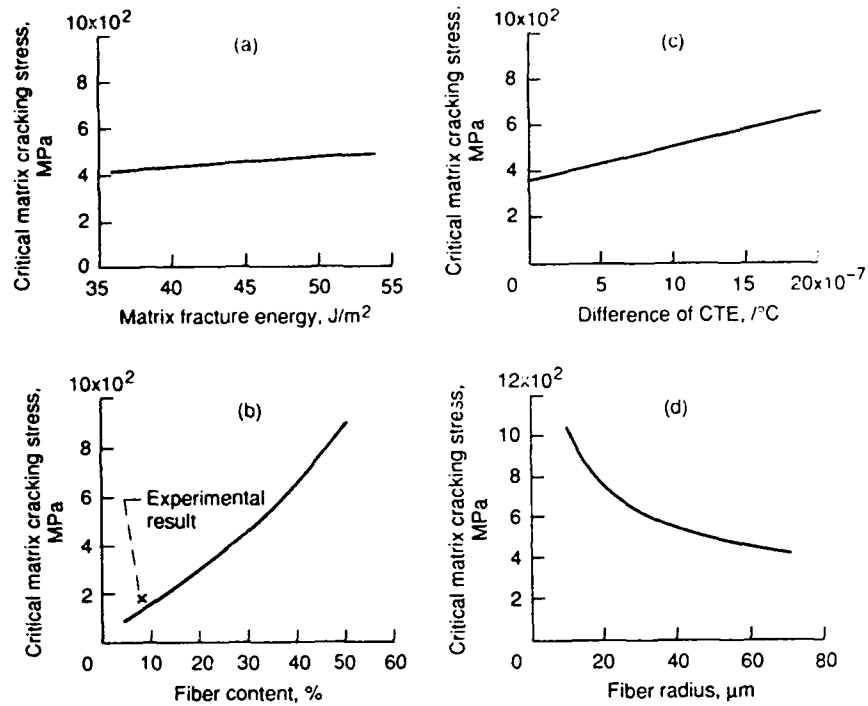
Figure 17.—Parametric studies of critical matrix cracking stress for the perfectly bonded case.

The effects on σ_{cr} of G_m , f , R and the difference in α_f and α_m are presented in figure 17. For a selected fiber content of 28 percent and Poisson's ratio of 0.22, the critical matrix cracking stress varies little with G_m . If the difference in CTE increased for $\alpha_f > \alpha_m$, the critical matrix cracking stress would rise significantly. In figure 17(d), it is clear that σ_{cr} is maximum for small fiber diameters. As anticipated, the model predicts that increasing the fiber content would also enhance σ_{cr} . Since it was impossible to accurately measure the critical matrix cracking stress experimentally, the ultimate strength of specimen S1B was used to compare the prediction of the model at 8-percent fiber content. The measured experimental value was slightly higher than the expected strength from theory

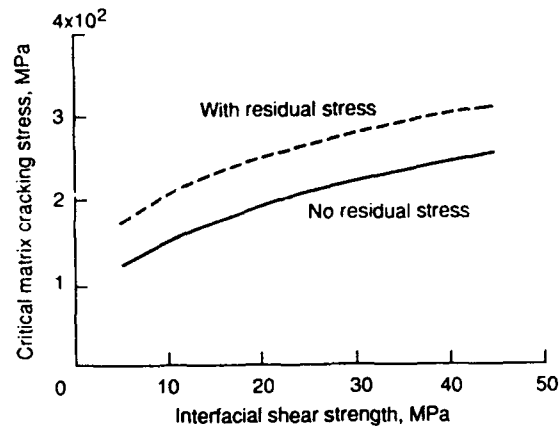
Figure 18.—Variation of critical matrix cracking stress with interfacial shear strength for multiple matrix cracking (slipping fibers) case.

Parametric calculations using equation (14) were made for the SiC/RBSN composite with 28-percent fiber content, interfacial frictional strength, τ , of 10 MPa, and μ equal to 0.1. The results are plotted in figure 18 showing the effects of residual stresses and interfacial shear strength. With the strain mismatch producing an initial matrix compressive stress, the composite critical matrix cracking strength is obviously improved. Clearly, the residual stresses can not be neglected even though they may decrease significantly as the operating temperature increases. Equation (13) is valid only up to a certain value of τ that assures multiple transverse matrix cracking, and the maximum τ used herein for this failure mode was 45 MPa. This value is based on the maximum value of τ that can be successfully measured from the push-out test in our laboratory. In figure 19(a), the critical matrix cracking strength is plotted as a function of fiber radius using equations (2), (3), (13) and (14). As mentioned before, small radius fibers will enhance the microcrack yield strength of unidirectional CMC's. However, improving matrix fracture toughness will not have a significant effect on the matrix cracking strength (fig. 19(b)). Figure 19(c) shows an almost linear relation between σ_{cr} and the fiber content. Figure 19(d) shows that higher strain mismatch improves the critical matrix cracking strength, at least when loaded in the fiber direction. The tradeoff is that as the strain mismatch increases, the radial residual stress would cause higher tension in the interface. This would weaken the interfacial shear strength,

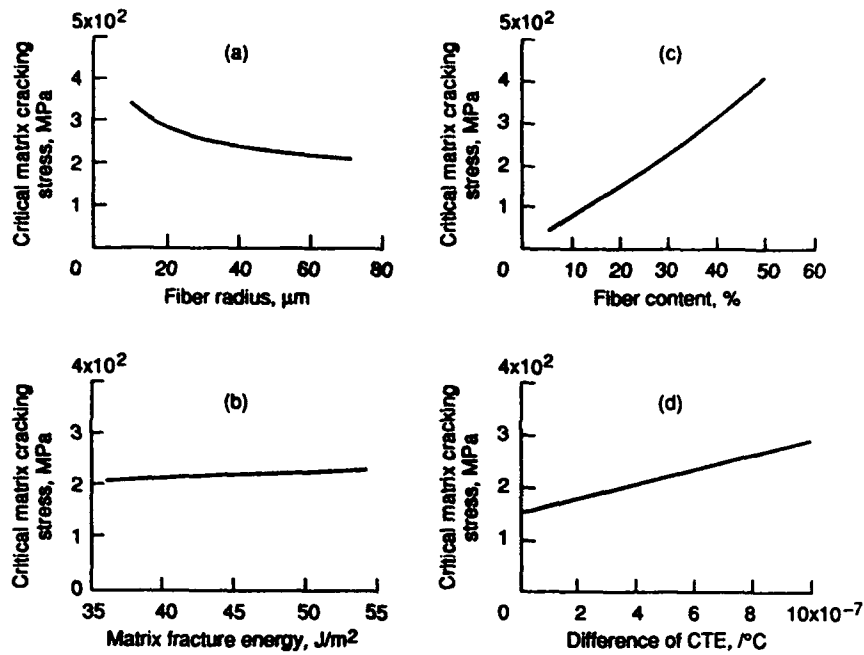
Figure 19.—Parametric studies of critical matrix cracking stress for multiple matrix cracking (slipping fibers) case.

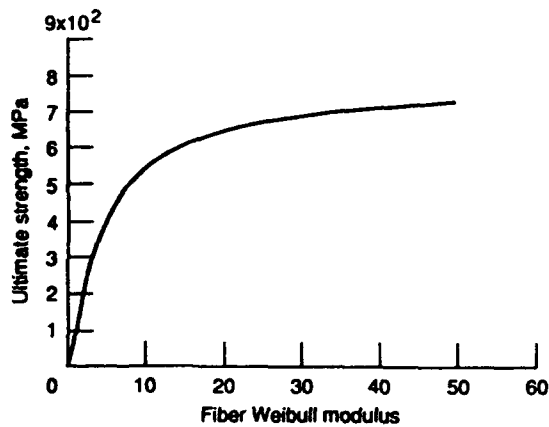
Figure 20.—Variation of ultimate strength with fiber Weibull modulus. $A_0 = 1 \text{ m}^2$; $\bar{S} = 2.86 \text{ GPa}$; $L = .1016 \text{ m}$; $f = 0.28$; $\tau = 10 \text{ MPa}$.

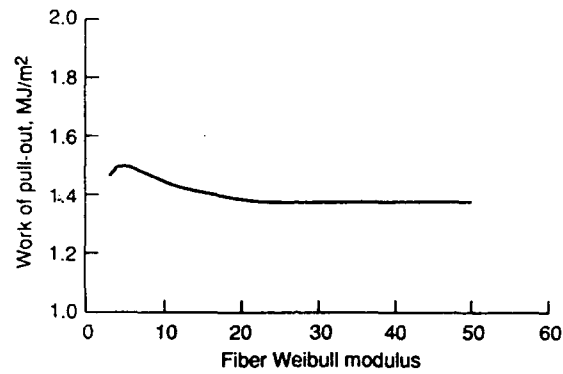
Figure 24.—Variation of work of pull-out with fiber Weibull modulus for multiple matrix cracking (slipping fibers) case.

The work of pull-out for both single and multiple matrix cracking increases with average fiber strength and fiber radius, but decreases with increasing values of τ . Similar trends can be observed in the average fiber pull-out lengths. The work of pull-out for single matrix cracking is plotted in figure 23 as a function of the Weibull modulus. It shows that the fibers should have a low Weibull modulus to enhance fiber pull-out beyond the ultimate strength. Furthermore, the work of pull-out approaches zero when the variation of fiber strength decreases which is what was observed experimentally in composites with brittle failure modes. Figure 24 shows that the work of pull-out for multiple matrix cracking initially increases and then decreases gradually with increasing m ; it asymptotically approaches a particular value which can be explained as follows. The stresses in the fibers are highest in the matrix cracking planes. Therefore, for deterministic fiber strength, the fibers will fail at different matrix crack surfaces, not necessarily at the same crack. In this case the broken fibers can still bridge the cracks and eventually produce the work of pull-out.
