MISCELLANEOUS PAPER EL-91-14

US Army Corps
of Engineers

ENVIRONMENTAL SITE CHARACTERIZATION FOR THE WIDE AREA MINE SENSOR DEMONSTRATION, ABERDEEN PROVING GROUND, OCTOBER 1988

Final Report

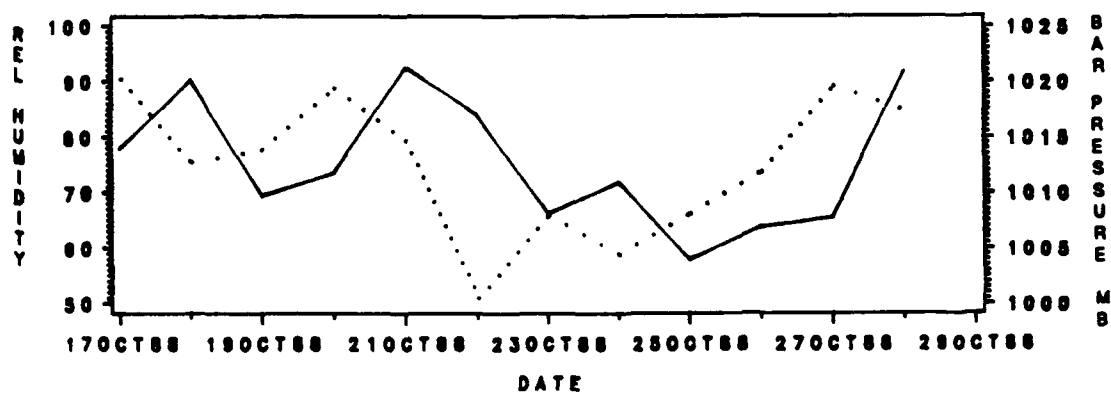
Figure 4. Daily average weather conditions

MAX, MIN, AND MEAN AIR TEMPERATURE

MEAN HUMIDITY / B PRESSURE

MEAN AVG. WIND SPEED / SOLAR LOADING

6. Weather conditions during the test were normal fall conditions for the APG area. Most days were sunny to partly cloudy with a few days of light rain. Average air temperature was 10.5°C , and the daytime average was 12.6°C . Daily average conditions over the test period are presented in Figure 4; average diurnal conditions for the captive flight test period are presented in Figure 5. Wind conditions during the ground sensor testing are depicted in Figure 6. During the CFT period, the number of tests conducted under overcast conditions is noteworthy because this tended to create low levels of thermal background clutter. During the ground sensor test period, the occurrence of relatively strong wind conditions is significant because this caused acoustic signatures to be refracted and resulted in acoustic and seismic background noise caused by vegetation movements; additionally, the acoustic source was downwind of the sensor for most of the testing. (The complete weather data set is available from WES.)
