RL-TR-91-81
Final Technical Report
June 1991

FAILURE MECHANISMS ON GaAs
INTEGRATED CIRCUITS:
ELECTROMIGRATION ON GaAs

General Electric Company

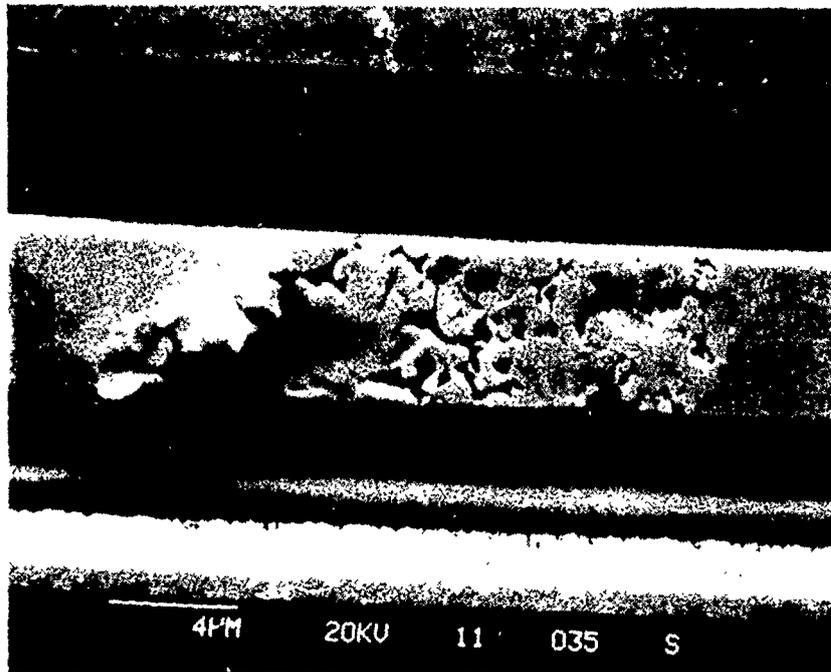
Figures 23 and 24 show, respectively, electromigration on 1 μ and 4 μ lines on a sample from GaAs wafer 3. Hillock formation can be seen to the left of the site.

Figure 23. Electromigration Site on 1μ Line, GaAs Wafer 3, Sample G-3-1-1-4

Figure 24. Electromigration Site on 4μ Line, GaAs Wafer 3, Sample G-3-1-1-3
