USACERL Technical Report P-91/37
May 1991

Six-Year Summary of Fort Irwin, CA, Family Housing Comparison Test: Operation and Maintenance Costs of Manufactured vs. Conventionally Built Units

by
Robert D. Neathammer

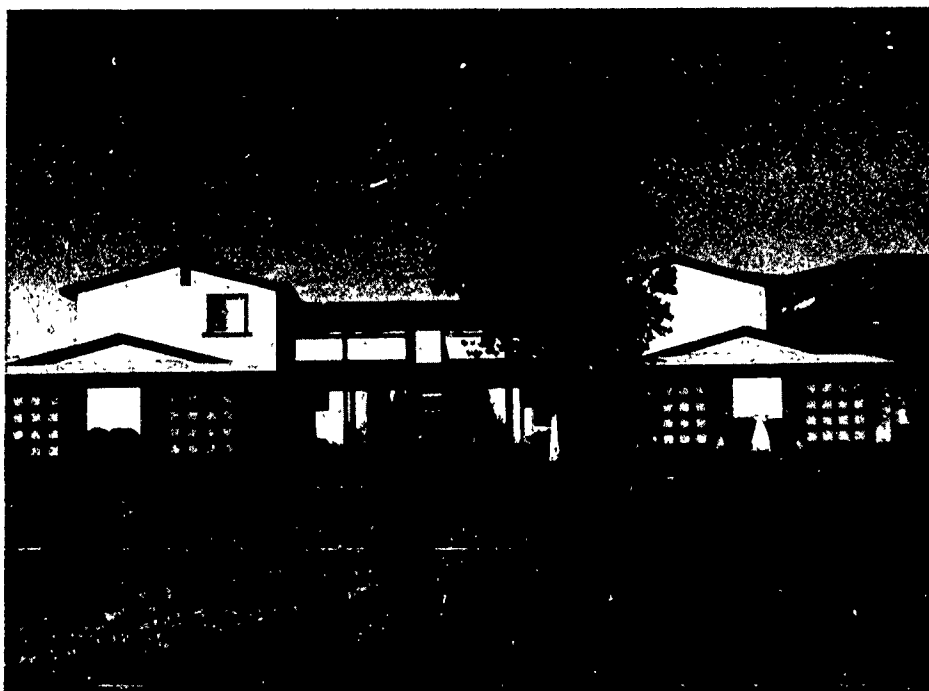
Figure 1. Front and rear views of typical MHUs.

These 200 units consist of 50 two-story fourplexes (two units on each of the first and second floors). Net floor area is 950 sq ft/unit.* These were constructed on perimeter footing with wood floors and crawl spaces. Each upper unit has a balcony-porch and each lower one has a patio with privacy fencing. Figure 1 shows front and rear views of typical buildings. Each unit has a refrigerator, gas range, gas water heater, garbage disposal, dishwasher, central air conditioning, and gas-fired forced-air furnace (all provided by the contractor). Each unit has two bedrooms, a kitchen, living-dining area, one bathroom, utility room, and a one-car garage. The garage was constructed on site.

Front View - MHU

Rear View - MHU

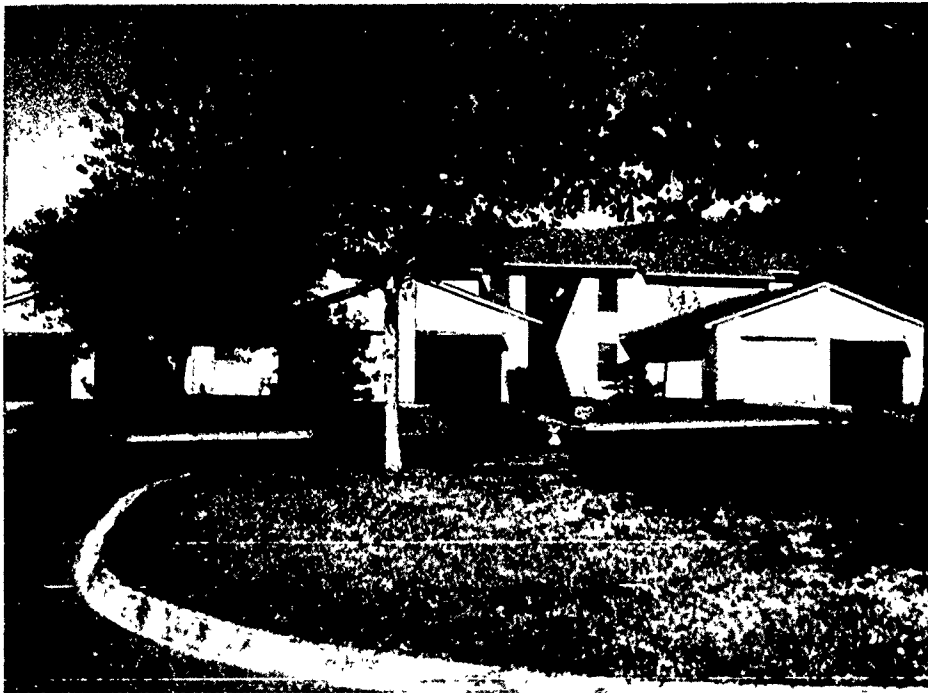
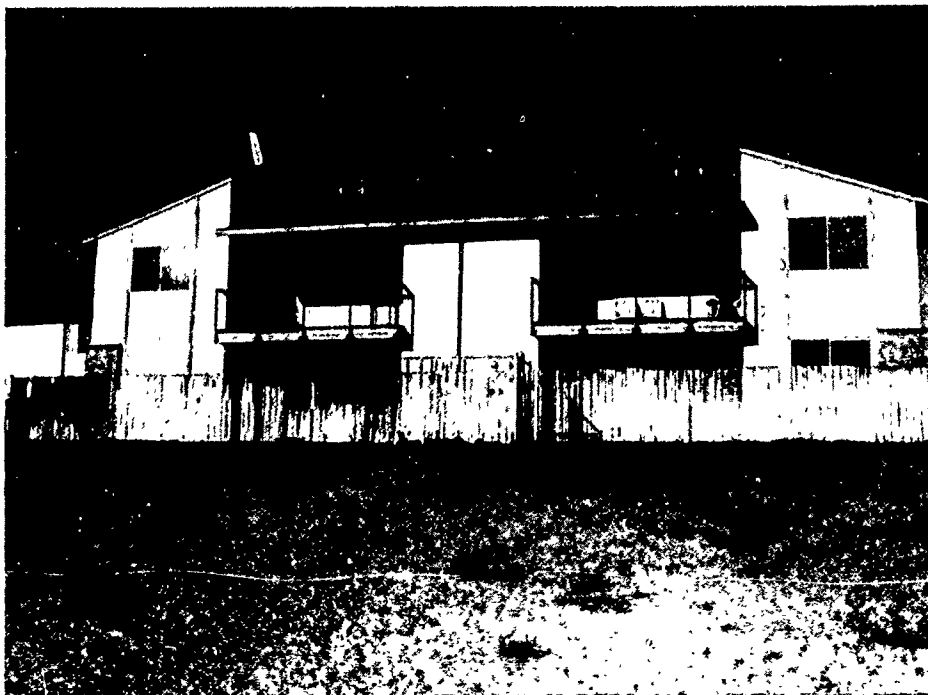
Figure 2. Front and rear views of typical CBUs.

Front View - CBU

Rear View - CBU

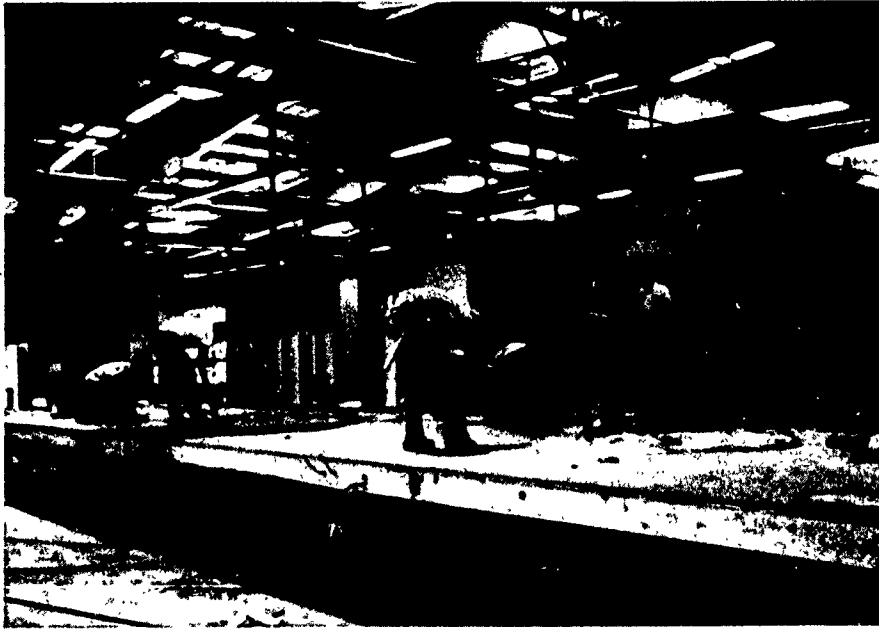
Figure A1. Construction in the factory.
