# BEACH RESPONSE TO THE PRESENCE OF A SEAWALL; COMPARISON OF FIELD OBSERVATIONS

James F. Tait, Gary B. Griggs

Final Report

Prepared for DEPARTMENT OF THE ARMY  
US Army Corps of Engineers  
Washington, DC 20314-1000

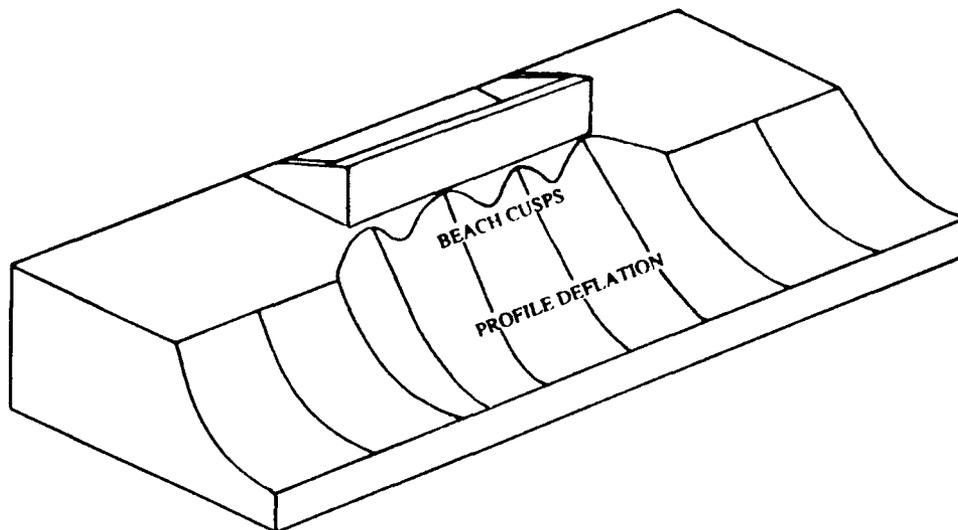
Figure 2. Types of beach response observed by Griggs and Tait before berm retreats past seawall

6. Beach response is the morphological transformation of the beach due to sediment transport. It is clear from the field studies reviewed for this paper that the response of a beach in front of a seawall to storm waves can be quite variable. For convenience of discussion, many of the types of beach response can be divided into two broad categories: "frontal effects" and "end effects." The following is a list of types of beach response which have been observed at seawalls (Figures 2 and 3):

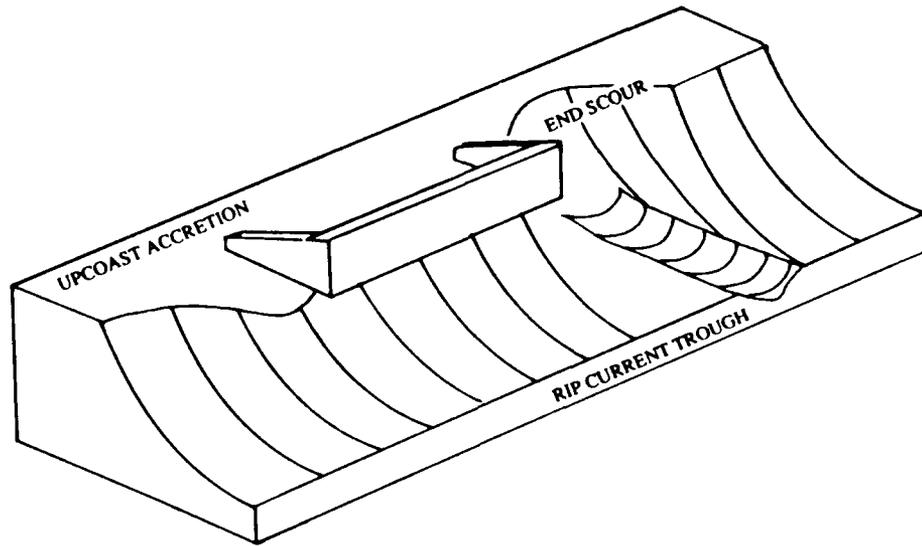
Figure 3. Types of beach response observed by Griggs and Tait after berm retreats past seawall

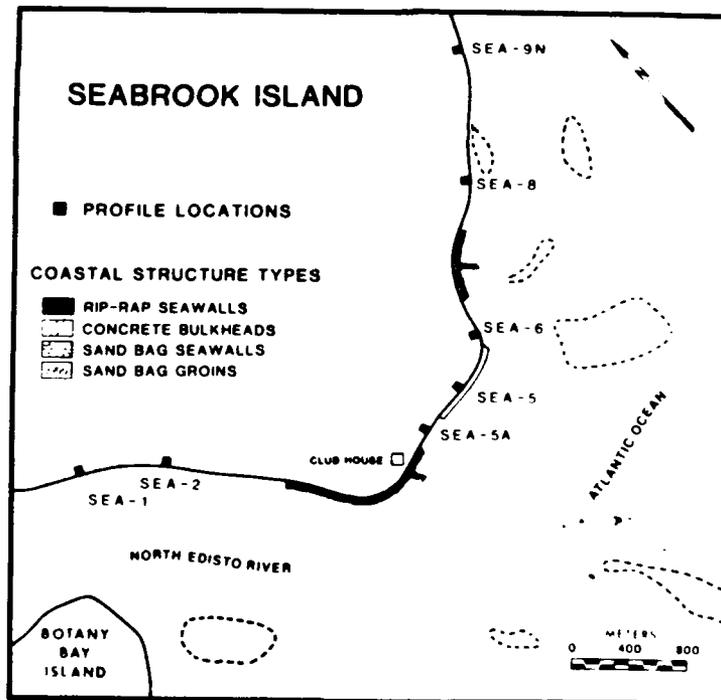
Figure 4. Location map of profile stations and structures in Sexton and Moslow study of the effects of Hurricane David on Seabrook Island. Note location of profiles Sea-5 and Sea-6 discussed in text. (From Sexton and Moslow 1981)

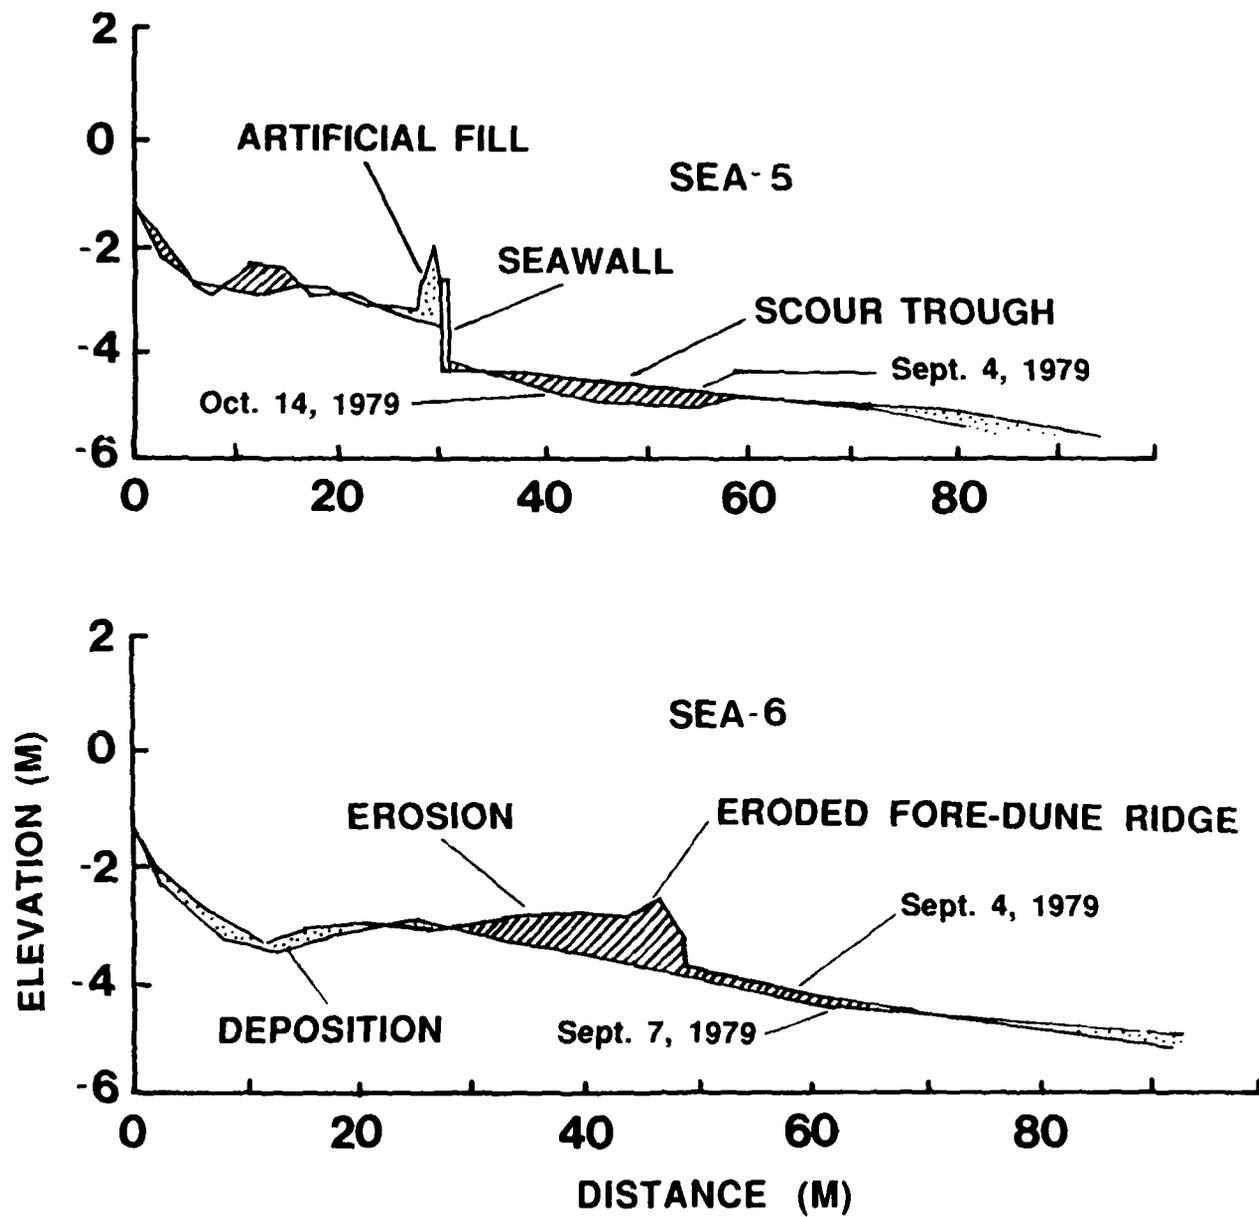
Figure 5. Pre- and post-storm profiles, Seabrook Island (Sexton and Moslow 1981)

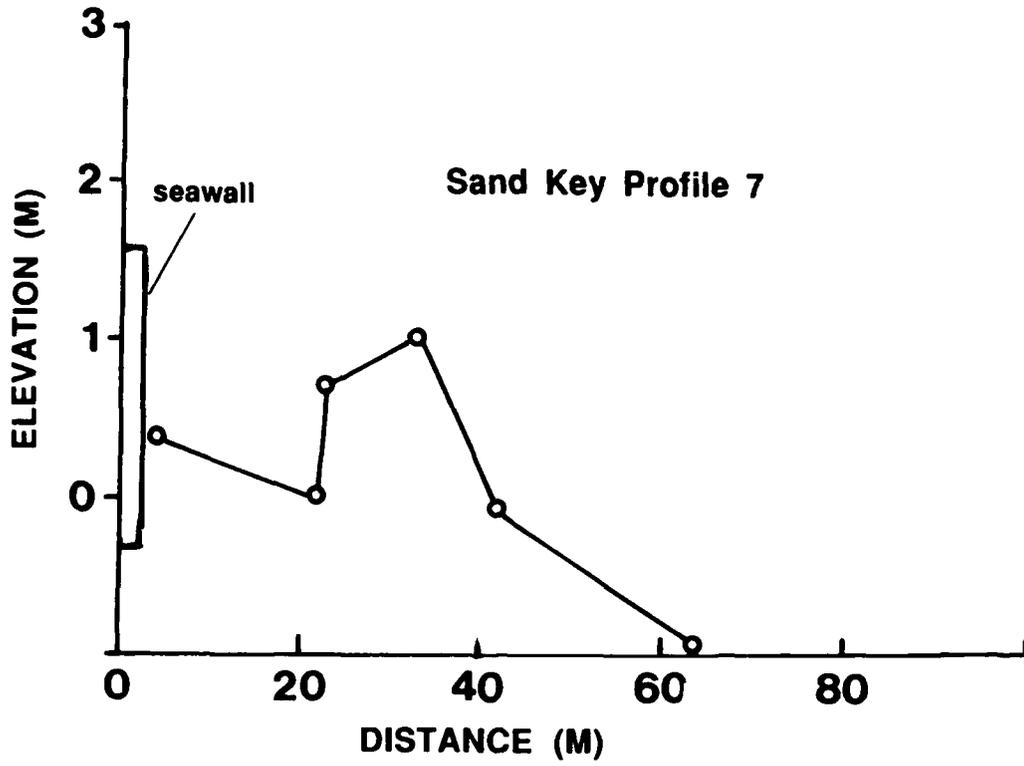
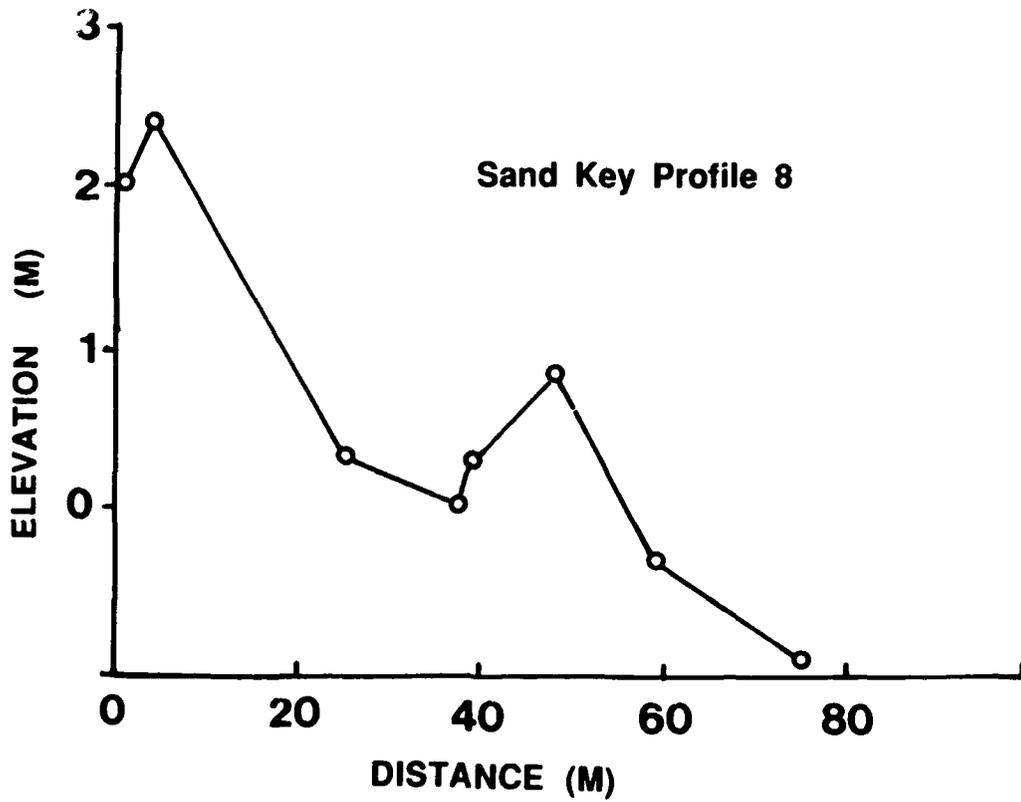
Figure 7. Post-storm profiles at Sand Key, Florida (Davis and Andronaco 1987)

11. The effects of Hurricane Elena in 1985 on west-central Florida have been reported by a number of investigators (Figure 6). Davis and Andronaco (1987), and Sayre (1987) both report the presence of a ridge and runnel system wherein the ridge was sometimes supratidal. This morphology developed regardless of whether or not a seawall was present. Davis and Andronaco noted that the largest and best-developed ridges and runnels were located in the northern part of the study area where exposure to high waves was greatest. Locally, however, erosion in front of seawalls was greater than erosion on adjacent natural profiles. At Sand Key, the beach elevation against a seawall (profile 7) was approximately 1.5 m lower than the beach elevation at a comparable location on a neighboring natural beach, profile 8 (Figure 7).

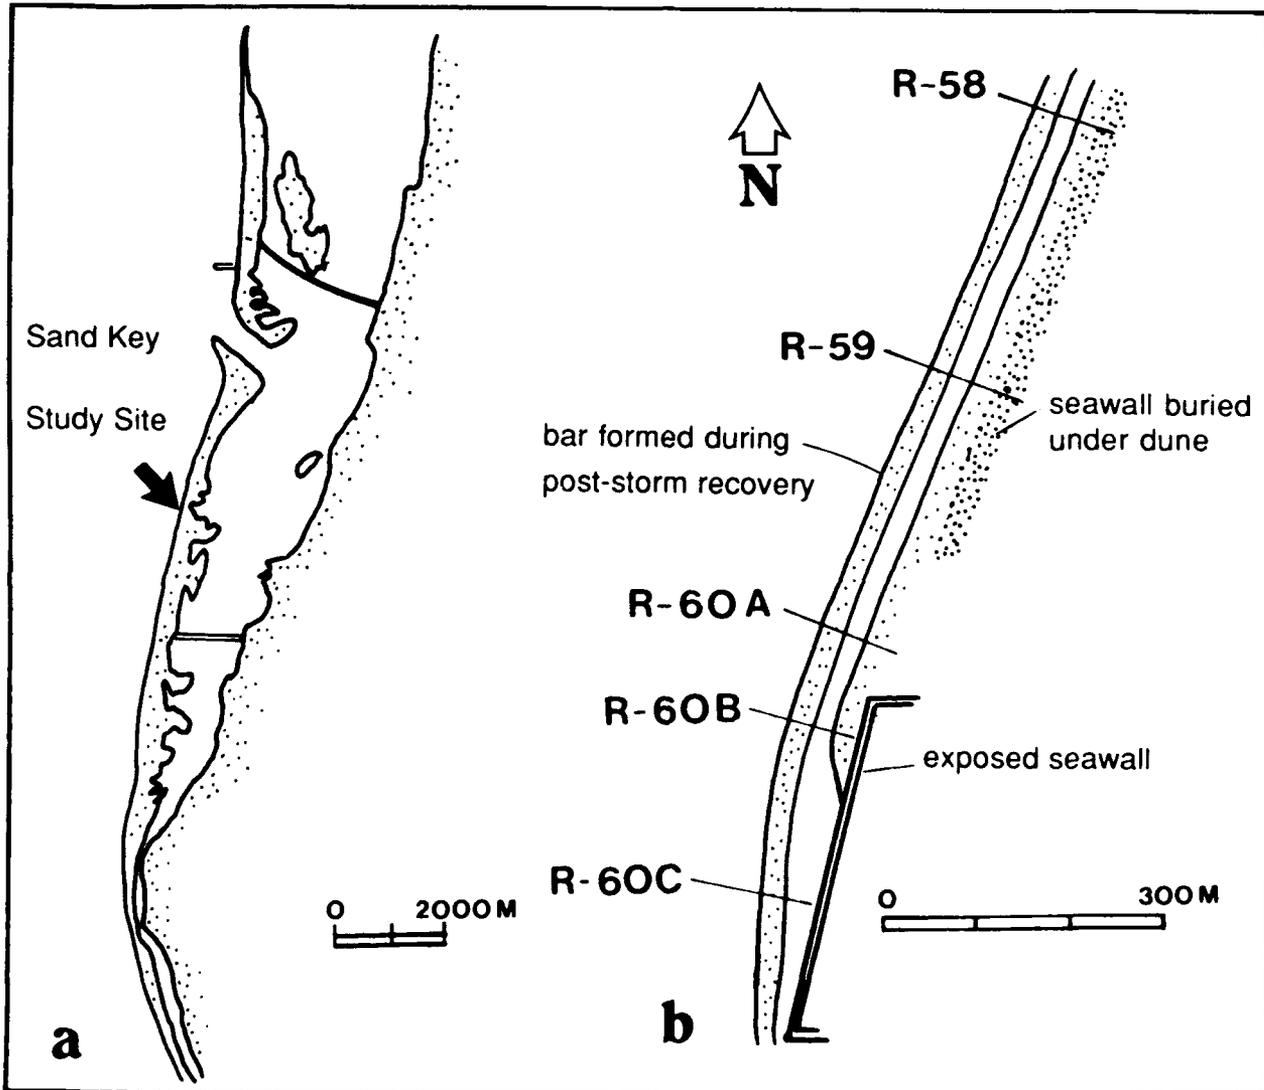
Figure 8. Site map for Sand Key, Florida study (Kriebel 1987)

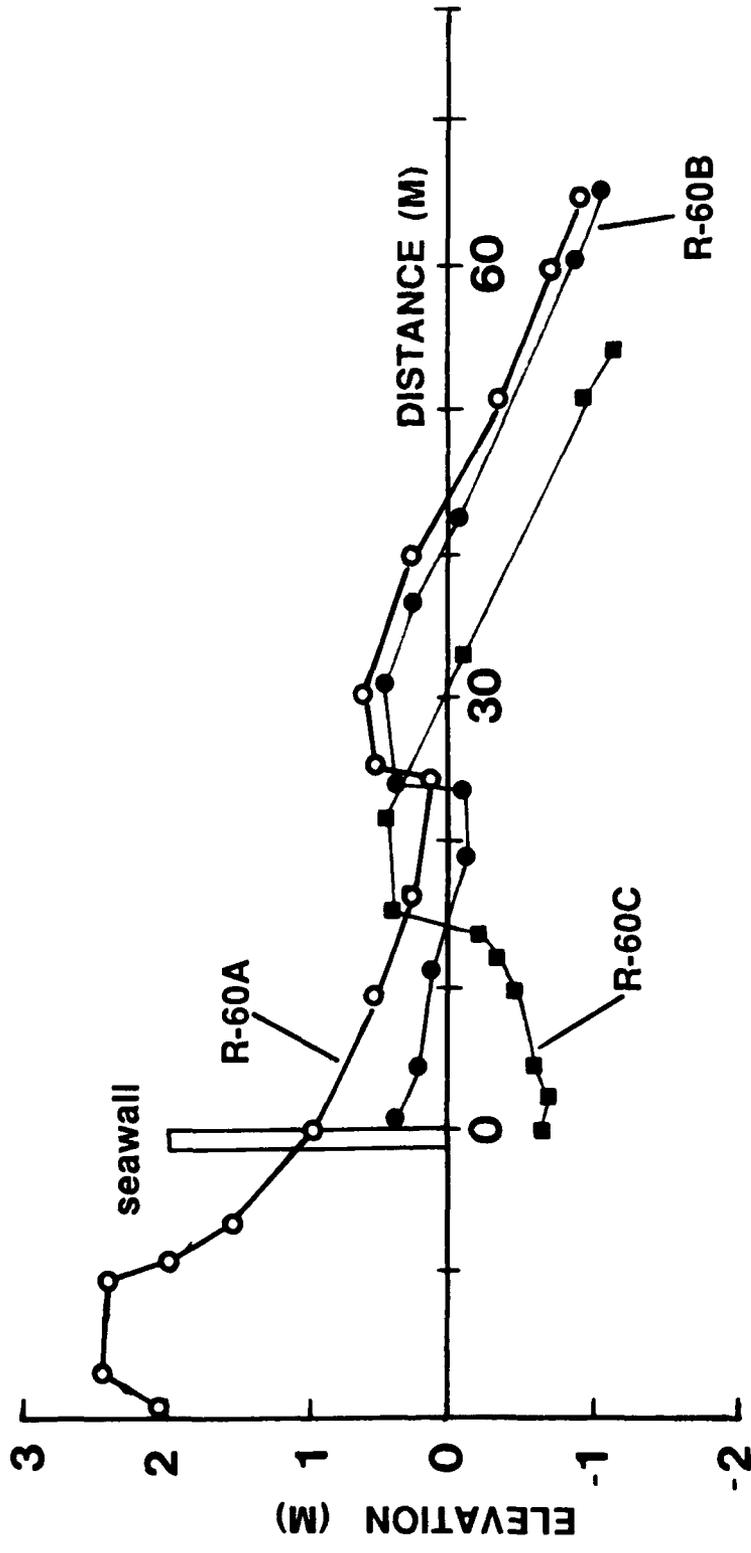
Figure 9. Post-Hurricane Elena profiles at Sand Key (Kriebel et al. 1986)

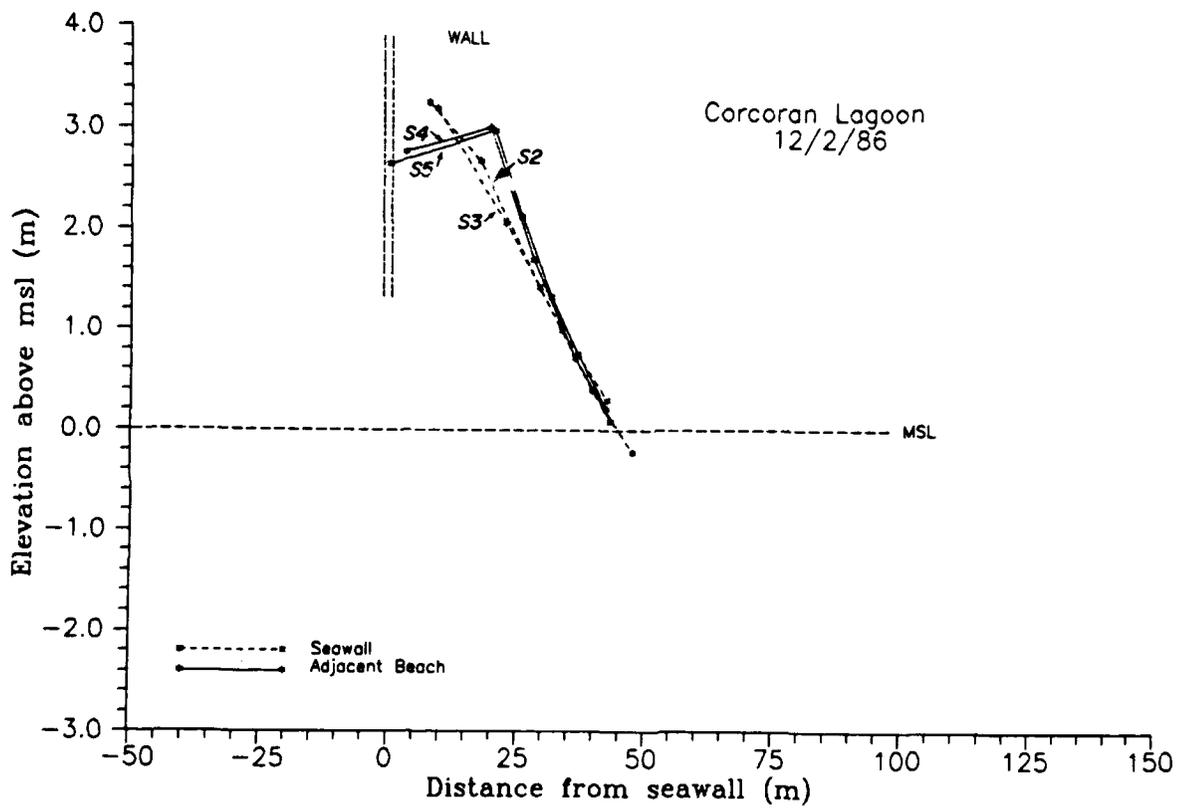
Figure 10. Beach profiles at Corcoran Lagoon, Monterey Bay, showing deflation of summer berm in front of seawall (dashed lines) and persistence of berm on adjacent natural beach (solid lines). (From Griggs and Tait 1988)

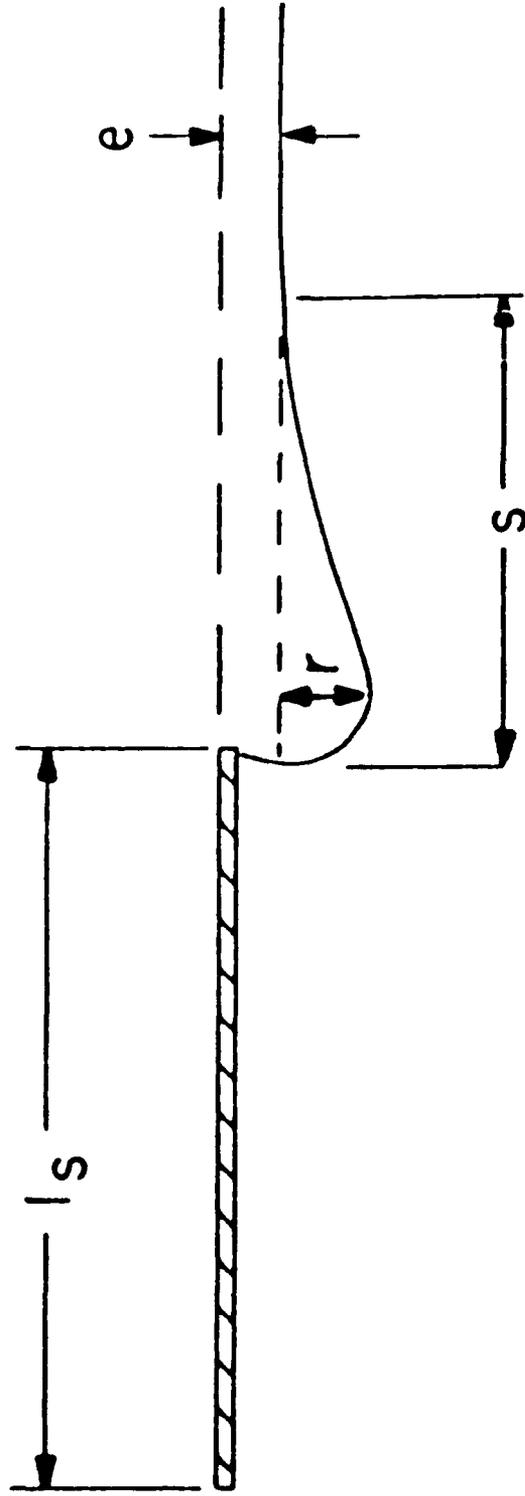
Figure 13. Typical scour pattern at end of seawall (McDougal et al. 1987)

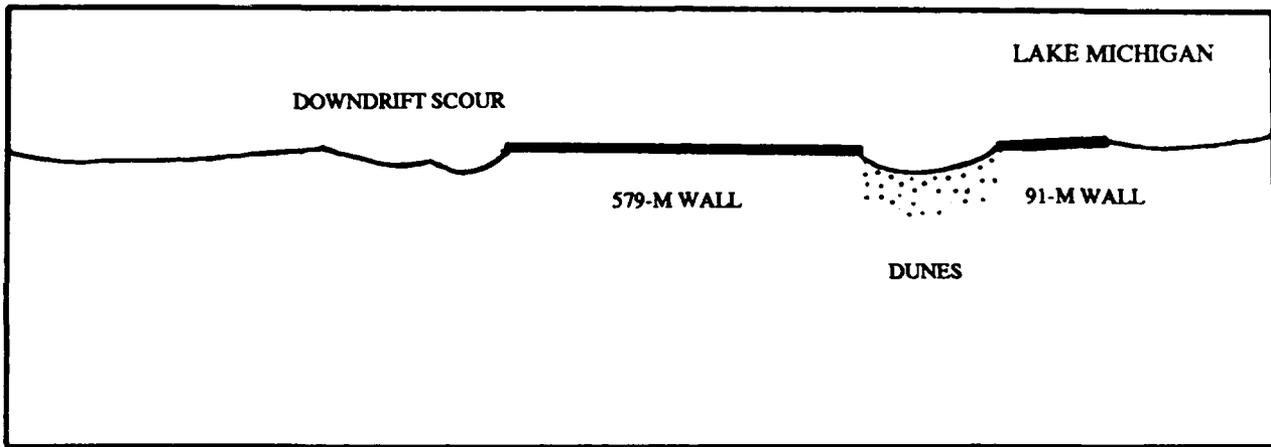
Figure 14. Site map of Birkemeier's Lake Michigan study. Downtdrift cut, dune area, and seawalls are depicted. (After Birkemeier 1980)

24. Birkemeier (1980) investigated the effects of structures and lake levels on bluff and shore erosion along Lake Michigan (Figure 14). One site was a 1.6 km reach backed mainly by sand bluffs. This reach also contained a 579-m long seawall with a shorter, 91-m seawall just upcoast. Birkemeier noted progressive scour at the downcoast end of the 579-m wall. There was also active bluff recession in this area. He quantifies this by stating that there was a 380 percent increase in volume eroded downdrift over expected recession based on profiles surveyed on a neighboring upcoast study site. He noted that the exact effects of the seawall on the downdrift cut were hard to assess because construction of yet another wall in the area of the downdrift erosion produced a second cut to the south of the first.

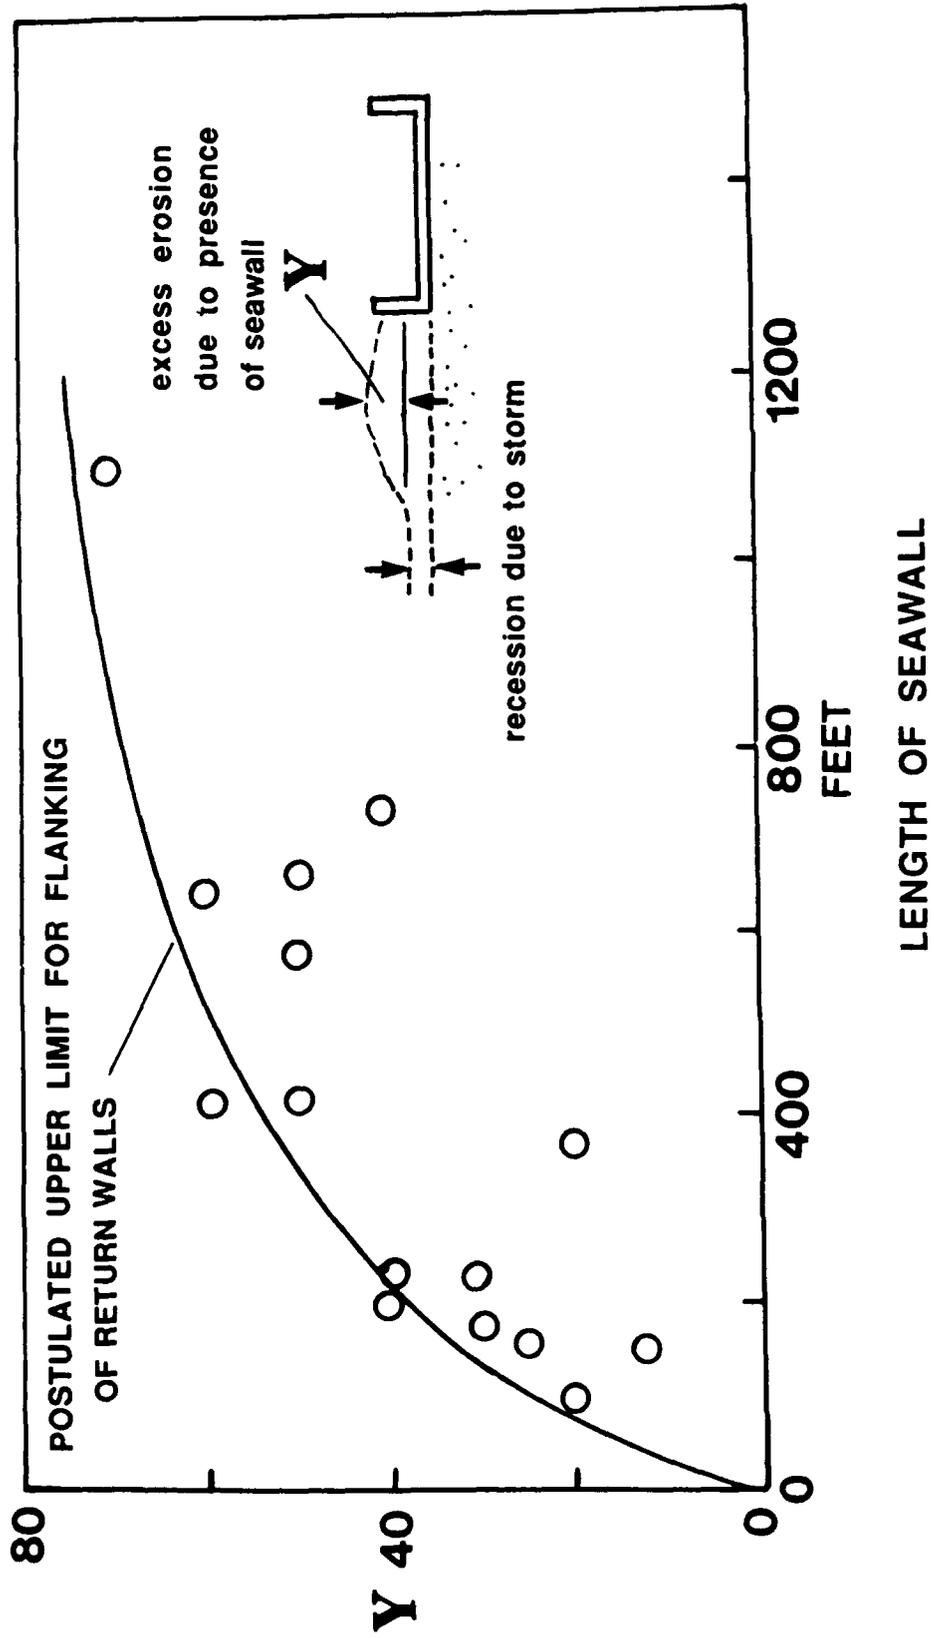
Figure 15. Graph of seawall length versus end scour (Walton and Sensabaugh 1979)  
 (To convert feet to meters, multiply by )

87. The hydraulic model studies of McDougal et al. (1987) indicate that the magnitude of end scour increases with the length of the wall. In laboratory tests, and in the field data of Walton and Sensabaugh (Figure 15), it was observed that the cross-shore extent of end scour is approximately 10 percent of the wall length. Several small scale model tests indicate that the downcoast extent of end scour is approximately 70 percent of the wall length. This control should be viewed with a certain amount of skepticism as the results of Walton and Sensabaugh show considerable scatter and the laboratory results of McDougal et al. have not been confirmed in the field.

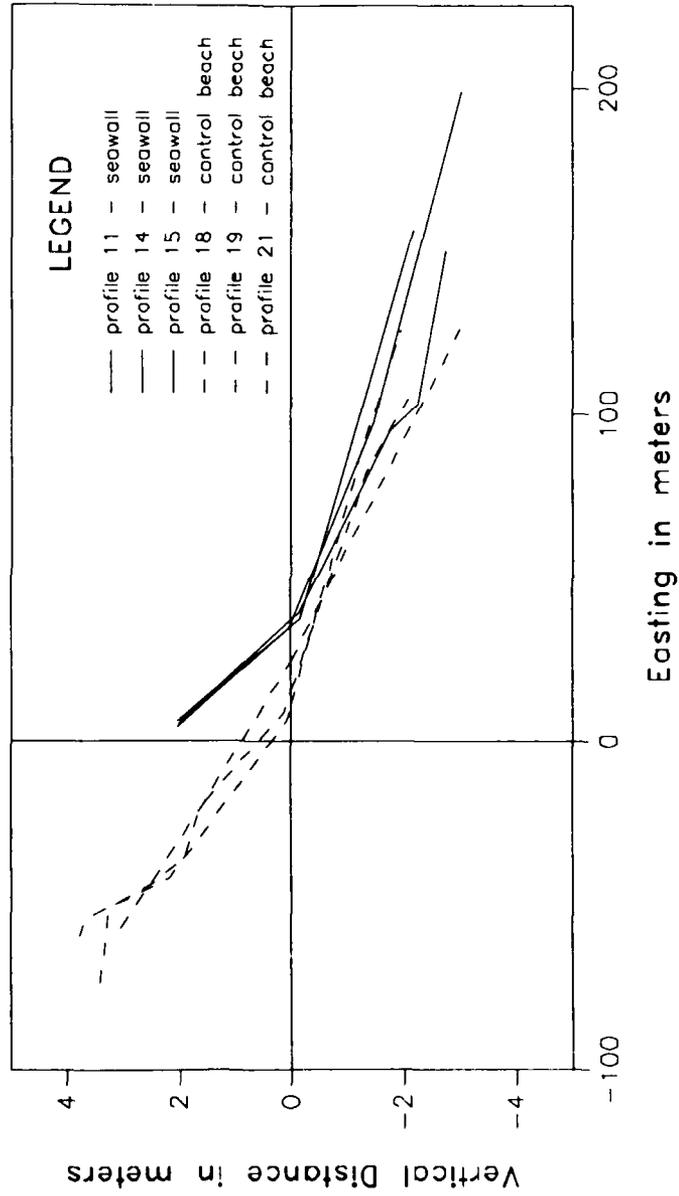
Figure 17. Winter beach profiles from the Aptos Seascape seawall site in northern Monterey Bay, California

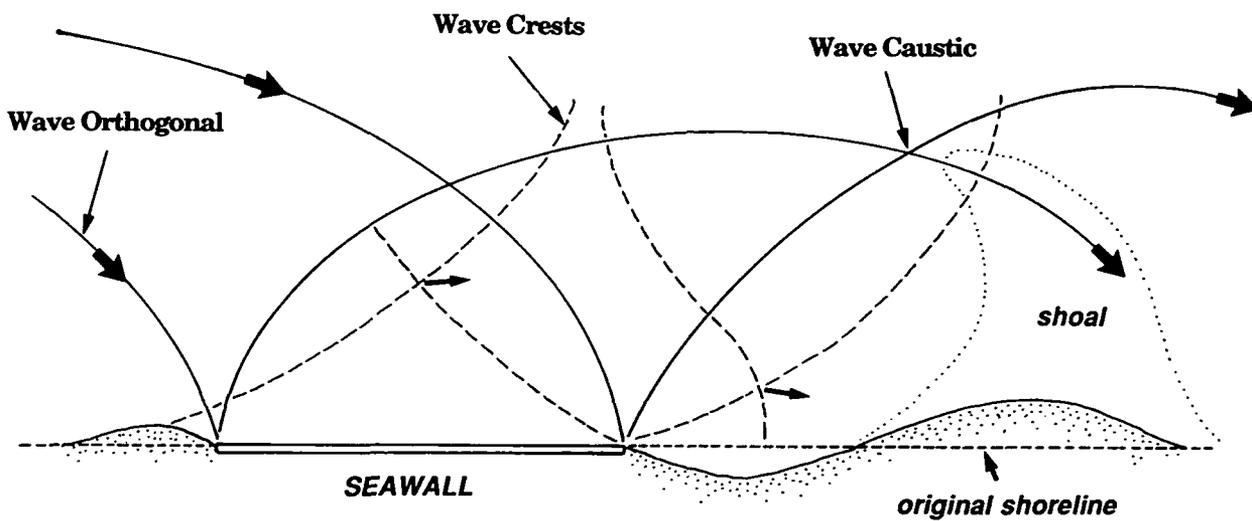
Figure 18. Short-crested wave system generated by obliquely reflected waves summing with incident waves. Areas of scour are produced in the vicinity of the wall and deposition occurs further downcoast. (From Silvester 1977)

47. Another mechanism proposed for increasing sand mobilization is the effect of reflected waves interacting with incident waves. If the reflection is oblique, an interference pattern (Figure 18) of short-crested waves is created (Silvester 1977). This system has higher wave heights due to constructive adding of segments of the incident and reflected waves. Lin et al. (1986) have demonstrated that under laboratory conditions sediment mobilization is increased due to orbital motions in the higher waves created in a short-crested system.

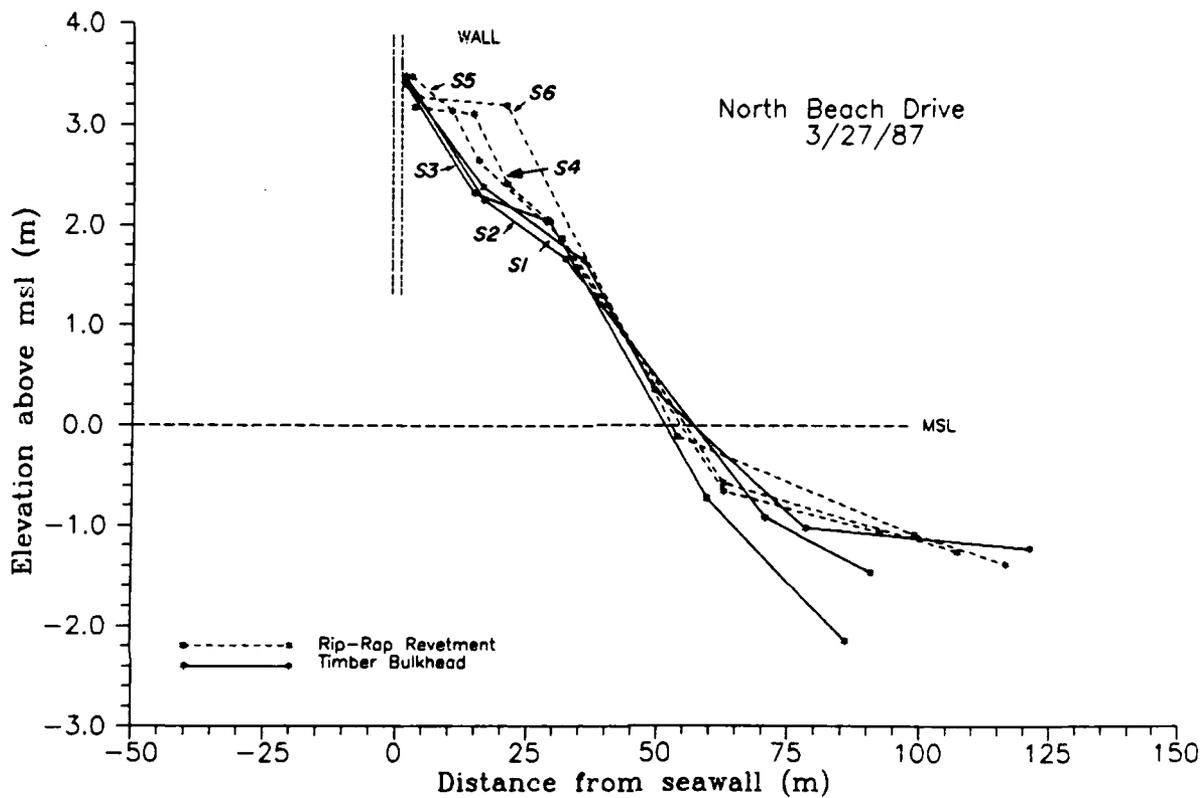
Figure 20. Beach profiles at North Beach Drive. Note persistence of wide berm in front of permeable revetment (dashed lines) in contrast to absence of berm in front of impermeable bulkhead (solid lines). (From Griggs and Tait 1988)

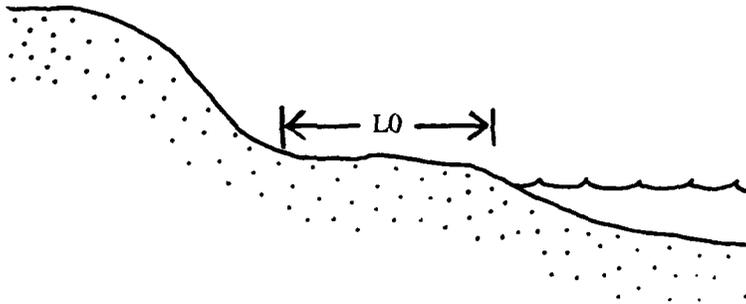
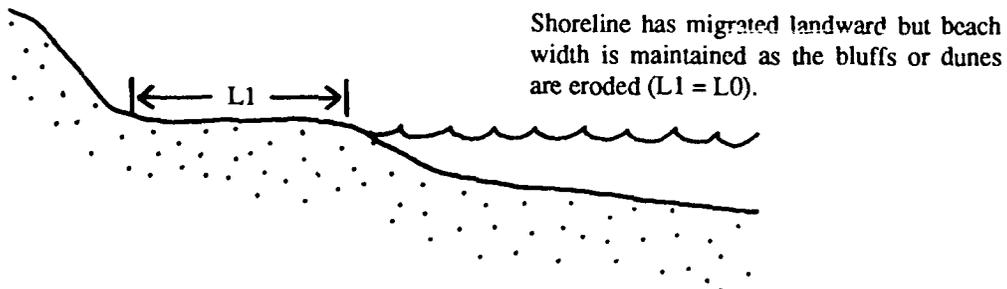
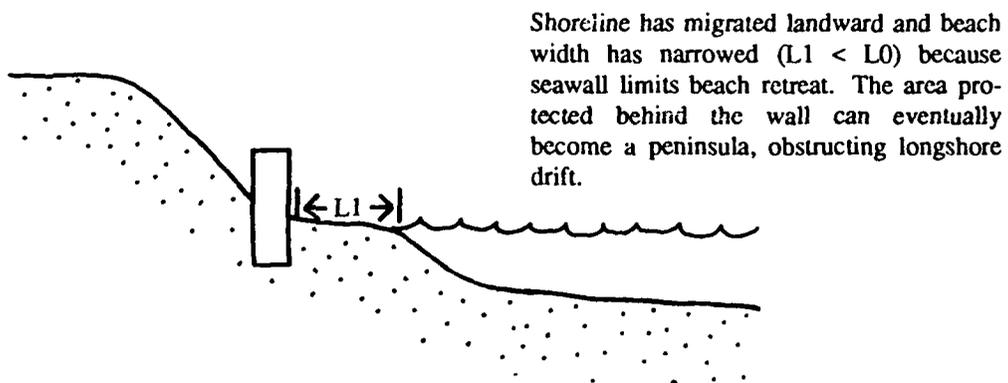
Figure 21. Long term effects of a seawall on a retreating shoreline

CASE I: ERODIBLE BLUFFS OR DUNES, SEDIMENT DEFICIENCY AND SEA LEVEL RISE, WALL AT BACK BEACH.

INITIAL SHORE PROFILE

SHORE PROFILE AFTER SHORELINE RETREAT

SHORE PROFILE AFTER SHORELINE RETREAT WITH SEAWALL

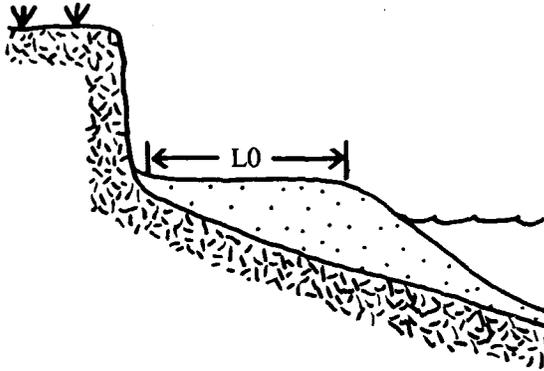
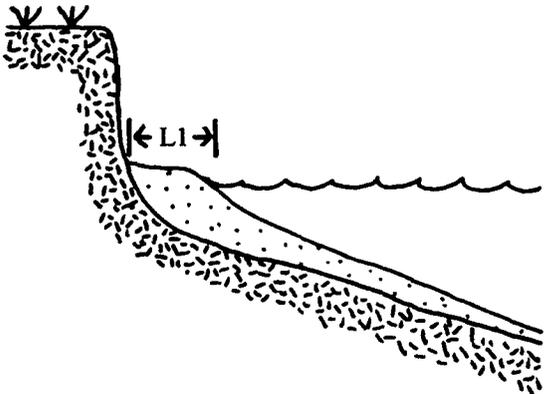
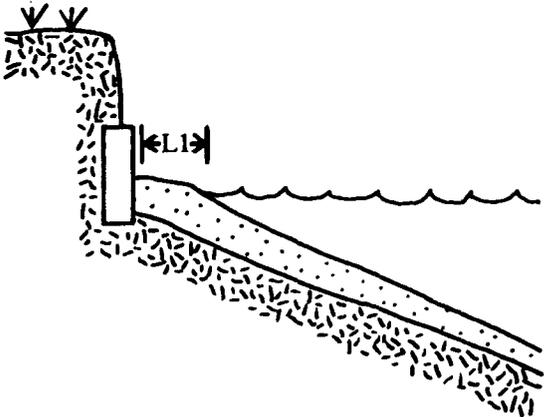
Figure 22. Long term effects of a seawall on a retreating shoreline

CASE II: RESISTANT SEA CLIFF, SEDIMENT DEFICIENCY AND SEA LEVEL RISE, WALL AT BASE OF CLIFF.

Shoreline migrates landward and beach narrows because seacliff limits beach retreat ( $L_1 < L_0$ ).

Seawall has approximately the same effect on the beach as would the seacliff ( $L_1 < L_0$ ). If the wall is more resistant than the seacliff, the seawall could become a small headland over time. If the shoreline is stable or advancing, the wall has little effect.

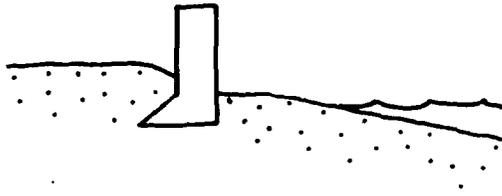
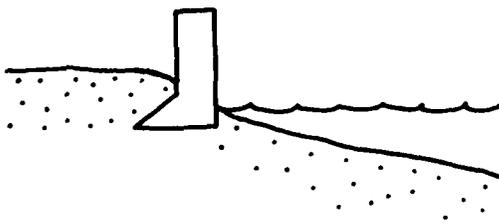
Figure 23. Long term effects of building a seawall well seaward on the beach profile

### WALL BUILT TOO FAR SEAWARD ON BEACH PROFILE

Seawall is placed well seaward on beach profile; a narrow summer berm exists. The beach in front of the wall is very sensitive to changes in sediment supply or sea level.

If there is net shoreline retreat, the area behind the wall may become a peninsula, obstructing longshore transport. Under seasonal changes, the wall may similarly lose the beach in front of it, project into the surf zone, impound littoral drift, promote down-coast erosion, and obstruct alongshore beach access (Griggs and Tait).
