**IMPACT OF STEEP-FRONT SHORT-DURATION
IMPULSE ON ELECTRIC POWER
SYSTEM INSULATION**

**PHASE II: LABORATORY EVALUATION OF
SELECTED POWER SYSTEM COMPONENTS**

L. M. Burrage
E. F. Veverka
J. H. Shaw
B. W. McConnell (ORNL)

Published April 1991

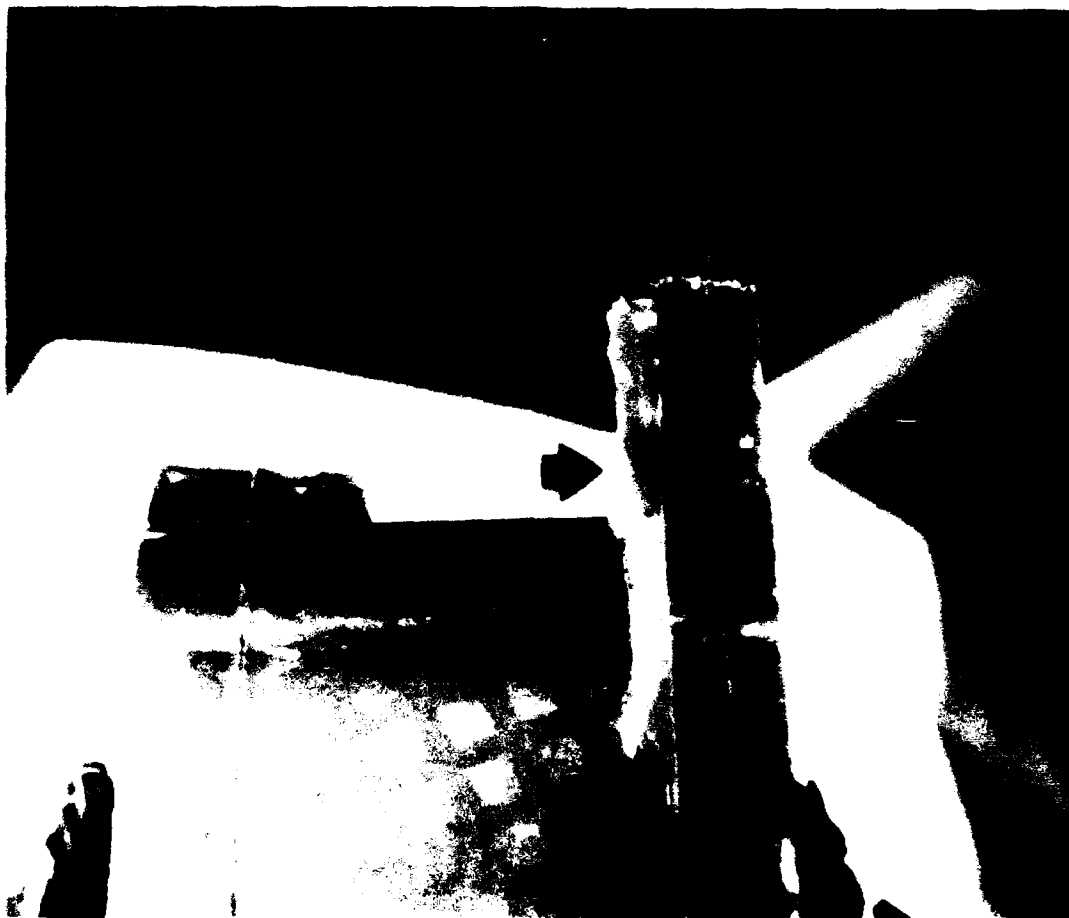
Fig. 4.10. Failure at the edge of the outer layer of the primary winding. The outer section of the secondary winding has been removed.

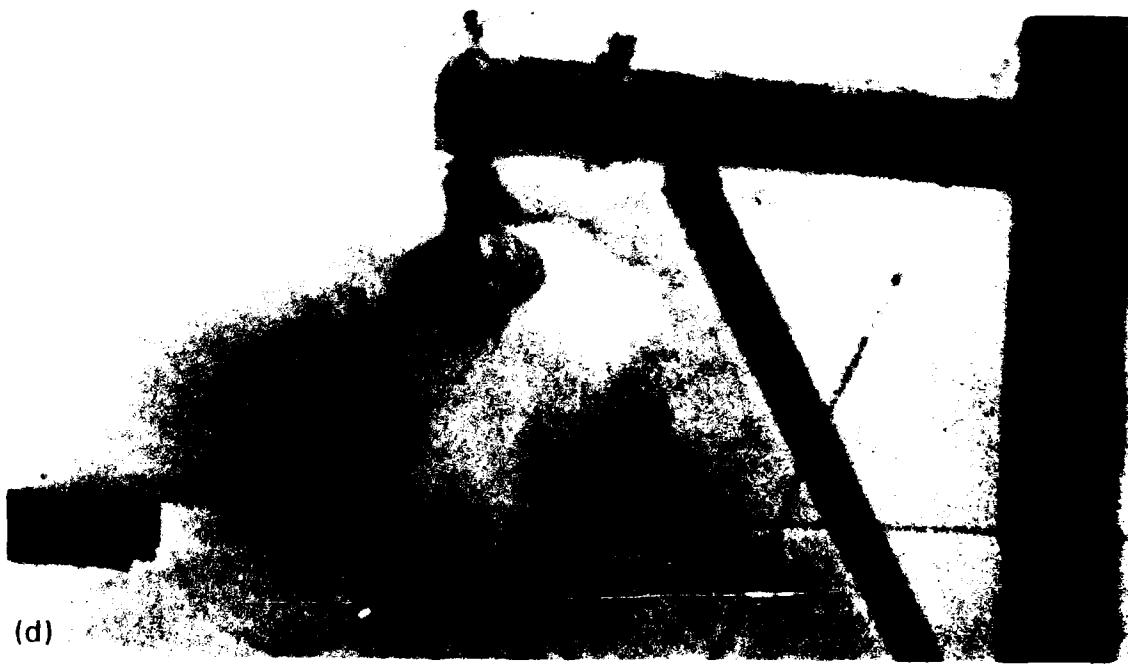
Fig. 4.17. (c) Maximum current and beginning of destruction of disk, (d) destruction of disk.
