## **Remedial Investigation Concept Plan for Picatinny Arsenal**

**Volume 2: Descriptions of and Sampling  
Plans for Remedial Investigation Sites**

March 1991 (*Final Report*)

Environmental Assessment and Information Sciences Division  
Argonne National Laboratory, Argonne, Illinois 60439-4801

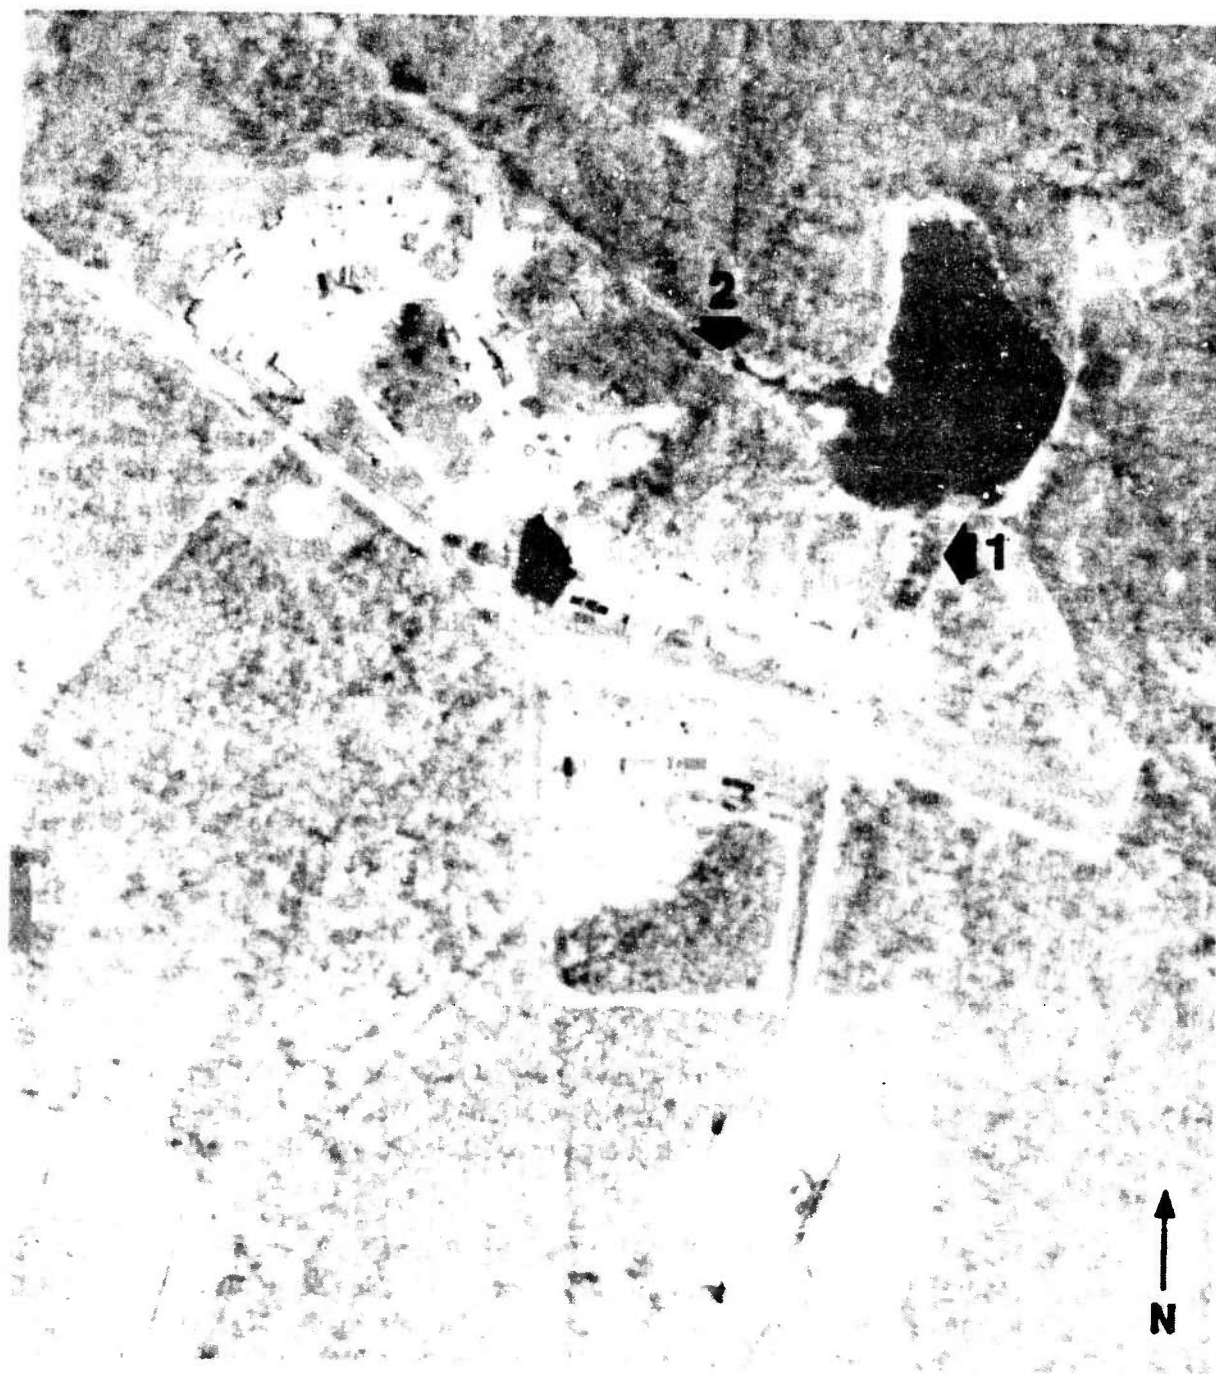
**FIGURE 11.4** Aerial View of the Site 2 Area in 1963 (arrows indicate possible stained areas) (Source: Sitton 1989)
