THE EFFECTIVENESS OF A SEDIMENT AND EROSION CONTROL
ORDINANCE: RICHLAND COUNTY, SOUTH CAROLINA

Submitted in Partial Fulfillment of the
Requirements for the Degree of Master of Science
in the Department of Geography
University of South Carolina

1991

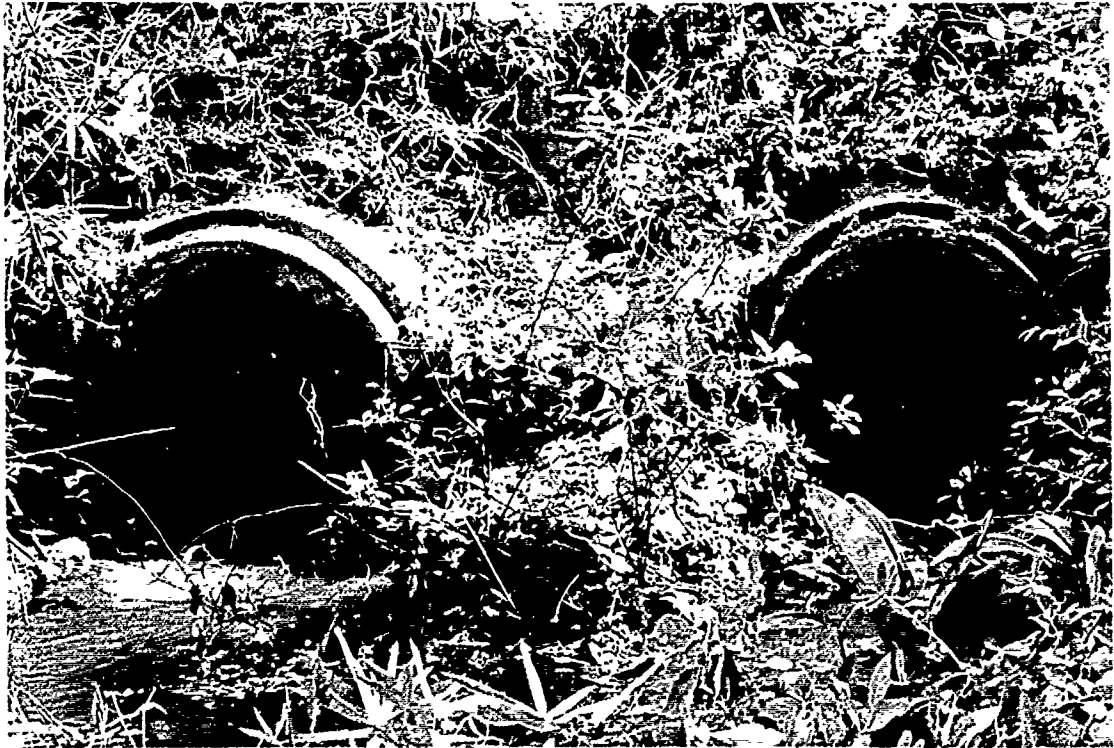
Photo 1-1 Downstream section of 30" and 36" concrete pipes.

southerly direction for 7,000 feet (2,133 m) to Clemson Road (Figure 1-3). At Clemson Road, Winslow Creek drains the basin through a pair of concrete pipes approximately 30" and 36" in diameter (Photo 1-1).

pipes are approximately 25 to 30 years old and show signs of deterioration including differential settling, leakage, and spalling of interiors, and cracking. Based on these factors, a roughness coefficient of .017 was selected using the criteria established by Bodhaine (1986). The continuity equation (Dunne and Leopold, 1978) was applied to both culvert geometries to estimate discharge:

downstream sections of the 30" and 36" concrete pipes (Figure 2-3 and Photo 1-1). This site was selected on the basis of its accessibility under high-water and adverse conditions and the ability to accurately estimate stream velocity and discharge at the pipes. Adverse effects of this sample site include a tendency for slack-water sedimentation upstream of the pipes and delivery of sediment from road side sources. These complications were unavoidable given the limitations of this project.

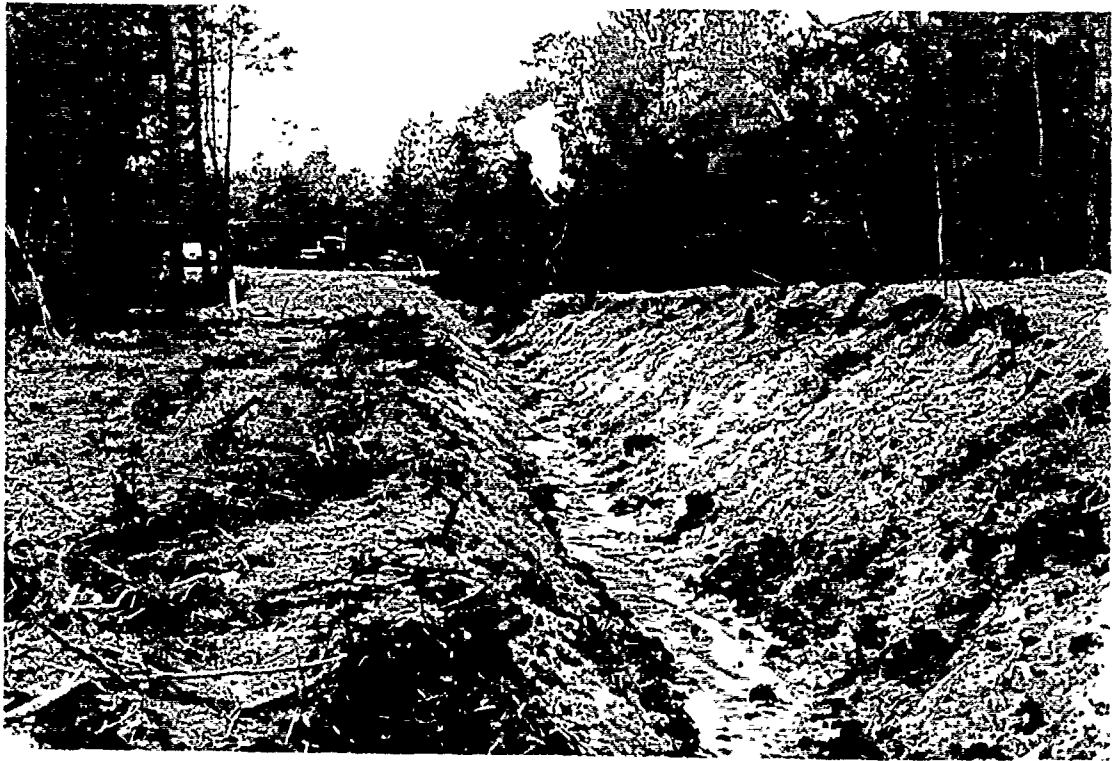
Photo 1-2 Upstream view of Moss Field Creek. Channel improvements include deepening and widening of channel.

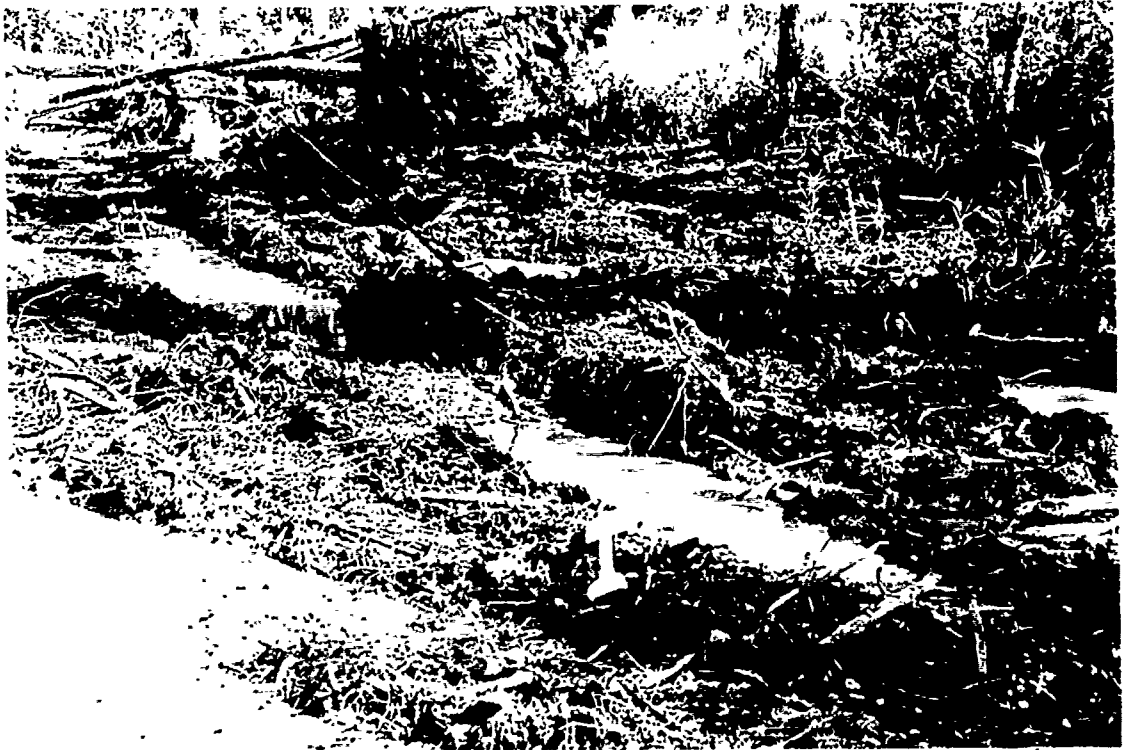
Photo 1-3 Typical Johnston Loam stripped of protective vegetation. Note standing water one-week after storm.

The Johnston (Jo) series are deep, very poorly drained soils that form in loamy fluvial and marine sediment (Lawrence, 1978) (Photo 1-3). These soils are found along stream channels and within the flood plain of the basin.

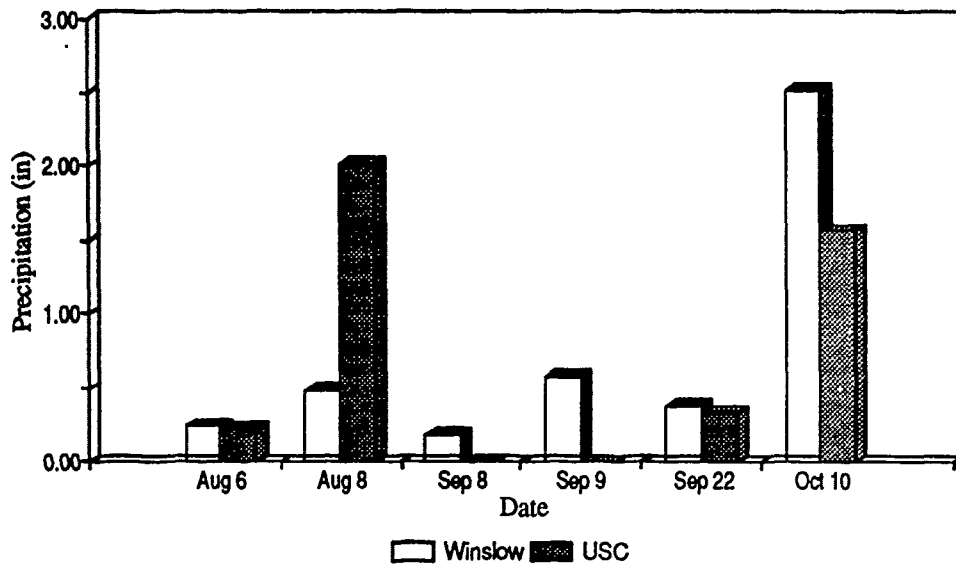
Fig. 3-1 Comparison of Winslow Creek and University of South Carolina rain gauge data.

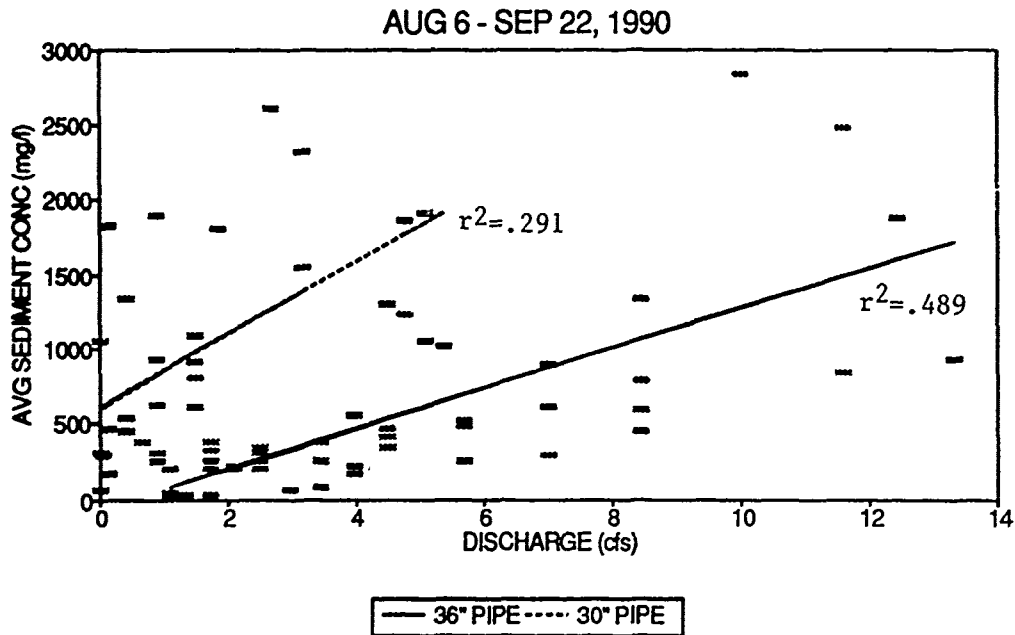
Fig. 3-6 Sediment concentration on discharge regression for 30" and 36" pipes, August 6 - September 22, 1990.

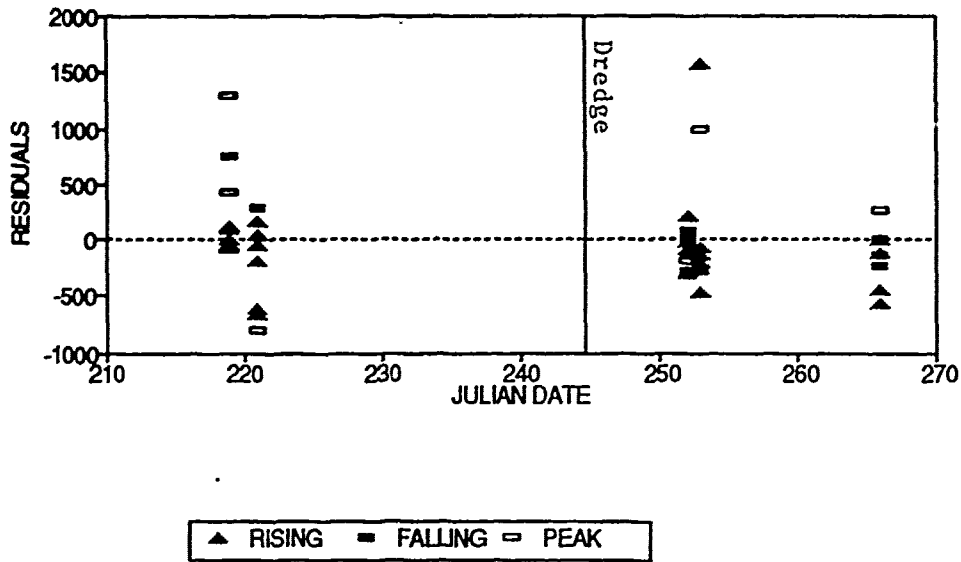
Fig. 3-9 Residuals for 36" pipe, August 6 - September 22, 1990.

Examination of the regression residuals for each pipe during the post-dredge hydrograph period indicates that 3 rising limb sediment concentrations for both pipes on September 9, 1990 are greater than predicted (Figures 3-8 and 3-9). Unlike sediment concentrations for rising limbs during the pre-dredge period, these high concentrations are directly attributable to sediment produced by storm water observed flowing through the freshly graded drainage ditch along Clemson Road. The early increase in sediment concentrations for the right pipe (36") shown as an average sediment concentration peak at ~ 15 minutes on figure 3-13, was due primarily, therefore, to removal of the sod from the

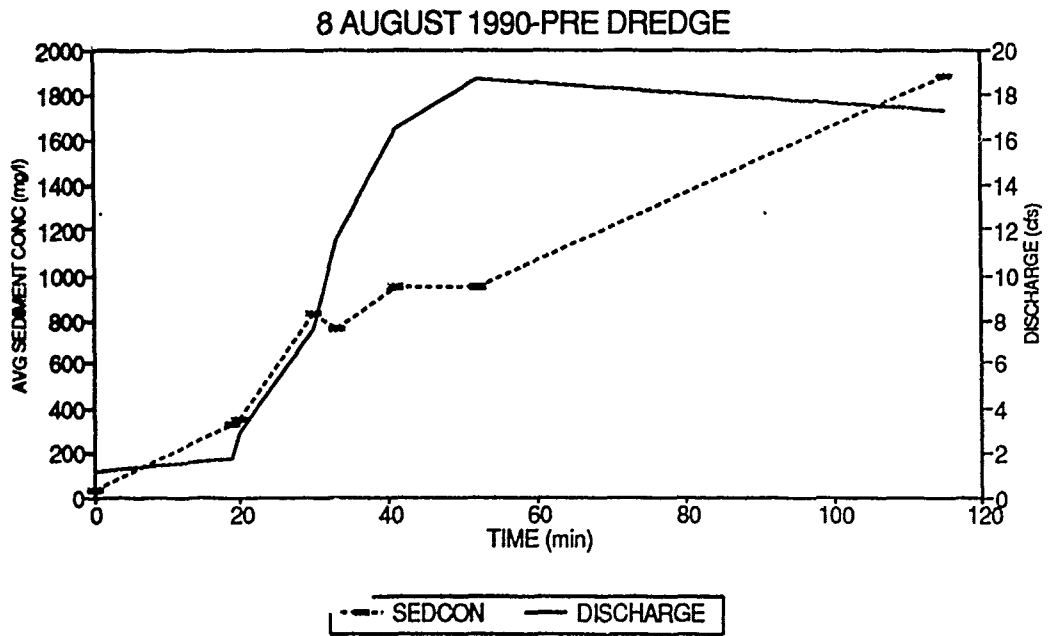
Fig. 3-12 Sediment concentration on stream hydrograph for Winslow Creek before dredging, August 8, 1990.

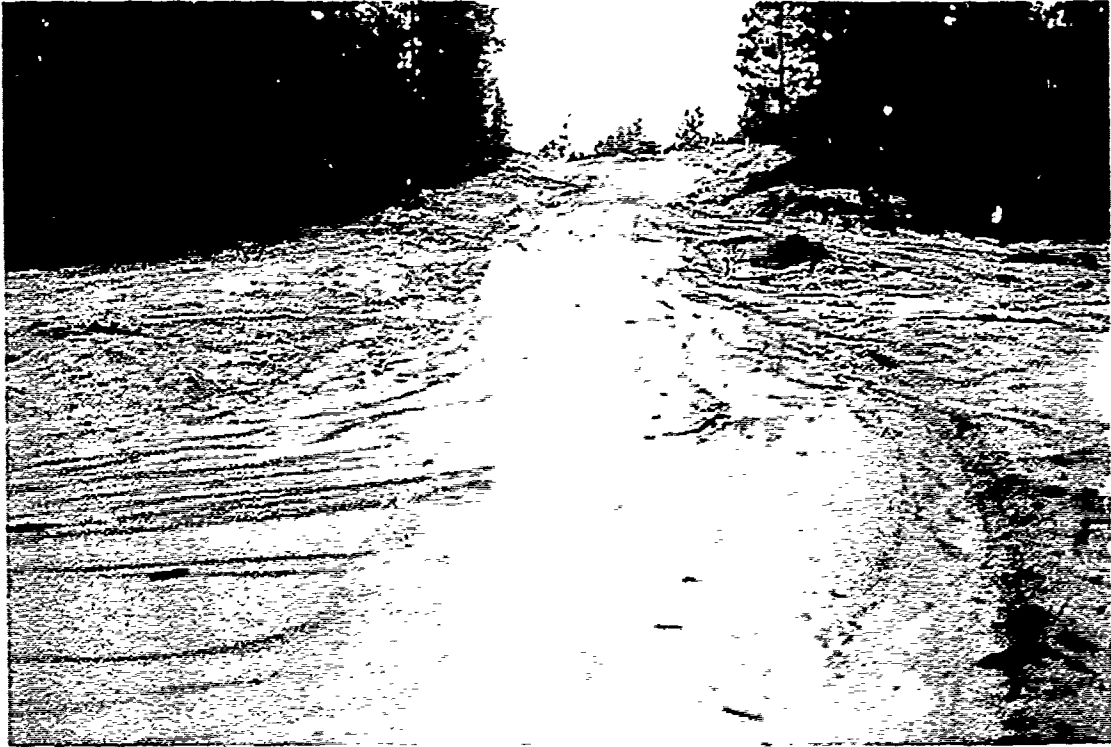
Photo 3-1 View up Winslow Way road cut, October 10, 1990. Sediment is transported directly into channel.

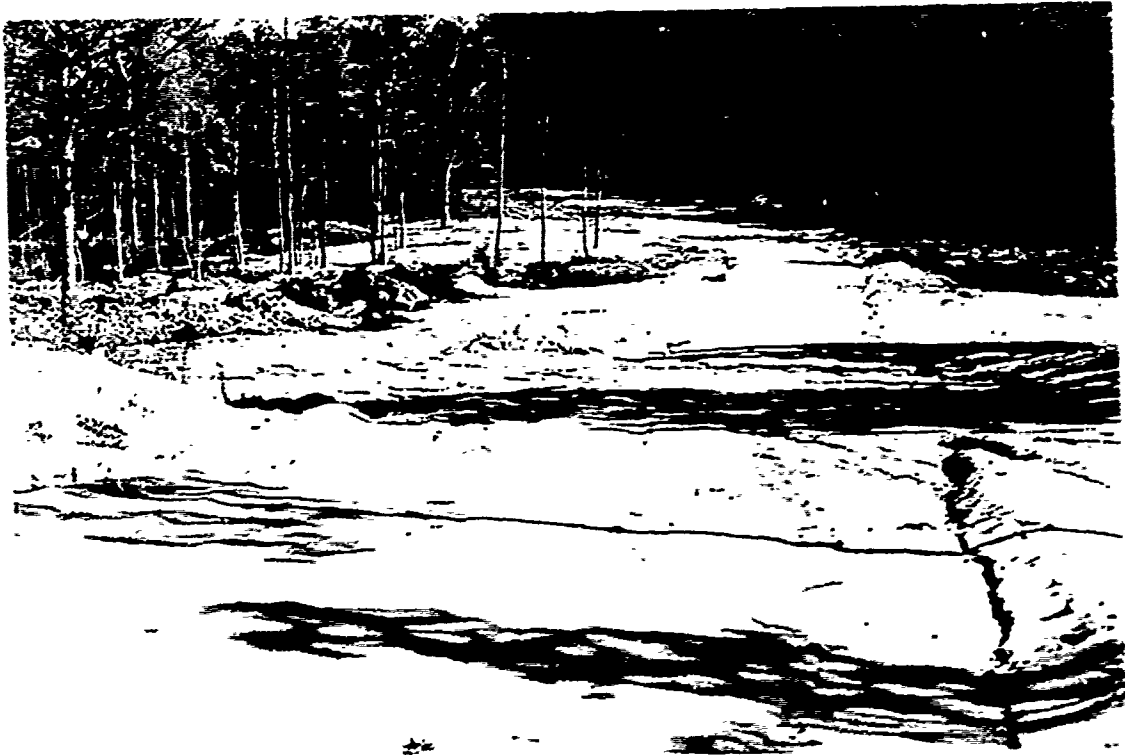
Photo 3-2 View down Winslow Way road cut. Winslow Creek in middle foreground flowing left to right.

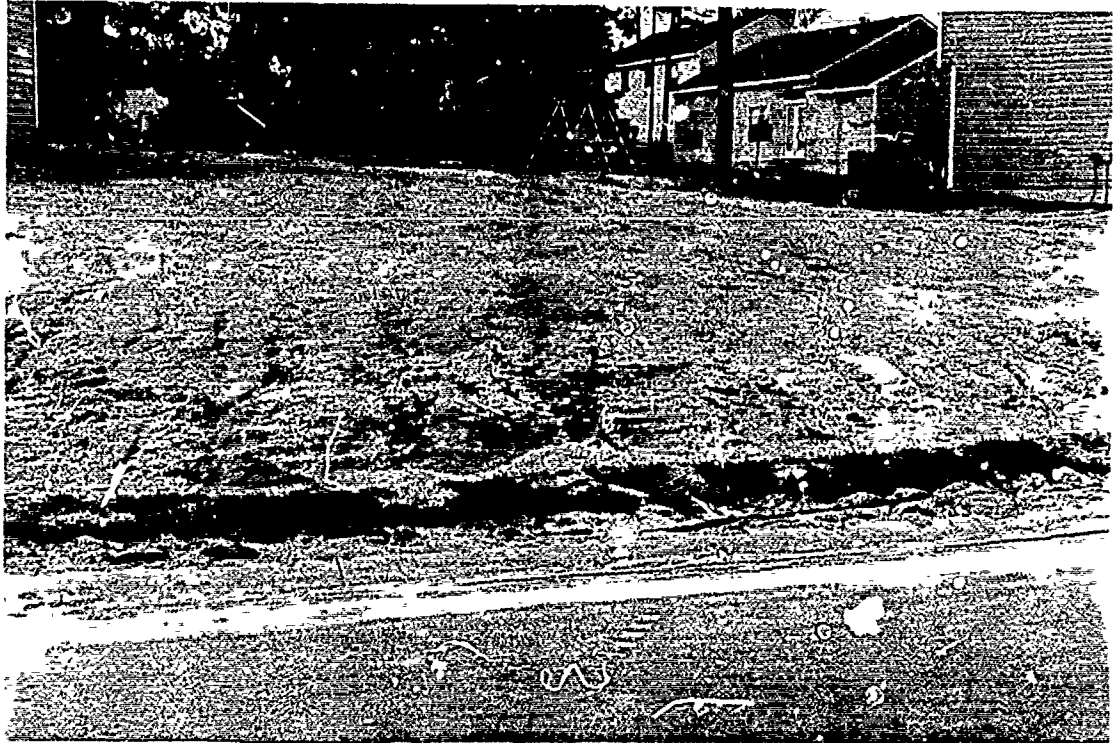
Photo 3-3 Unvegetated homesite in subdivision. Notice rills and sediment collecting in the street.

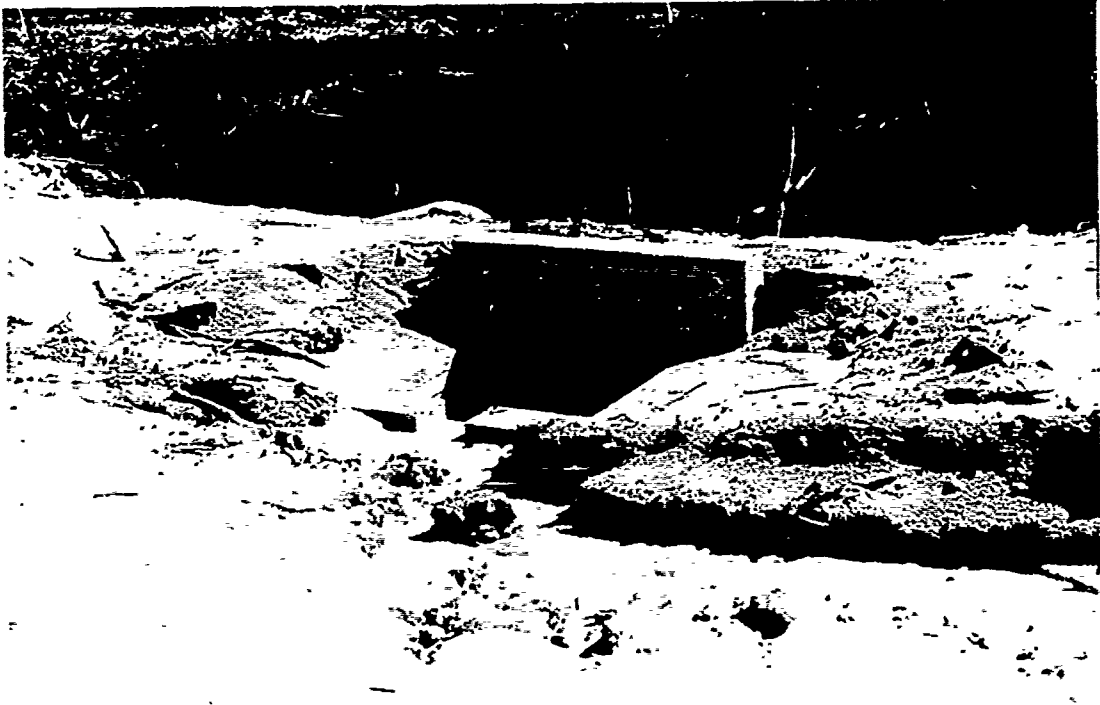
Photo 3-5 Unprotected storm sewer drop inlet on Winslow Way road cut. Sediment flows freely into creek through this.

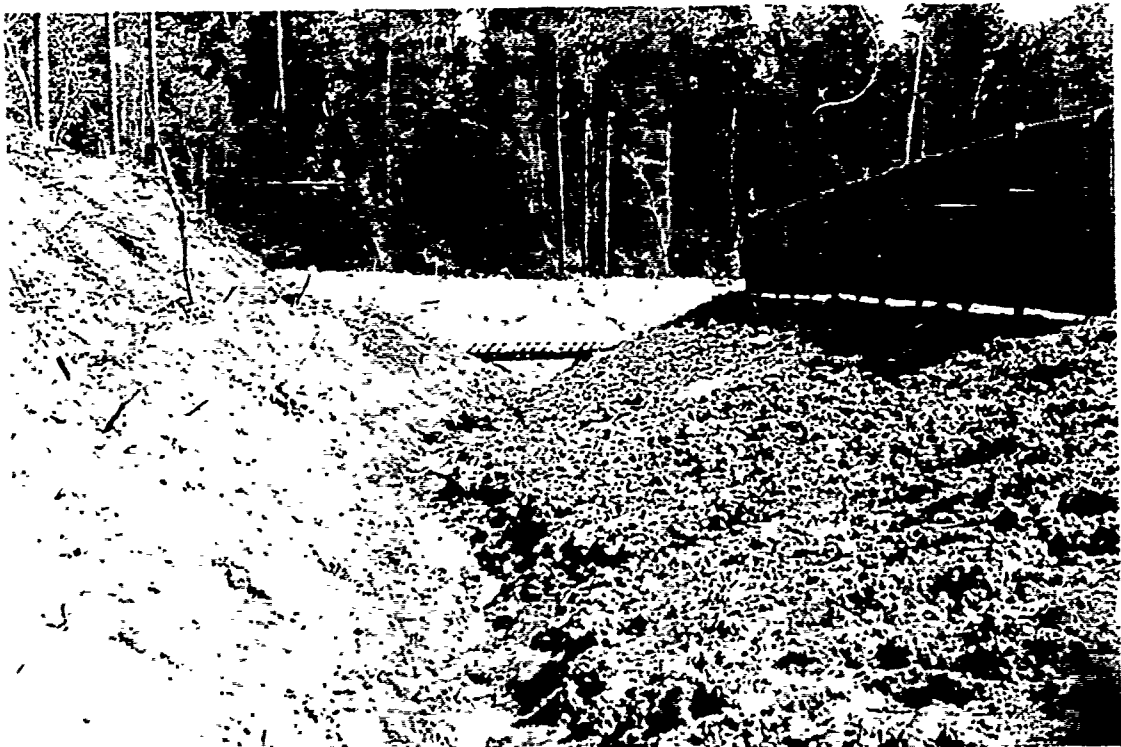
Photo 3-6 Channel cross-section #7 on Moss Field Creek. Notice large rills on channel banks and erosion in channel. August 23, 1990.

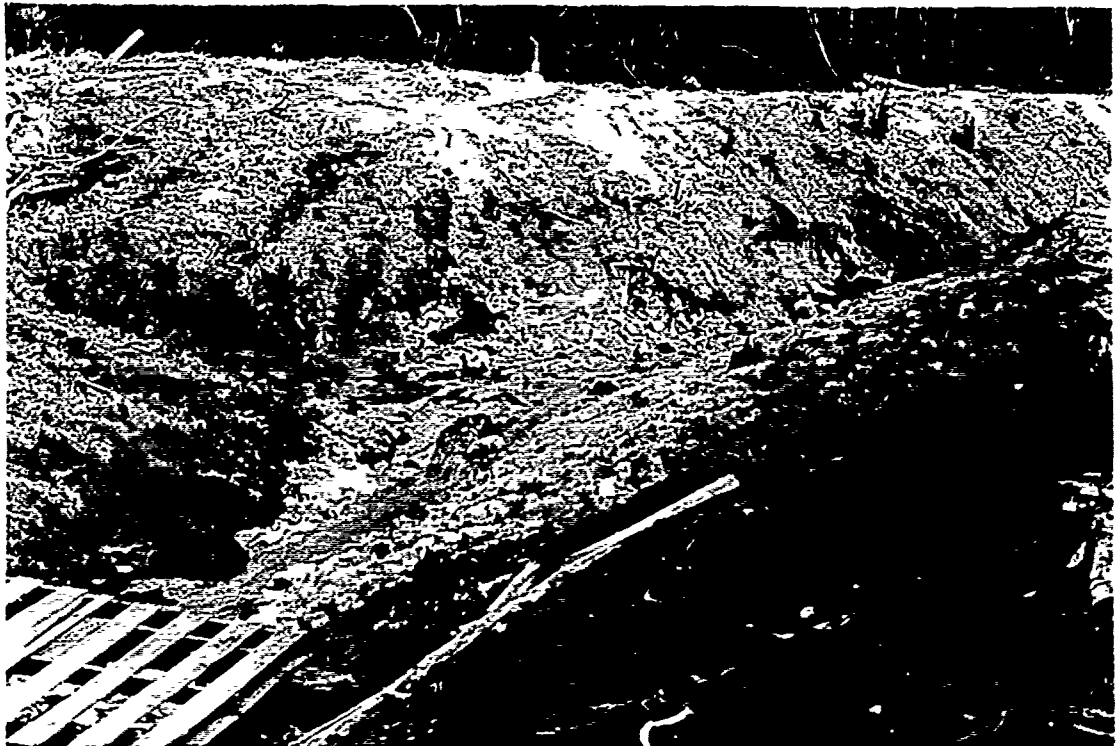
Photo 3-7 Confluence of Winslow and Moss Field Creeks.
Cross-section #8 is just above slough on right side of
photo. August 23, 1990.

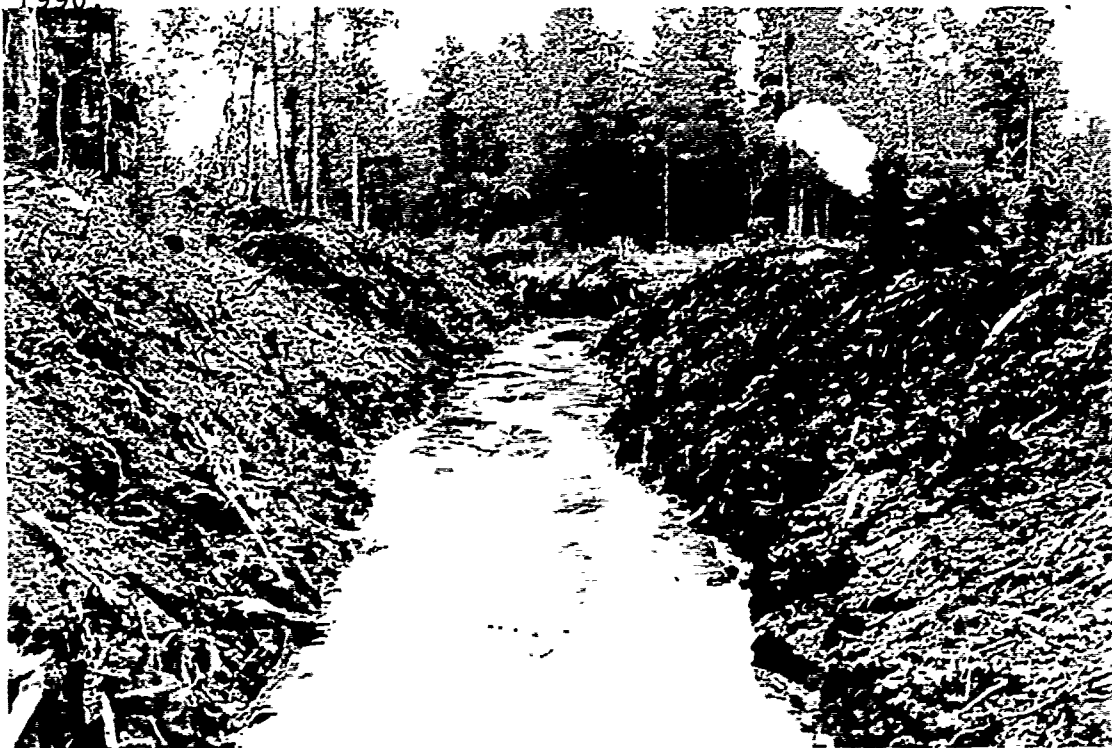
Photo 3-9 Cross-section #9. Sandy channel bottom bed material is approximately 2' thick. Note bare channel banks. August 23, 1990.

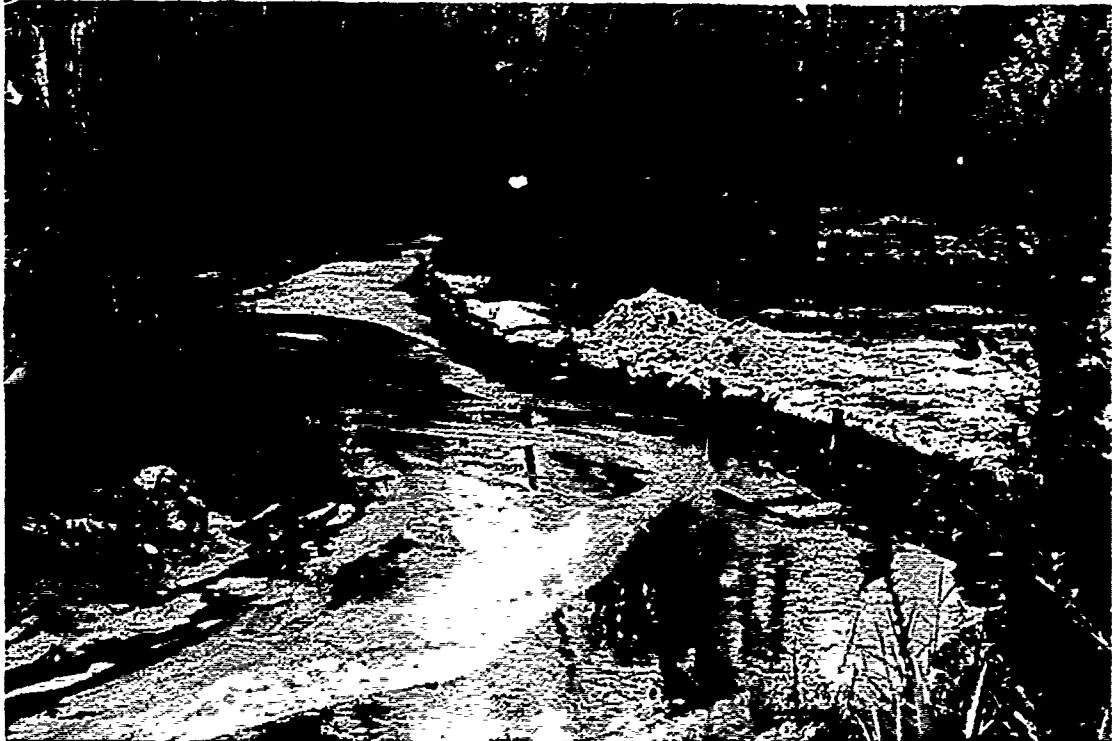
Photo 3-10 View downstream to cross-section #11 on Winslow Creek. Note point bar consisting of coarse sand and gravel. August 23, 1990.

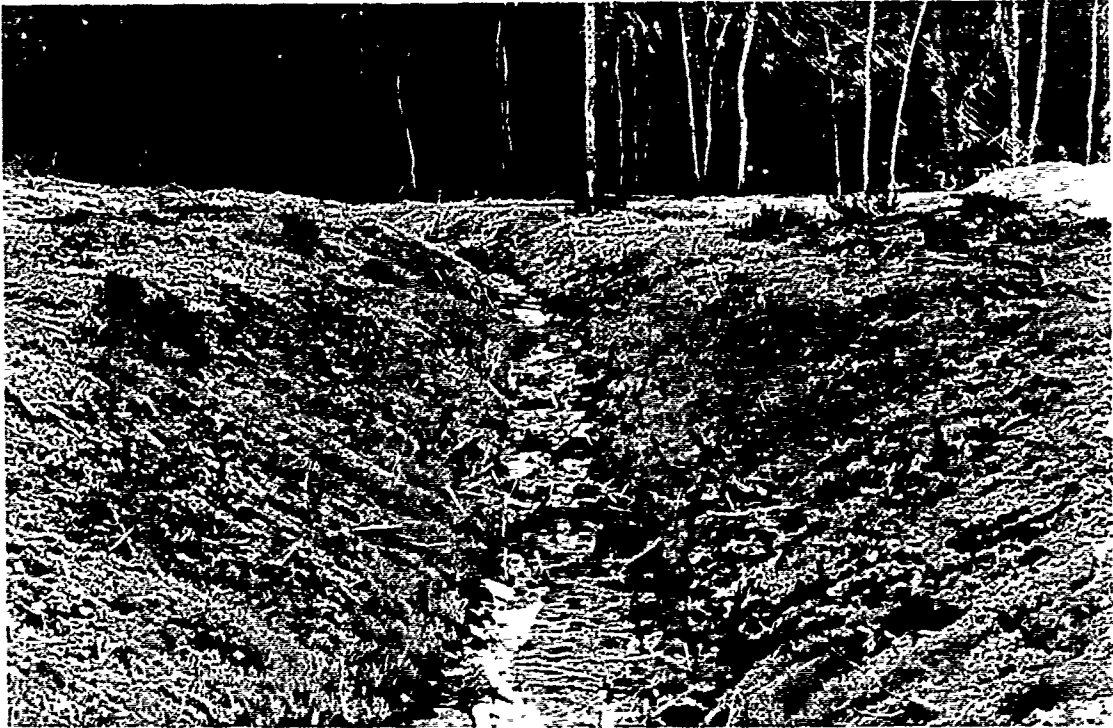
Photo 3-12 View upstream to cross-section #5 on Thornfield Creek. Note growth of grass seed emulsion. August 9, 1990.

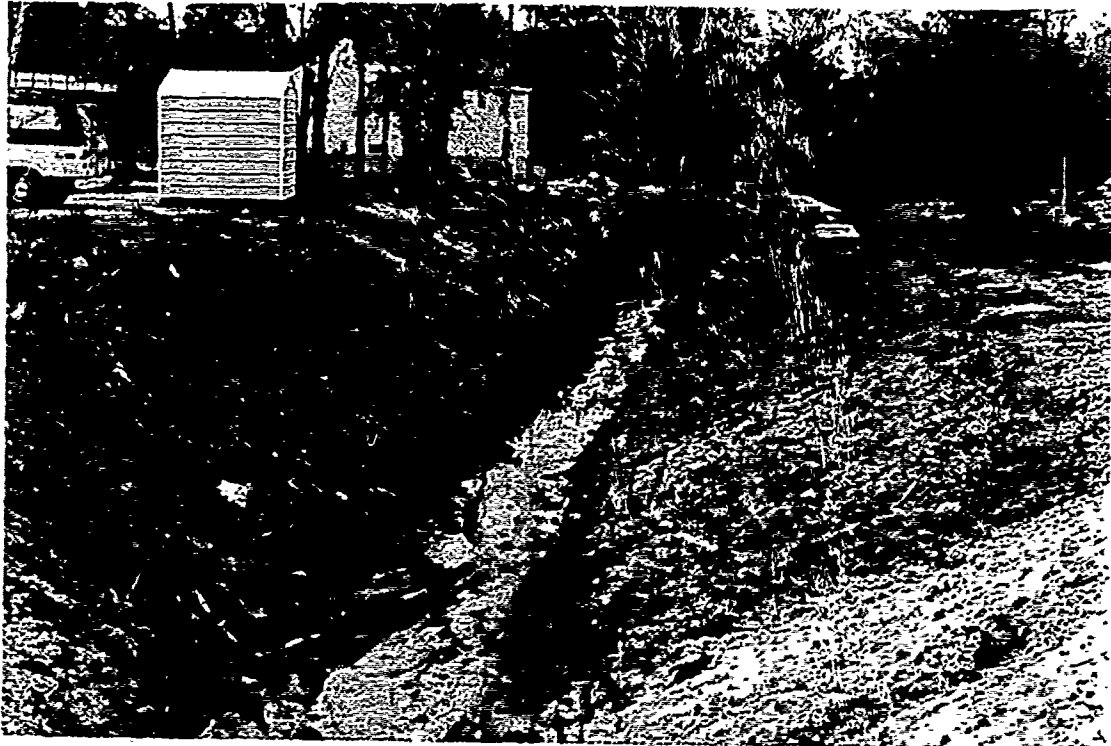
Photo 3-14 View downstream to cross-section #6 on Thornfield Creek near log. Note growth of grass. August 8, 1990.

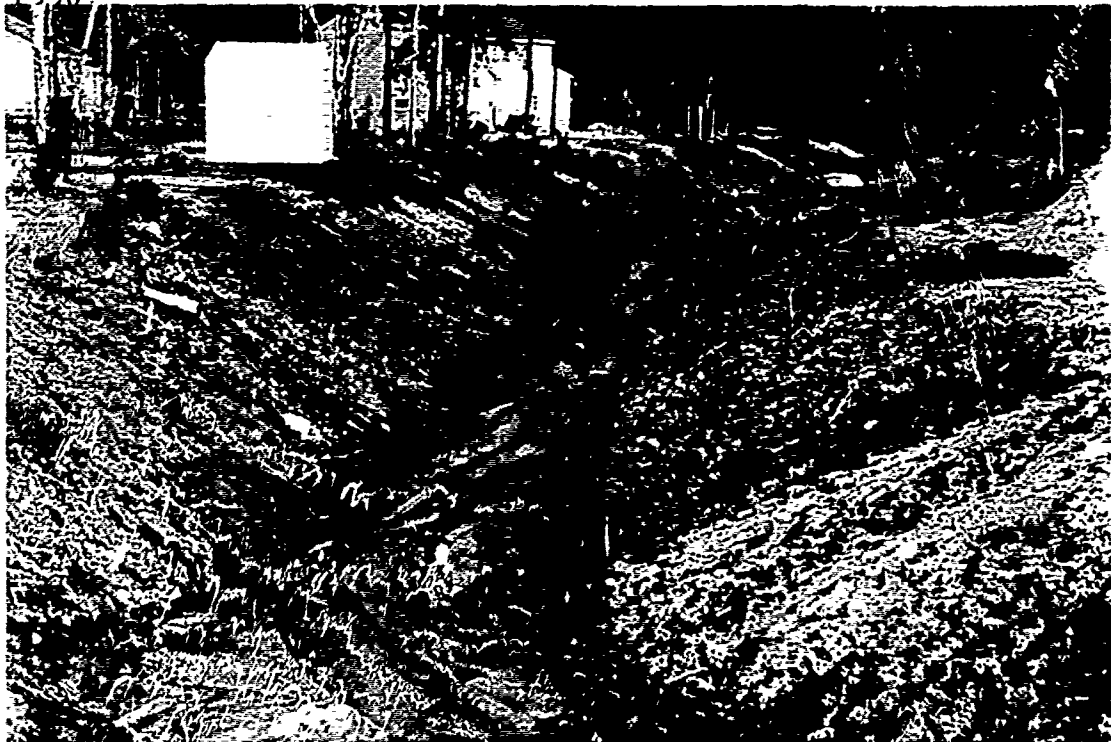
Photo 3-15 View downstream to cross-section #6 on Thornfield Creek near log. Grass at cross-section is stabilizing channel banks. August 31, 1990.
