1. Agency Use Only (Leave blank).		2. Report Date. March 1991		3. Report Type and Dates Covered. Proceedings	
4. Title and Subtitle. Microbiologically Influenced Corrosion of Copper Alloys in Saline Waters Containing Sulfate-Reducing Bacteria				5. Funding Numbers. Program Element No. 0601153N Project No. 3102 Task No. 330 Accession No. DN094463 Work Unit No. 13331A

The NACE Annual Conference and Corrosion Show

MICROBIOLOGICALLY INFLUENCED CORROSION OF COPPER ALLOYS IN SALINE WATERS CONTAINING SULFATE-REDUCING BACTERIA

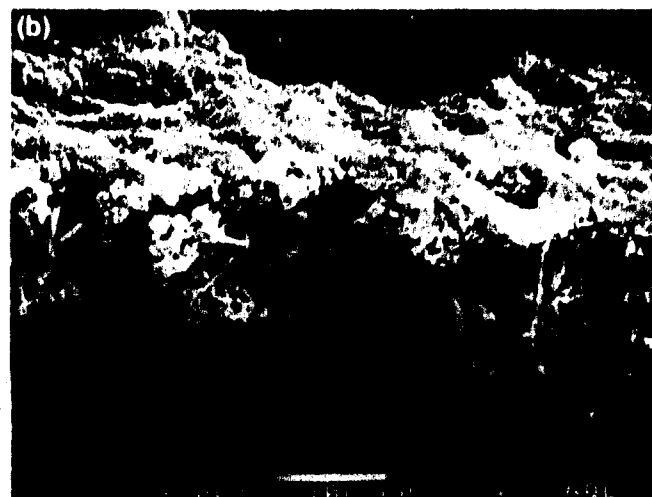
CDA 706. The surface of the CDA 706 pipe was heavily pitted (Figure 1a). Surface deposits were thick and multilayered, varying in color with depth. Outermost layers were dark green to reddish-brown. Bright bluish-green deposits were found on the surface in unpitted areas. Pit interiors were black and pit depths were typically 1.7-2.0 mm. A cross-section through the pitted areas exposed subsurface bacteria within the thin, black deposit and a spongy subsurface (Figure 1b). Scrapings from the area within the pits indicated the presence of 1×10^5 SRB cm⁻² compared to 1×10^1 SRB cm⁻² detected within the surface film on the unpitted areas. The EDS spectrum of the base metal showing the relative concentrations of iron, nickel and copper is shown in Figure 2a. An EDS spectrum taken in the bacterial layer showed concentrations of aluminum, silicon, phosphorus, sulfur, calcium and chlorine in addition to elevated amounts of iron and nickel (Figure 2b,c). The EDS spectrum of the spongy layer under the bacteria indicated an accumulation of phosphorus and a depletion of nickel (Figure 2d).

Figure 1. (a) Cross-section of CDA 706 piping after one year in seawater service showing thick surface deposits and pitting; (b) SEM micrograph of bacteria in cross-section of pitted area.

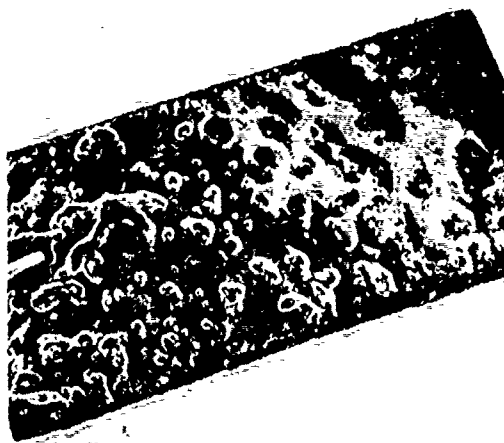
All copper-containing metals exposed to anaerobic cultures containing SRB were covered with black sulfur-rich deposits (Figure 5 b,d). Samples exposed to growth medium only exhibited a thin black tenacious layer on 99Cu and no black deposits on brass (Figure 5 a,c). The thickness of the surface deposits on 99Cu in the presence of SRB varied among the cultures (Figures 6 a,b, Table 3). The tenacity of the corrosion products varied with material and culture.

Figure 5. (a) Surface of 99Cu after 4-month exposure to growth medium-NaCl with no SRB added, (b) Surface of 99Cu after a 4-month incubation with culture III, (c) Surface of brass foil after 4-month exposure to growth medium NaCl with no SRB added; (d) Surface of brass foil after 4-month incubation with culture I.

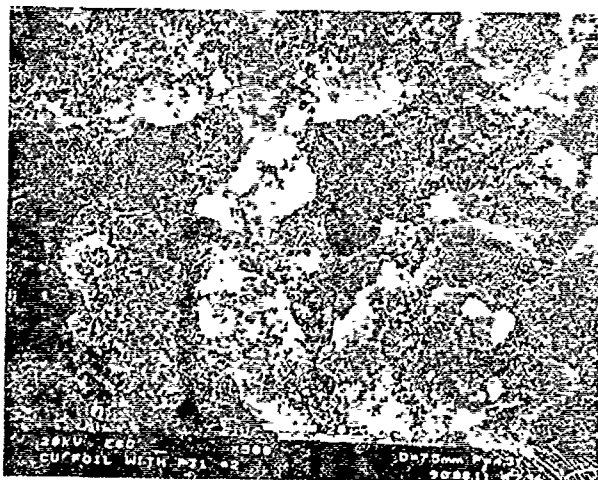
Sulfide layers on 99Cu were consistently nonadherent and in the case of culture VI most of the surface deposits sloughed into the growth medium (Figure 7). Sulfide corrosion products on copper alloys were more adherent. Sulfide layers on all brass samples were thin, tenacious and difficult to scrape from the surface. In all cases, bacteria were closely associated with the sulfur-rich deposits (Figure 8 a-d). Many of the bacteria were encrusted with deposits of copper sulfides (Figure 9). Figure 10 is an EDS spectrum collected from the surface of CDA 706 colonized by culture VII. Surface deposits were enriched in silicon, phosphorus, sulfur, manganese, iron and nickel. Table 4 is a summary of the elemental composition of 90Cu:10Ni and 70Cu:30Ni before and after colonization by cultures II and VII, respectively. In both cases the sulfide layers were enriched in iron and nickel. The biofilm on 90Cu:10Ni contained elevated amounts of manganese. The surface chemistries on brass were not evaluated because the EDS software cannot quantify zinc.

Figure 7 Surface of 99Cu after 4-month incubation with culture VI

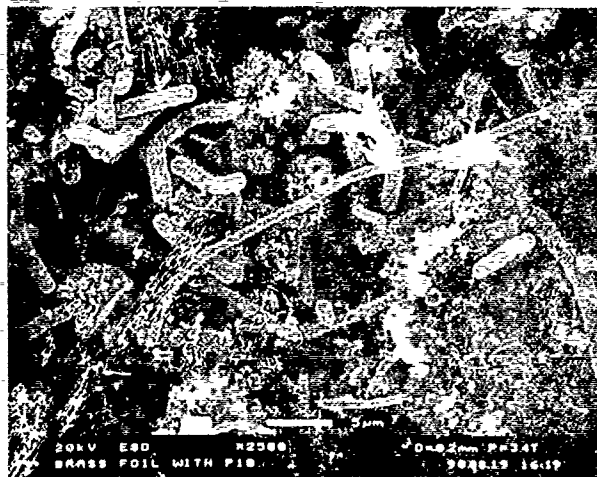
Figure 8. ESEM micrographs of biofilms: (a) Copper foil after 4-month incubation with culture II, (b) Copper foil after 4-month incubation with culture III, (c) Brass foil after 4-month incubation with culture I, and (d) Brass foil after 4-month incubation with culture V.

A very important feature of wet biofilms on copper-containing metals was that the microorganisms were distributed throughout the copper/nickel/iron-rich surface layers and not on top of these layers as some traditional scanning electron
