**TENSILE STRENGTH CHARACTERIZATION  
OF A METAL MATRIX COMPOSITE  
WITH CIRCULAR HOLES**

**THESIS**

Master of Science in Aeronautical Engineering

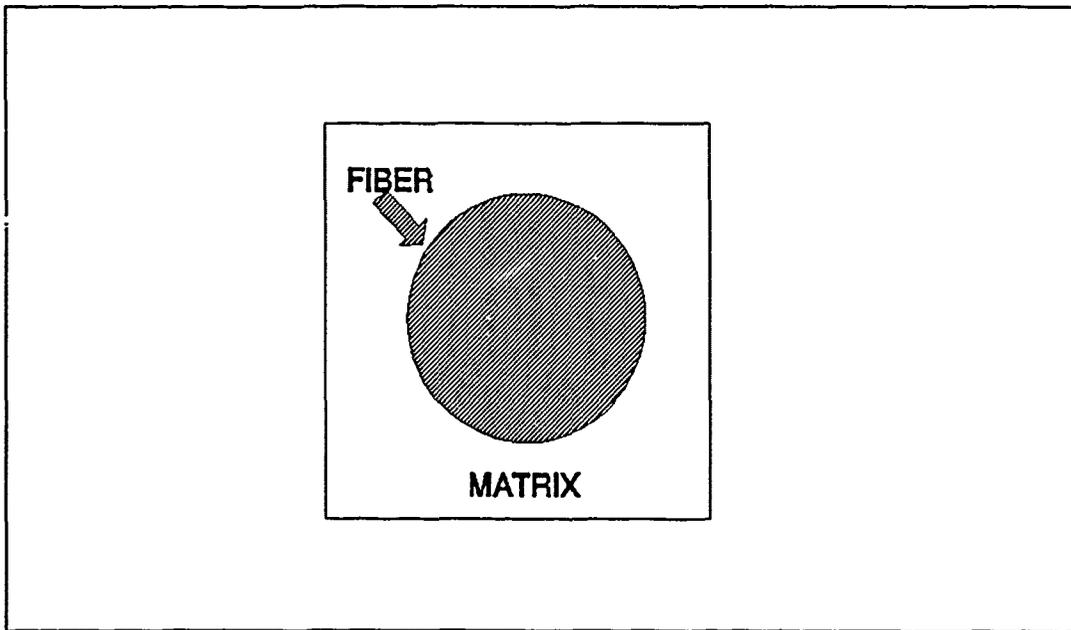
be taken up by the matrix so that the sum of the matrix volume fraction ( $V_m$ ) and  $V_f$  is always one. Several techniques exist for calculating  $V_f$  and a rectangular representative volume element was chosen for this research. The cell contains one circular fiber and the dimensions of the rectangle are determined by the fiber spacing and the lamina thickness. Figure 1 shows a rectangular volume element.

**Figure 1** Representative Volume Element

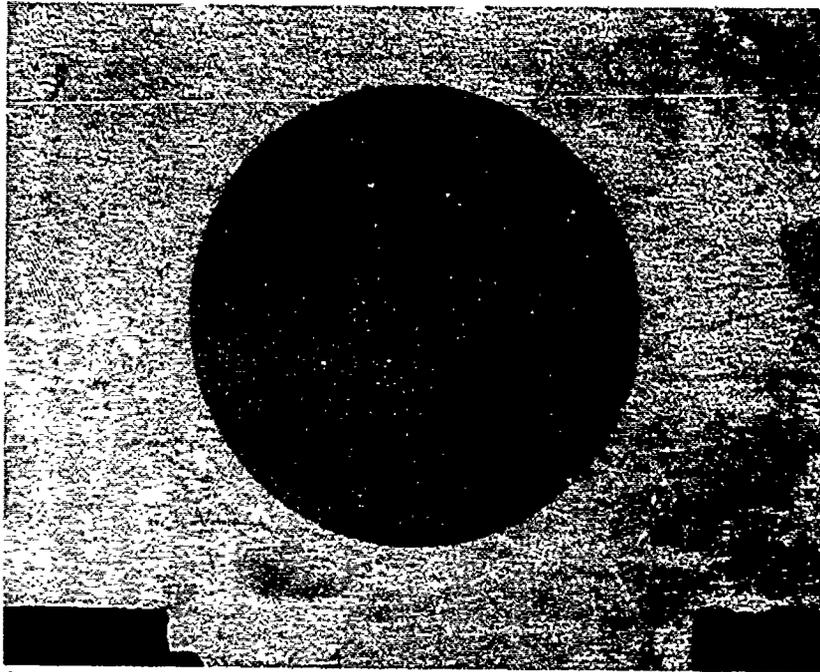
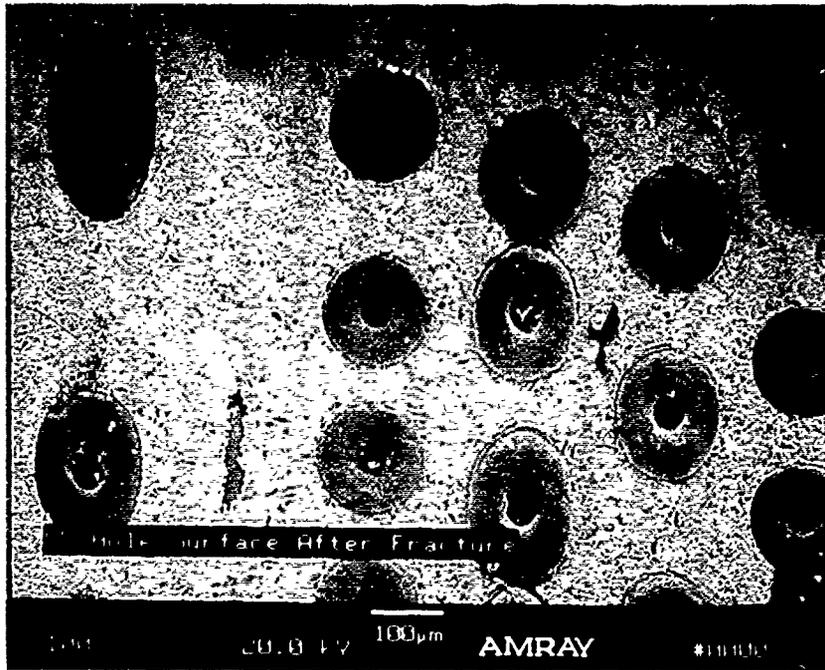
Figure 2 Typical Hole Shape

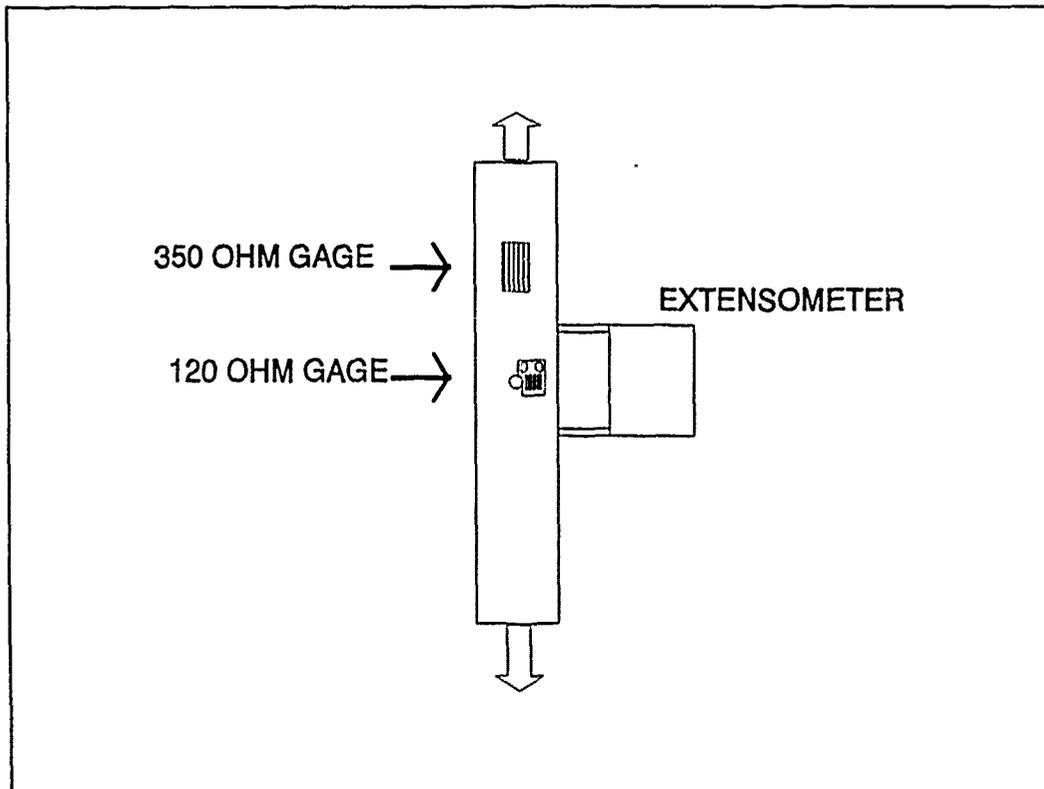
Two strain gages were used to measure tensile strain for the room temperature tests. A Micromeritics CEA-06-032UW-120 gage was mounted close to the hole. This has a gage length of 0.8 mm, a gage factor of 2.05, and a resistance of 120 ohms. A 350 ohm gage with a gage length

of 6.4 mm was located over two hole diameters away from the expected failure zone. This Micromeasurements CEA-03-250UW-350 has a gage factor of 2.075 and provided remote strain data. While the entire effect of the stress concentration created by the hole can only be seen by placing a gage on the surface inside the hole, some increase in strain could be seen with the local gage. Removing the extra foil nearest the hole allowed the placement of the gage less than 1 mm from the hole edge. Both gages were affixed using standard techniques. Figure 3 shows the placement of the gages.

Figure 3 Strain Gage and Extensometer Location

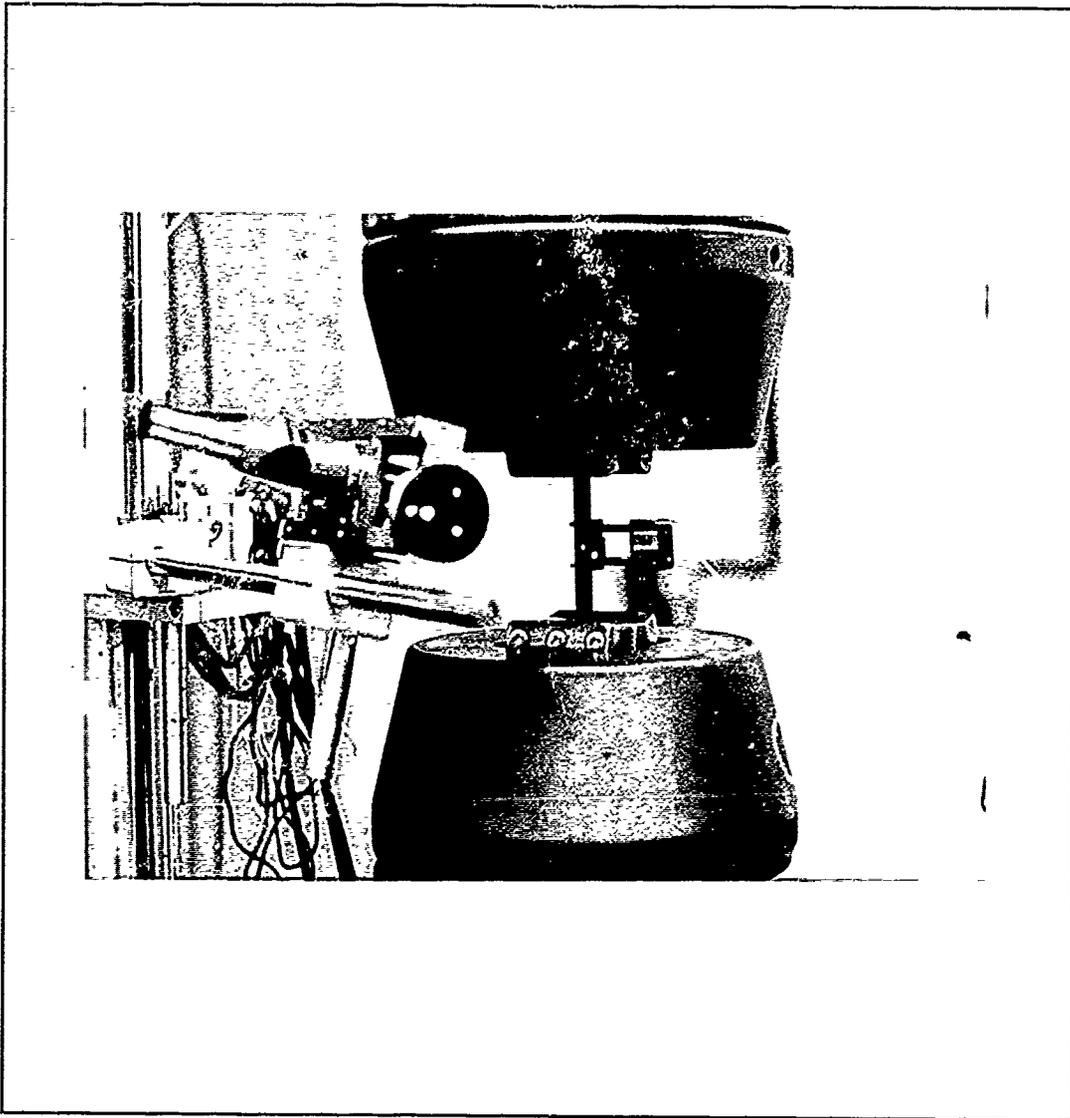
Room Temperature Set-up and Procedures. The data collection for the room temperature tests consisted of strain gages and extensometer with amplifiers, the load cell of the MTS tensile tester, and the acoustic emission equipment. Figure 4 shows a specimen in the grips with the extensometer mounted. The two strain gages were connected through Micromeritics 2300 Strain Gage Conditioning Amplifiers to a Quatech ADM-12 analog to digital conversion board. The MTS 632-20b clip gage extensometer used the same type of amplifier. A fourth port on the Quatech board received the data from the MTS 810 load cell output and the data was all stored in a single file using a personal computer.

The extensometer used a one inch gage length and was mounted to surround the hole. This provided a total of three strain information sources for the tests. The strain into the extensometer included some strain similar to the 350 ohm remote gage and the strain reflected by the 120 ohm local gage. It then provided a check on strain gage

**Figure 4** Room Temperature Set-up

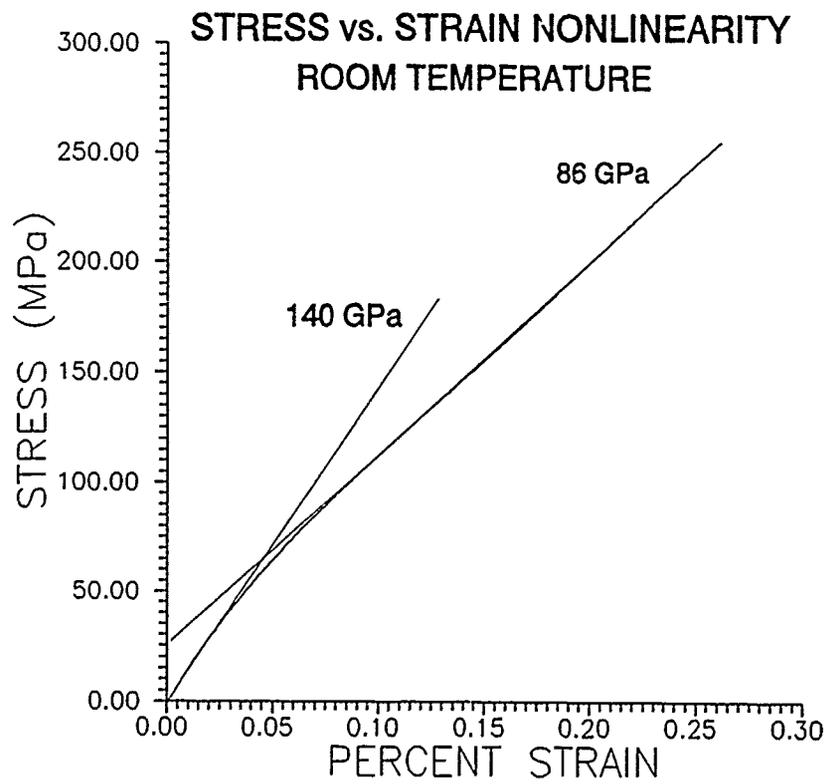
Yield Stress Calculation. While the shape of the curve is not typical of matrix yielding, the residual stresses in some metal matrix composites cause yielding at very low mechanical loads. The possibility of matrix yielding must be addressed. Figure 6 shows the remote stress plotted against remote strain for four different room temperature tests. The specimens had different hole sizes so the curves end at different ultimate stresses. Note that in each case the plot is linear to about 60 MPa and then curves until

**Figure 5** Stress vs. Strain Showing Nonlinearity at Room Temperature

about 120 MPa. The plot is linear from this point all the way up to 500 MPa. The largest tensile residual stress for any off-axis laminae in this material and lay-up is 270 MPa. This was calculated using a program called METCAN, which was developed at NASA by Murthy (16). It is a micromechanics analysis which has been developed to calculate the microstresses in metal matrix composites. The first evidence of debonding shown is in the 90° ply so the sum of mechanical and residual stresses is examined there. The mechanical stress in the 90° plies is less than 100 MPa for a 140 MPa stress on the laminate. The value of 140 MPa is used because Figure 5 shows the stress vs. strain linear again by that stress. The sum of the 100 MPa mechanical stress and the 270 MPa residual stress totals less than half of the 840 MPa yield stress of Beta 21S (4). This shows that the nonlinearity is not due to yielding of the matrix.

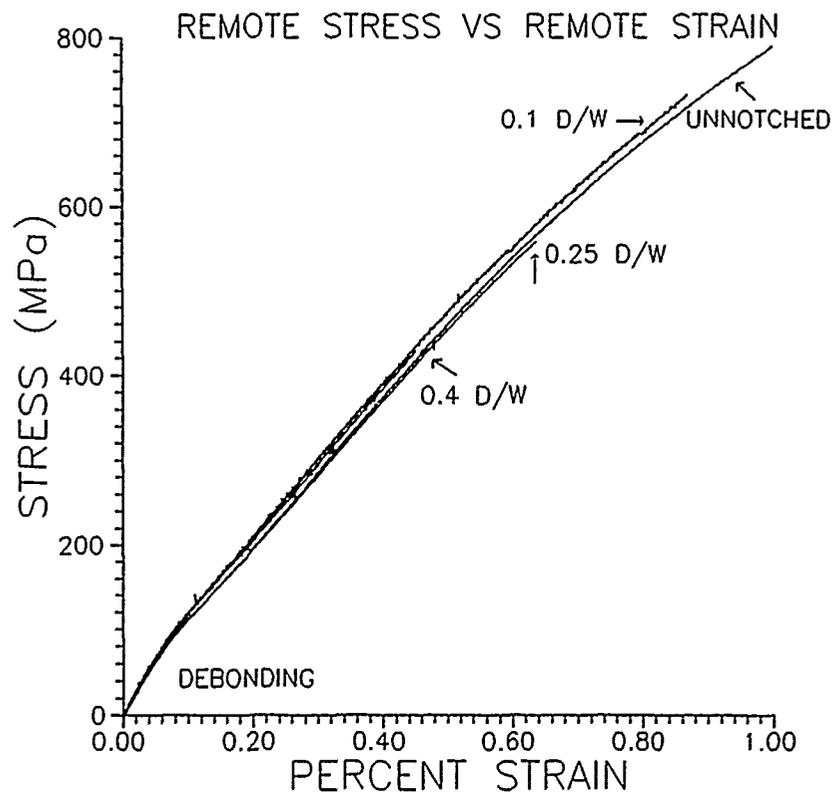
Figure 6 Nonlinearity Consistent for Four Separate Tests

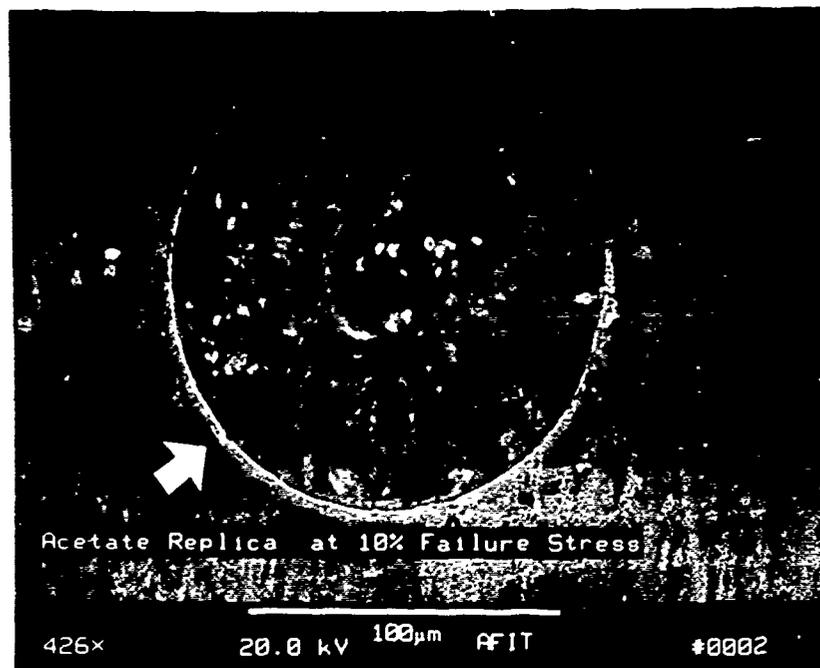
Figure 8 Acetate Replica for 10% of Failure Stress

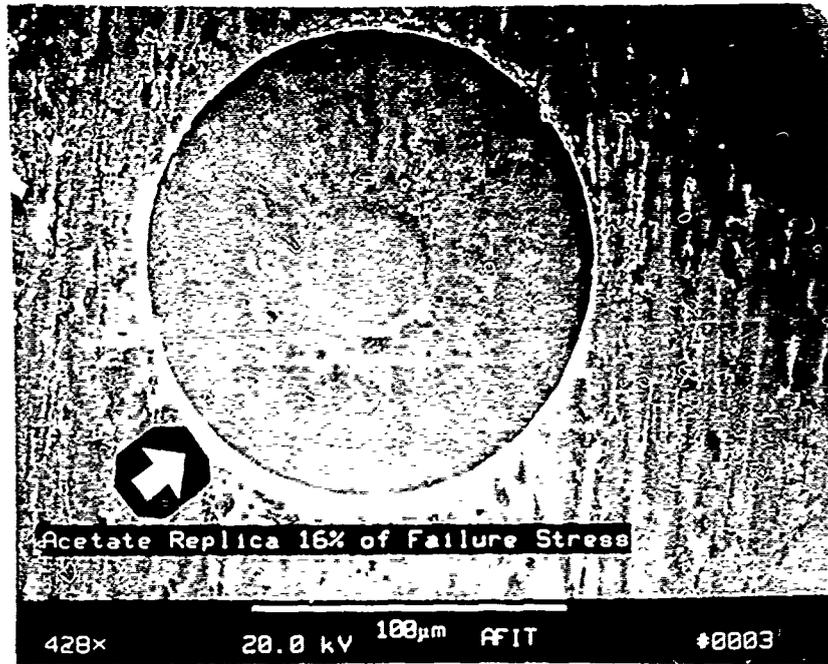
Figure 9 Acetate Replica at 16% of Failure Stress

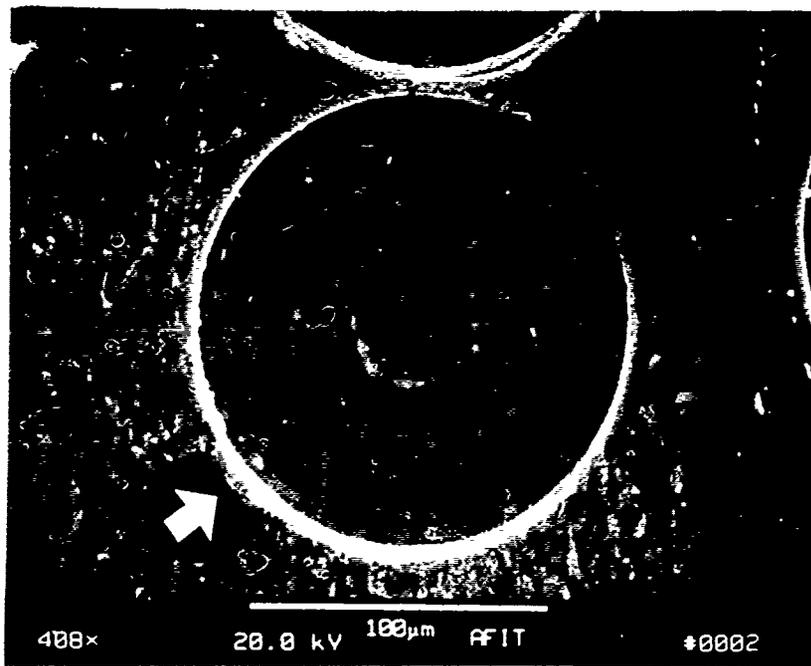
Figure 10 Acetate Replica at 20% of Failure Stress

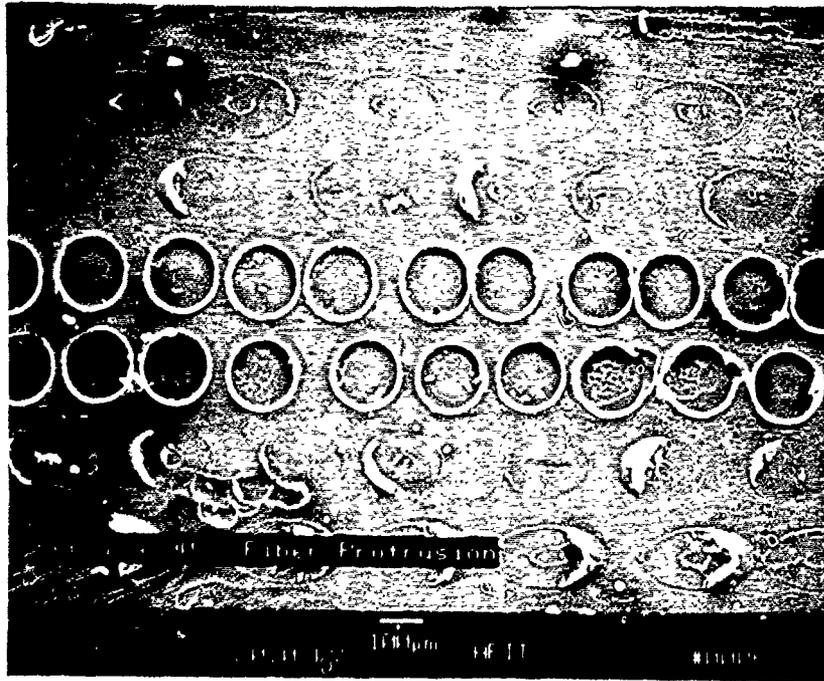
The final replica shows the clumps of acetate which surround the 90° fibers at 90% of failure stress. The high

modulus debonded fibers extend beyond the matrix during loading, since the Poisson effect pulls the matrix in. The effect is most prominent in the  $90^{\circ}$  fibers, since transverse stresses easily pull the matrix directly along the fibers. At higher stresses the transverse strain of the matrix is greater and near failure stress the fibers protrude significantly. The acetate gathers around the rim on the surface of the matrix, as seen in Figure 11. Very little acetate is seen surrounding the  $45^{\circ}$  fibers, but further evidence and analytical work show that they are debonded as well.

Figure 11 Acetate Replica at 90% of Failure Stress

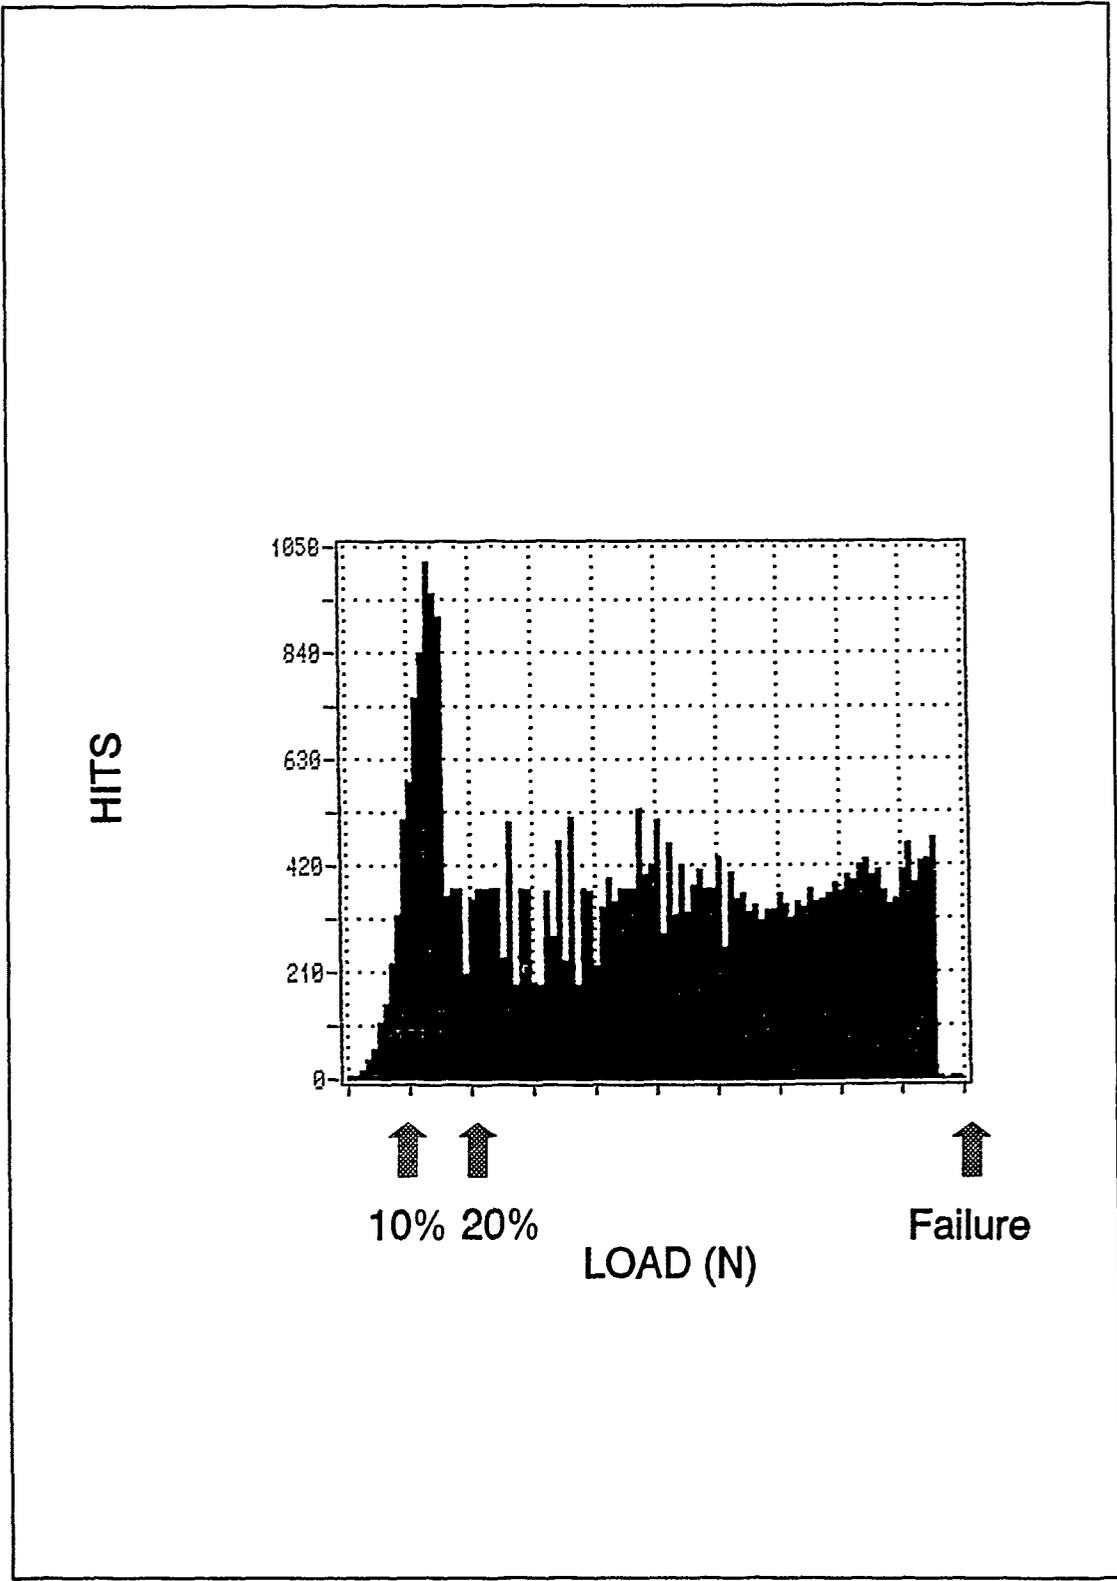
Acoustic Emission. Acoustic emission data for all specimens tested showed tremendous activity at the same stress levels where the replicas show debonding. Figure 13

is a histogram of hits vs. load. Surprisingly, the peak activity zone is not near the failure load. The large number of hits between 10% and 20% of failure stress corresponds to the nonlinearity of the stress vs. strain curve and the evidence shown by the replicas. This acoustic activity is the result of the matrix pulling away from the fibers and cracking the interface zone.

Figure 13 Acoustic Emission Plot of Hits vs. Load Showing Debonding

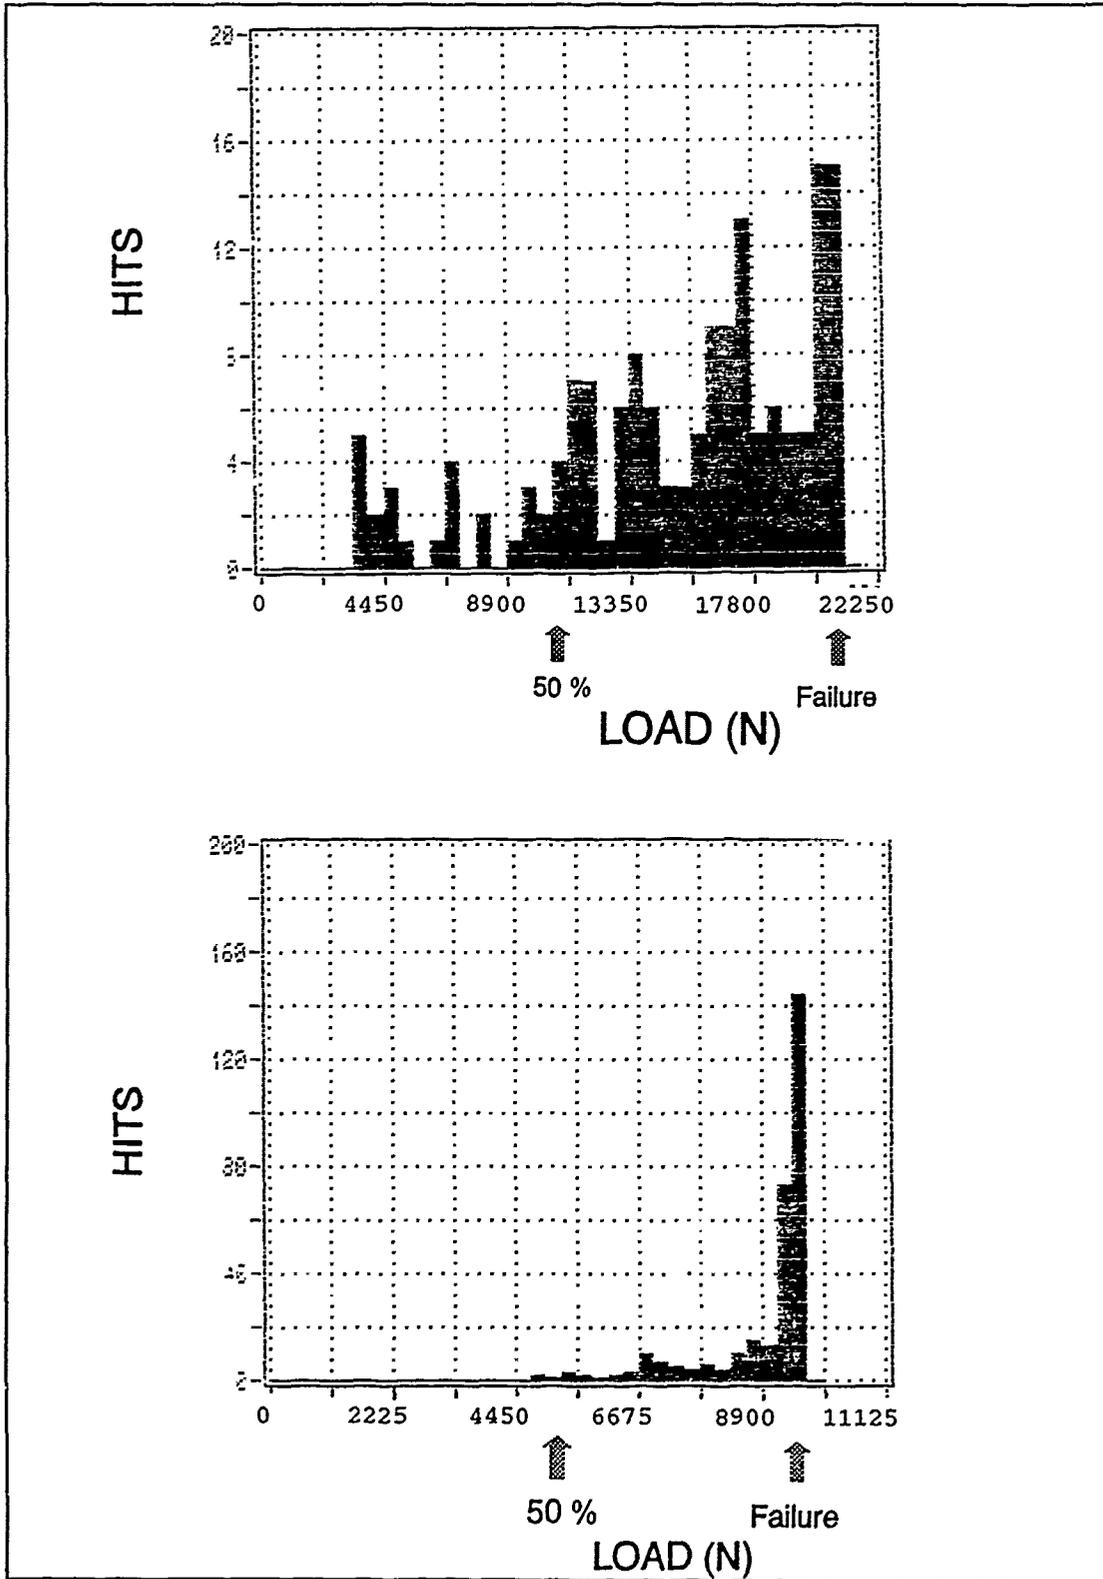
Figure 14 Acoustic Emission Data For Unnotched Tests at Room Temperature

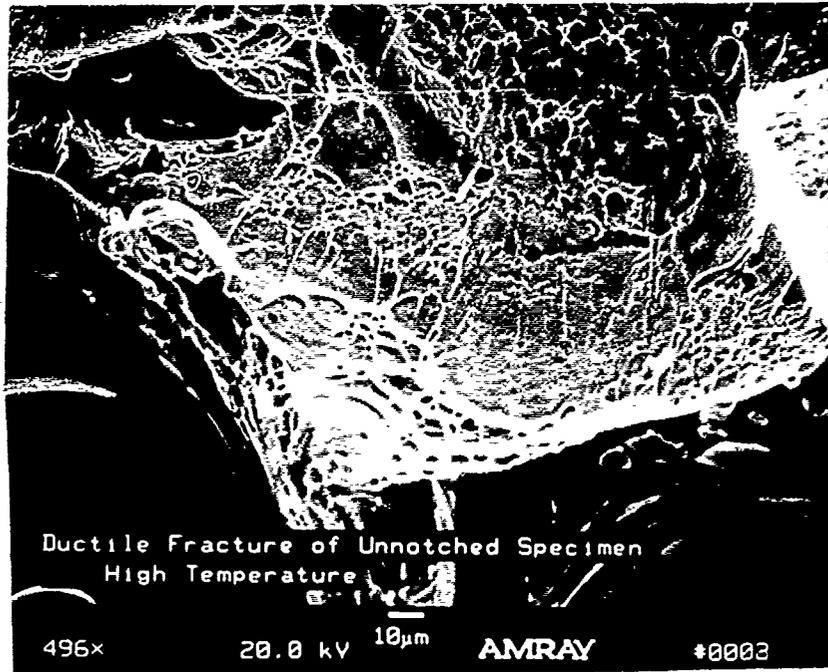
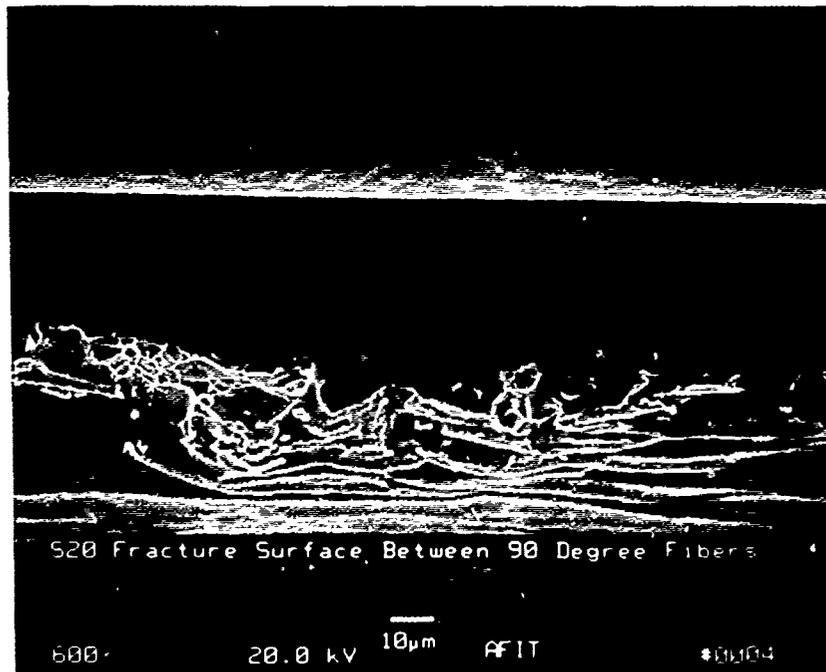
The SEM photographs in Figure 16 shows the type of fracture surfaces seen in the matrix of the 650°C specimen. The top photograph was taken near the 0° fibers. This type of ductile fracture was seen over most of the surface, especially near the fibers. In a few cases the cleavage fracture shown in the bottom picture was seen. Even for this picture higher magnification shows that it is primarily a ductile fracture. Photographs of room temperature specimens with holes shown below have obvious dimpling in the fracture surfaces. Higher magnification of the apparently flat surfaces in the bottom photograph of Figure 16 revealed dimples here as well. The weaker matrix at elevated temperature allows initiation of dimpled fracture at small particles as well as large ones. This results in a flatter surface, but the fracture is still primarily

Figure 16 Fracture Surface of Unnotched Specimen at 650°C

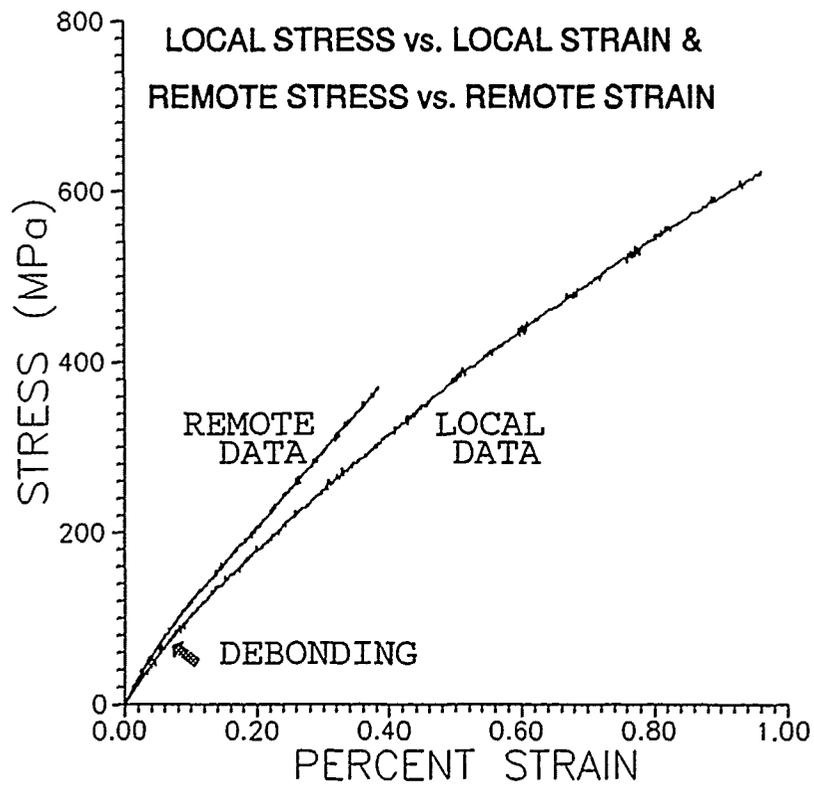
Figure 18 Local  $\sigma$  vs Local  $\epsilon$  & Remote  $\sigma$  vs Remote  $\epsilon$

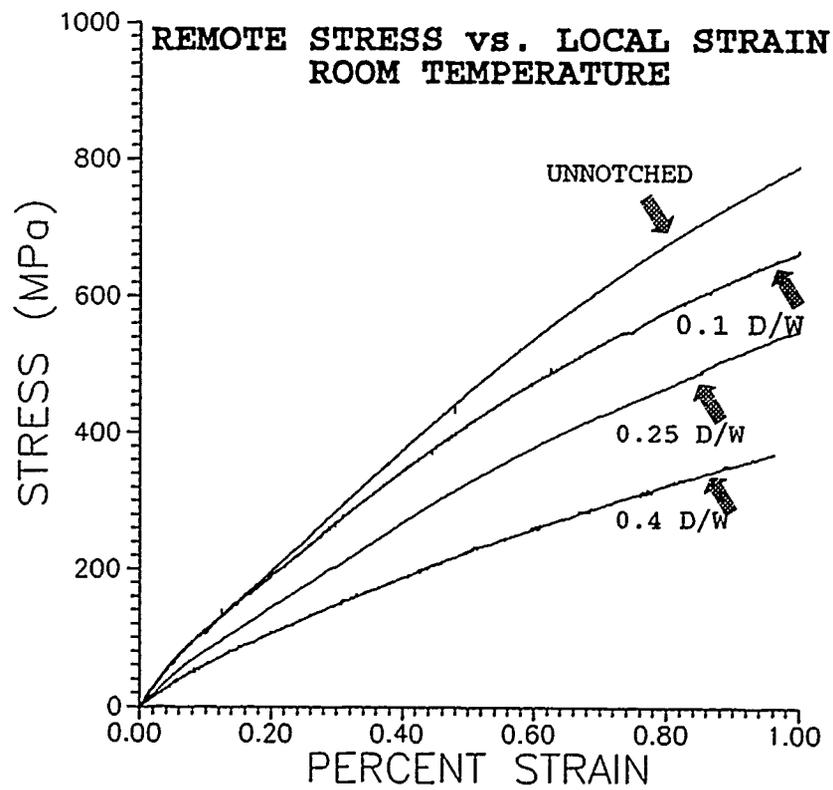
Figure 19 Remote Stress vs Local Strain at Room Temperature

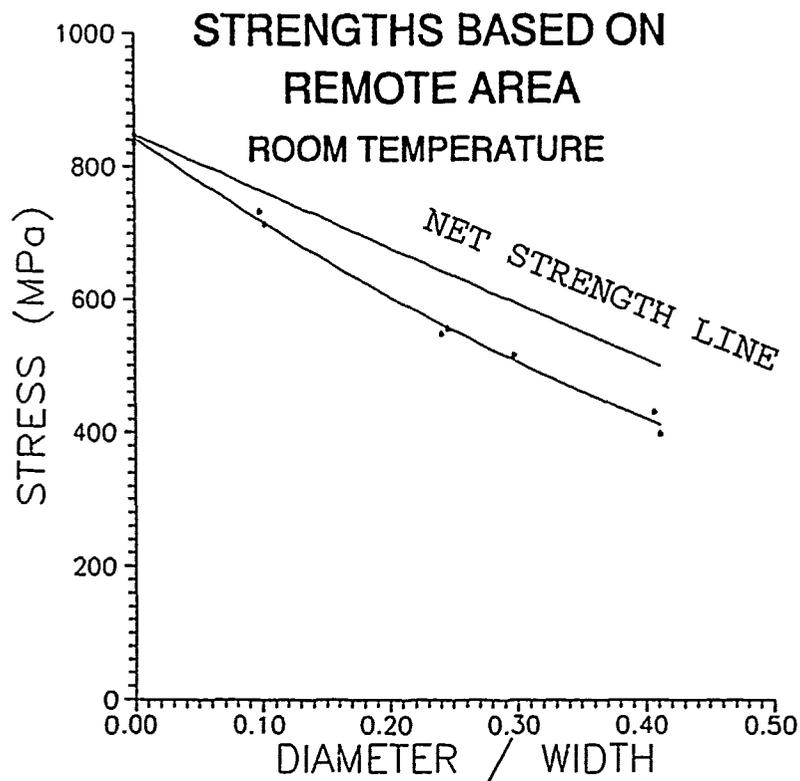
Figure 21 Failure Stresses as a Function of D/W

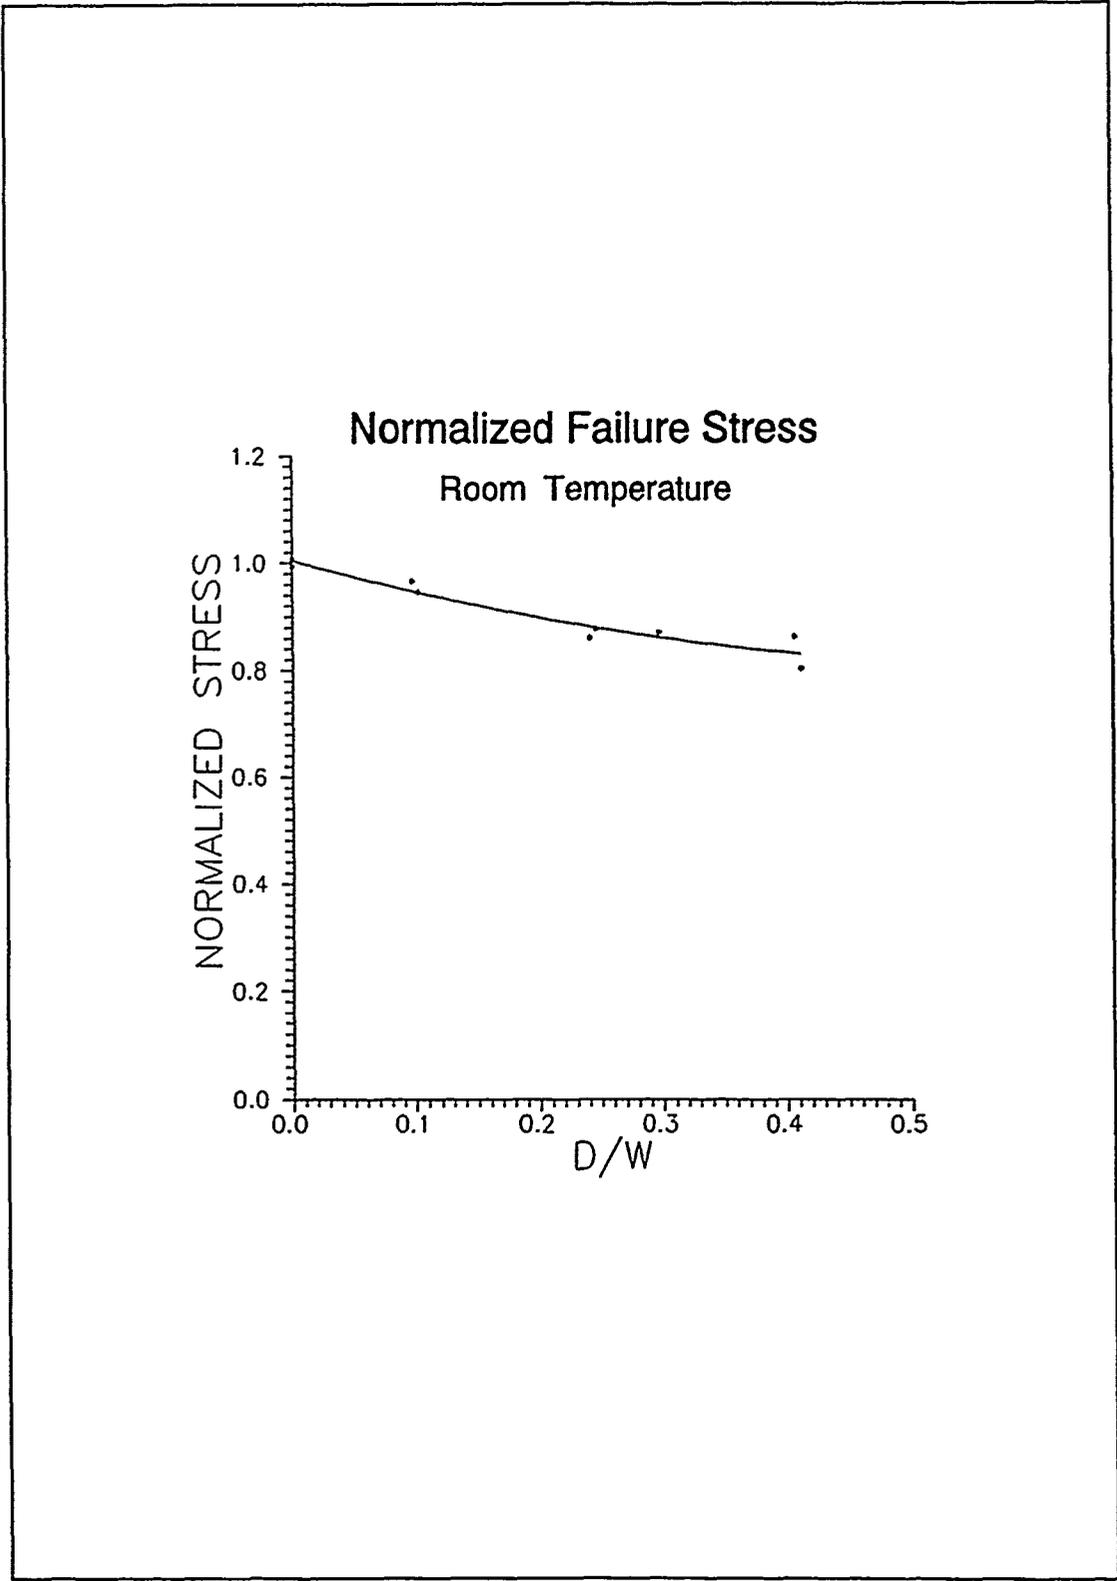
To accentuate the effect of the stress concentration at the hole, Figure 22 plots the same data as before, but with the section area stress at failure. The stresses are normalized by the average strength of the unnotched specimen tests. If there was no effect from the hole, the points would cluster around the normalized value of one. Since all points are below that value and the strength continues to decrease as the D/W increases, the room temperature tests show notch sensitivity.

Figure 22 Normalized Section Area Stress at Failure

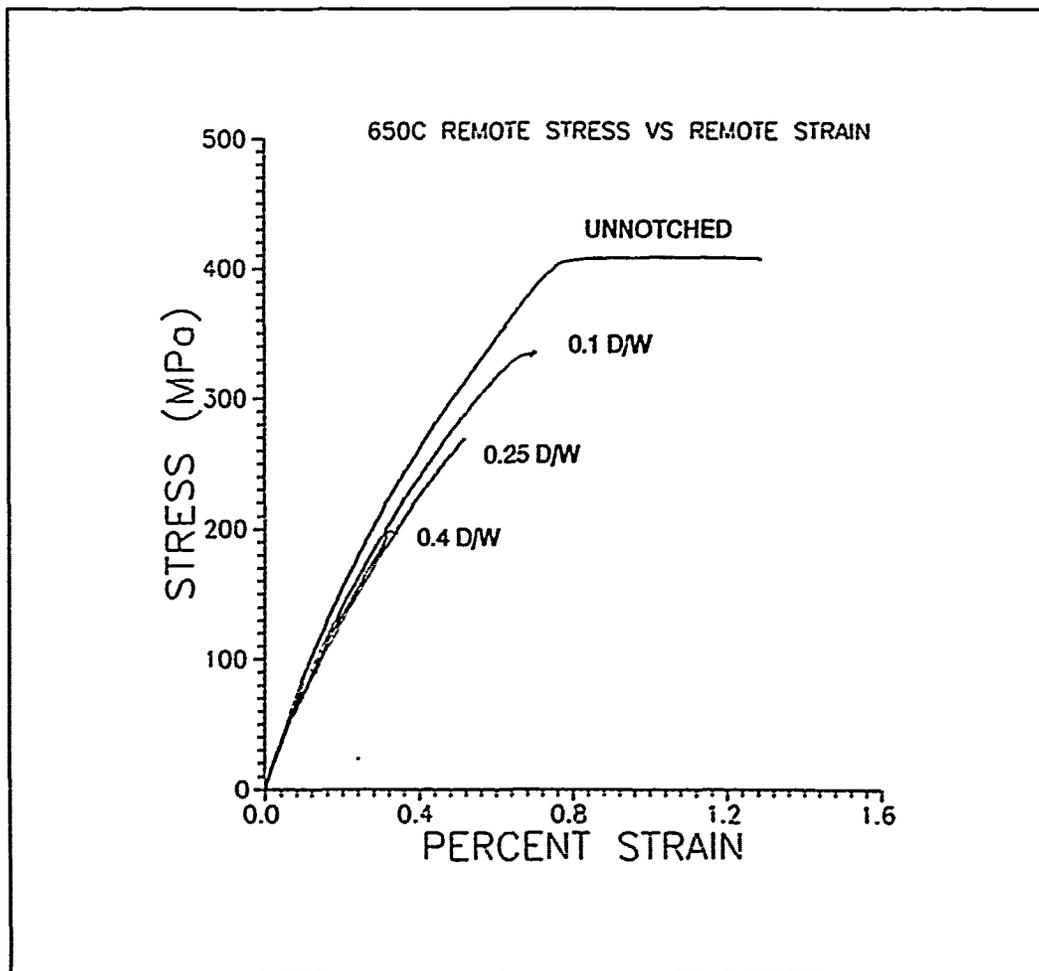
available. The extensometer was mounted away from the hole in some tests and in others it was mounted such that the gage length included the hole. The results for remote strain and local strain are presented in Figures 23 and 24 respectively. Figure 23 shows very little yielding prior to failure. The yielding is taking place at the hole and is outside the gage length of the extensometer when the extensometer is located to measure far field strain. Figure

Figure 23 Remote Stress vs Remote Strain - 650°C

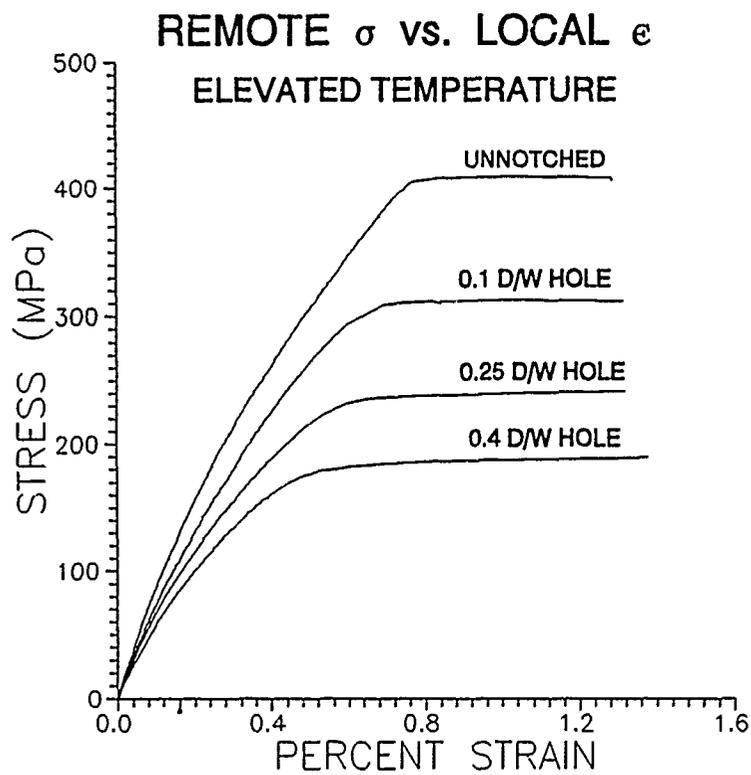
24 shows a drastic change in behavior just prior to failure. This last portion of the curve is plastic behavior of the matrix after the fibers have failed and are pulling out of the matrix. Figure 16 and other photographs below with necking of the failed elevated temperature specimens also show this plastic behavior.

**Figure 24** Remote Stress vs Local Strain - 650°C

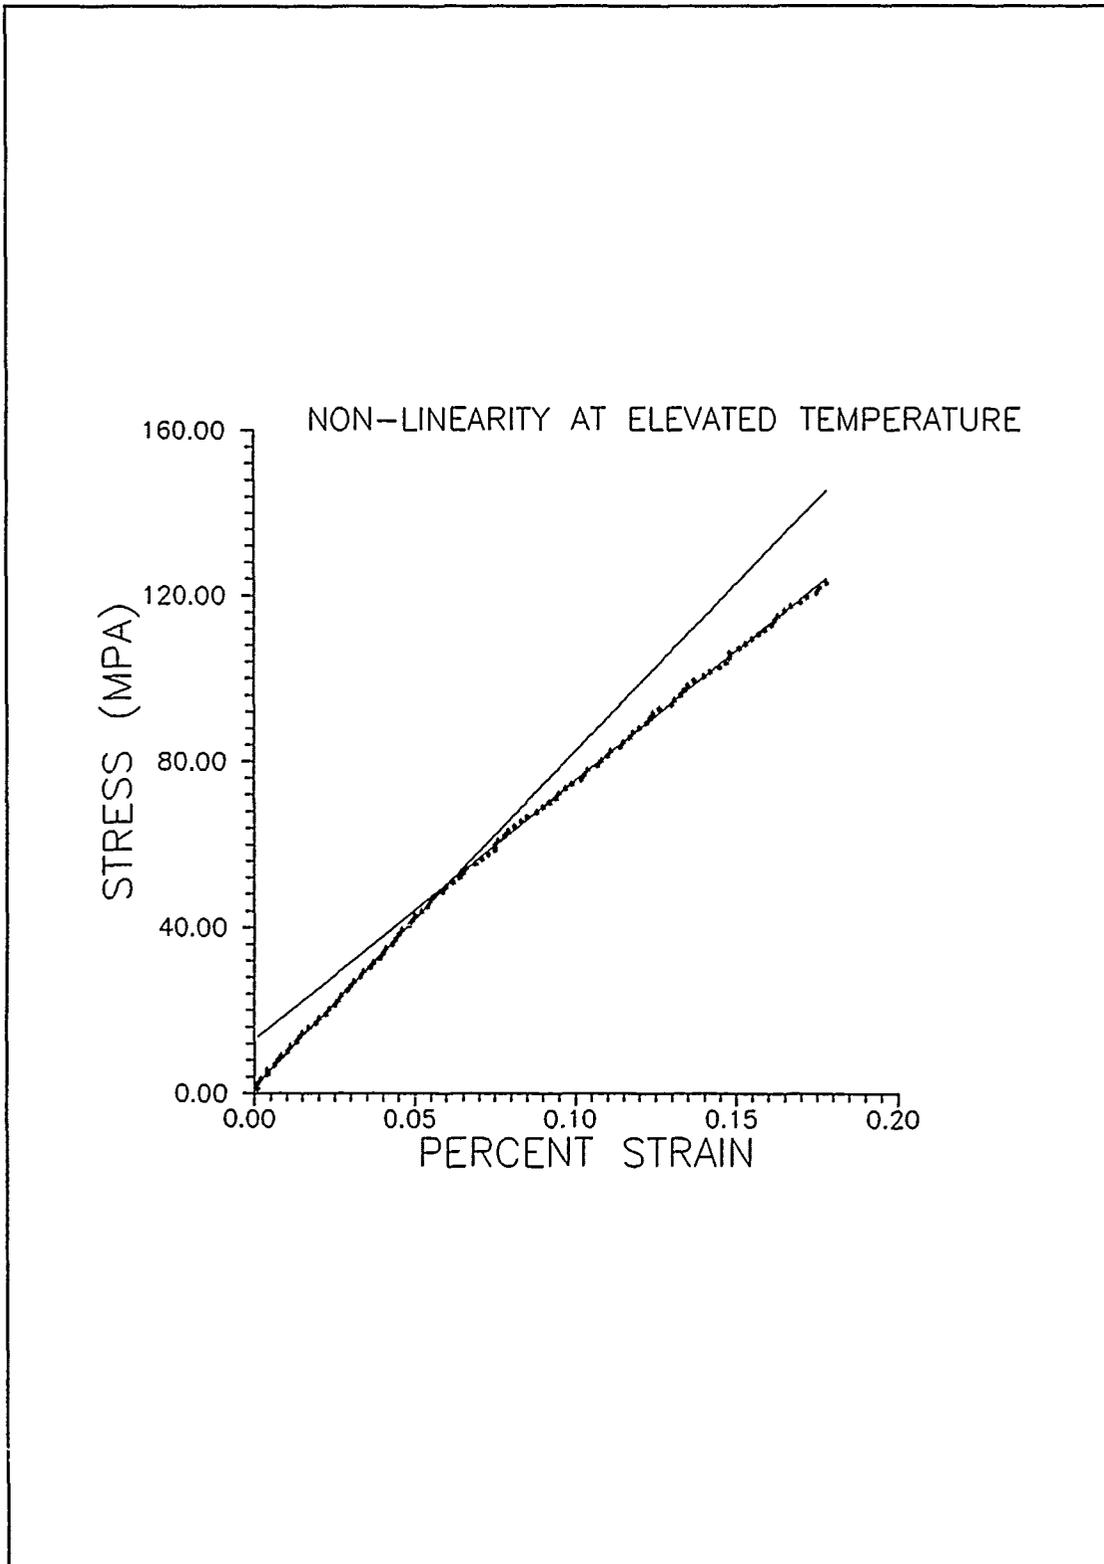
Figure 25 Nonlinearity of Rem. Stress vs. Rem. Strain 650°C

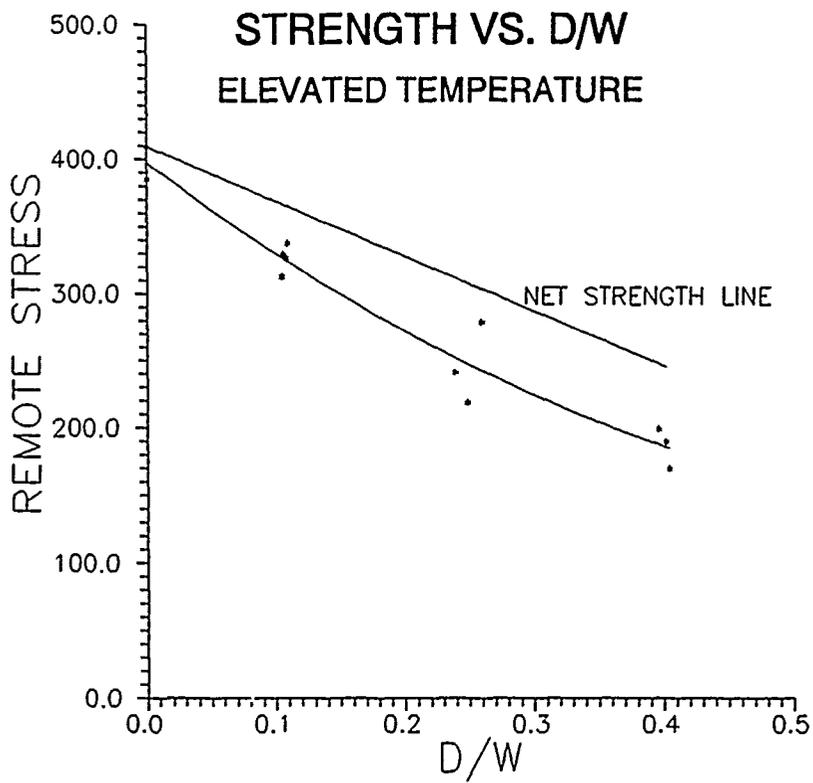
Figure 26 Failure Stresses vs. D/W for 650°C Tests

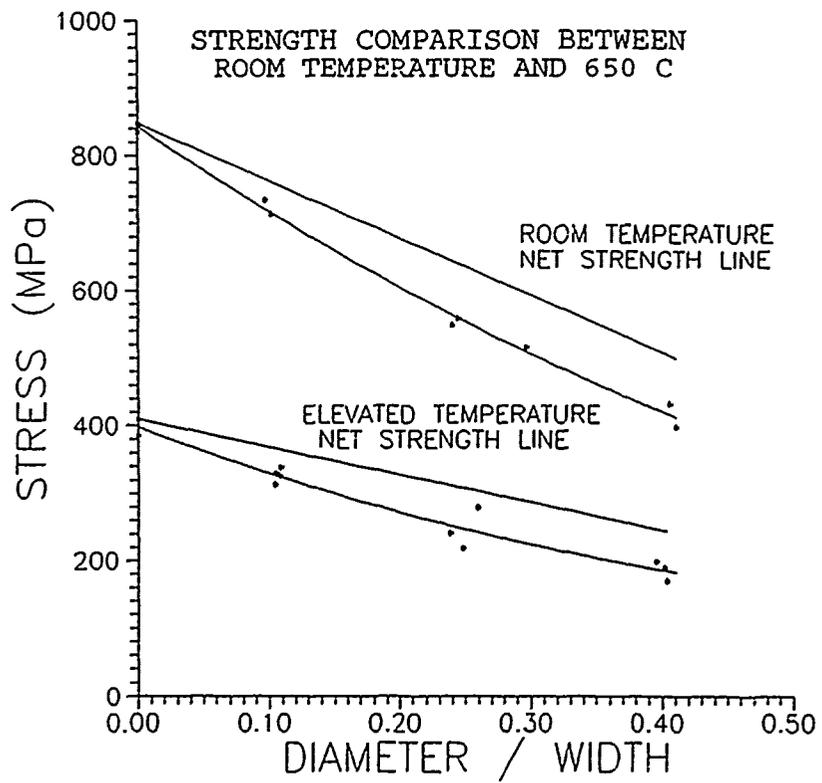
Figure 27 Absolute Strengths for All Tensile Tests
