**TENSILE STRENGTH CHARACTERIZATION  
OF A METAL MATRIX COMPOSITE  
WITH CIRCULAR HOLES**

**THESIS**

Master of Science in Aeronautical Engineering

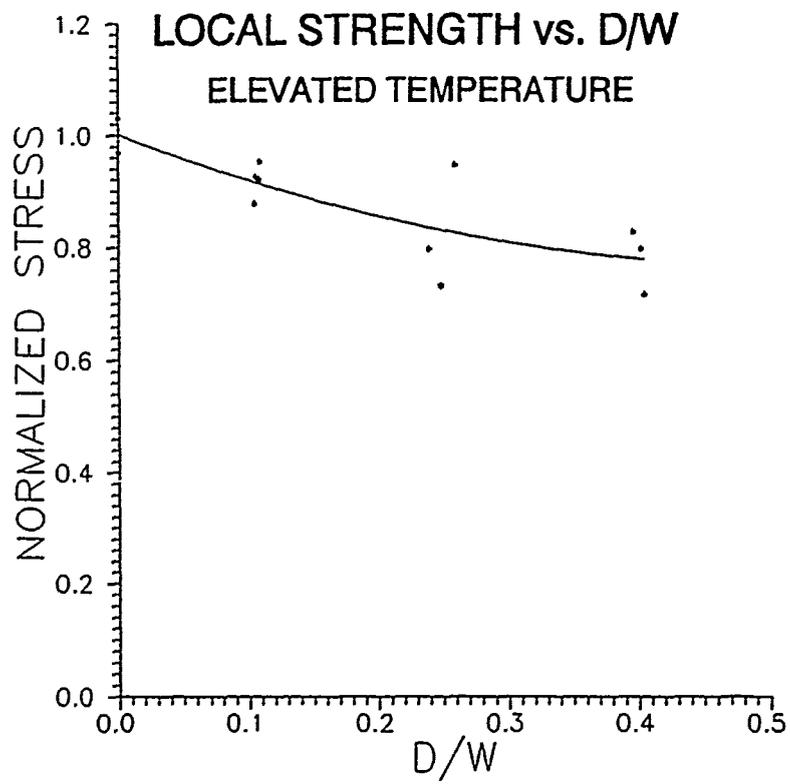
Figure 28 Normalized Section Area Strengths at 650°C

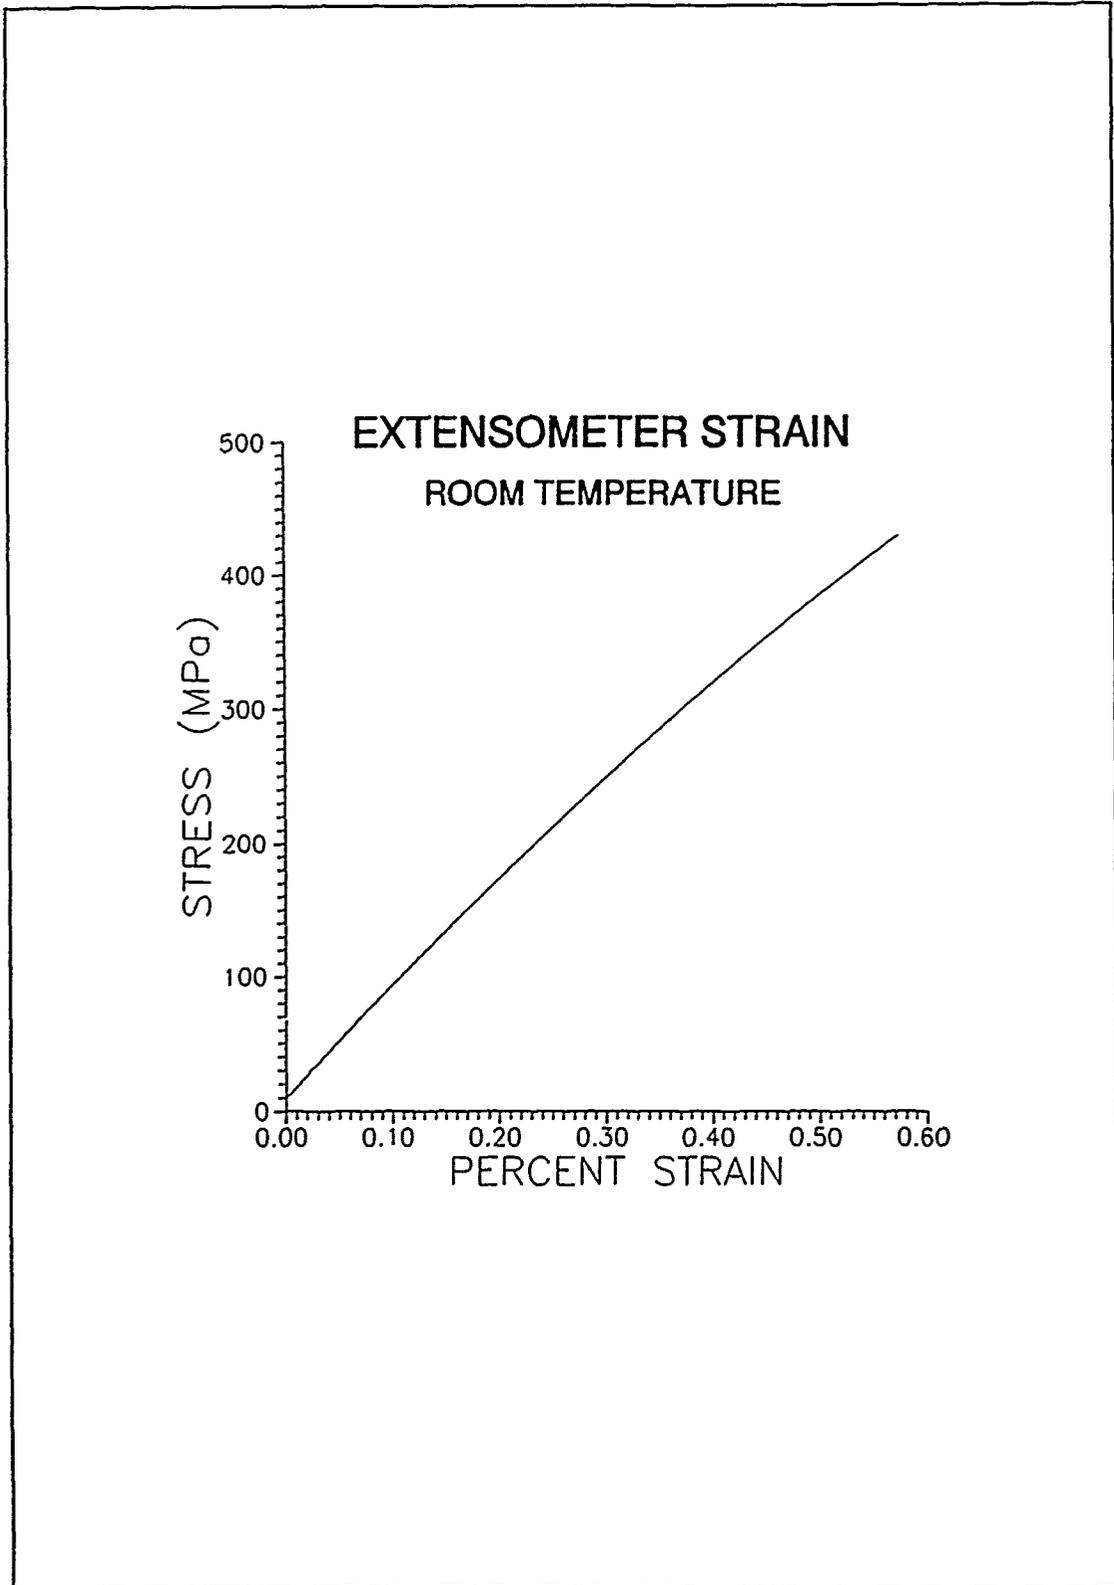
Figure 29 Stress vs. Extensometer Strain Around the Hole

than 1% strain. Figure 29 shows the remote stress vs. the strain of an extensometer surrounding the hole for a room temperature test. The curve is not perfectly linear to failure after the debonding, but it is close. Certainly it does not look like a typical stress vs. strain curve for a metal specimen taken all the way to failure. The flattening of the curve which is typical of metals as they yield near failure is not observed. The photograph in Figure 30 shows a failed room temperature specimen, which has a D/W of about 0.25. Notice that specimen does not reduce in area near the fracture surface, as one would expect if a material yielded significantly. The hole is circular or very nearly so even after fracture.

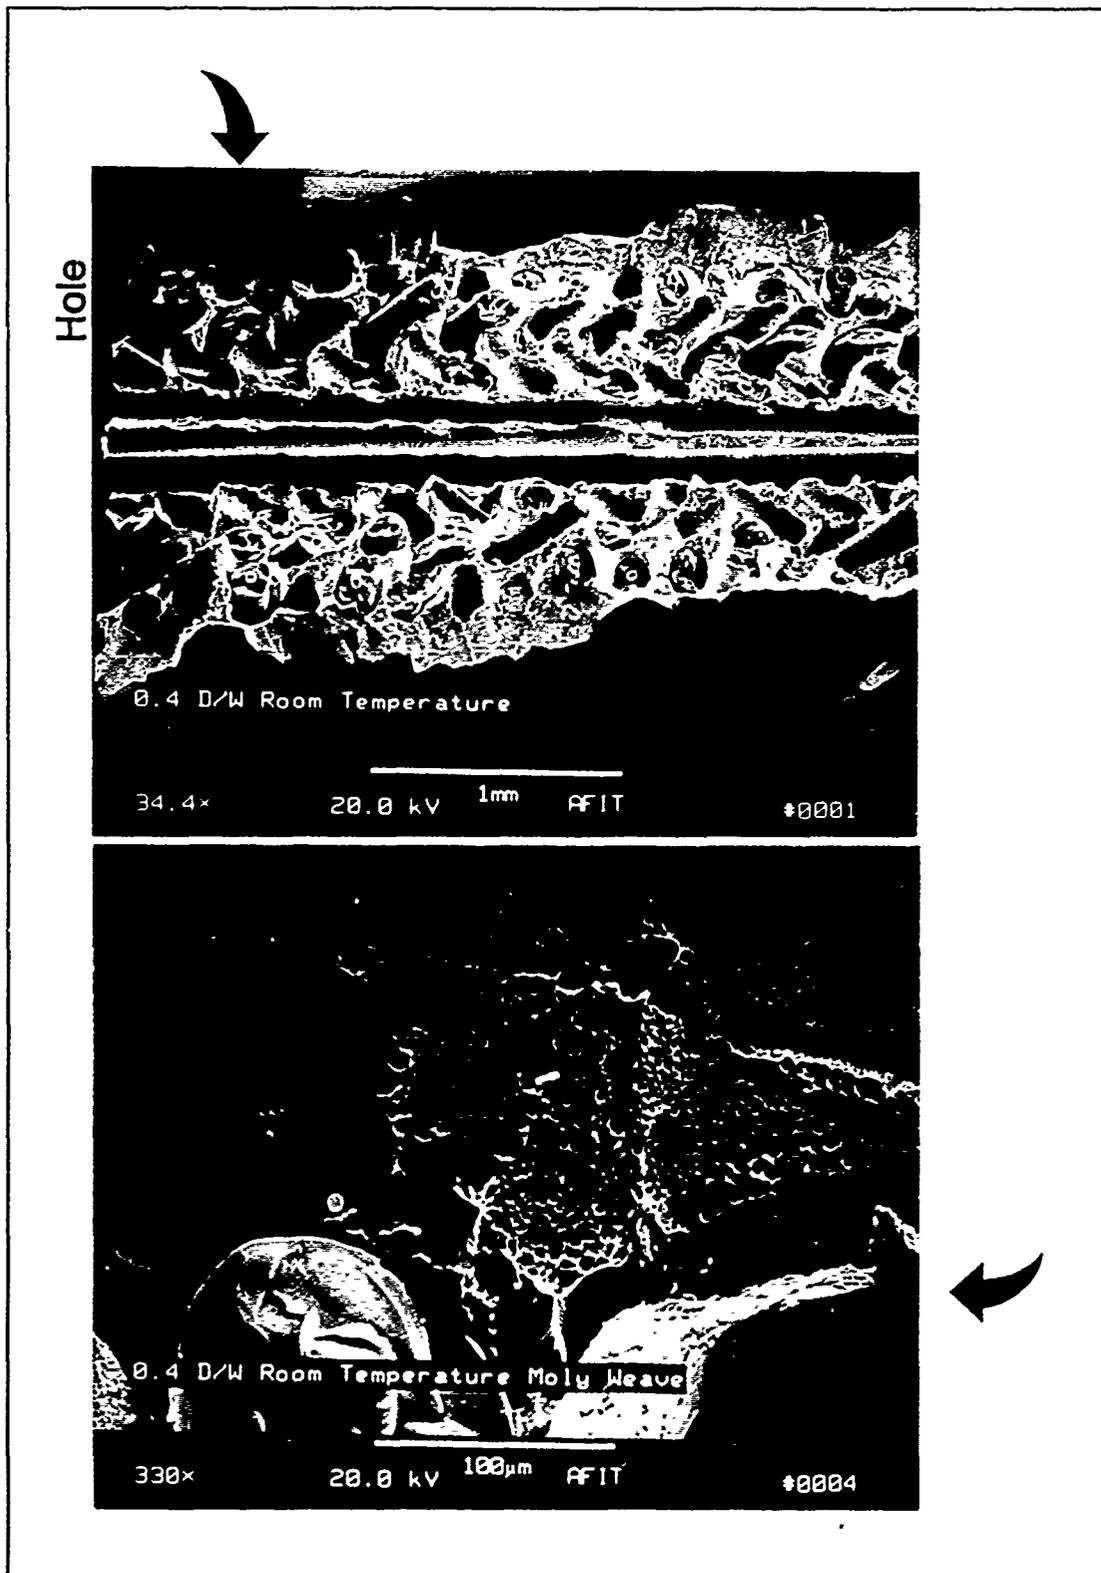
Figure 31A shows the fracture surface for the D/W of 0.4 specimen. The hole is at the very left of the picture. The only evidence of fiber pullout is seen in the 45° fibers which are debonded long before failure. The arrow shows the location for the higher magnification picture presented in Figure 31B.

Figure 31 A (TOP) & B Fracture Surface of 0.4 D/W Specimen RT

Figure 31B shows several characteristics typical of the room temperature fracture surfaces. The arrow points to the light colored material near the fibers. This is the molybdenum wire used to hold the SCS-6 fibers in place during manufacturing. Many fracture surfaces showed this wire around the zero degree fibers. Khobaib and others have documented molybdenum as a weak point in metal matrix composites (22). Overall, the dimpled ductile fracture seen here dominates the room temperature fracture surfaces.

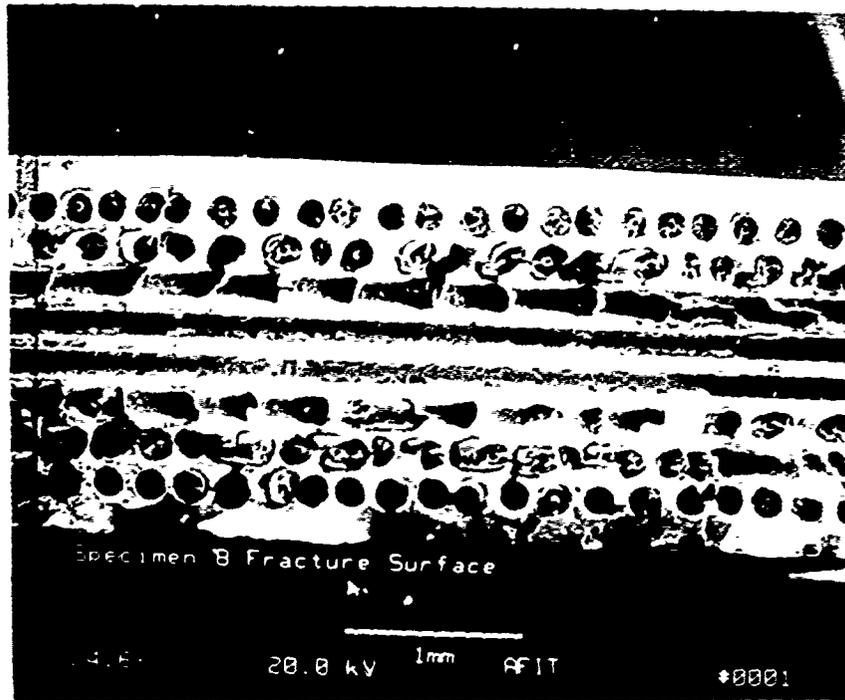
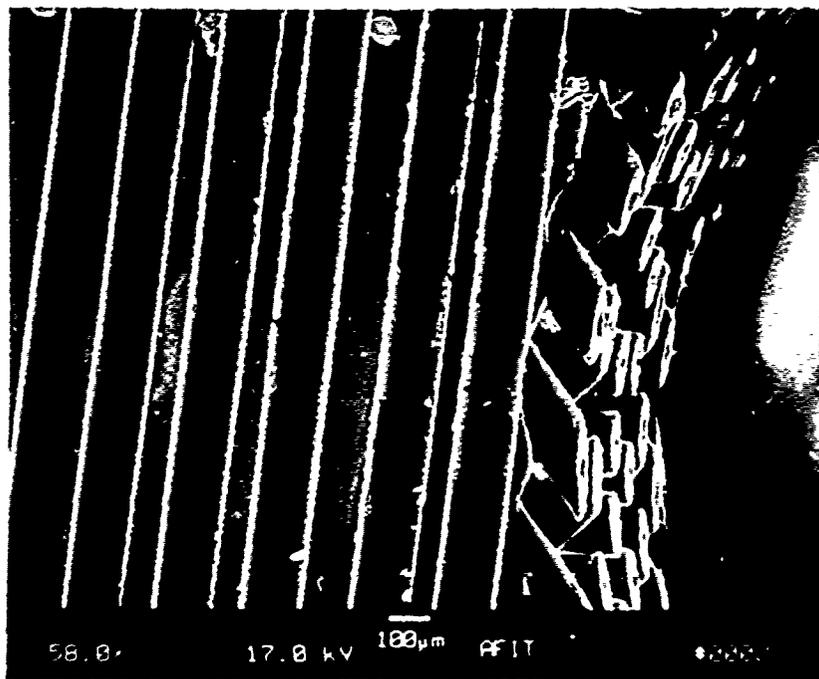
Figure 32 A (Top) & B Fracture Surface for 0.1 D/W 20°C

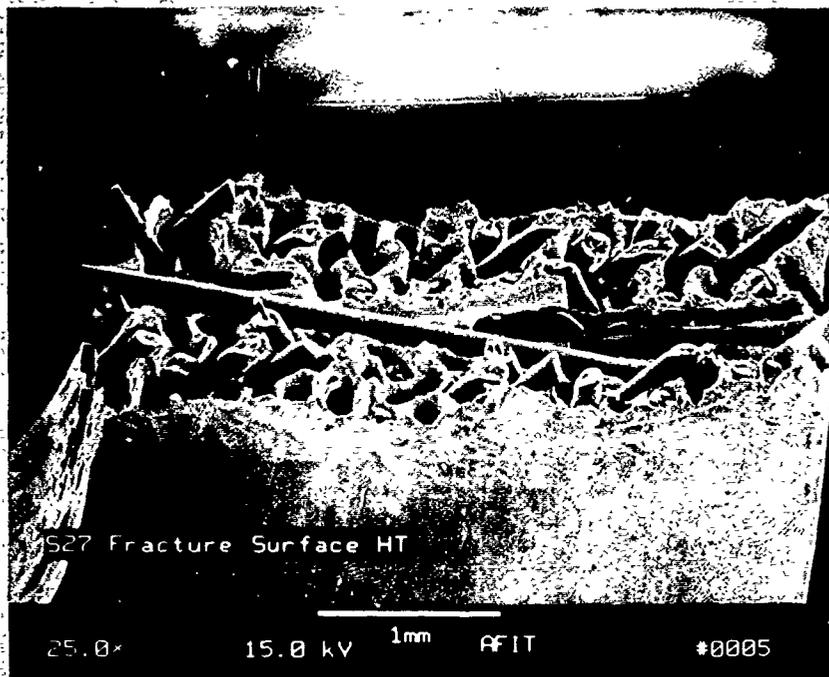
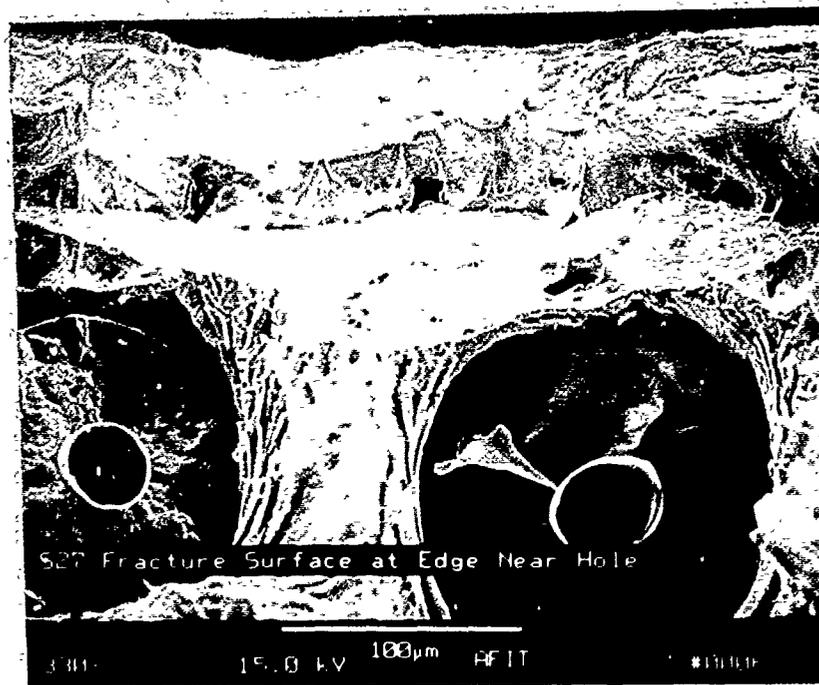
Figure 34 A (Top) & B Fracture Surface of 0.4 D/W at 650°C

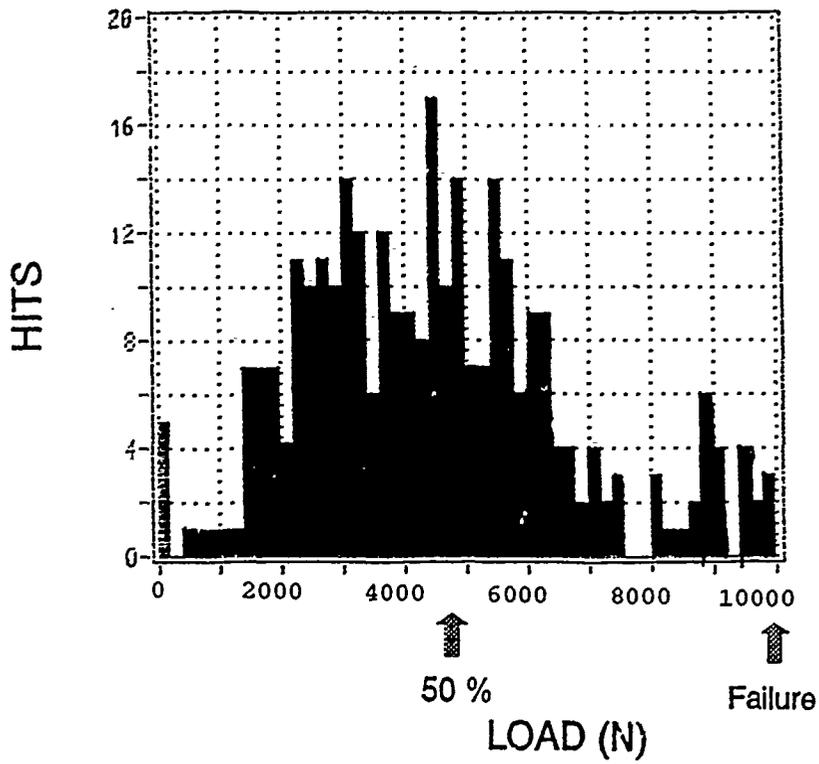
Figure 36 Acoustic Emission of Hits vs. Load at Room Temp.

Figure 36 shows the same pattern for acoustic emission activity, but since the specimen is tested all the way to failure there are more hits at the end of the test. The fiber hits in the final 10% of the load reflect damage far from the hole. Many fibers in the rest of the cross section must fail at that time. After many fibers have failed, the

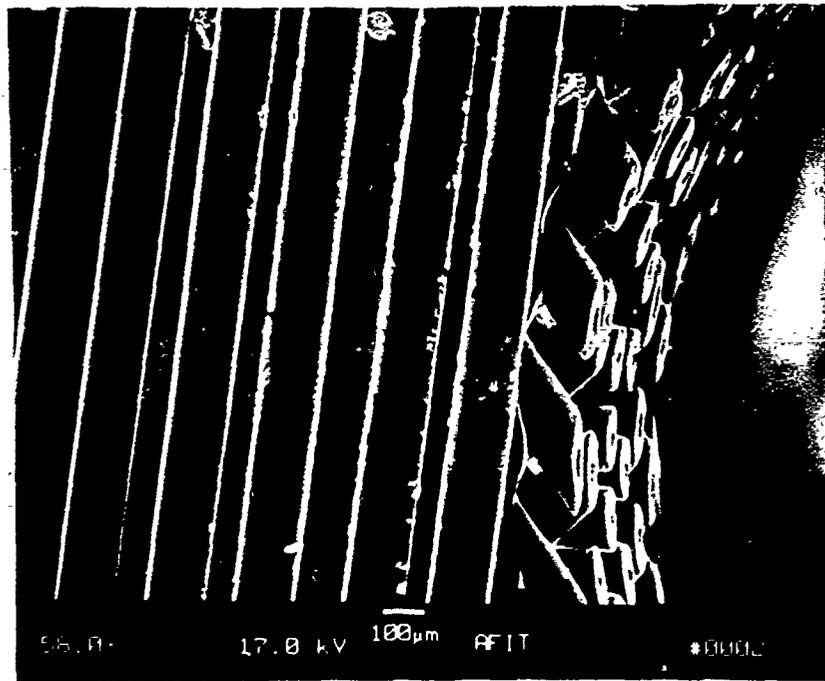
Figure 37 Damage to Fibers Near the Hole for 90% Failure

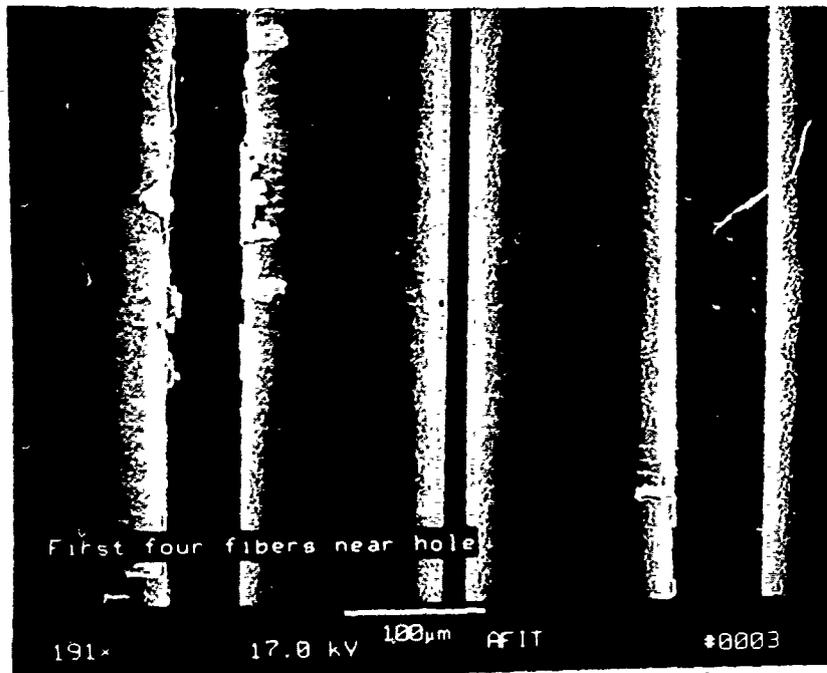
Figure 38 shows two SEM photographs of the fibers at higher magnification. The relatively equal spacing of the

Figure 38 Fiber Damage and Equally Spaced Cracks

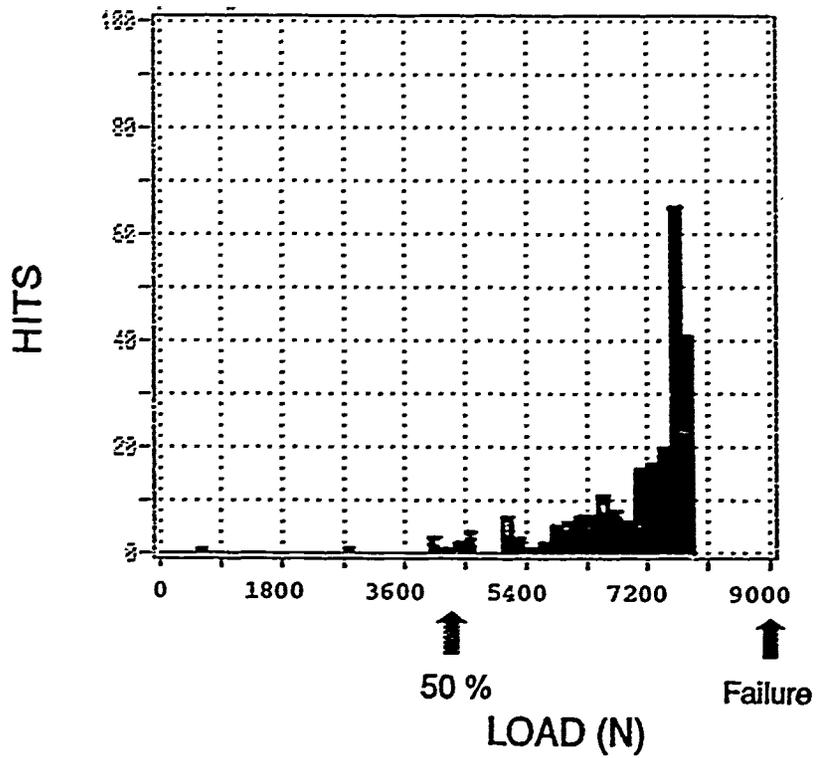
Elevated Temperature Acoustic Emission. Acoustic emission data was collected for elevated temperature tests and showed a different pattern for the long duration high amplitude events. High temperature tests show a very large number of huge events in the 10% of load preceding failure, as shown in Figure 40. The stress concentration at the hole creates more events at lower loads than the specimen without a hole

Figure 40 Acoustic Emission for 650°C With a Hole

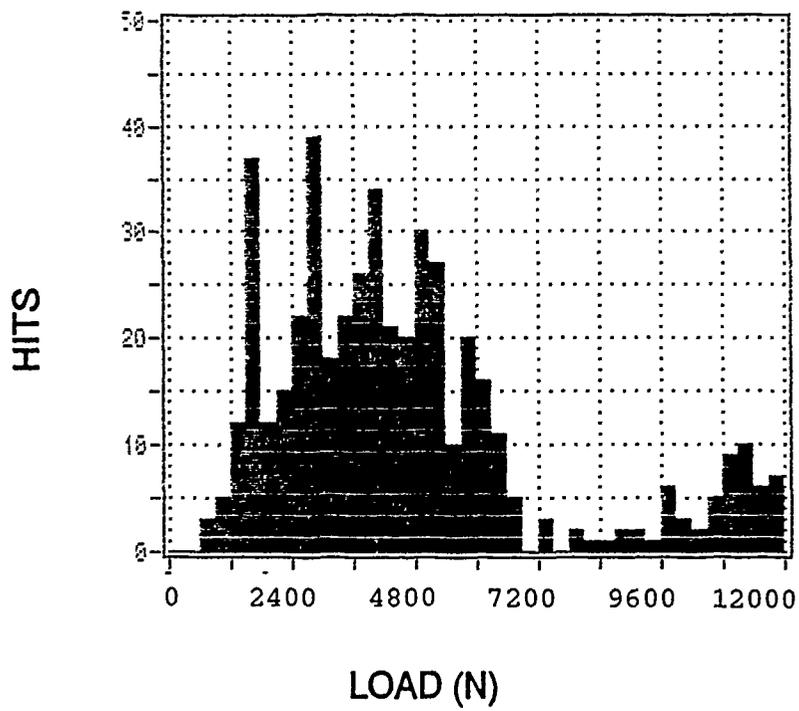
Figure 41 Acoustic Emission for Test to 90% of Failure Stress

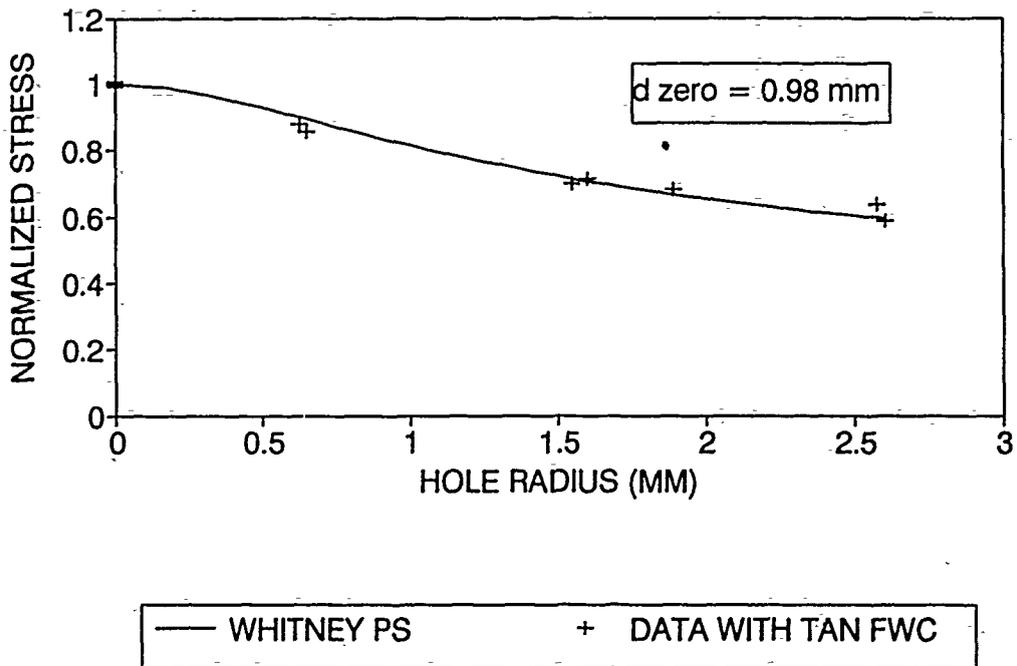
ROOM TEMPERATURE SCF = 3.0

Figure 44 Whitney-Nuismer for Stress Concentration of 3.0

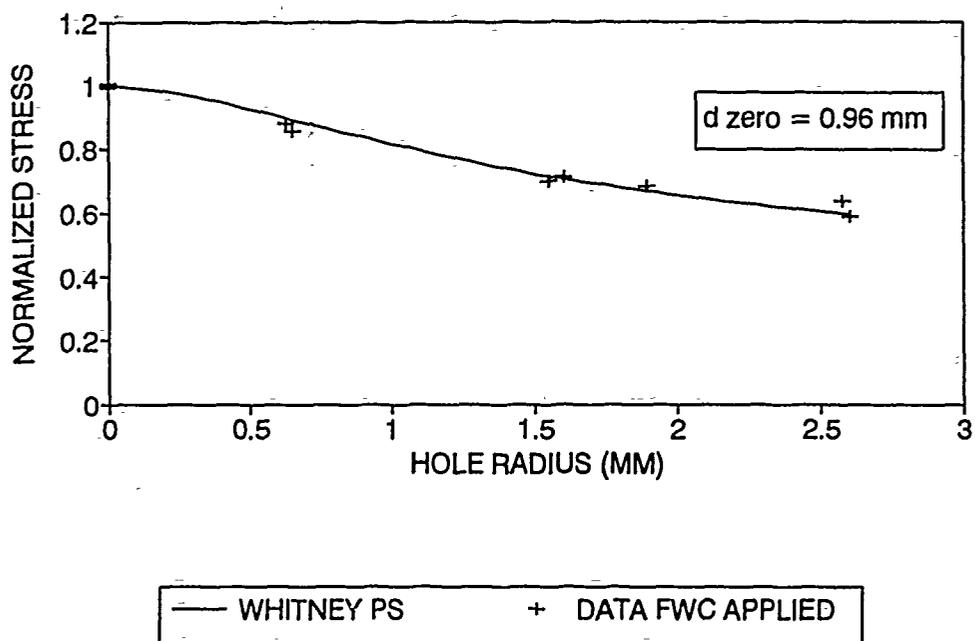
ROOM TEMPERATURE SCF = 3.18

Figure 45 Whitney-Nuismer with Stress Concentration of 3.18

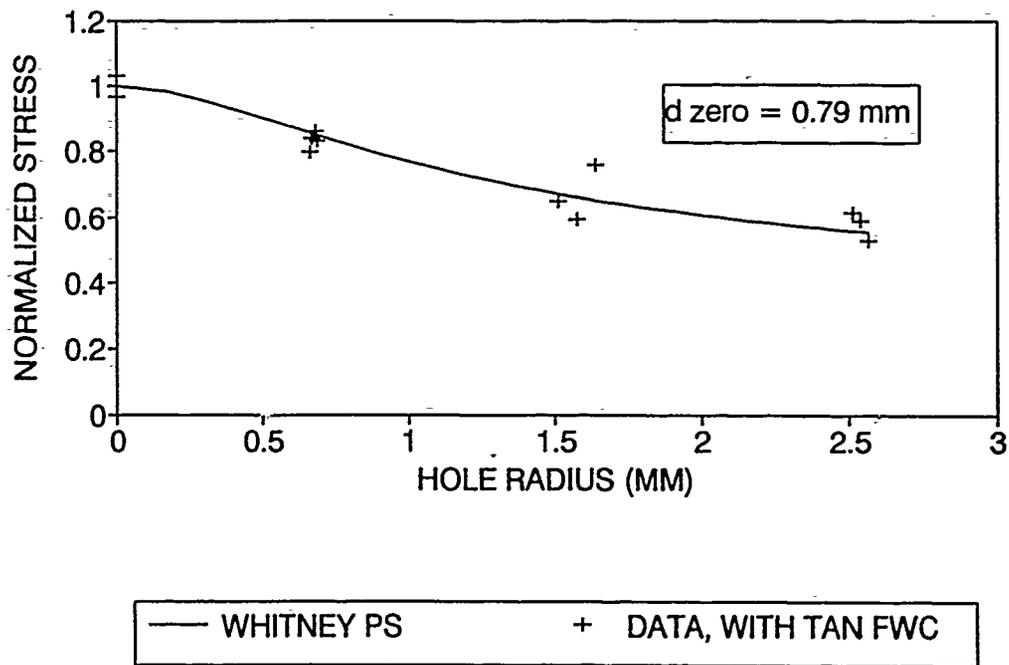
ELEVATED TEMPERATURE SCF = 3

Figure 46 Whitney-Nuismer for SCF = 3 at 650°C

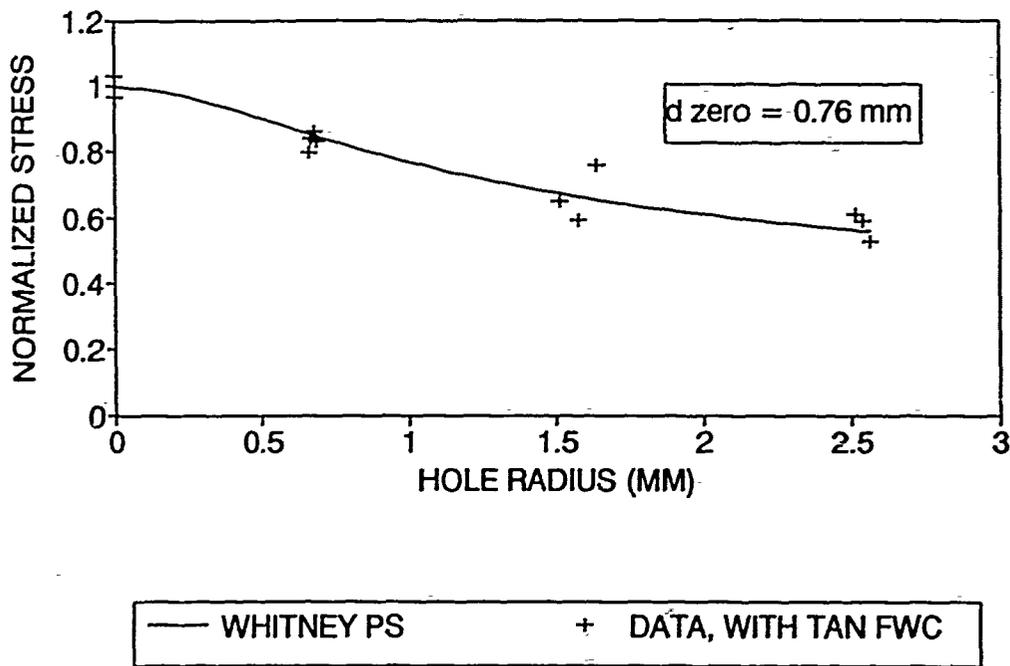
ELEVATED TEMPERATURE SCF = 3.28

Figure 47 Whitney-Nuismer for SCF = 3.28 650°C
