MIL-STD-1660 TEST ON
PALLET ADAPTER AND TOP LIFT ASSEMBLY
FOR 40MM CONTAINERS

REPORT NO. EVT 11-88-3

MIL-STD-1660 TESTS ON
PALLET ADAPTER AND TOP LIFT ASSEMBLY
FOR 40MM CONTAINERS

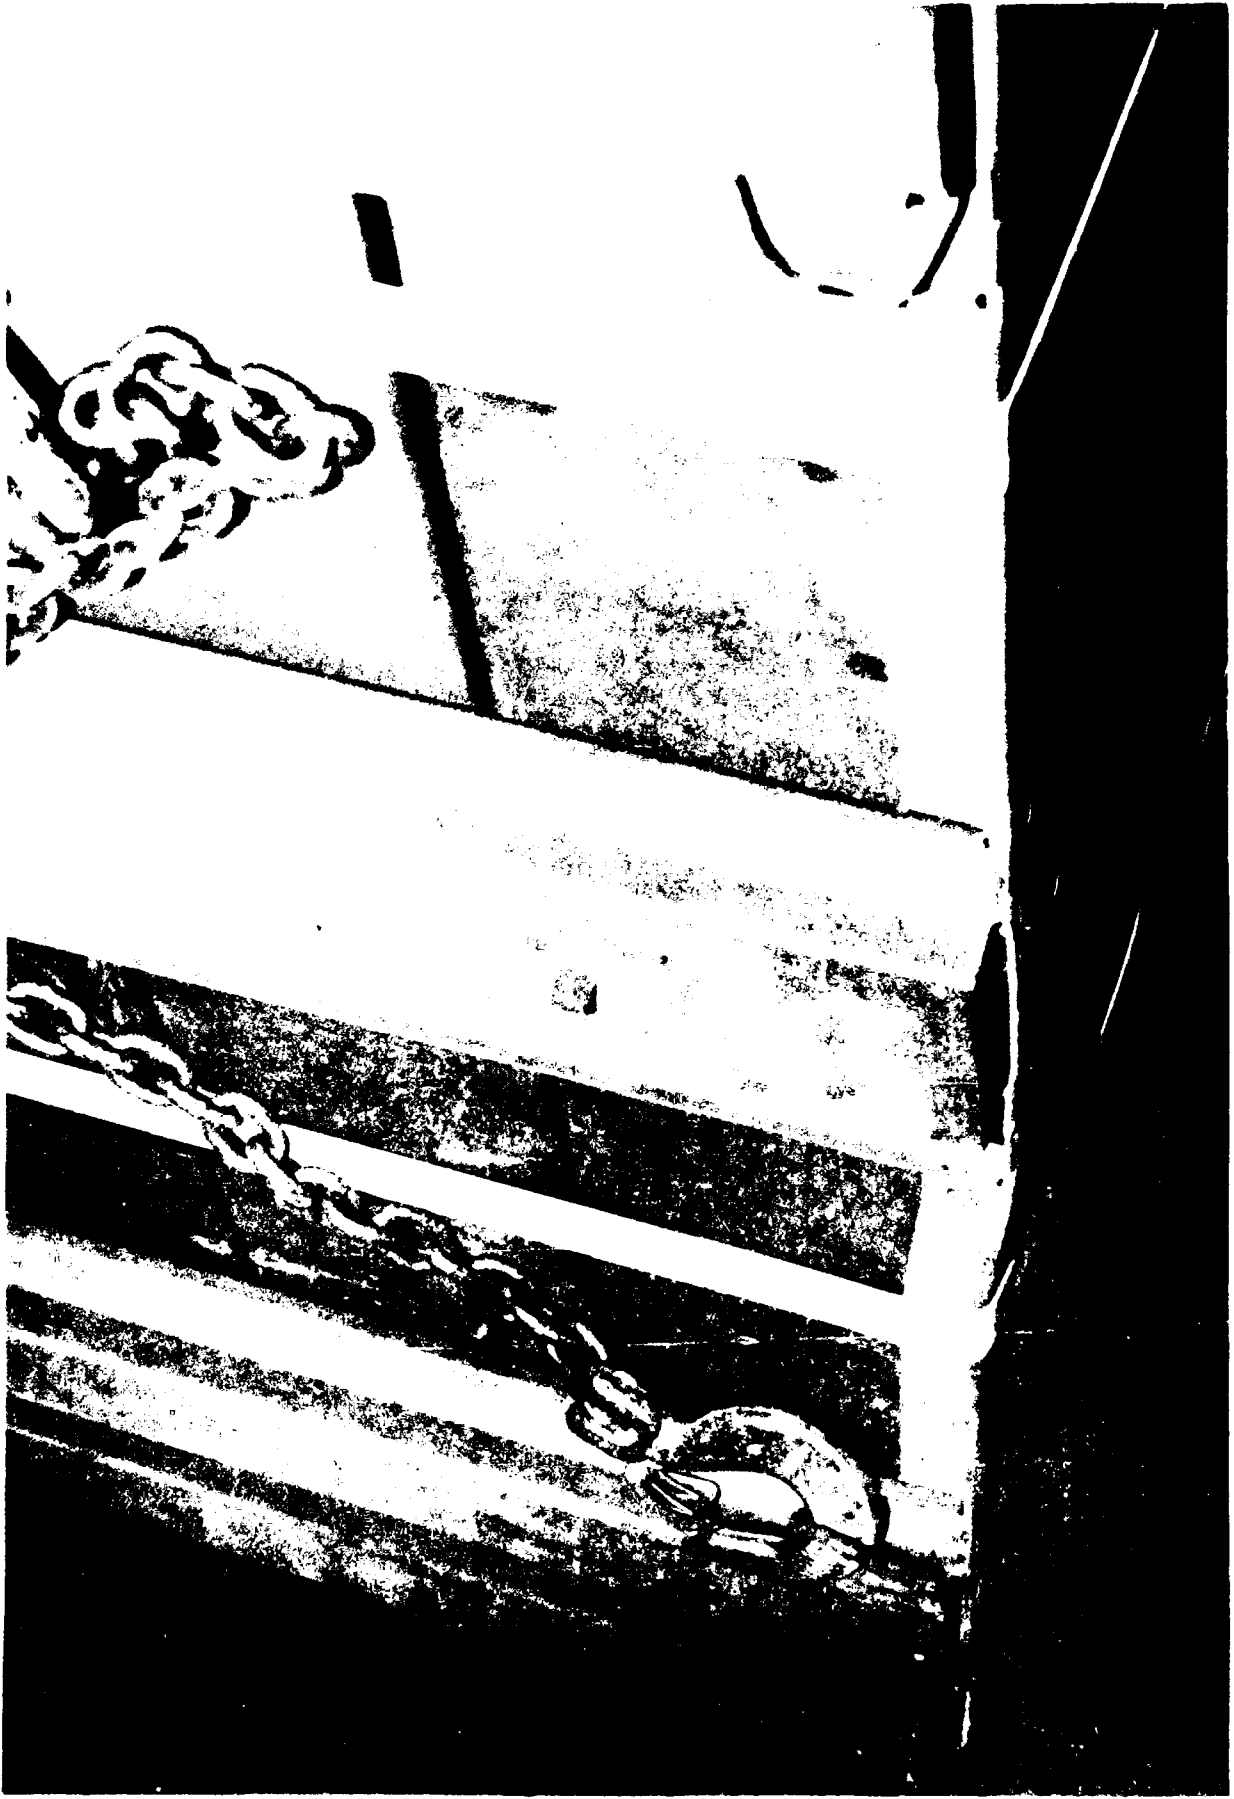
90-2200

configurations included three corners, two alternate corners, two adjacent corners, another pair of adjacent corners, and single corner lifts. The top lift assembly showed extreme bending during the three-legged-sling test (see photos). As a result, unitization was modified by moving the banding outward as far as possible to decrease the bending moment. The slinging test was then repeated with a new top lift assembly. The top lift assembly still showed slight bending during the three-legged-sling test. The bending in the top lift assembly worsened during the two-legged-sling test on opposite corners.

The pallet adapter and top lift assembly failed MIL-STD-1660 Design Criteria for Ammunition Unit Loads. The top lift assembly did not show structural soundness, since permanent deformation occurred during slinging tests on all of the top lift assemblies (see photos). All pallets tested had stacking lug failure with the pallet adapter due to fracture. Recommendations given below will reduce the chances of this happening on production pallets.

Photo No. 1 This photo shows the deformation in the top lift assembly due to the slinging test.

a. Strengthen the lateral members of the top lift assembly to avoid the bending during top lift which has occurred consistently in MIL-STD-1660 tests conducted.

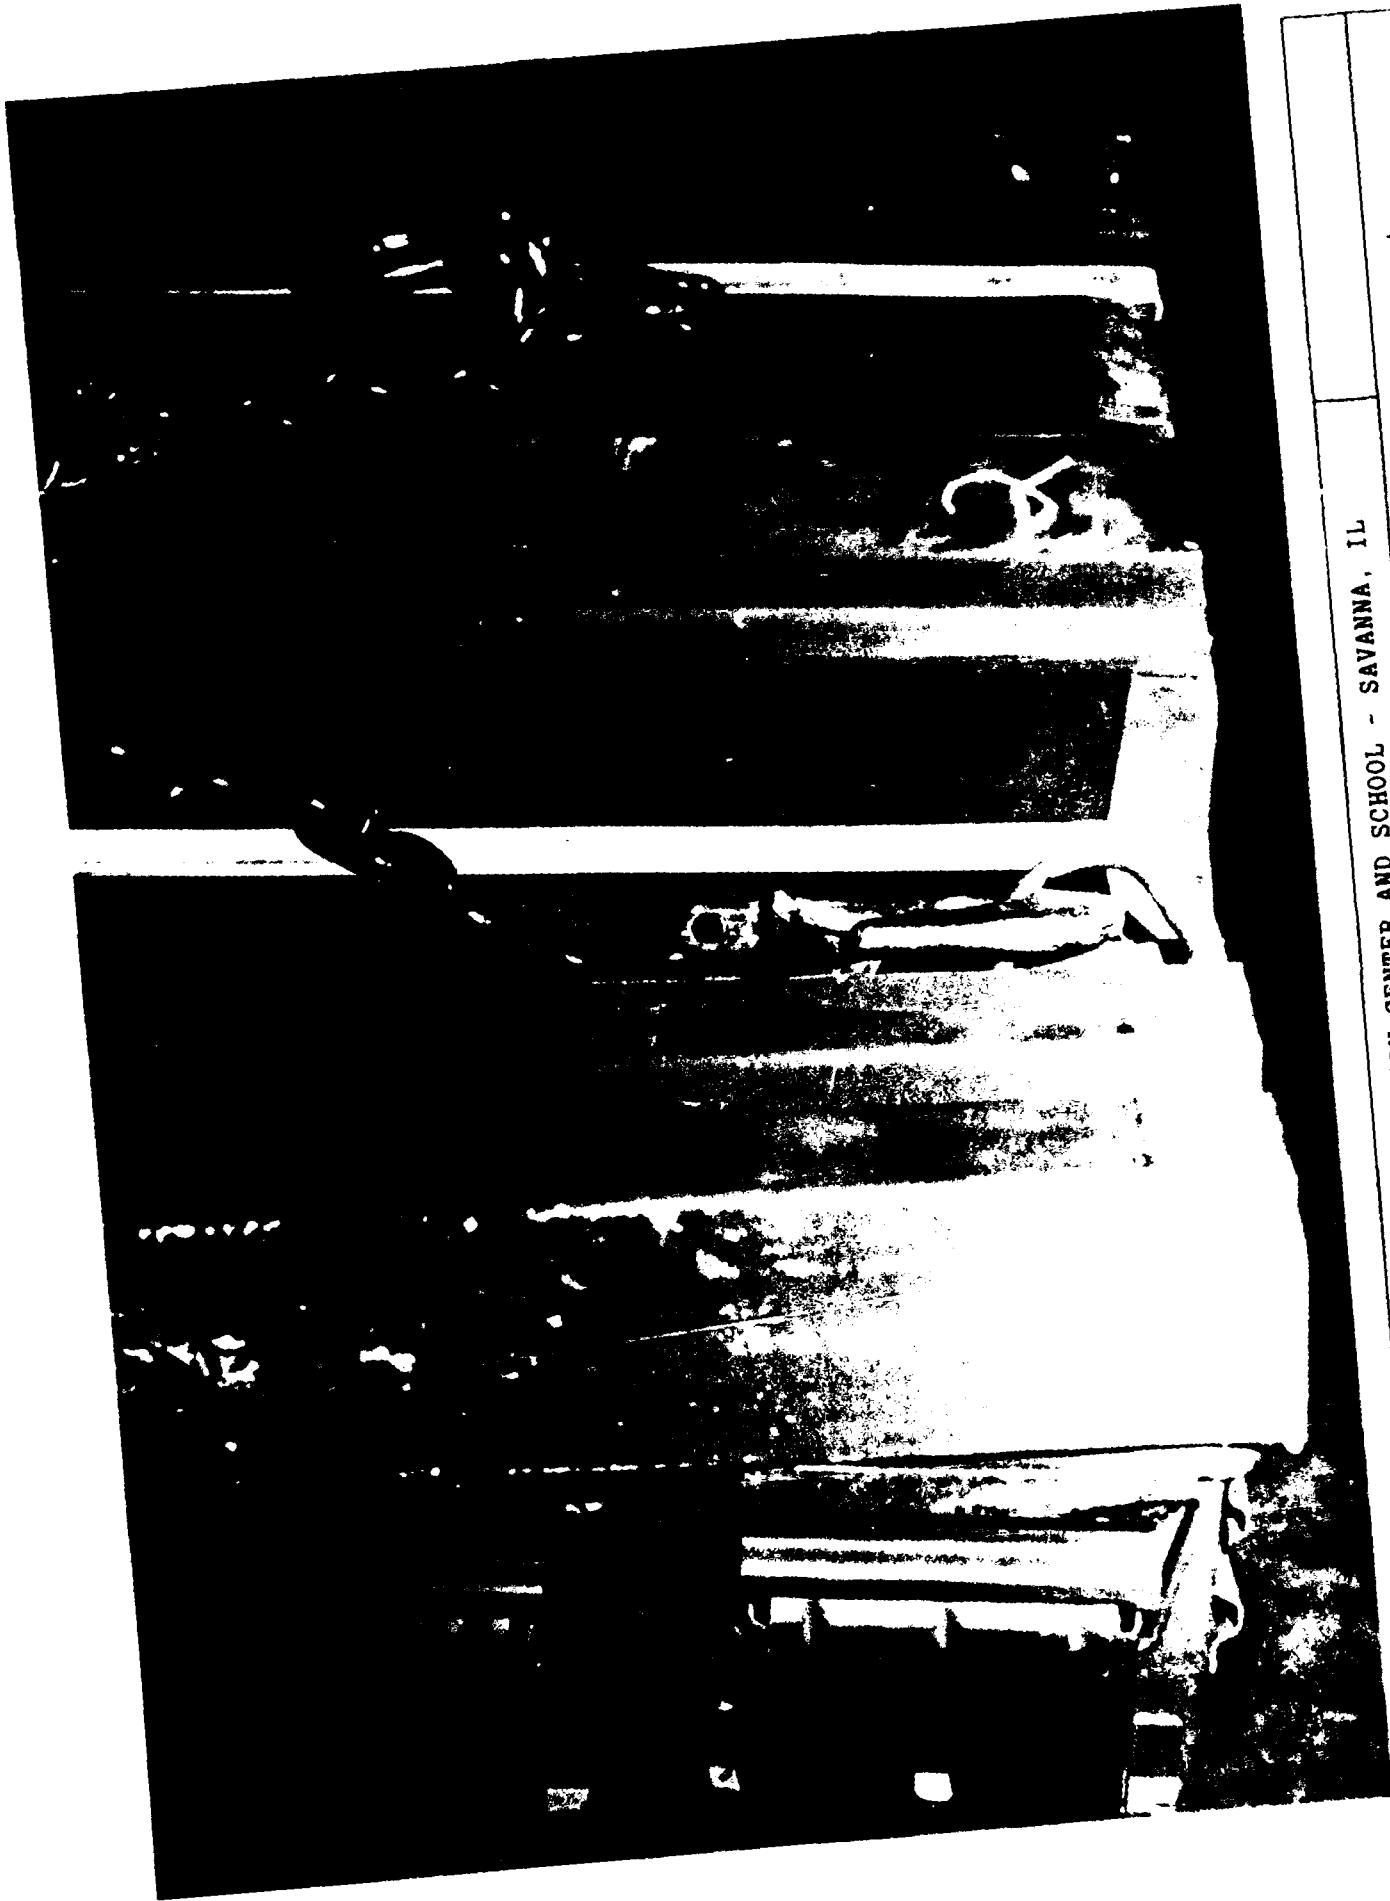
90-2201

Photo No. 2 This photo shows the deformation in the top lift assembly due to the slinging test.

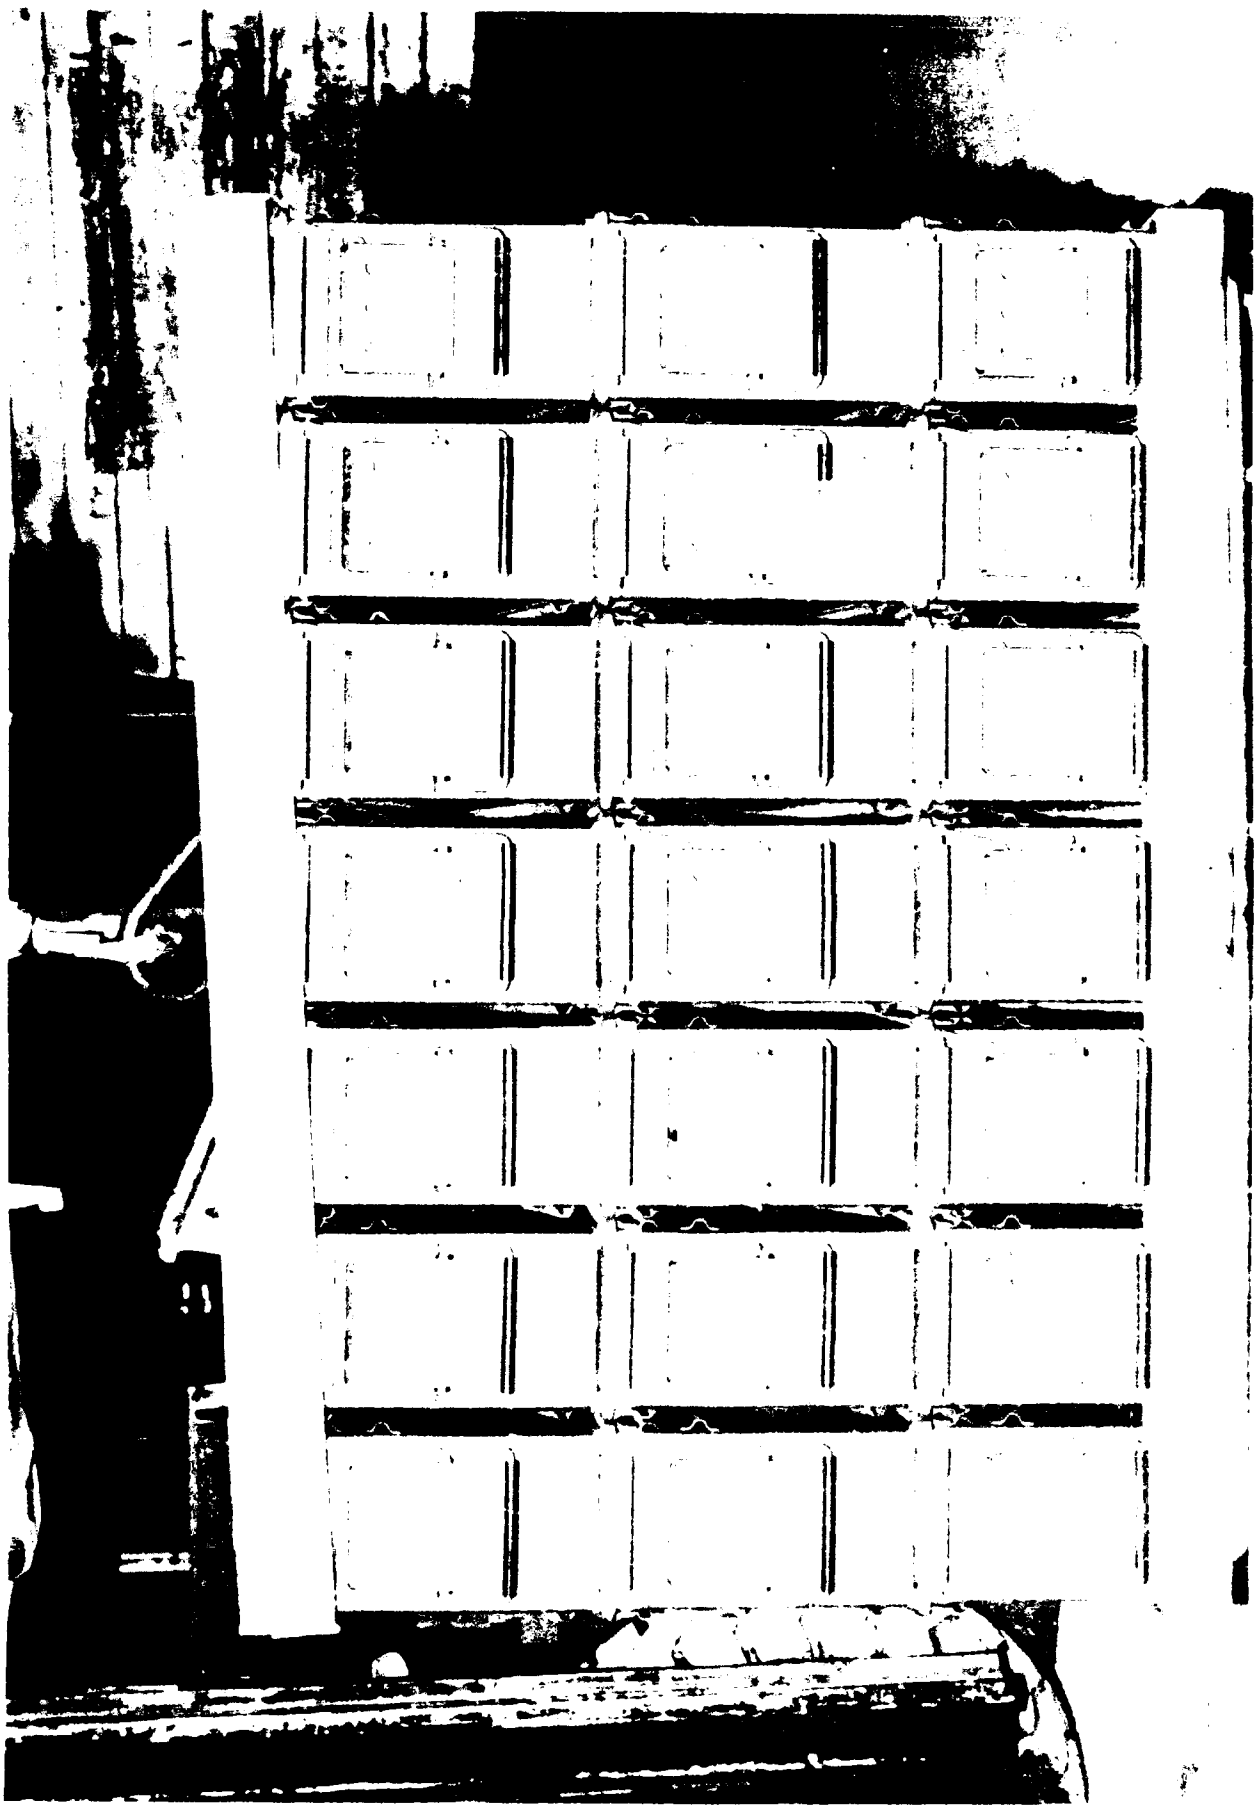
90-2196

Photo No. 3 This photo shows the deformation in the top lift assembly due to the slinging test.

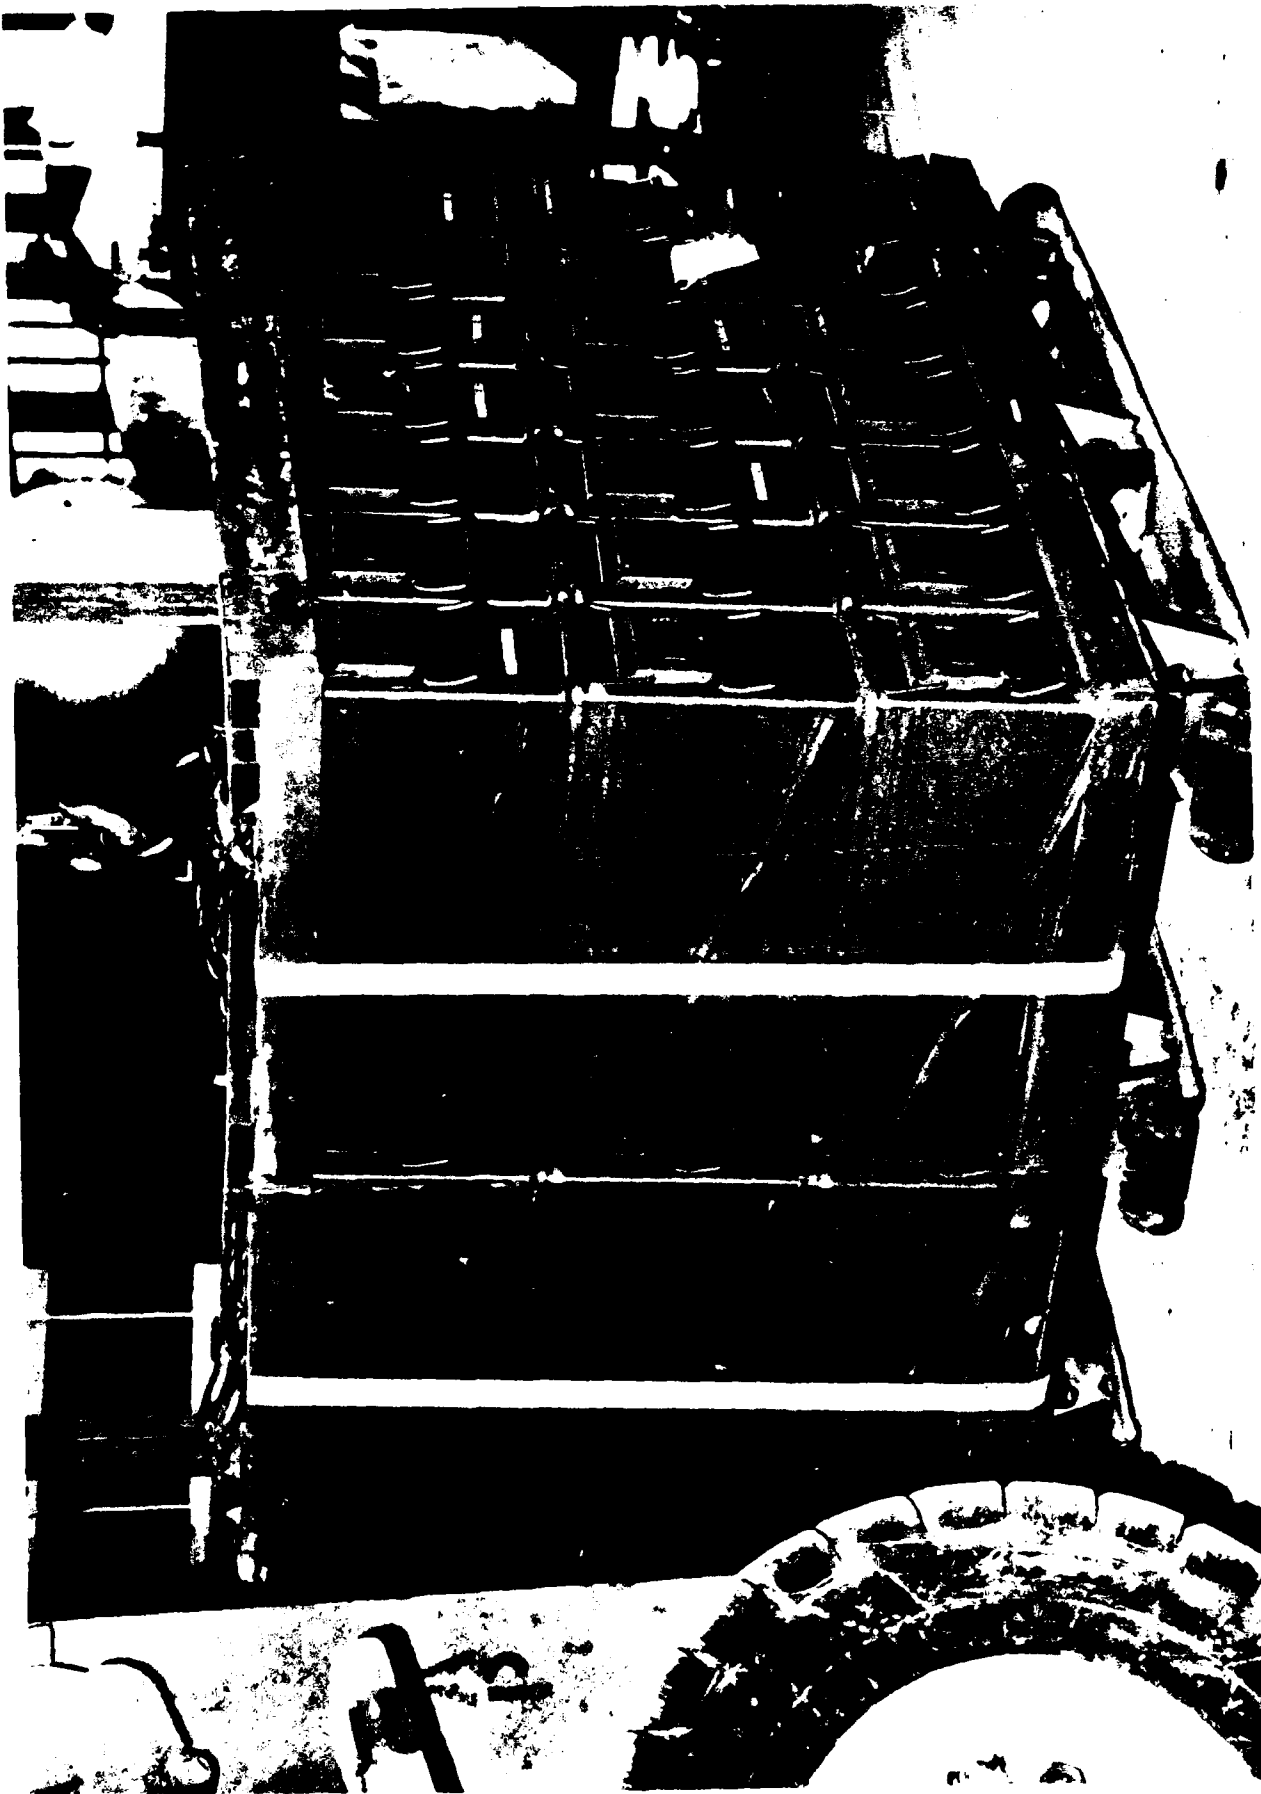
90-2198

Photo No. 4 This photo shows the deformation in the top lift assembly due to the slinging test.

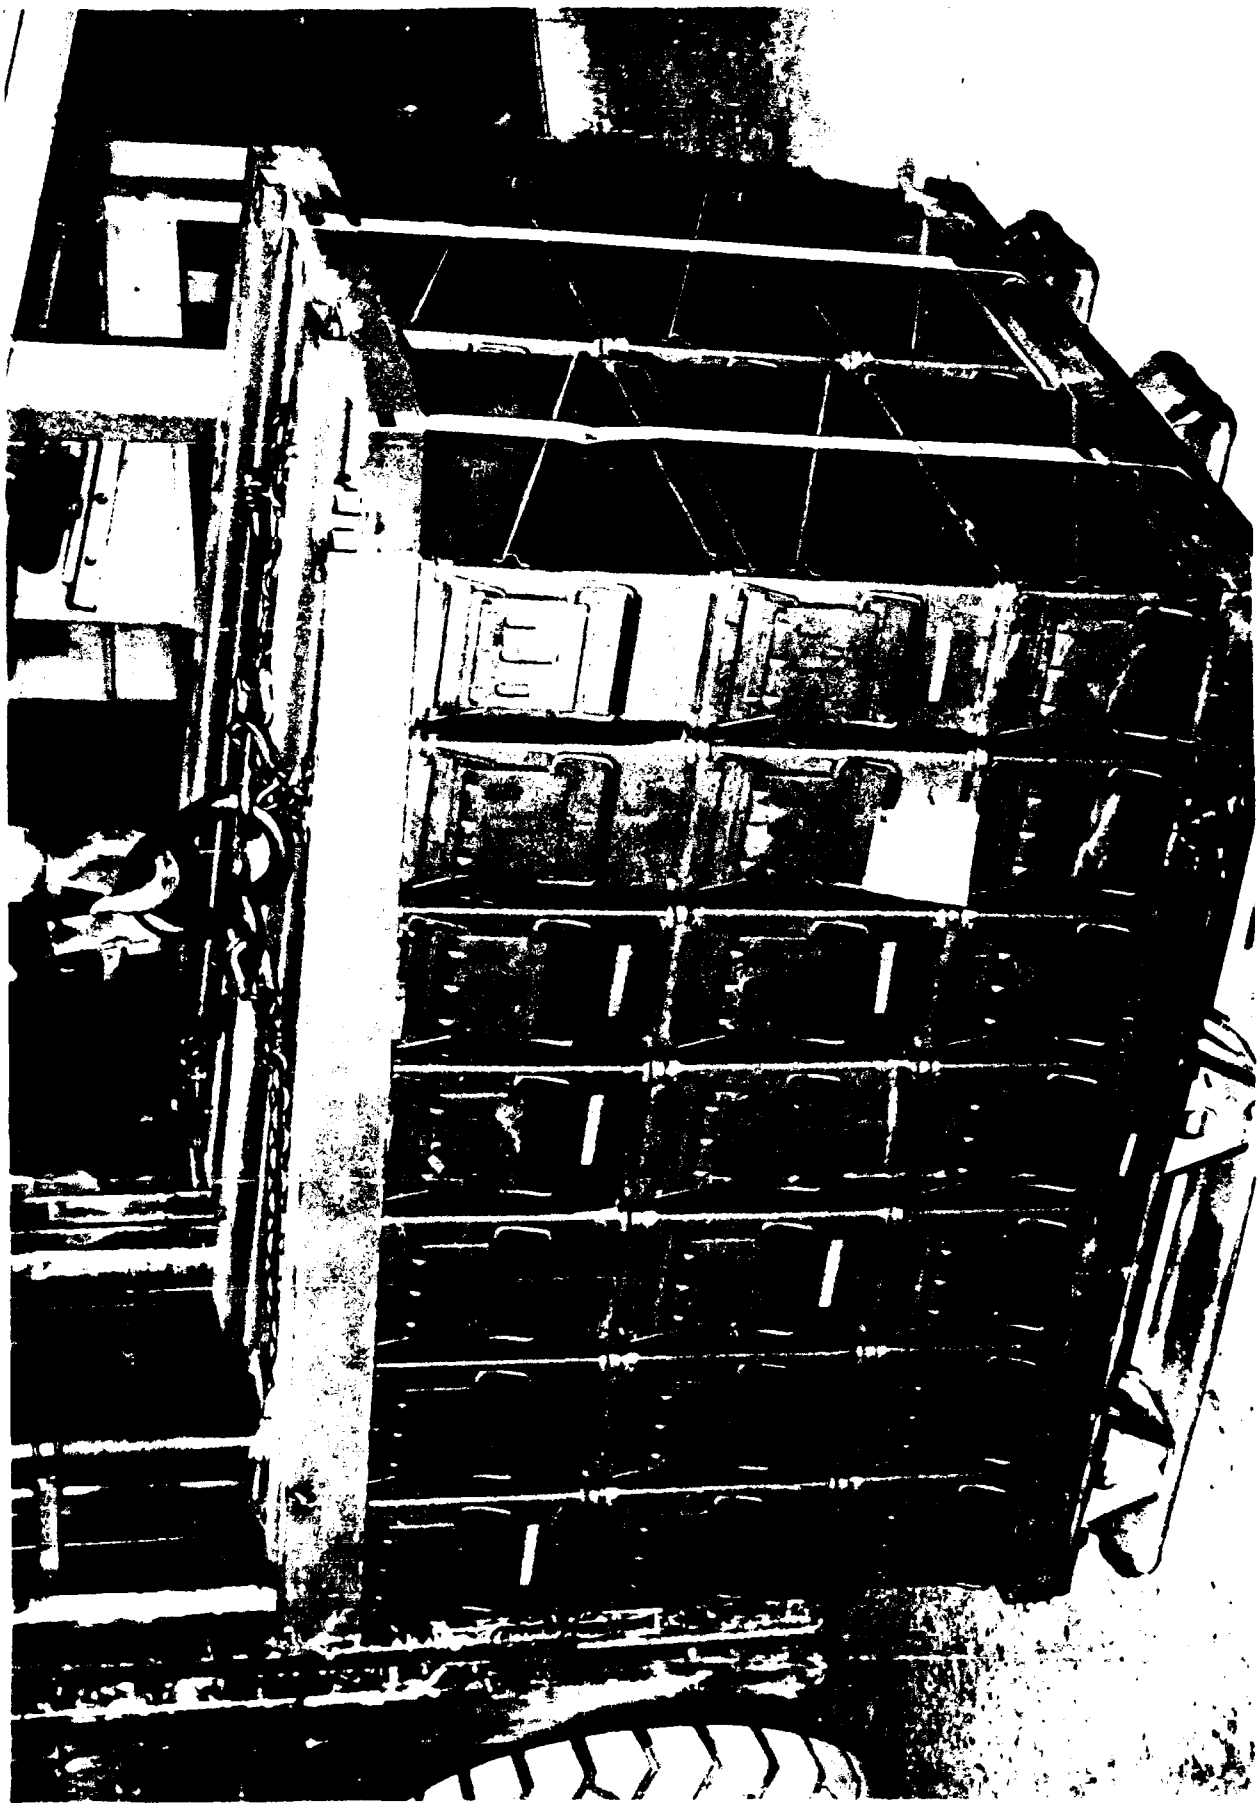
90-2199

Photo No. 5 This photo shows the deformation in the top lift assembly due to the slinging test.

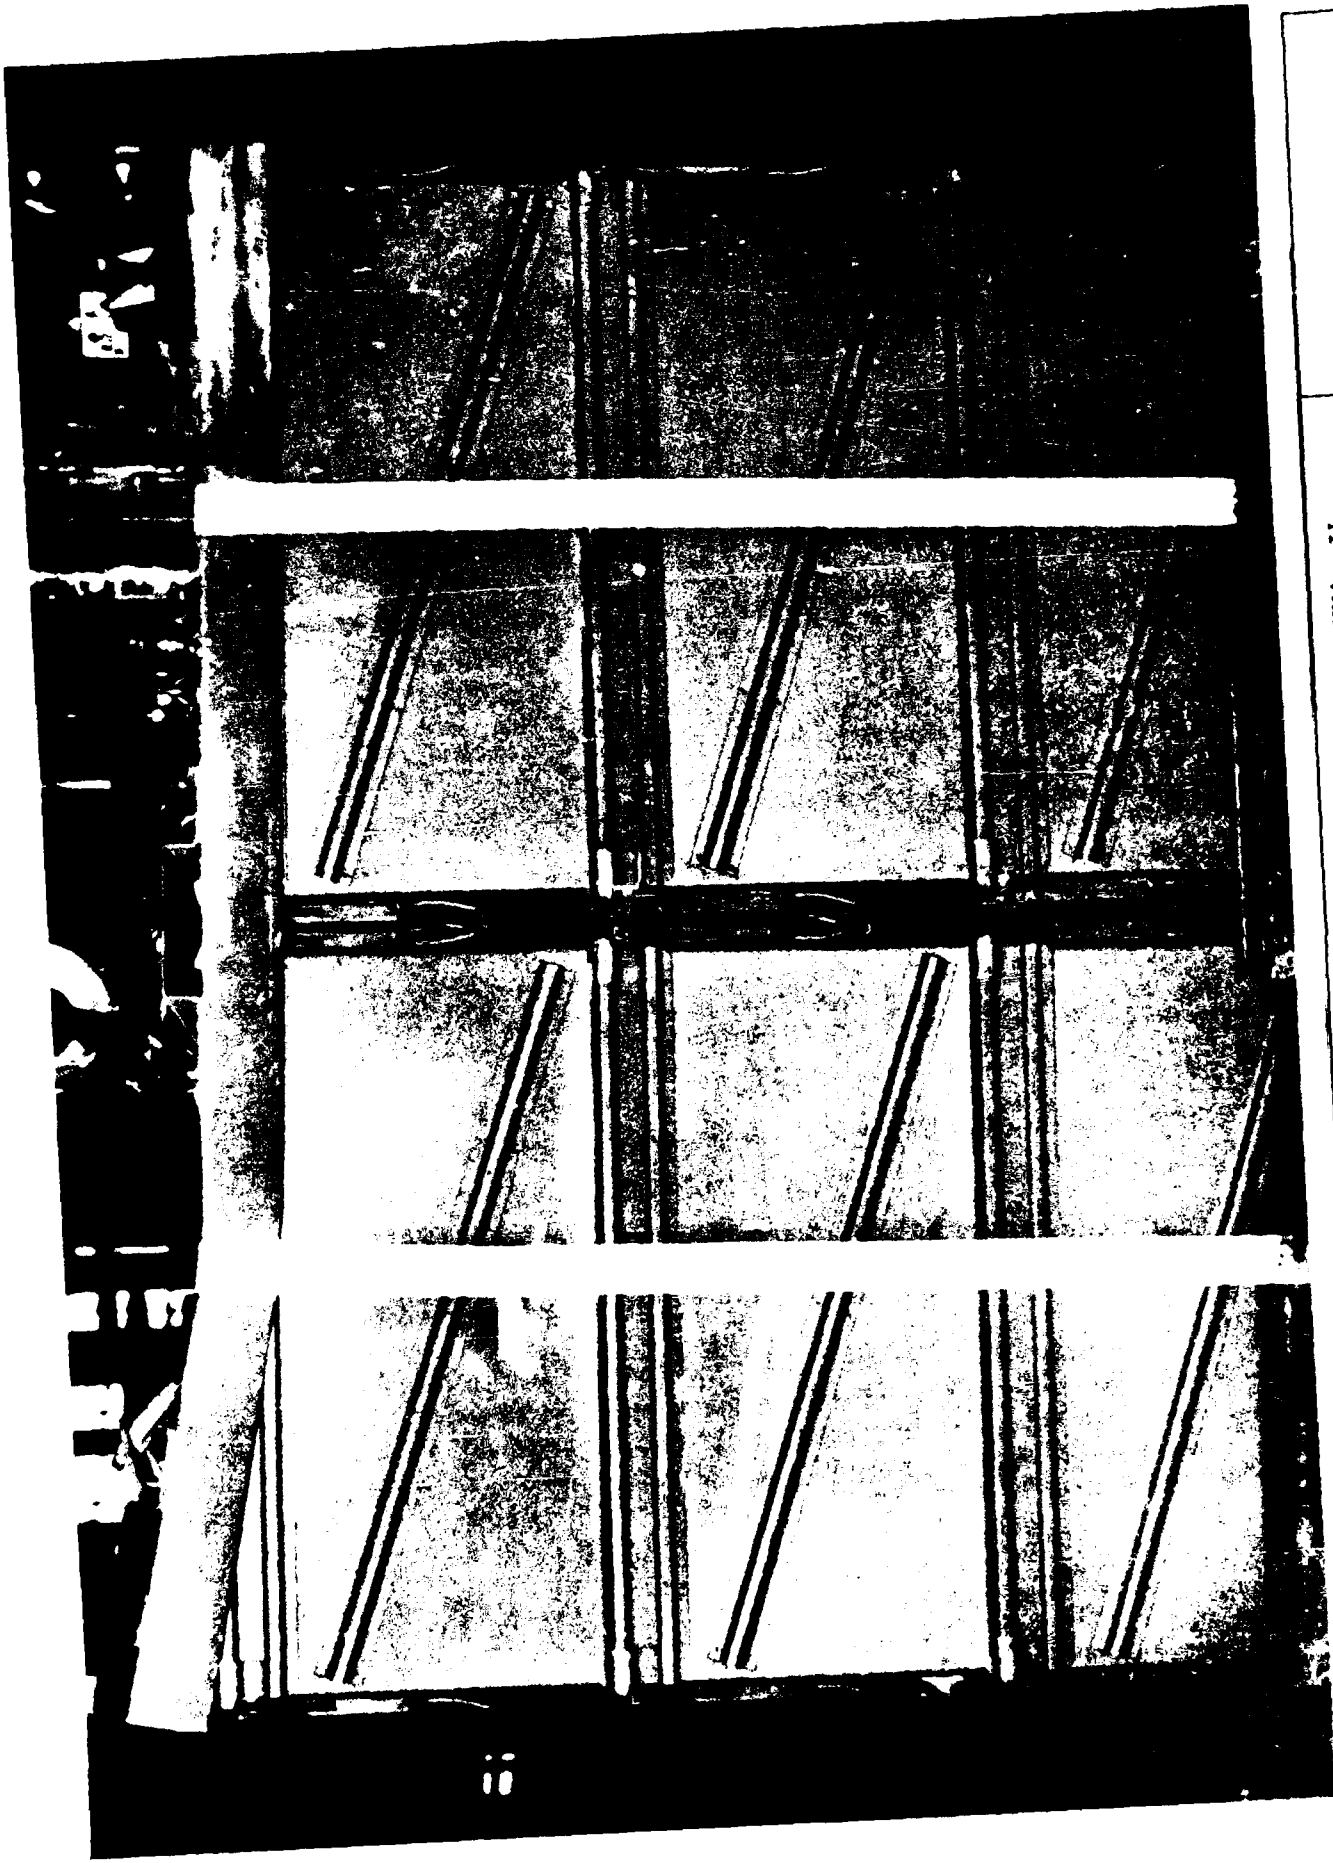
90-2195

Photo No. 6 This photo shows the damage to the lateral members of the top lift assembly due to the slinging test.
