U.S. Army Corps of Engineers  
Technology Transfer  
Test Bed Program

# Considerations For The Use Of Exterior Insulation & Finish Systems (EIFS) On U.S. Army Facilities

DEPARTMENT OF THE ARMY  
OMAHA DISTRICT, CORPS OF ENGINEERS  
OMAHA, NEBRASKA  
December 1991

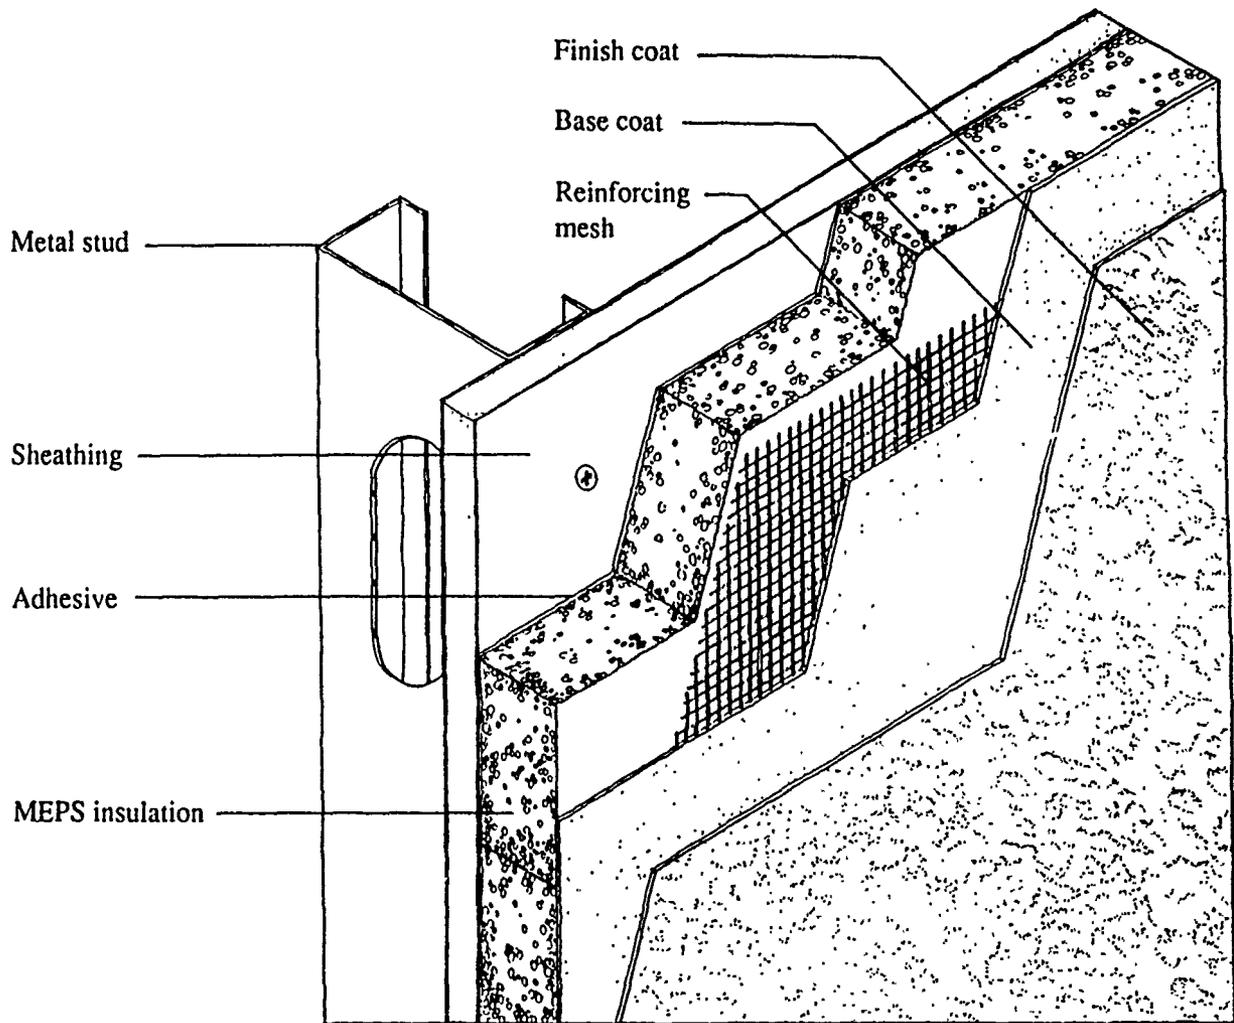
**Figure 1. Typical Class PB System.**

Lamina is a composite layer consisting of three parts: finish coat, base coat, and reinforcement. Finish coat is the system's outermost surface and provides color and texture to the building. Base coat is the foundation for the finish coat, holds the system reinforcement, and most importantly, serves as the wall assembly's primary barrier against water penetration. EIFS reinforcement can be external, either fiberglass mesh or metal lath, which may be combined with internal fiber reinforcement mixed in the base coat.

For reference, Figure 1 presents the components of a typical Class PB system.

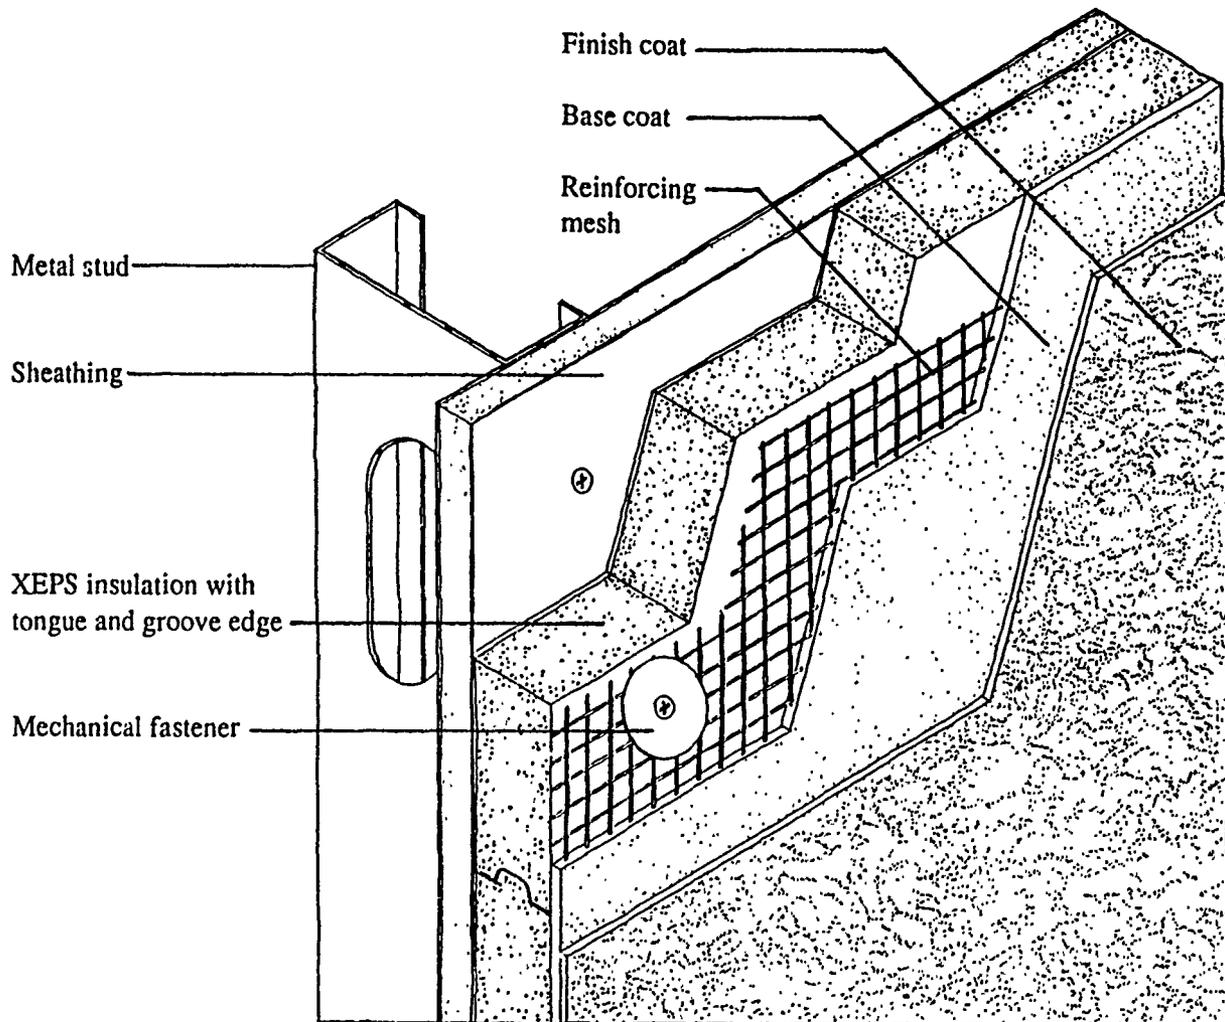
Figure 2. Typical Class PM System.

- Most Class PM systems use a polymer-modified cementitious finish coat, although a noncementitious finish coat can also be used.
- All Class PM systems specify a "thick" base coat, ranging between a nominal 1/4 to 3/8 inch.

- For Class PM systems, a metal lath or fiberglass mesh reinforcement is commonly used.
- All Class PM systems use mechanical as opposed to adhesive attachment. This method of attachment is used because of the weight of Class PM cementitious materials. In addition, the smooth surface of XEPS cannot provide an adequate surface for lamina adherence.
- Class PM systems usually use XEPS insulation, which is always mechanically attached to the substrate.
- Exterior grade gypsum sheathing is the most frequently used substrate material. Other substrates include cementitious-based sheathing, calcium silicate boards, and masonry.

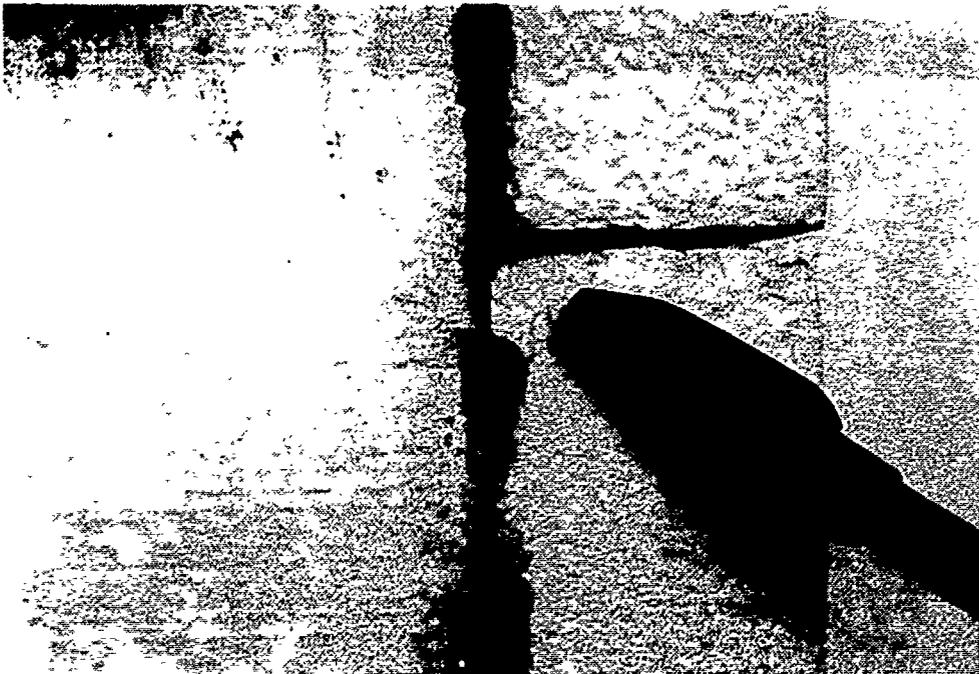
**Figure 5. Adhesive between EPS boards - improper.**

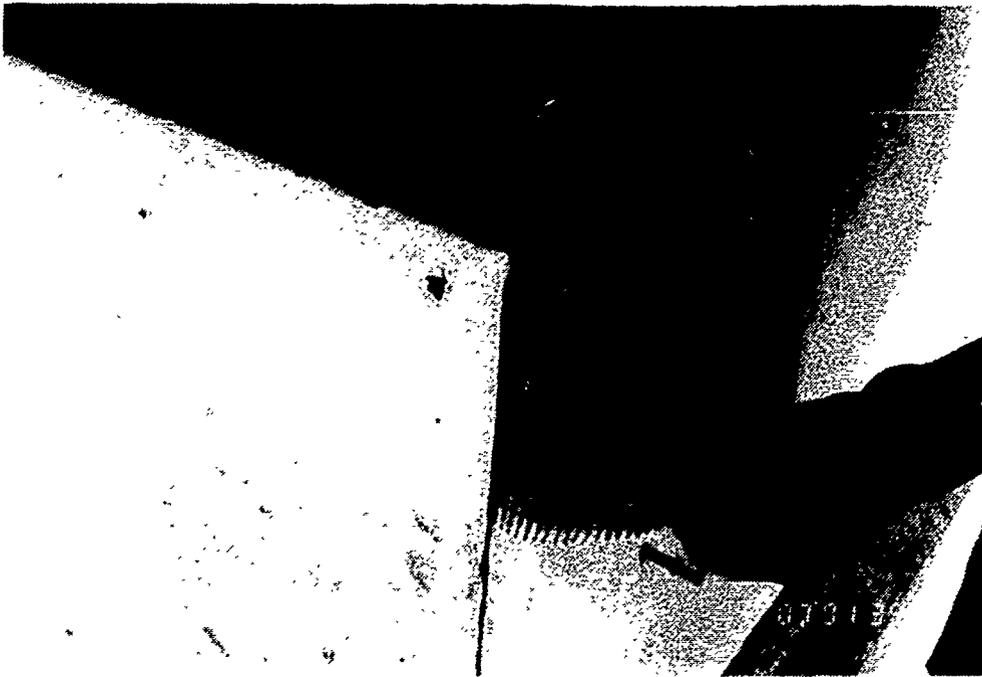
**Figure 6. Incorrect backwrap between EPS boards.**

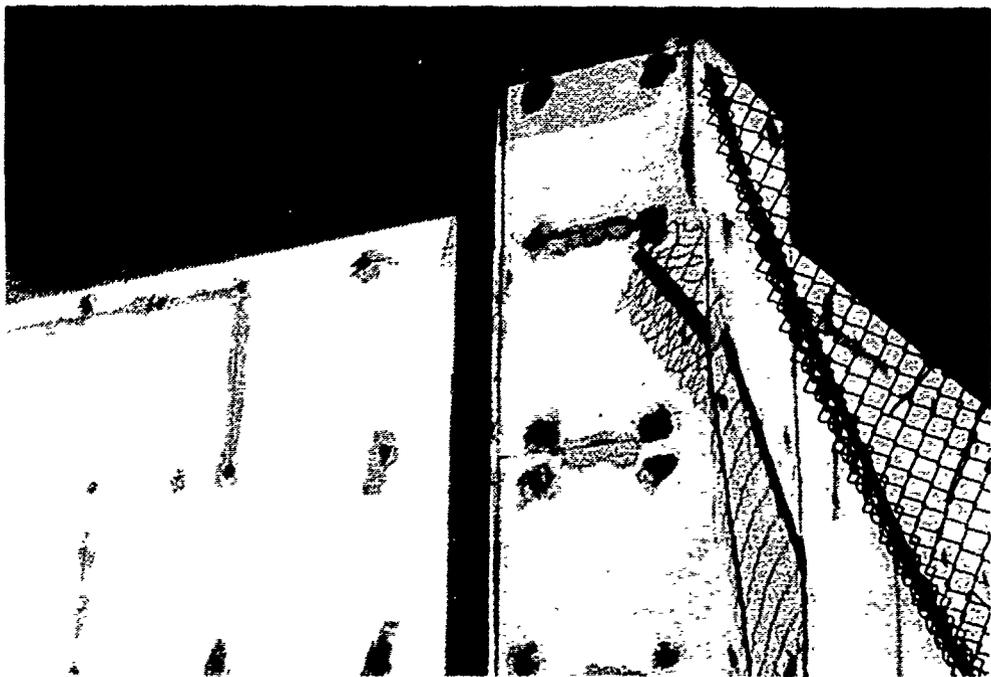
**Figure 7. EPS outside corner - interlock omitted.**

**Failure to interlock corners** — MEPS boards should be interlocked at corner terminations. The use of an interlocking board pattern results in a staggered joint configuration. The stacking of board courses without interlocking corners creates continuous joints. This incorrect method of installation results in cracks along the corners of Class PB claddings (Figure 7).

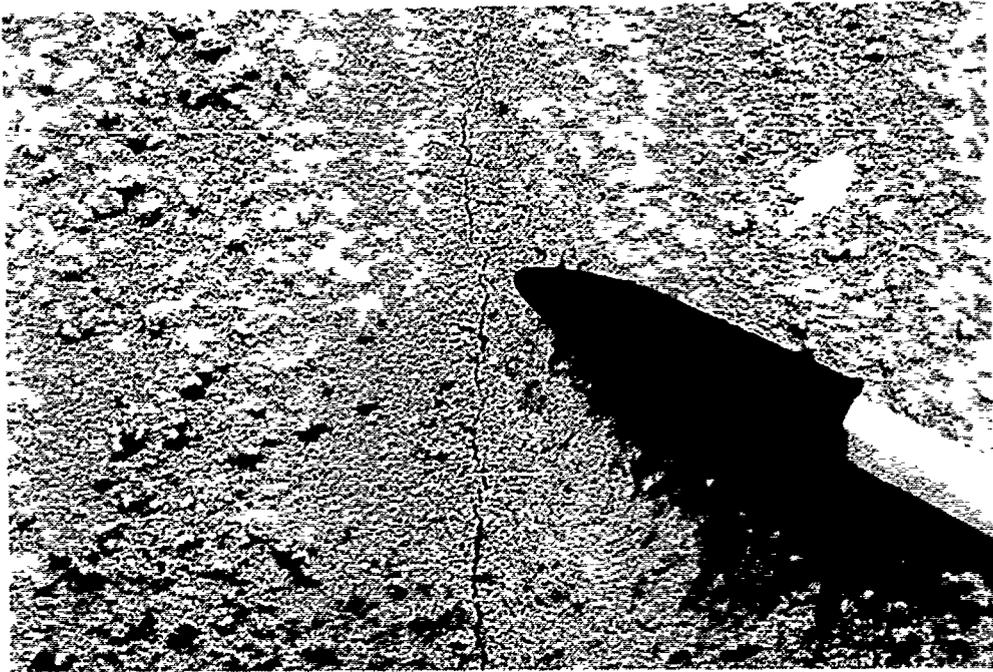
**Figure 9. Cracking in "V" groove articulation.**

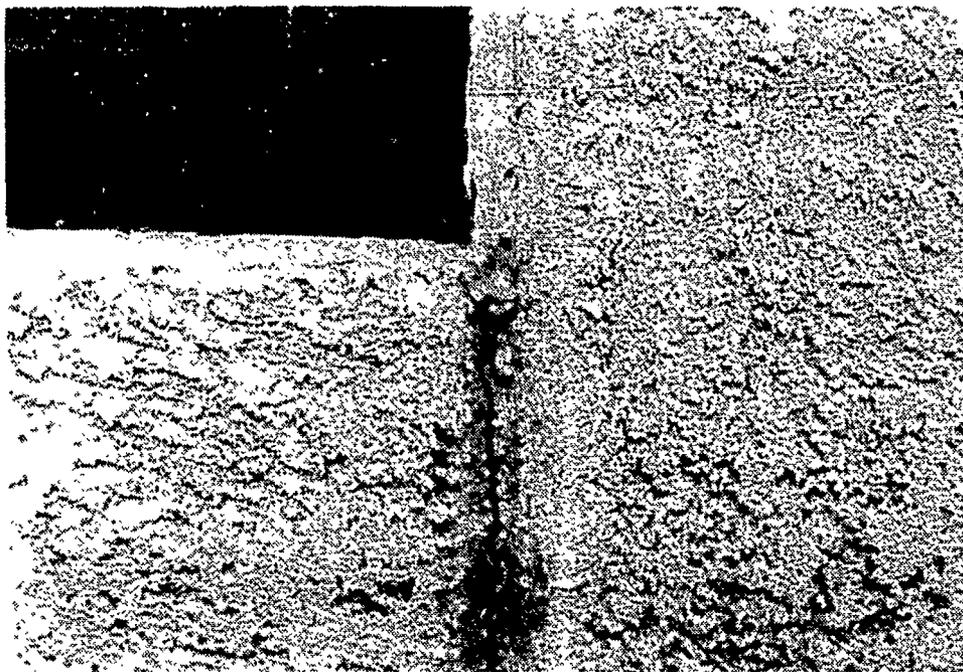
**Figure 11. Cracking in "V" groove articulation.**

**Improper alignment with windows** — The alignment of system articulations with window heads, jambs, or sills can cause cracking (Figures 11 and 12). Proper design should isolate these articulations from other system details.

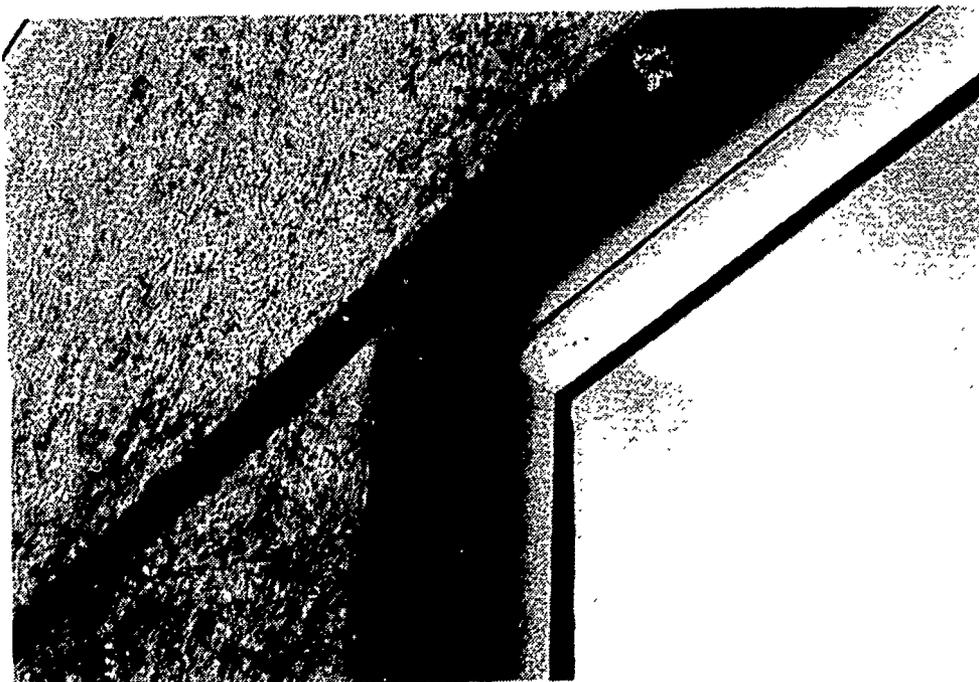
**Figure 12. Cracking in "U" groove articulation.**

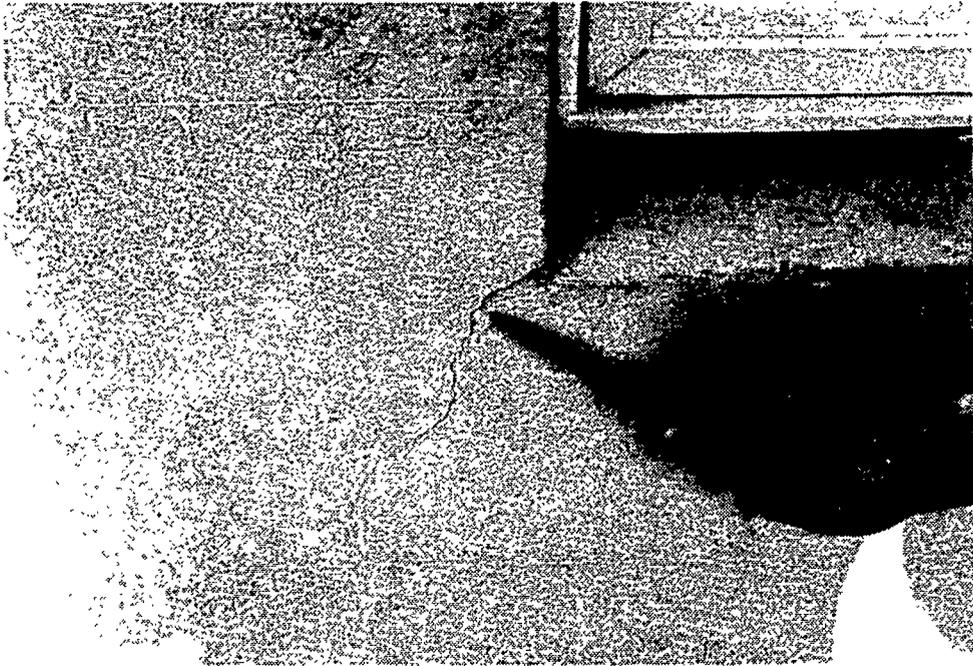
**Figure 14. Diagonal crack at window sill.**

**Omission of diagonal mesh** — Doors and windows are the most common kind of building opening. Other system penetrations include openings for building equipment such as air conditioning units and fixtures. Because the corners of openings are points of concentrated stress, additional reinforcement is necessary. Diagonal mesh is required at the corners of all EIFS openings. The omission of diagonal mesh at corners leads to cracking (Figures 13 and 14).

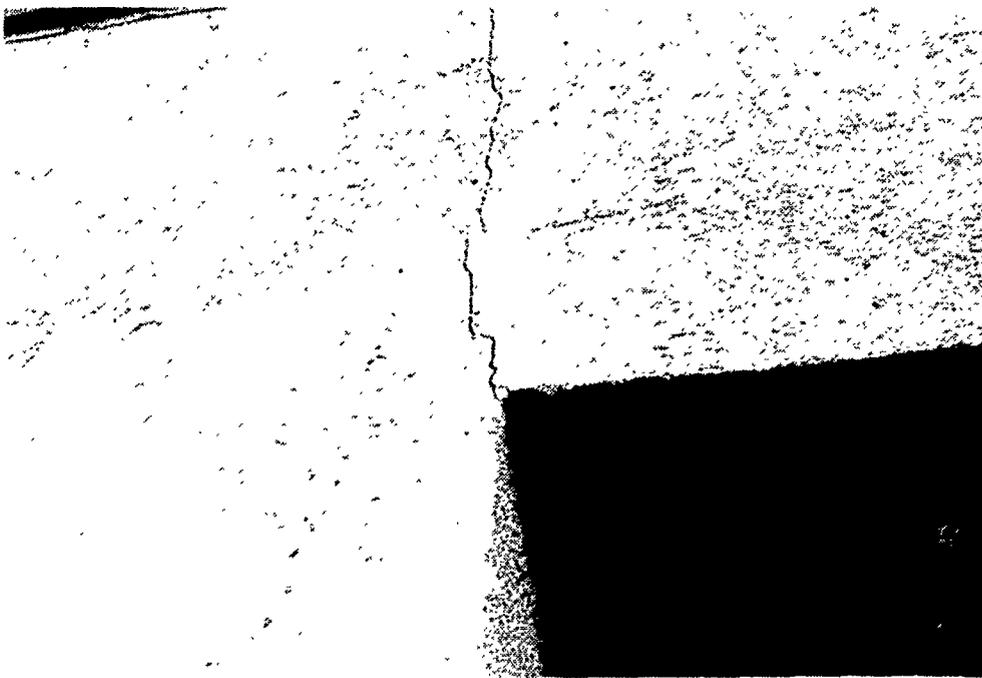
**Figure 15. Vertical crack at window head showing improper alignment of insulation board joint at window head.**

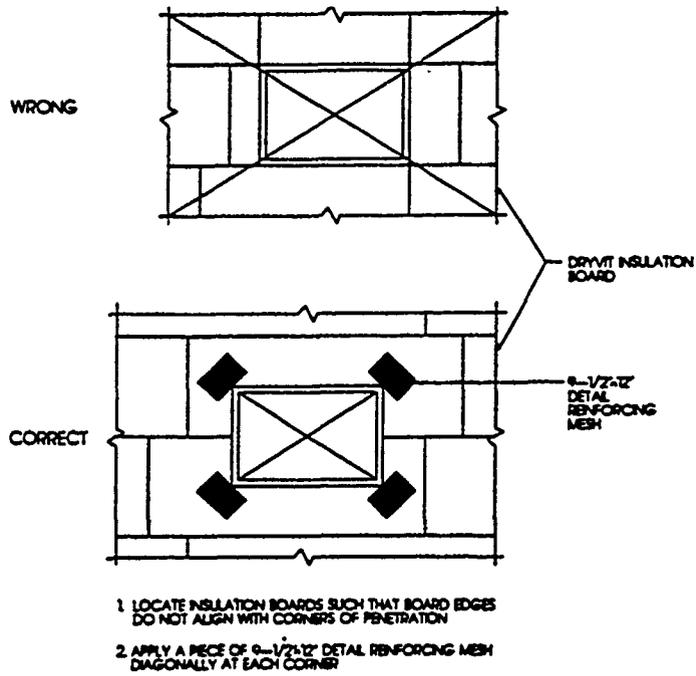
**Figure 16. Dryvit: Wall Penetration Details.** (Source: Dryvit Systems, Inc. Used with permission.)

**Improper board installation at windows** — An incorrect practice is to install insulation boards against door and window openings so that board joints align with window heads, sills, and jambs. When board joints coincide with corners, horizontal and vertical cracking typically occur (Figure 15). L- or saddle-shaped boards should be installed around all openings to diminish the number of board joints at corners (Figure 16).

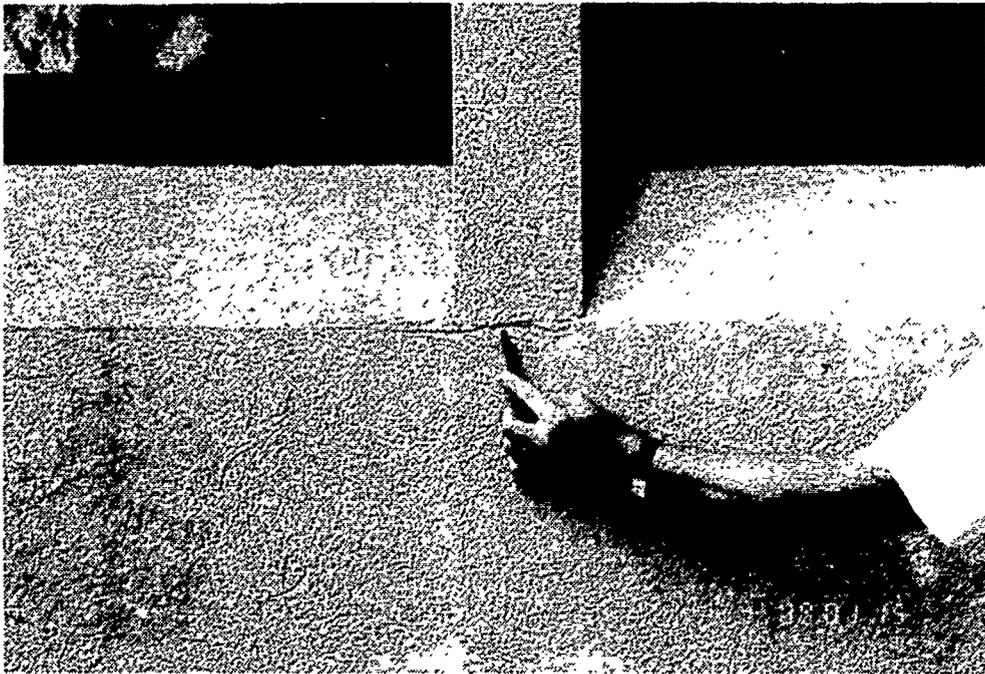
**Figure 17. Crack due to control joint omission.**

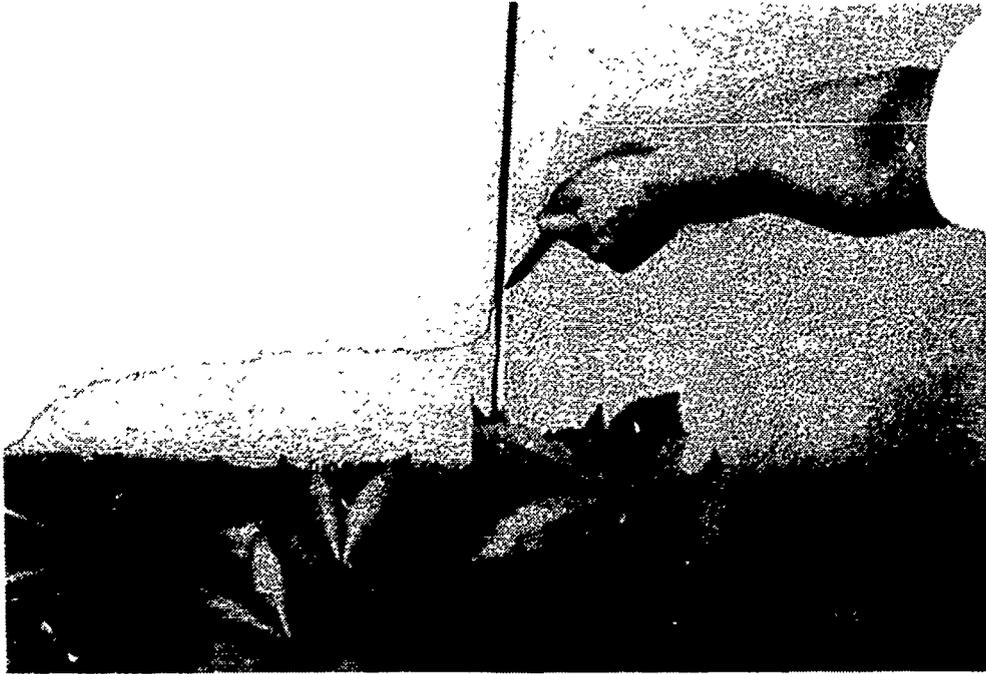
**Figure 19. Impingement at control joint - crack.**

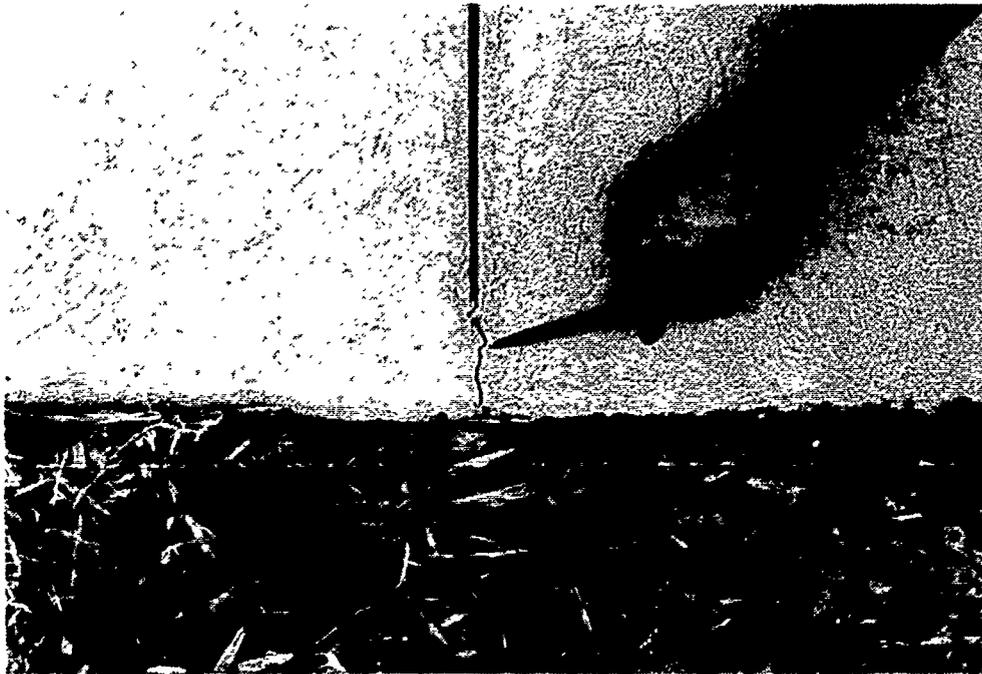
**Figure 20. Premature control joint termination.**

**Premature joint termination** — Horizontal and vertical control joints that are terminated prematurely lead to cracking at the ends of joints (Figures 20 through 23). Control joints should extend the full width and height of the detailed area. For instance, vertical joints should run the full height of the building from roof line to ground. Vertical and horizontal joints which intersect should permit the vertical member to continue through the intersection (Figure 24). If terminated at the intersection, the joint is prone to horizontal, vertical, and diagonal cracking.

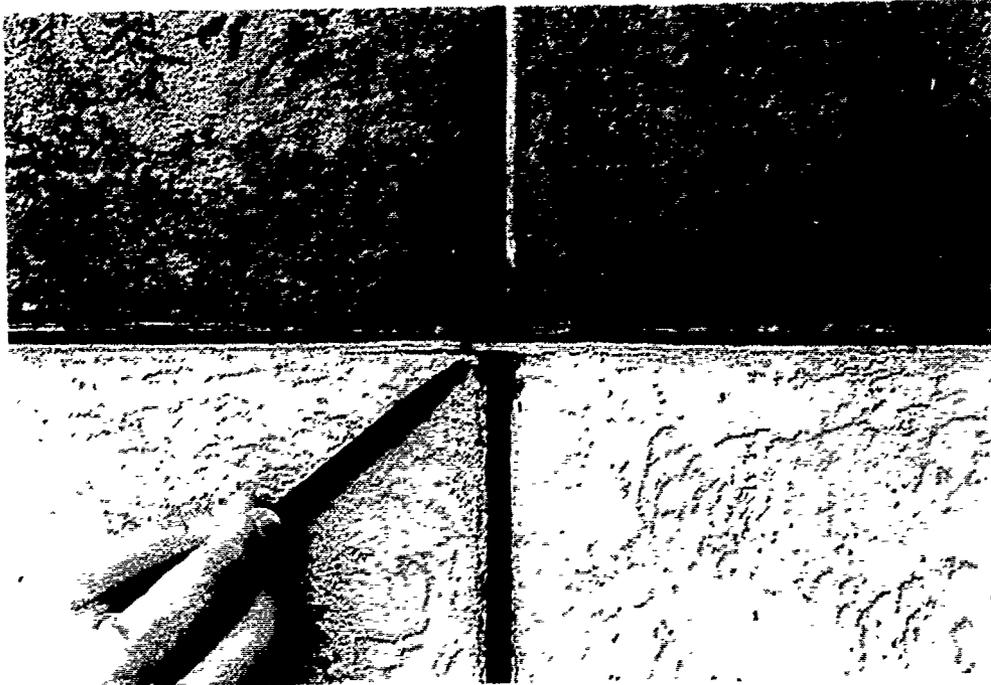
**Figure 24. Improper control joint termination.**

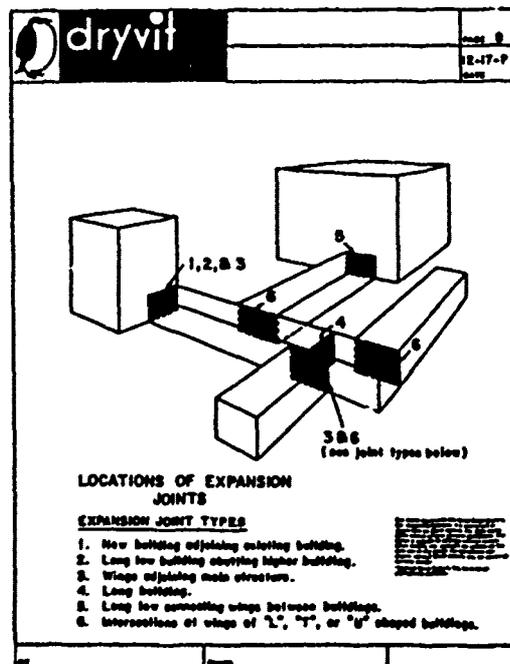
Figure 27. Dryvit: Expansion joint location drawing. (Source: Dryvit Systems, Inc. Used with permission.)

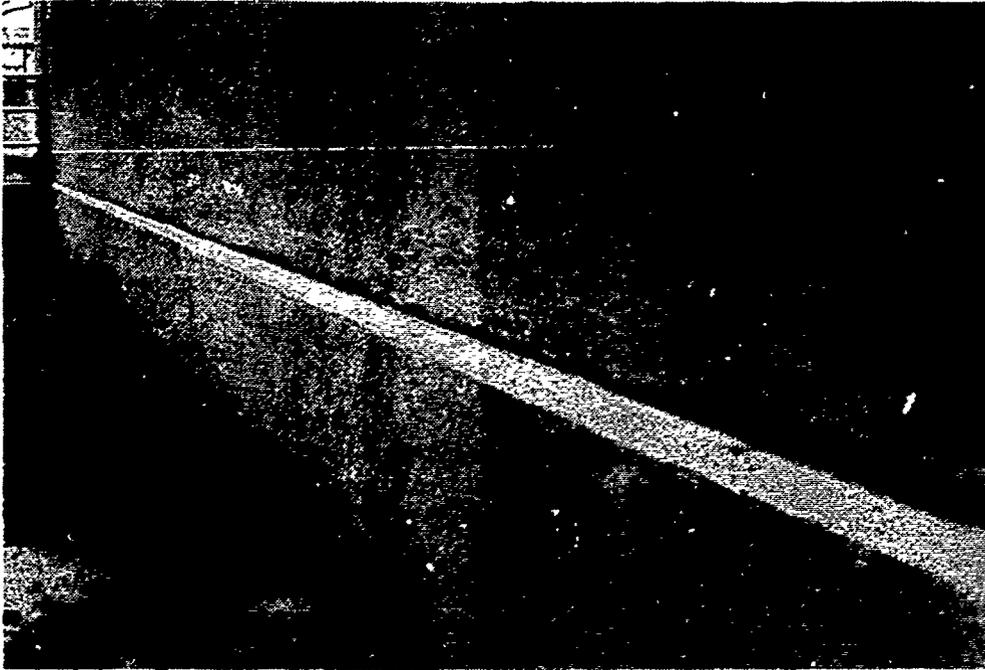
**Figure 30. Successful expansion joint at building base.**

**Poor joint installation** — Among the numerous application factors that contribute to poor joint installation, and thus cracking, are improper joint dimensions, incorrect use of materials, and incorrect finishing. Expansion joints typically incorporate sealant material. The proper application and tooling of sealant material are important aspects of successful joint installation (Figure 30).

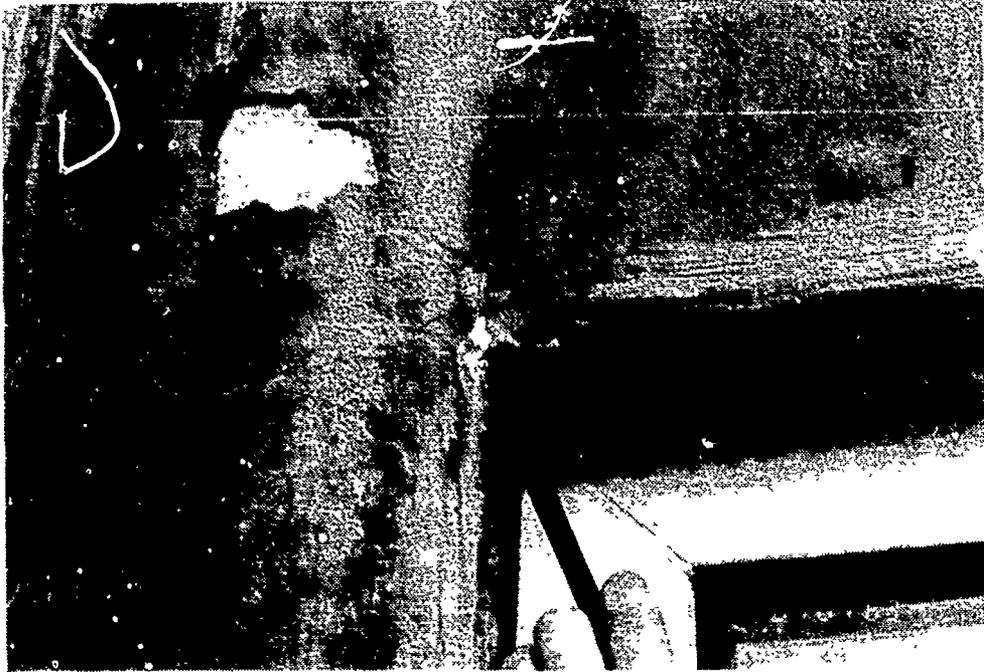
**Figure 31. Spalling of base coat due to improper application.**

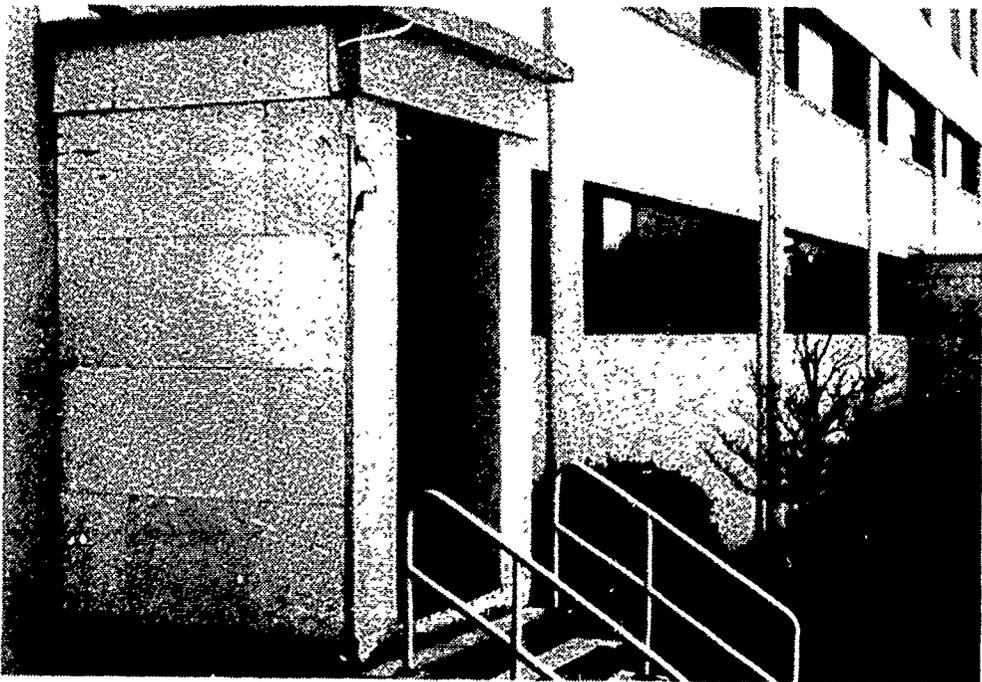
**Figure 34. Ultraviolet EPS board damage.**

**Materials deterioration** — Poor preparation of MEPS insulation board can result in the deterioration of insulation and lead to spalling and cracking. Site dirt, UV degradation (Figure 34) and unevenness should be corrected by rasping MEPS board surfaces prior to base coat application. Correct board preparation ensures a good bond between the lamina and insulation board.

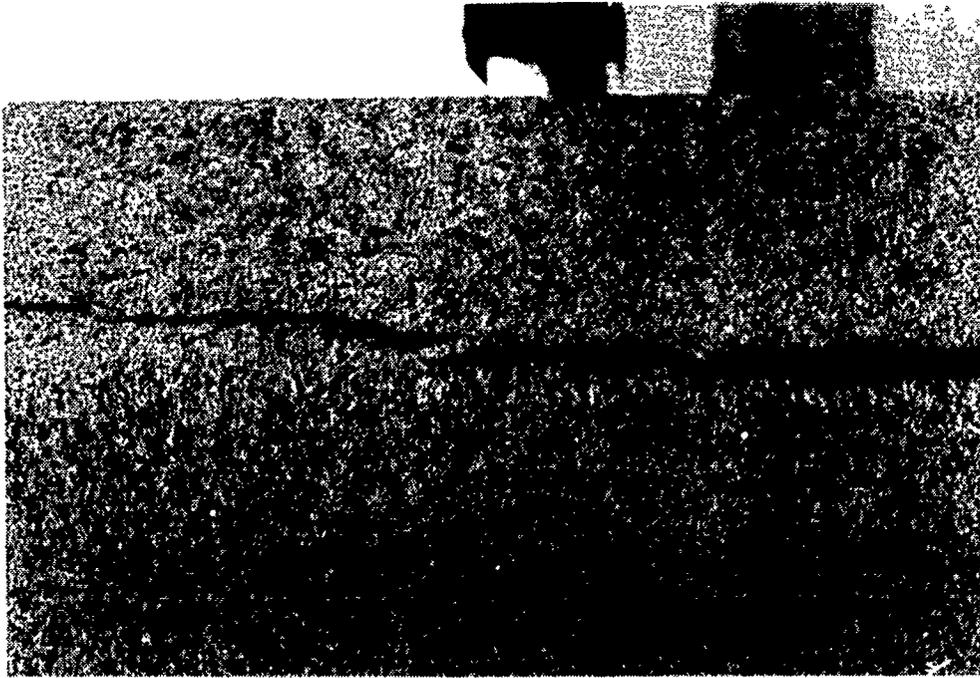
**Figure 36.** Closeup of EIFS lamina failure shown in Figure 35.

**Inappropriate substrate** — The application of lamina on substrates other than those recommended represents noncompliance with manufacturer's guidelines; for instance, applying lamina directly to plywood or gypsum board is not an approved practice. Some products that have the appearance of EIFS allow for the direct application of coatings over concrete, masonry, and stucco. Additionally, manufacturers offer polymer paints which also resemble EIFS. However, the application of EIFS lamina on inappropriate substrates results in failure (Figures 35 and 36).

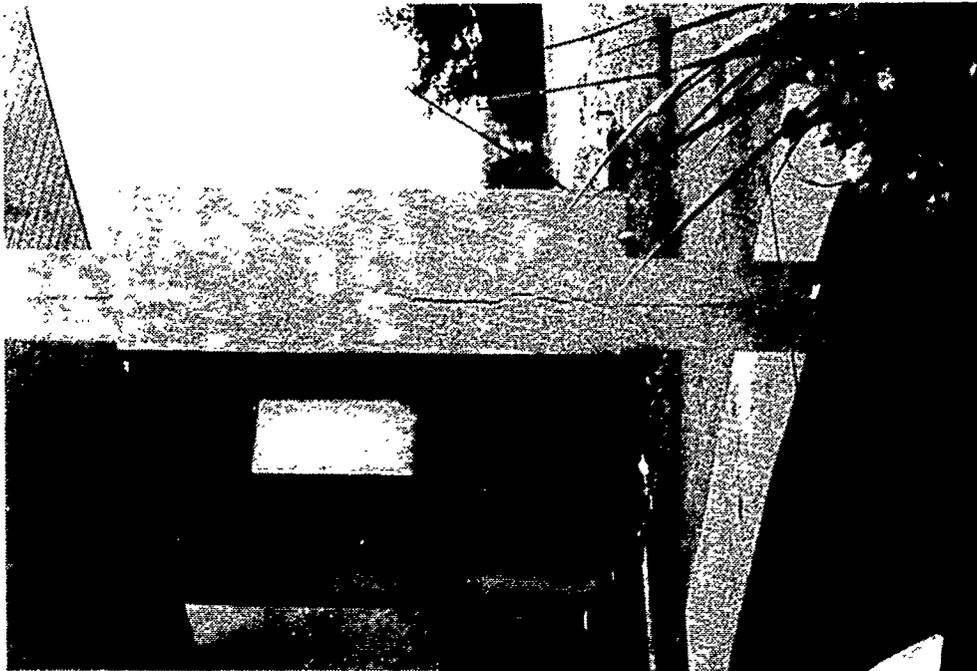
**Figure 35.** EIFS lamina failure due to application over improper substrate: in this case, a wooden column.

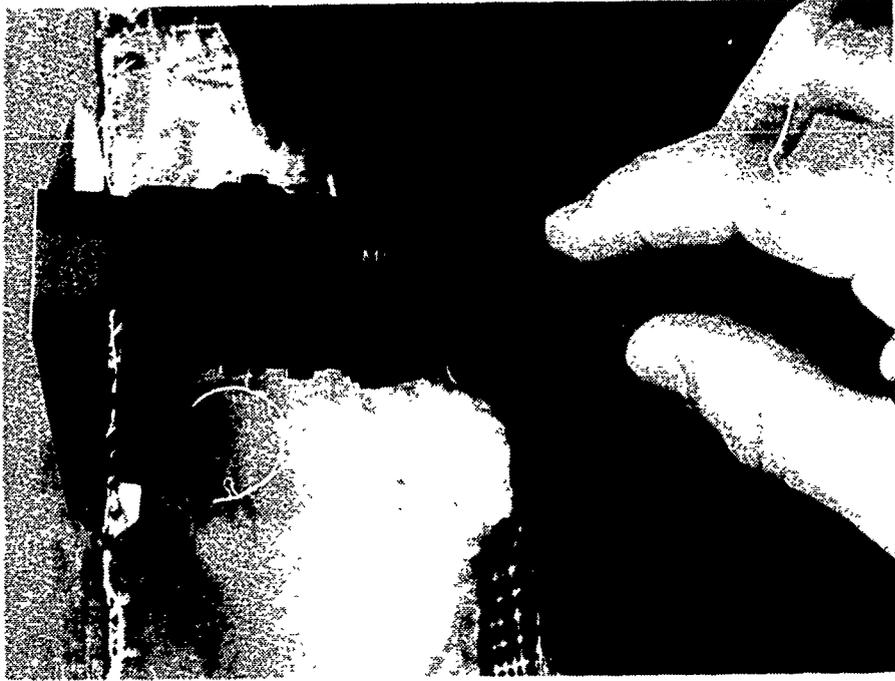
**Figure 37. Inadequate material application.**

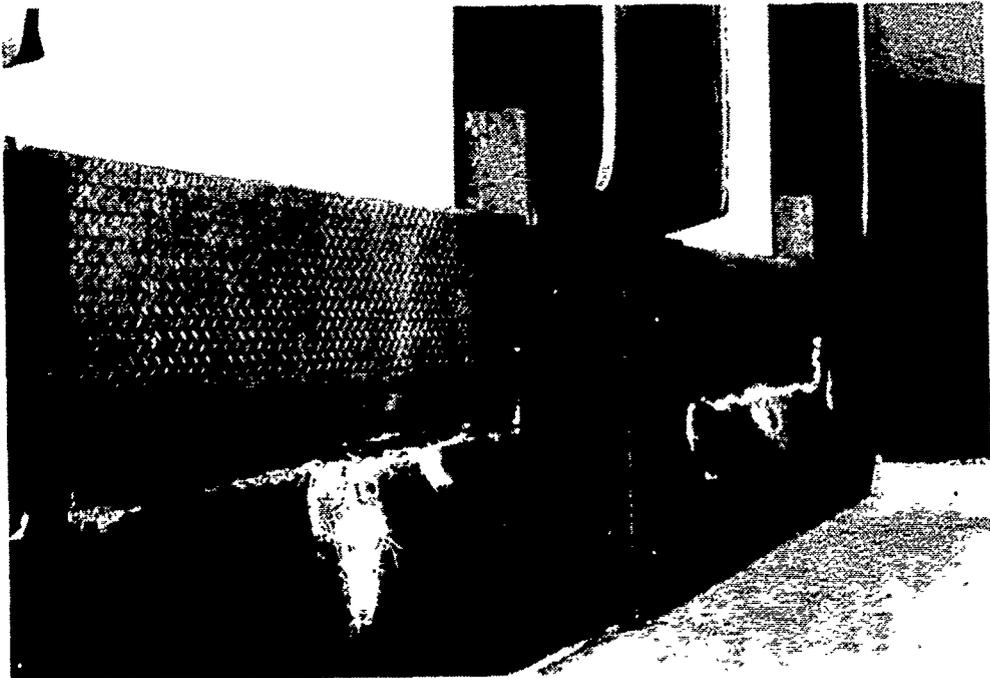
**Figure 38. Impact damage at loading area.**

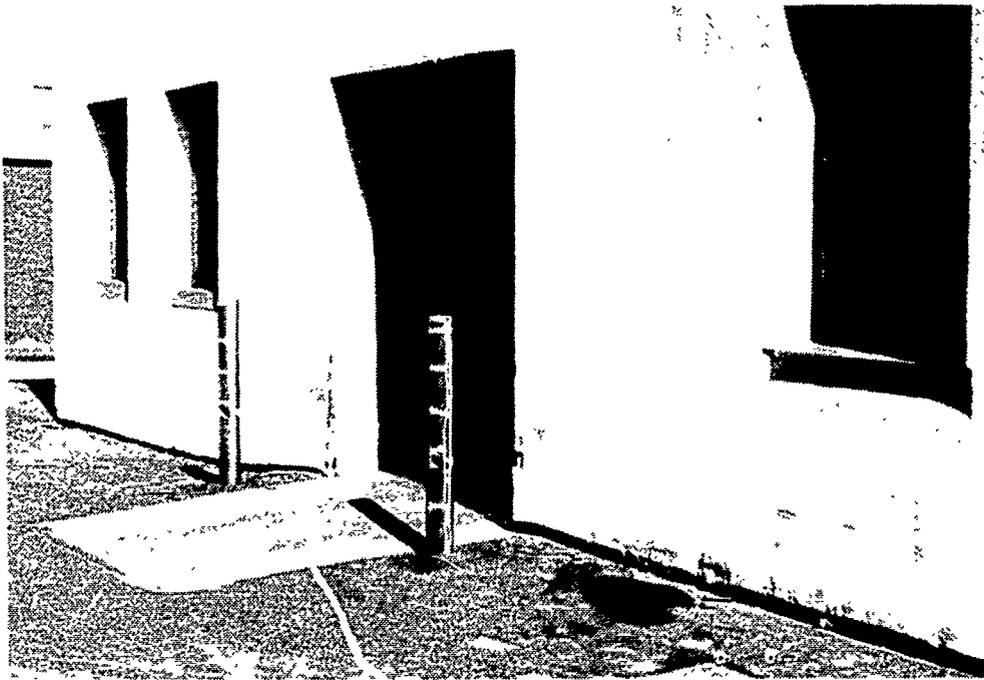
**Figure 39. Impact damage at service area.**

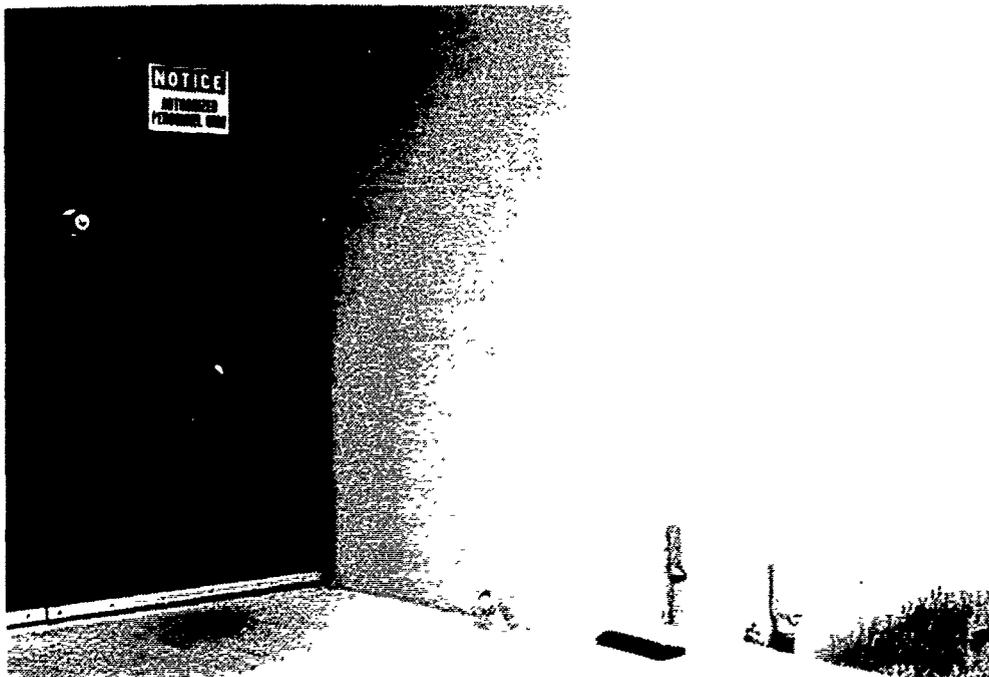
**Figure 40. Doorstop prevents impact damage.**

**Lack of provision for penetrations** — Building penetrations (doors or windows) and fixtures (door hardware or HVAC equipment) should be detailed and installed in a manner consistent with use (Figure 40). For example, an incorrectly positioned doorstop can subject the cladding to repeated impact from the door knob and puncture the lamina (Figure 41). Design professionals and EIFS applicators must work together to ensure adequate provision for such details.

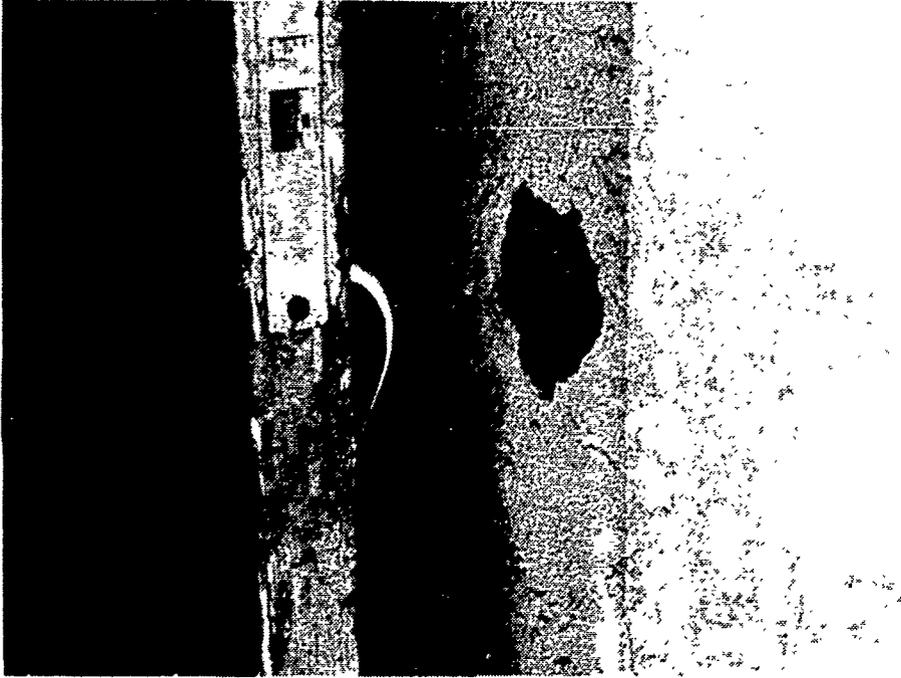
**Figure 41. Impact damage due to door hardware.**

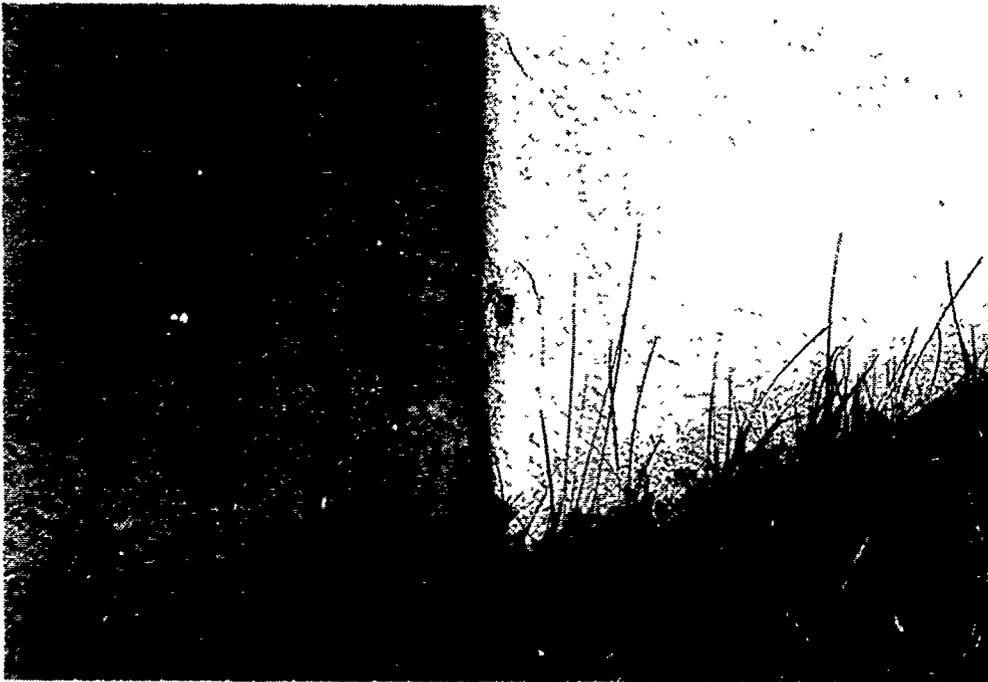
**Figure 42. Impact damage due to lawn maintenance.**

**Lack of provision for maintenance equipment** — Lawn mowers and other lawn maintenance equipment can cause impact damage to EIFS (Figure 42). This type of impact damage can be prevented by changing the EIFS base detail (Figure 43) or by adding a gravel boarder around the base of the building (Figure 44).

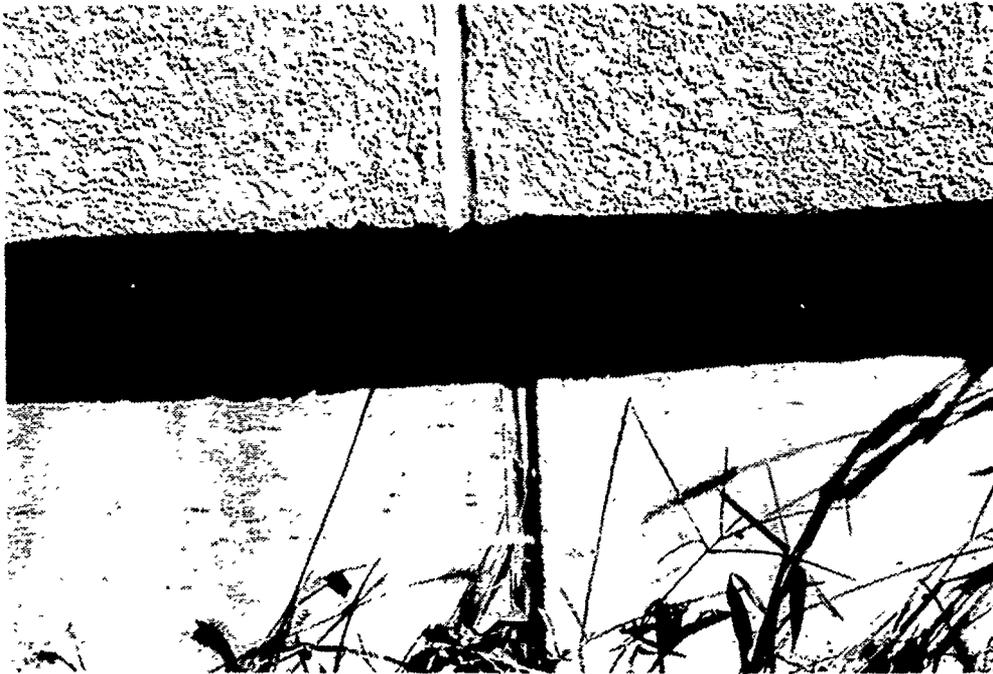
**Figure 43. Base detail to accommodate lawn equipment.**

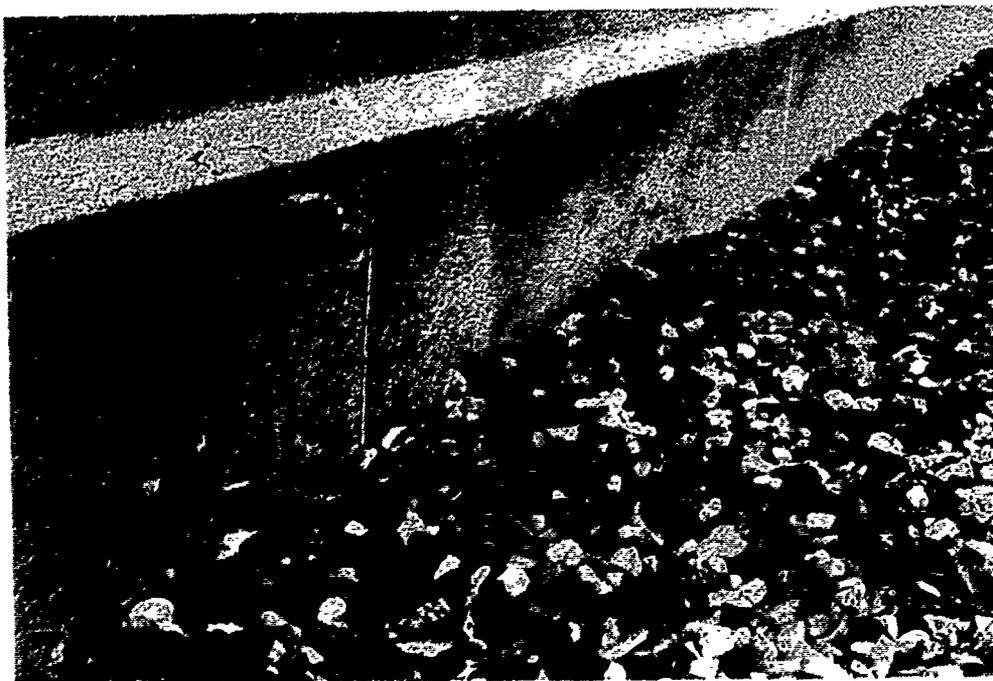
**Figure 44. Gravel border around building perimeter.**

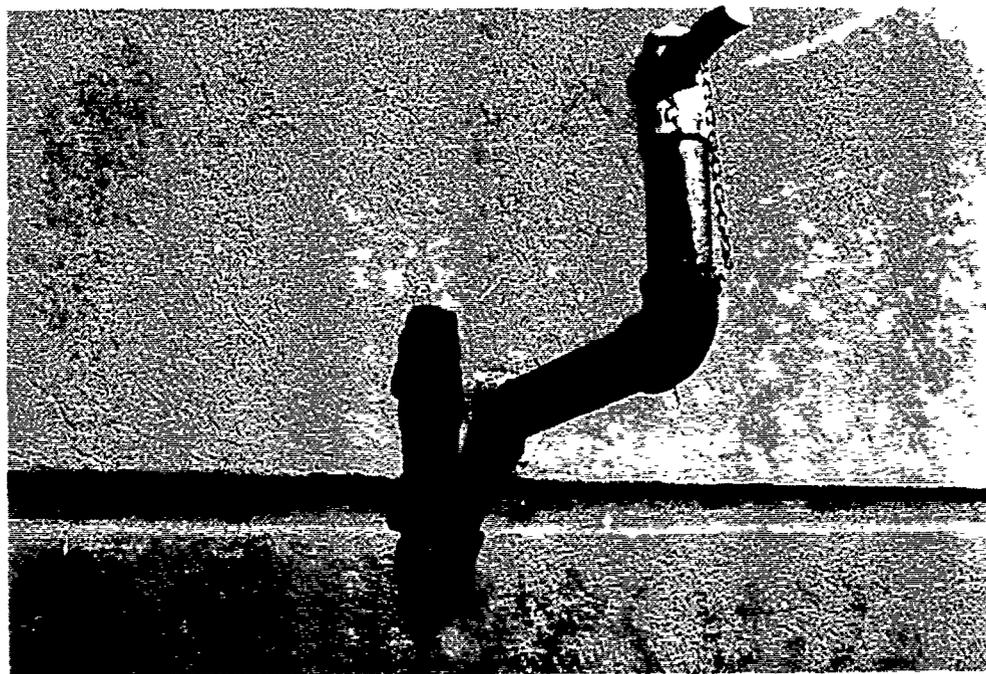
**Figure 49. Inadequate closure at pipe.**
