U.S. Army Corps of Engineers  
Technology Transfer  
Test Bed Program

# Considerations For The Use Of Exterior Insulation & Finish Systems (EIFS) On U.S. Army Facilities

DEPARTMENT OF THE ARMY  
OMAHA DISTRICT, CORPS OF ENGINEERS  
OMAHA, NEBRASKA  
December 1991

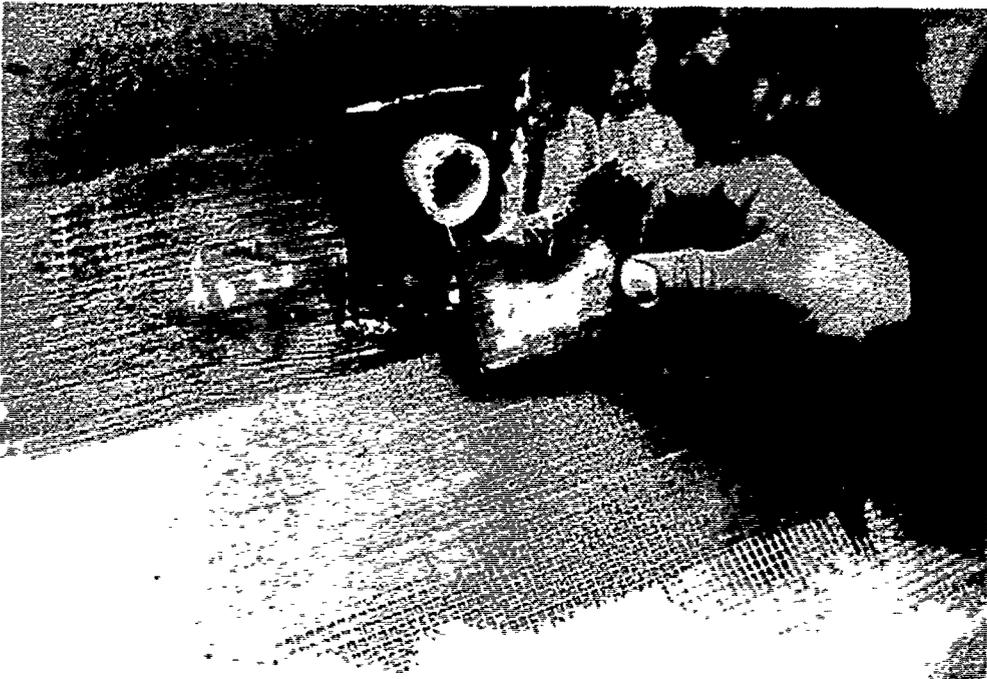
**Figure 51. Inadequate closure at pipe.**

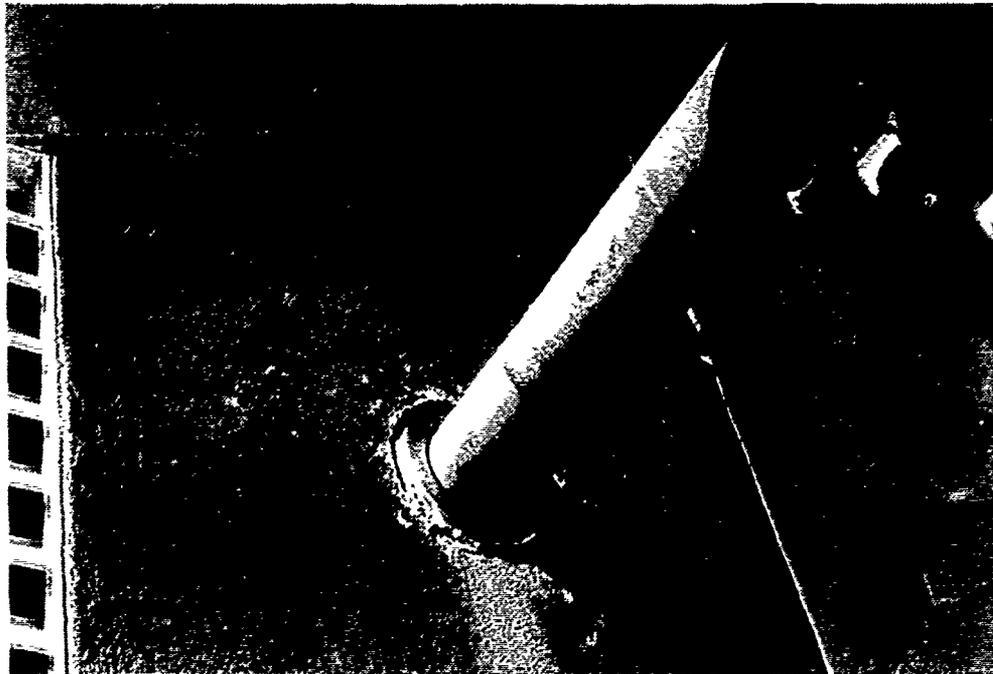
**Figure 52. Inadequate closure at pipe.**

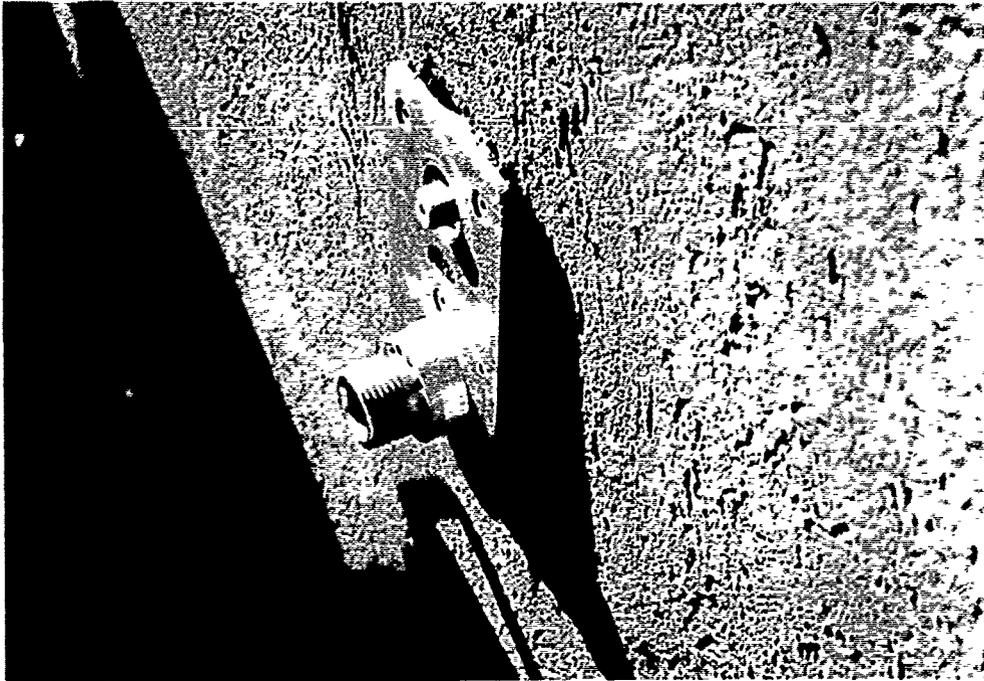
**Figure 54. Inadequate closure at hose bib.**

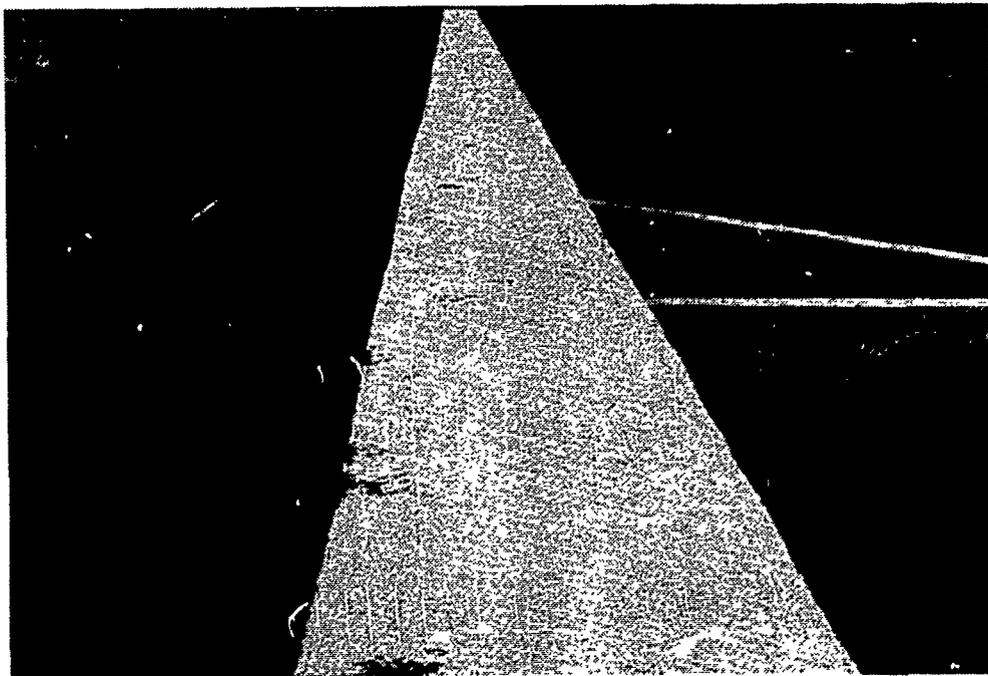
Figure 57. Poor parapet termination — insufficient slope.

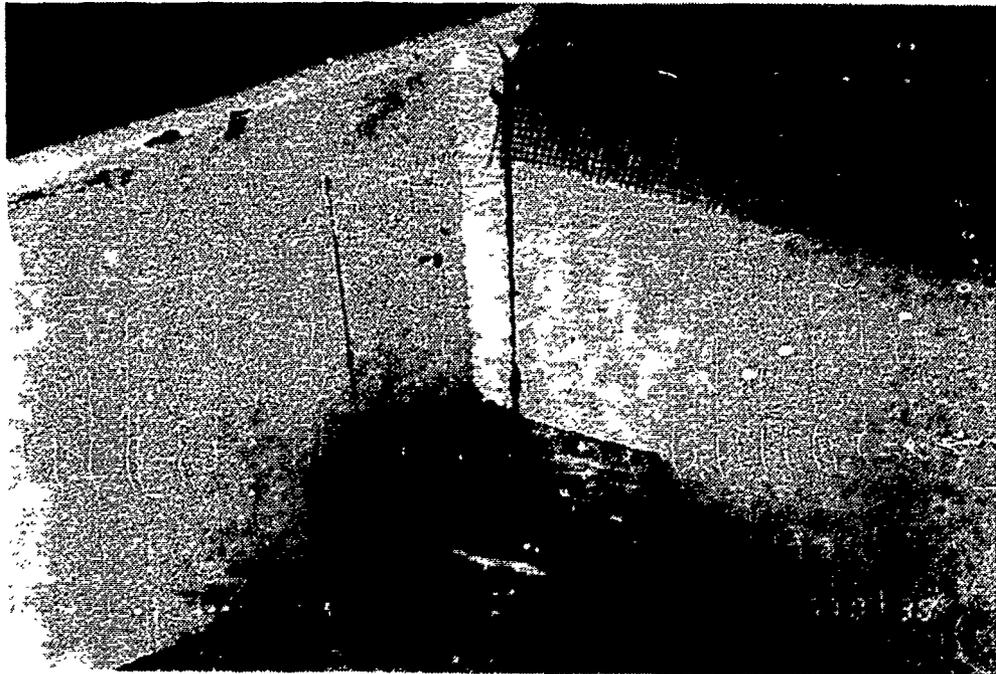
**Figure 61. Good EIFS termination — incorrect backwrap.**

**Improper backwrapping:** Backwrapping is typically required at all exposed edges of EIFS. Boards at the roof and ground require backwrapping. Figure 61 shows backwrapping which was improperly installed. This can subject insulation boards to moisture and chemicals. In addition, the continuity of system reinforcement is interrupted, making unwrapped areas more vulnerable to impact damage.

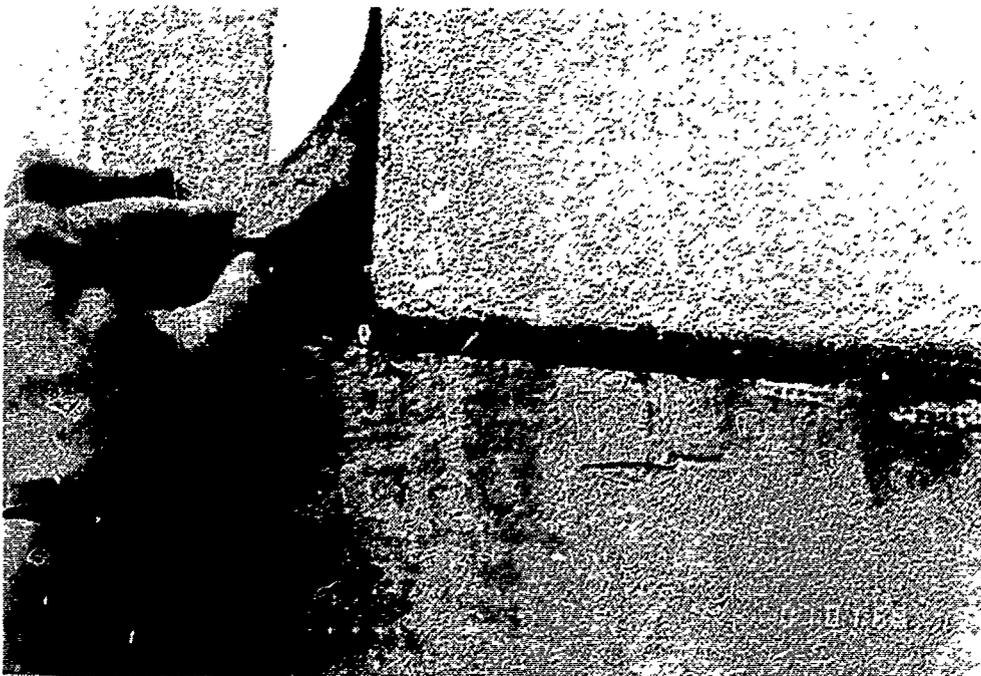
**Figure 63. EIFS/sealant – cohesive EIFS lamina failure.**

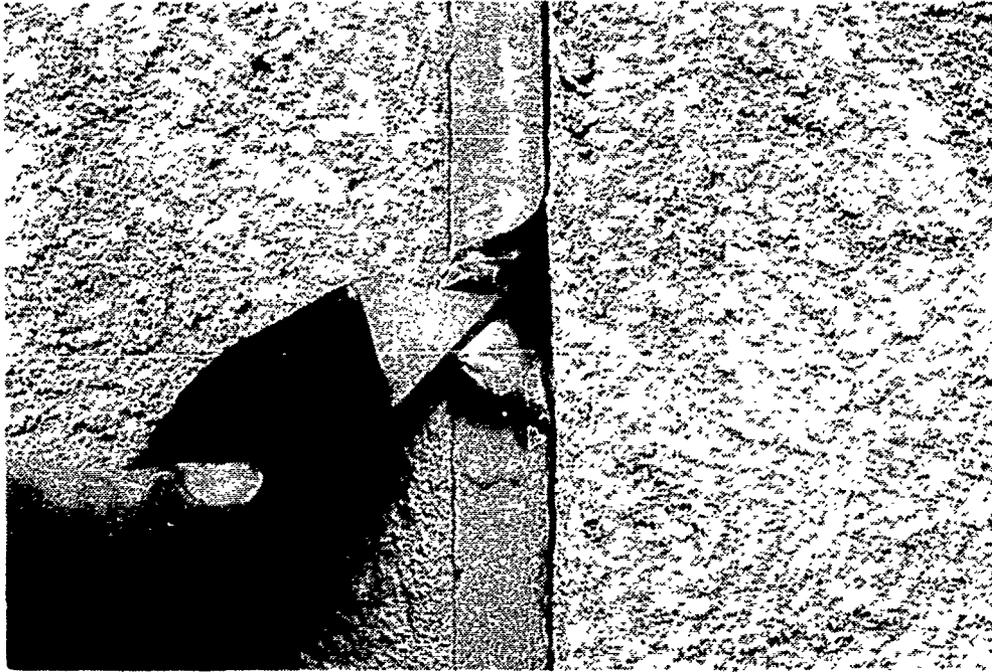
**Figure 64. Cohesive and adhesive sealant failure.**

**Cohesive sealant failure** — Cohesive sealant failures, those within the sealant material itself, are usually caused by incorrect application procedures (Figure 64). EIFS and sealant manufacturers recommend joint preparation procedures, specify joint materials such as bond-breaker tape and back-up rods, and provide directions for sealant mixing and installation. Noncompliance with these recommendations is a common reason for cohesive failure. Improper tooling is another. Techniques standard for all sealant joint installation as well as those particular to EIFS should be followed.

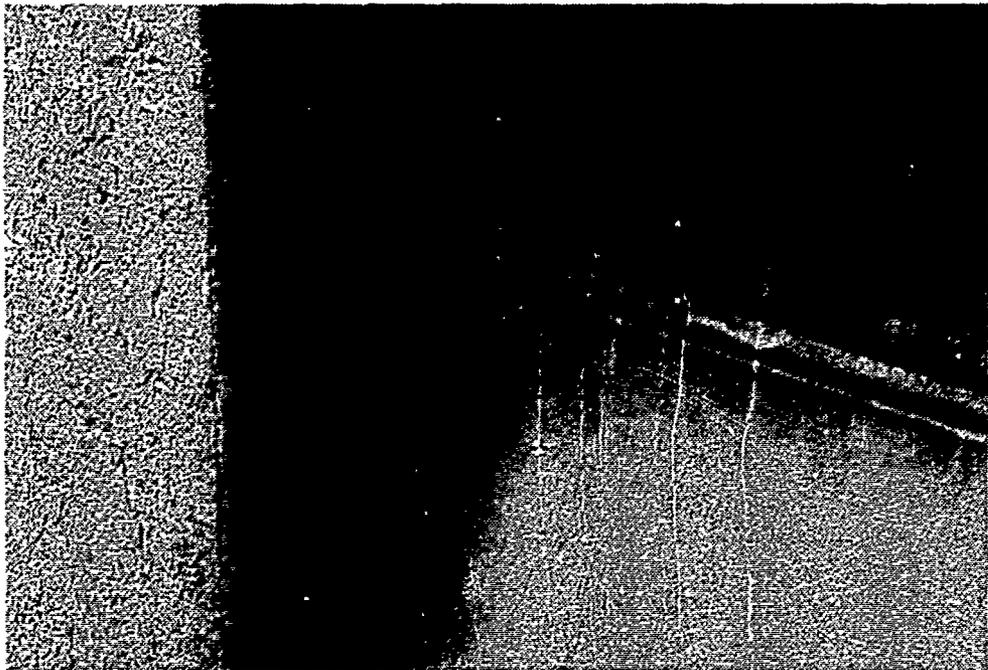
**Figure 65. EIFS/sealant - adhesive failure.**

**Adhesive sealant failure** — Adhesive sealant failure occurs between the sealant material and sealant joint substrate. Improper sealant preparation, omission of primer or back-up rods, the presence of exposed mesh (Figure 65), and improper backwrapping are factors which contribute to adhesive failure.

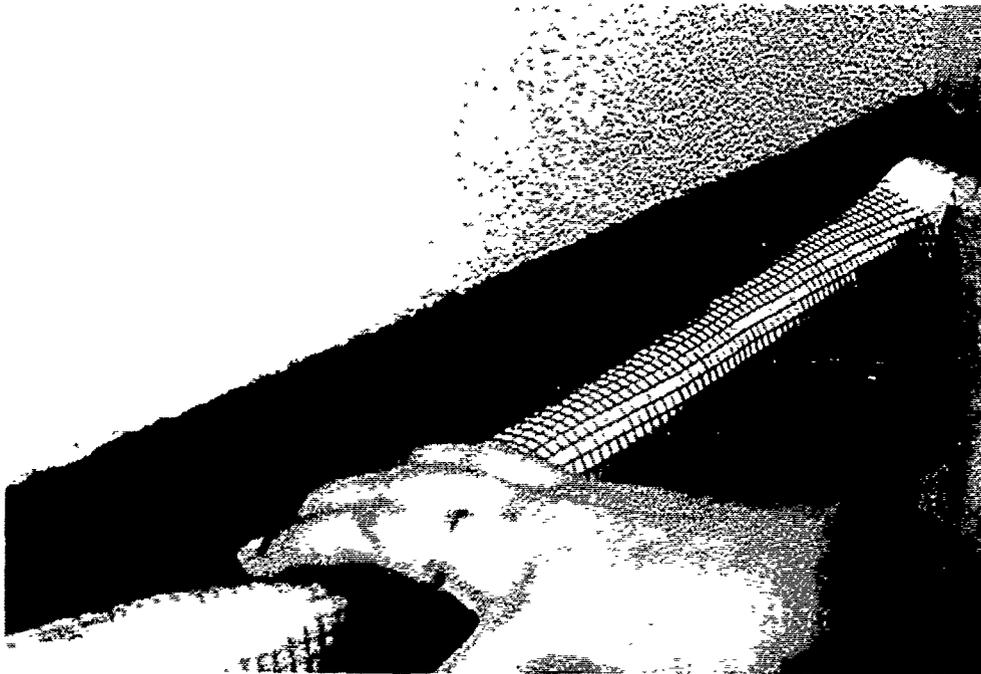
Figure 66. Insufficient adhesive attachment.

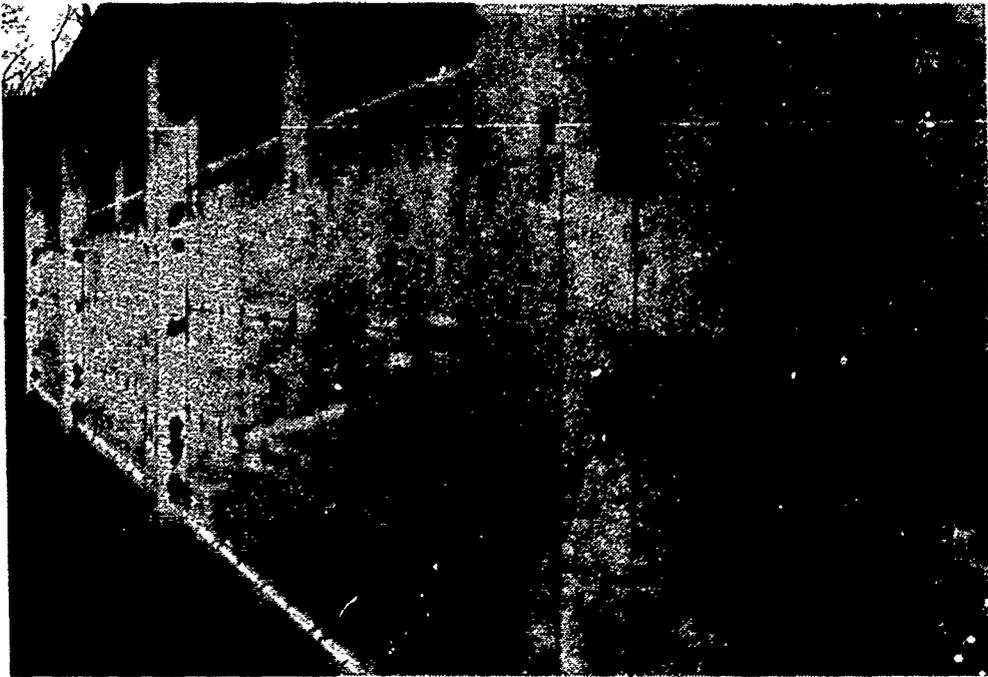
**Figure 69. Improper mechanical fastener spacing.**

**Mechanical attachment** — In the case of mechanical attachment, fasteners improperly placed or spaced can result in system detachment (Figure 69). Fasteners should generally not be placed on board perimeters. Spacing should be in accordance with manufacturer directions. In Class PB systems, fasteners are sometimes countersunk and covered with plugs of insulation board. Figure 70 shows a protruding, exposed fastener. The spot application of base coat to cover fasteners is not an accepted practice (Figure 71).

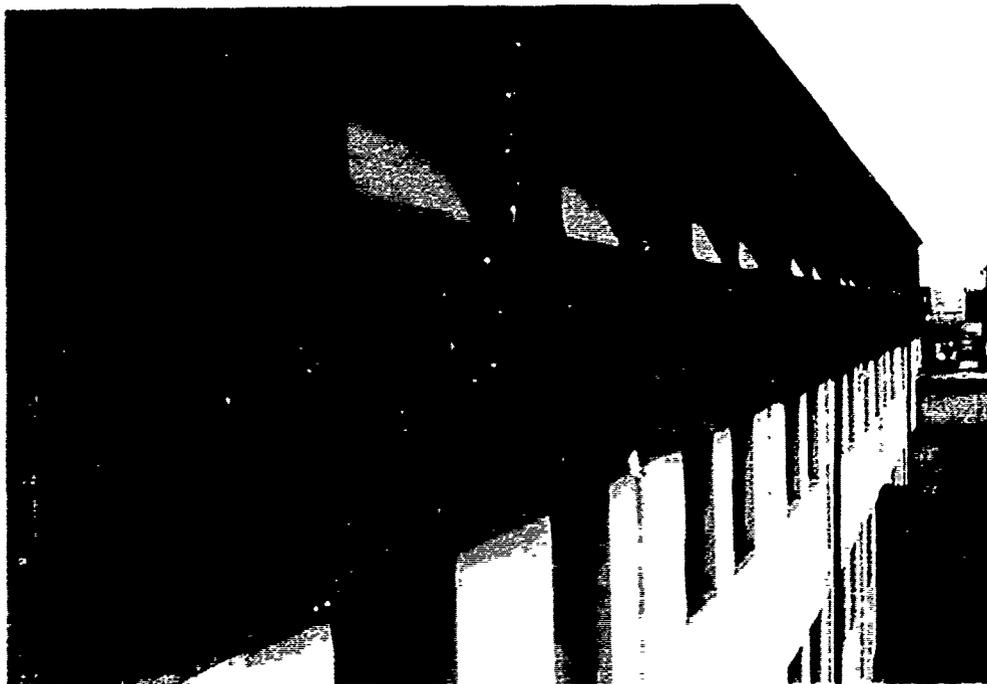
Figure 73. Faded finish coat.

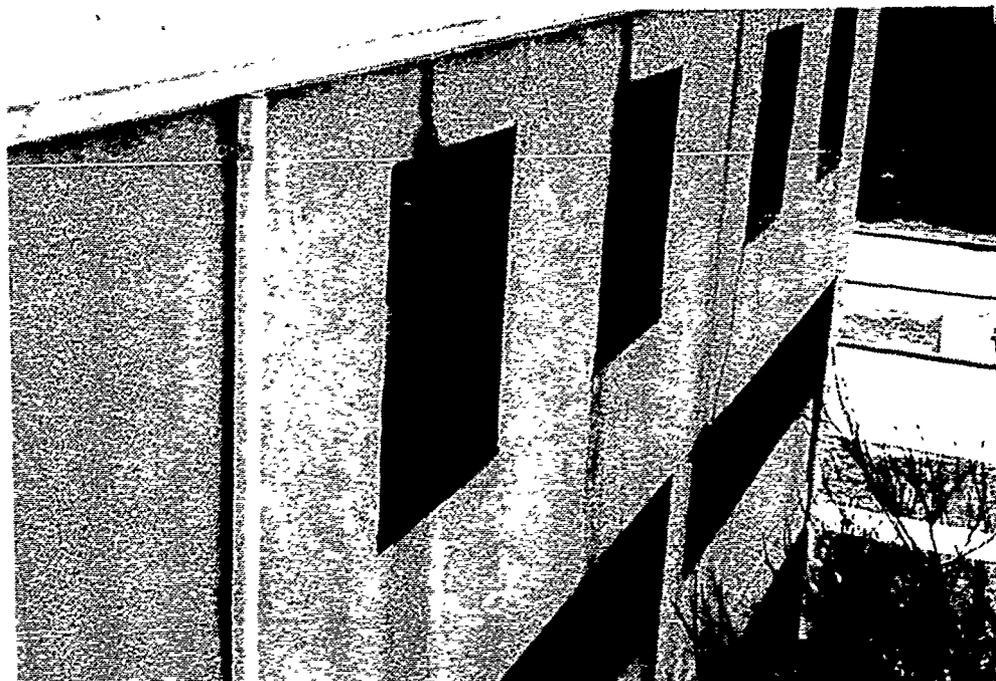
**Figure 74. Stains due to leaks in gutter.**

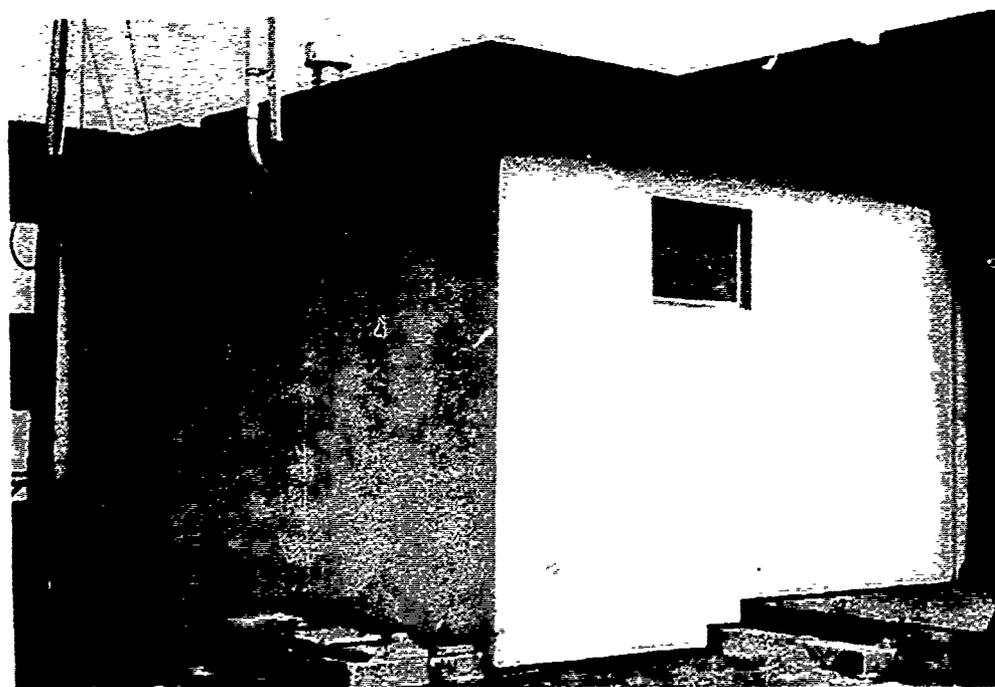
**Figure 75. Stains due to laundry room exhaust.**

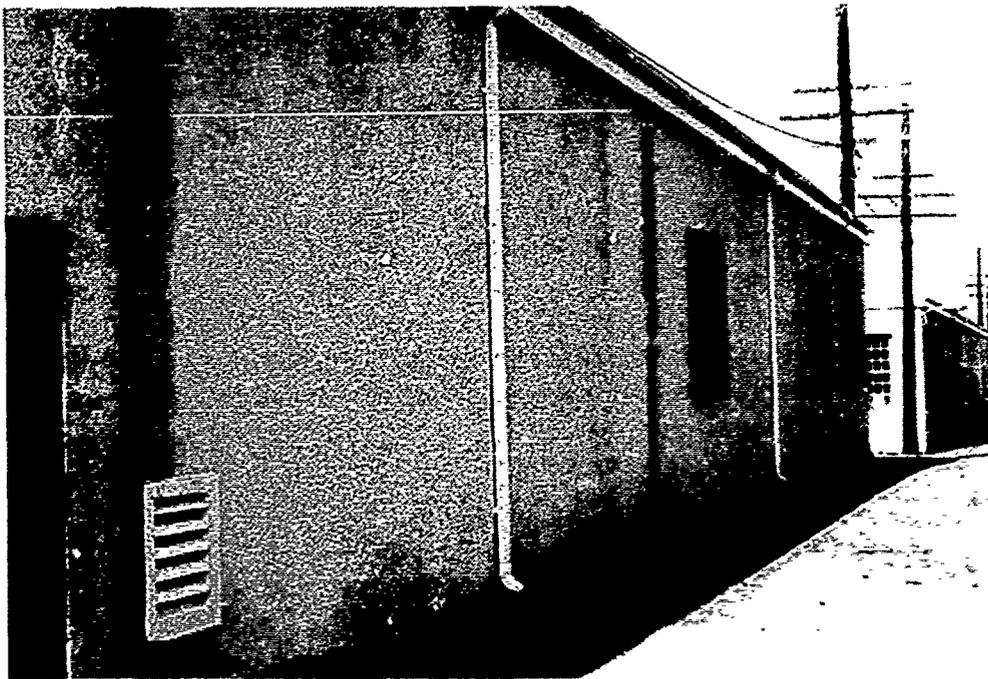
**Figure 76. Stains due to leaks in gutter.**

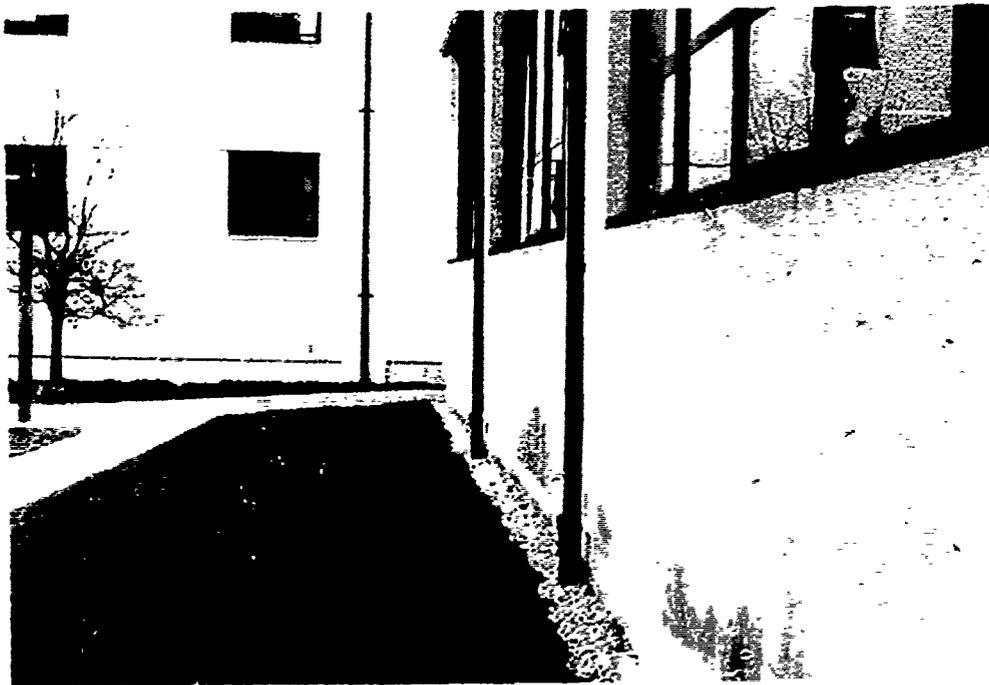
**Figure 77. Mildew at grade.**
