# THE RELATIONSHIP BETWEEN FUEL LUBRICITY AND DIESEL INJECTION SYSTEM WEAR

INTERIM REPORT  
BFLRF No. 275

By  
**P.I. Lacey**  
Belvoir Fuels and Lubricants Research Facility (SwRI)  
Southwest Research Institute  
San Antonio, Texas

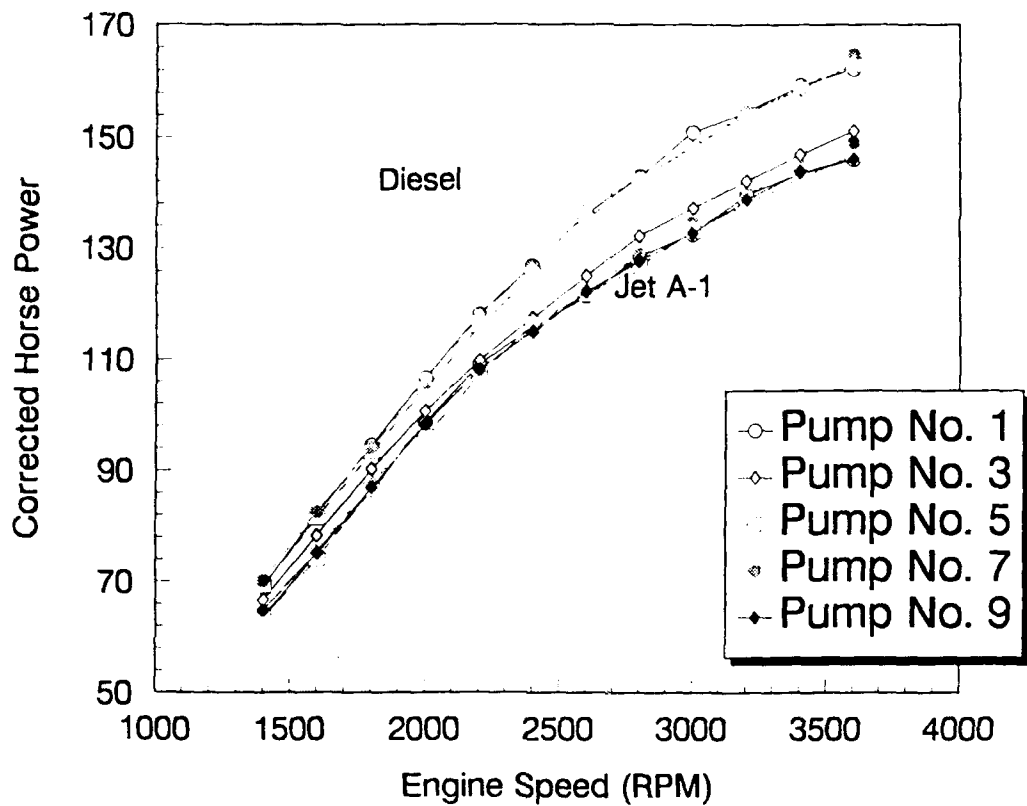
Figure 1. Brake horsepower with test pumps prior to testing

a. Standard Pump

b. Arctic Pump

The complete power curve for each pump is provided in Appendix C, while the average change in power output over the entire speed range is summarized in Fig. 10. In each instance, the results are corrected to standard temperature and pressure and are relative to the same fuel prior to testing. **The decrease in power for engine tests with low-viscosity jet fuels will be approximately 12 percent greater than the values provided in Fig. 10 when compared with the pretest results on diesel fuel (i.e., see Fig. 1).**

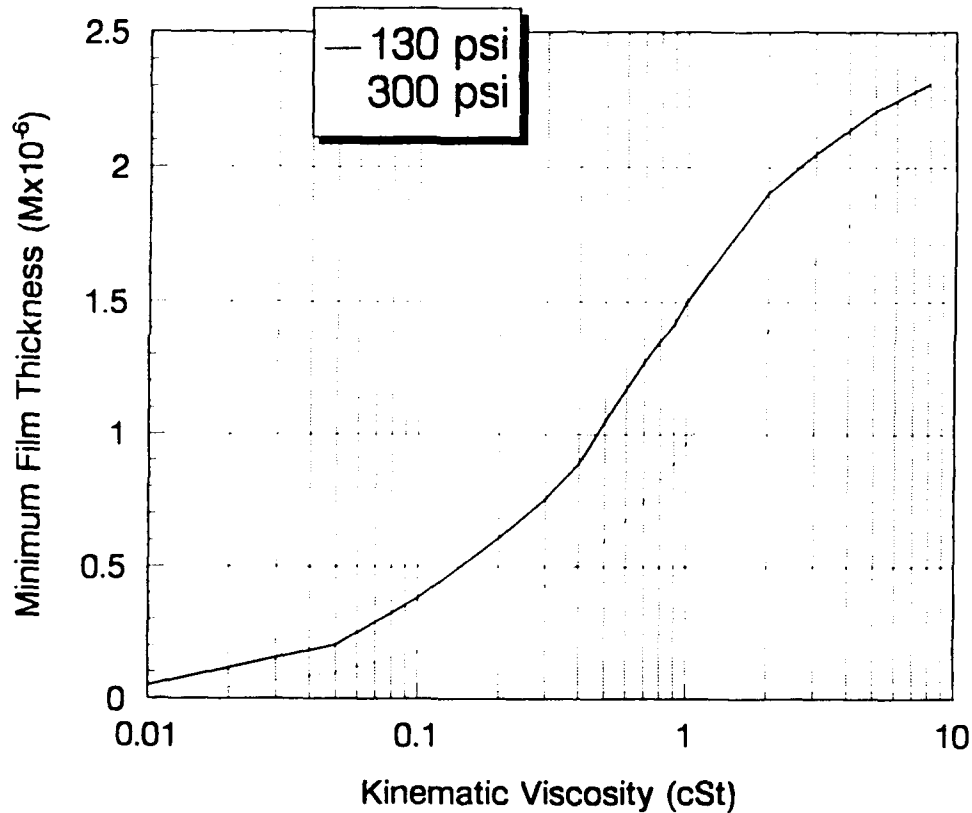
Figure 4. Minimum film thickness ( $h$ ) predicted to occur around the rotor of the Stanadyne DB2 pump at 1800 rpm

The calculated minimum film thickness (h) for the rotor on the Stanadyne DB2 pump is plotted in Fig. 4, as a function of kinematic viscosity. The results are plotted for a transfer pump pressure of 130 psi, which is the maximum recommended by Stanadyne.(34) The calculated minimum film thickness for a transfer pump pressure of 300 psi is also given, as this is the maximum pressure achieved in laboratory tests described later in the report. Low-speed operation will decrease the hydrodynamic film strength, however, a concomitant decrease in transfer pump pressure and resulting bearing load will occur under normal operation.

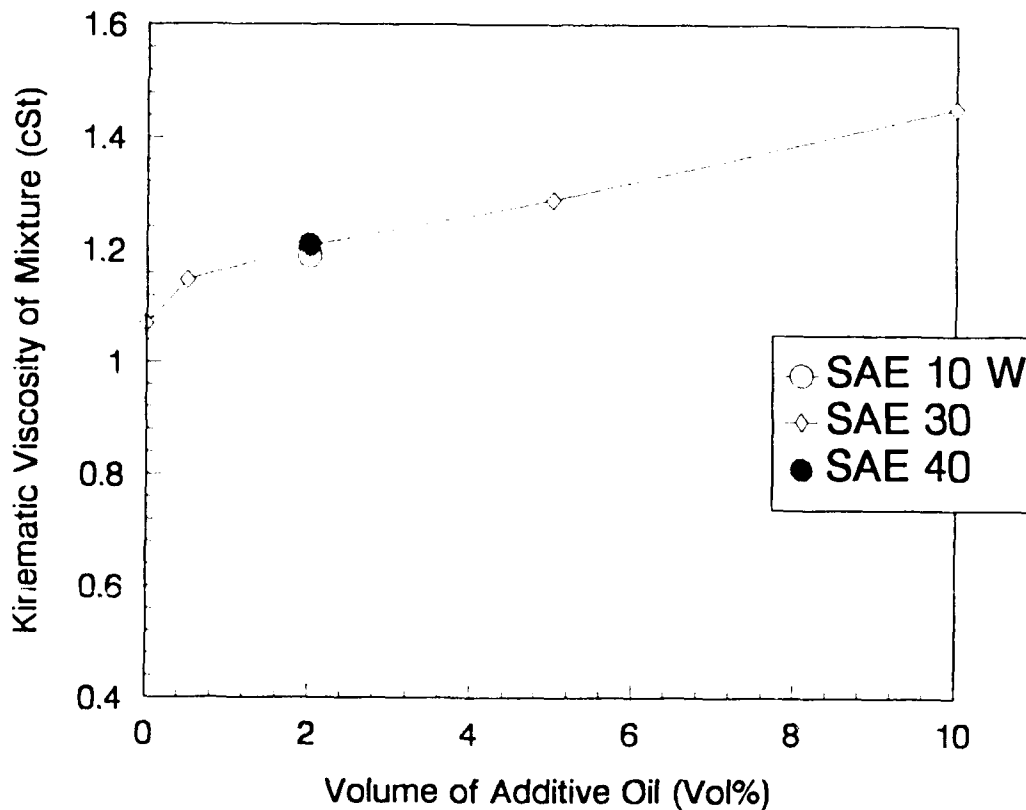
Figure 5. Kinematic viscosity of Jet A-1/engine oil mixtures

The addition of engine oils to the fuel will produce a slight increase in overall viscosity, as shown in Fig. 5. The net increase in hydrodynamic film thickness caused by the addition of reasonable concentrations (<5 vol%) is only a few percent. However, it should be recognized that the addition of such fluids may affect the inherent lubricity of the fuel.

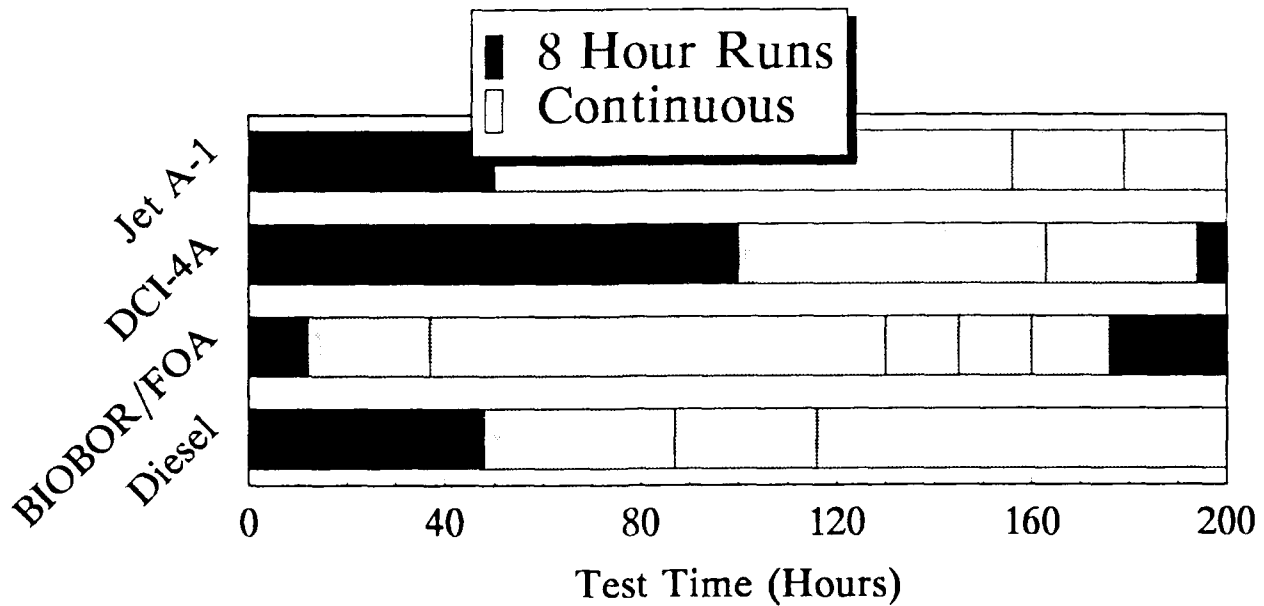
its 200-hour cycle is depicted in Fig. 6. The vertical lines denote a single halt in continuous operation, i.e., at weekends.

(Note: the vertical lines denote a single halt in continuous operation.)

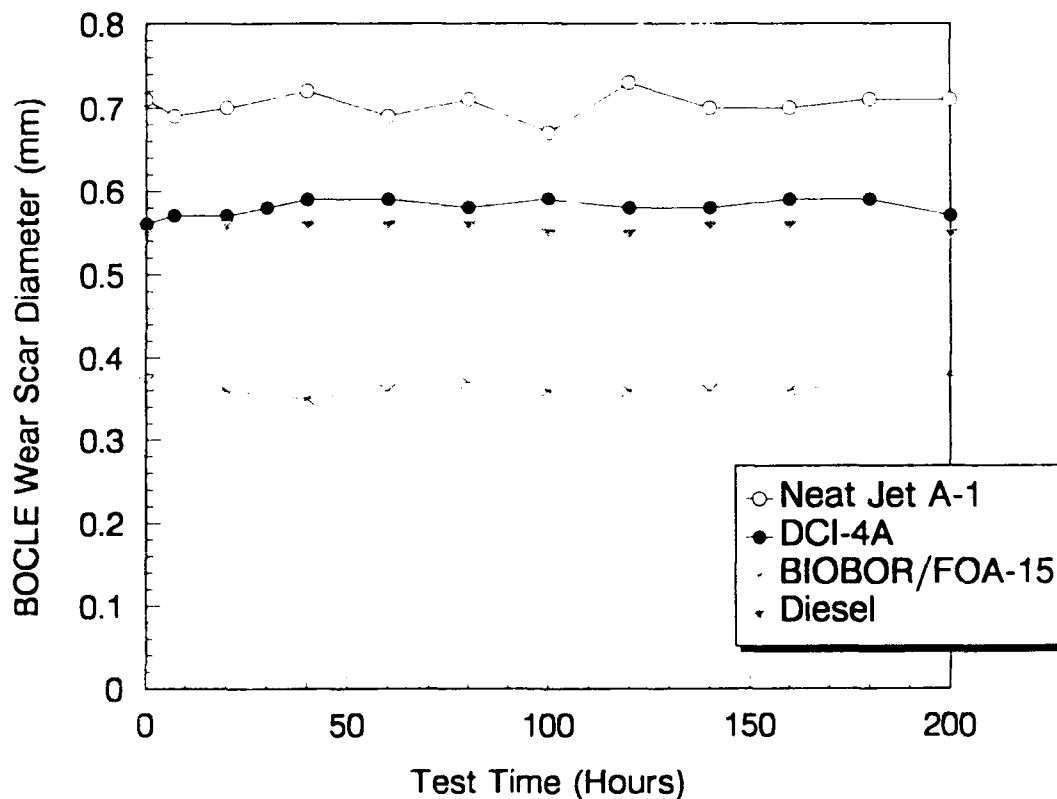
Figure 8. Fuel lubricity as a function of pump stand test duration

was clay treated continuously throughout the pump test to remove possible reactive products. Only the fuel that passed through the injectors was clay treated. The fuel return from the governor housing to the tank was not clay treated, as this is a normal function that exists on the vehicle. The additized Jet A-1 could not be continuously clay treated (NOTE: It was clay treated before use); however, reactive degradation products are less likely to have a measurable effect on better lubricity fuels. Nonetheless, samples of fuel were taken from the pump stand every 20 hours of testing and lubricity tests performed using the BOCLE. No variation in lubricity was observed for any test, as shown in Fig. 8. It is recognized that a once-through fuel cycle is the optimum solution, but was not practical for the present study.

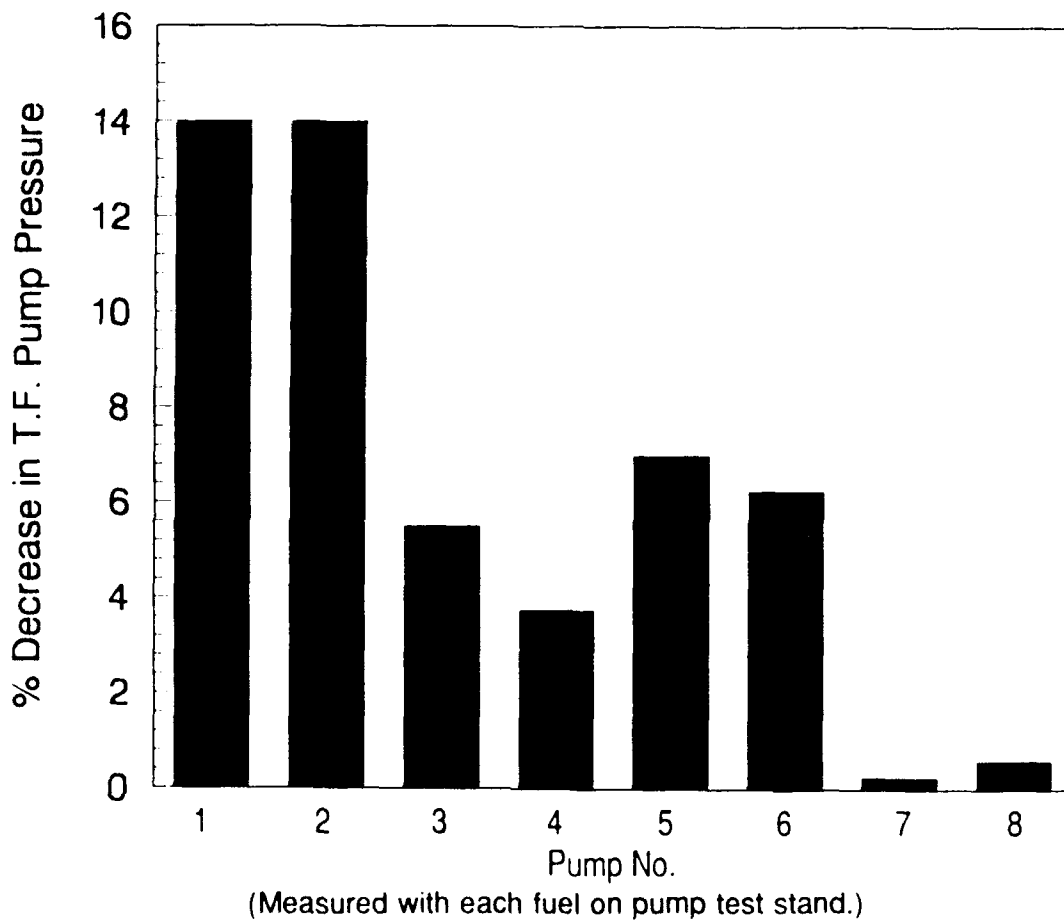
**Figure 9. Percentage change in transfer pump pressure**

The transfer pump pressures measured during each 200-hour test are shown in Appendix E and summarized in Fig. 9. This area of the pump has previously been observed to be affected by use of low-lubricity fuels.(20,21) A relatively large decrease in pressure occurred with neat Jet A-1, while the reduction was approximately halved by lubricity additives. Most variation

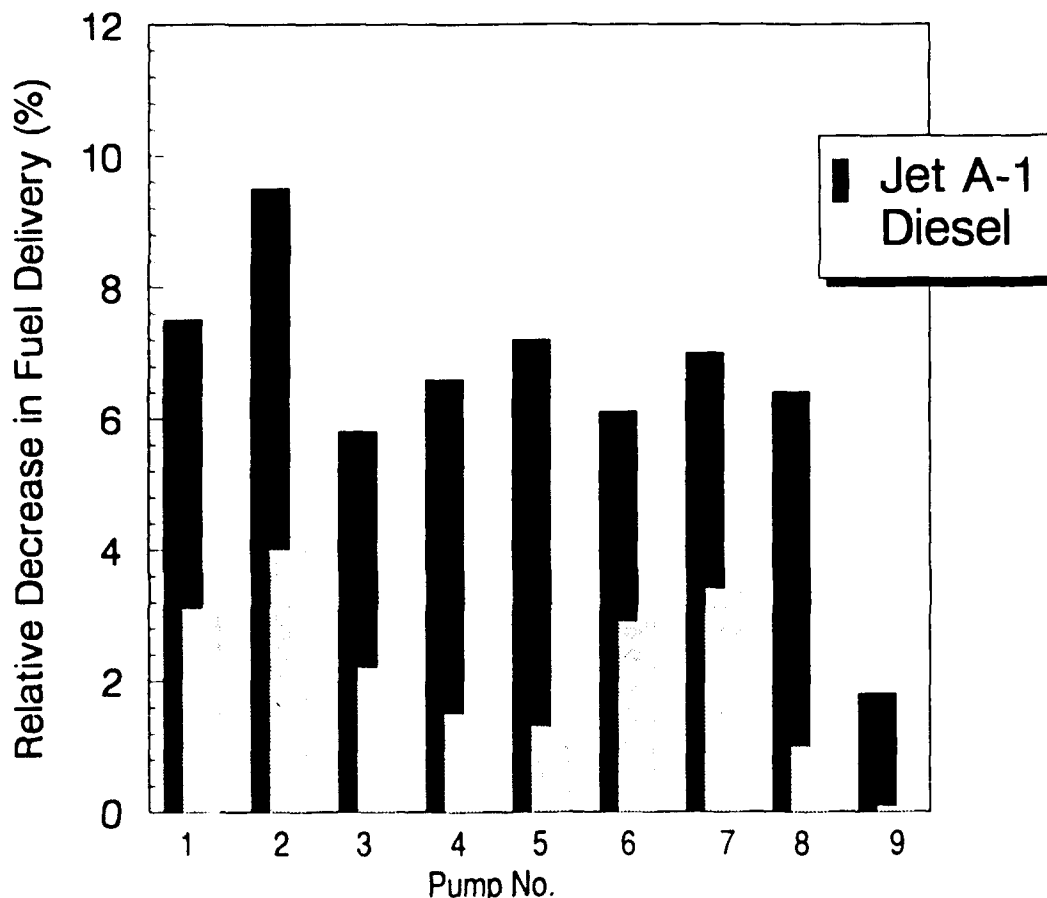
Figure 11. Decrease in pump delivery measured on engine test stand

The fuel delivery rate measured during the engine test for each pump is given in Appendix C. The decrease in pump delivery relative to the pretest value with the **same** fuel is summarized in Fig. 11. The fuel delivery with each of the tested pumps (Pump Nos. 1 to 8) is reduced by

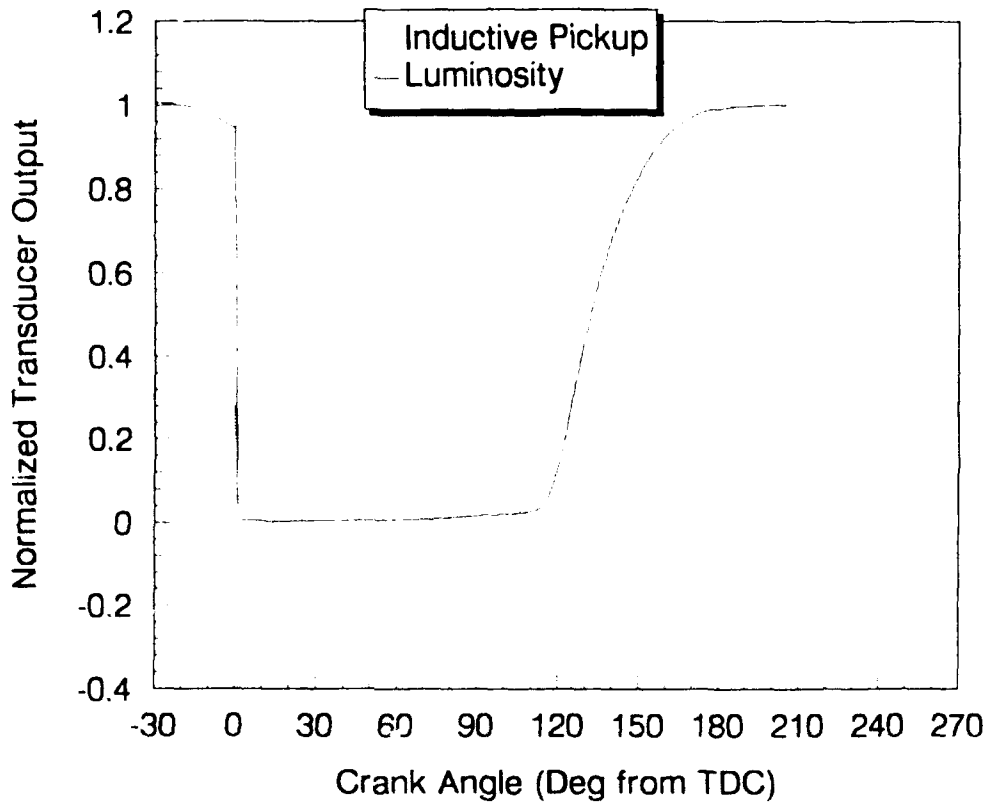
**Figure 12. Combustion luminosity**

*a. Pump No. 1 (Standard Pump/Neat Jet A-1)*

*b. Pump No. 9 (Reference Pump)*

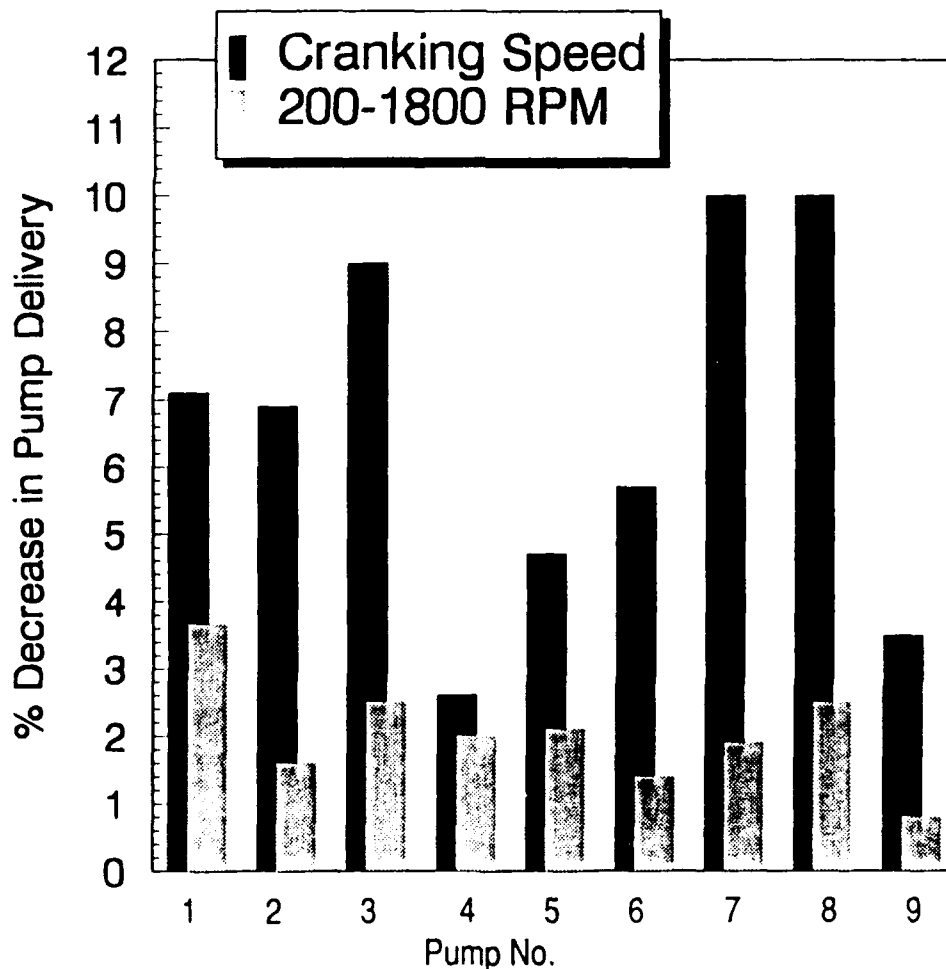
Figure 17. Percentage decrease in overall pump delivery on calibration stand

A decrease in overall pump delivery was observed for each pump, as summarized in Fig. 17. A smaller decrease in fuel flow was also reported for the reference pump (Pump No. 9), indicating a slight bias error in the results. As expected, the reduction in delivery at higher speeds (>200 pump rpm) is considerably less than that observed with Jet A-1 measured during the engine tests (Fig. 11). However, at cranking speed (150 pump rpm) pump delivery is down by an average of 5 percent. Such low-speed operation partially compensates for the increased viscosity of the test fluid and allows fuel to leak around the pumping mechanism. However, the

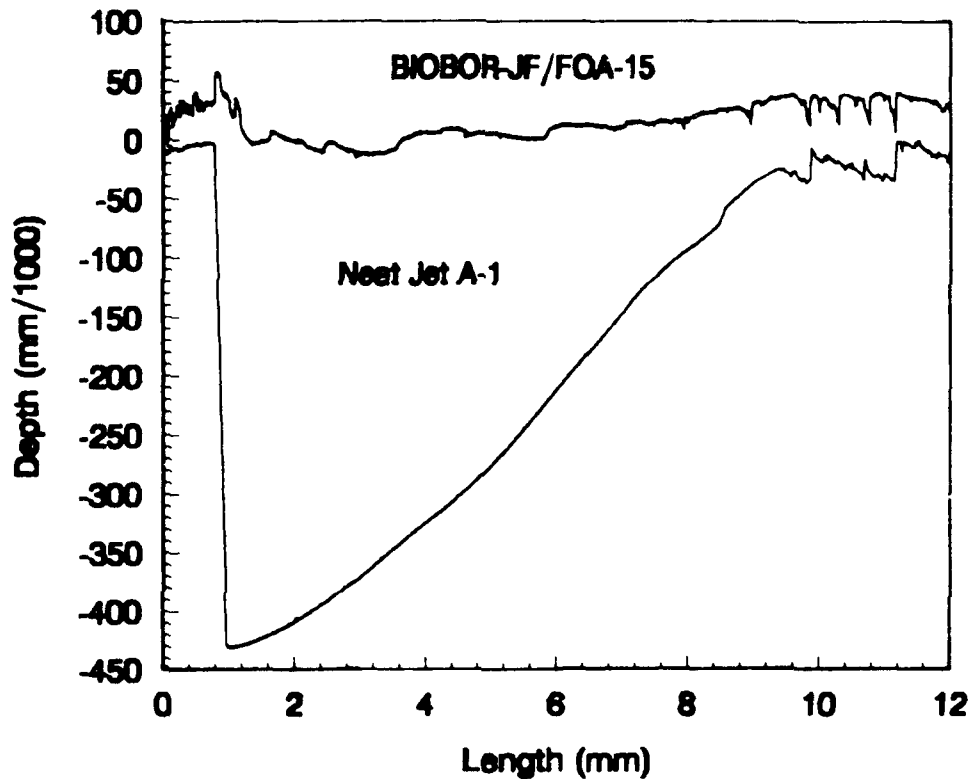
Figure 20. Surface profiles taken from the drive slot on standard pumps

Severe wear is present throughout the complete standard pump (Pump No. 1) that operated on neat Jet A-1. Particularly severe wear was present on highly loaded areas such as the drive tang and roller shoe when compared with tests performed with additized fuel. For comparison, Fig. 20 shows surface profiles taken across the sharp step formed at the edge of the wear scar on the drive slot with neat Jet A-1 and Jet A-1 containing the BIOBOR-JF/FOA-15 combination.

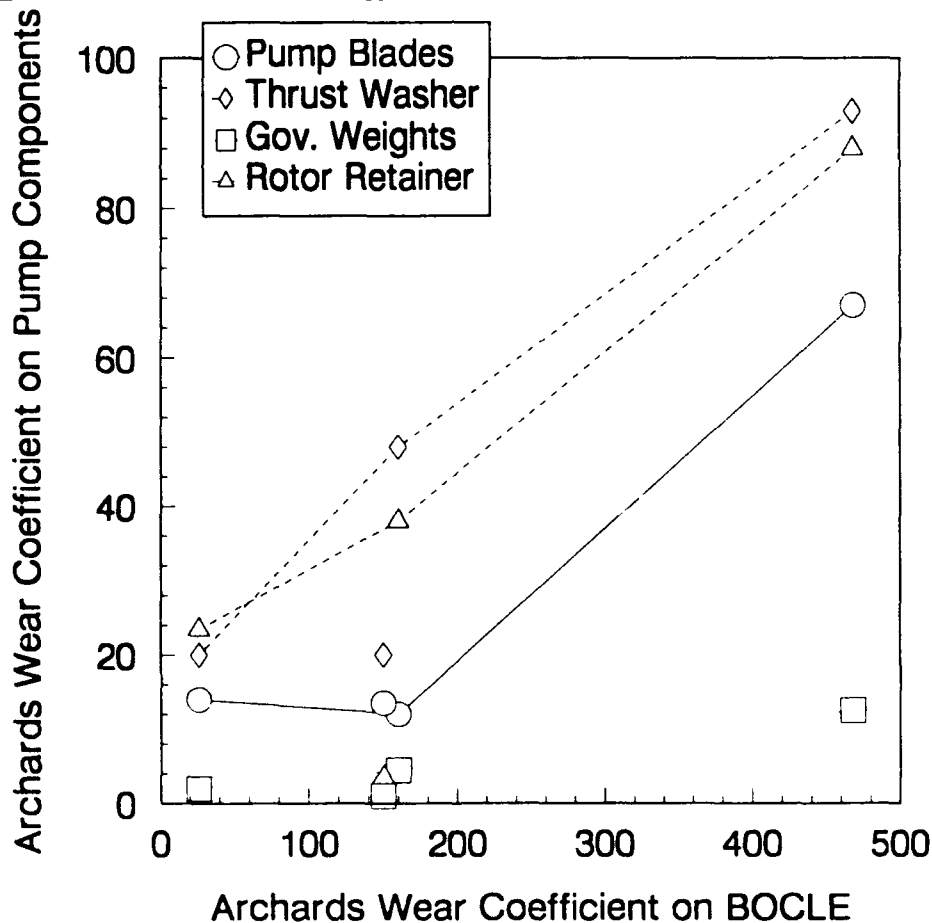
Figure 26. Correlation between BOCLE and wear measurements on lightly loaded components from pump stand tests

A detailed description of the calculation of Archards wear coefficient may be found in Appendix F. The results obtained are plotted in Figs. 26 and 27, for mild and severe contacts, respectively, as a function of the BOCLE results. Application of Archards equation reduces the relative difference between the wear of the components by approximately an order of magnitude, although a wide variation in wear still exists. Moreover, the wear coefficient observed for the lightly loaded components is several times less than that observed in the BOCLE. However, Archard himself noted that the constant  $K$  can vary widely with seemingly minor changes in test conditions.<sup>(37)</sup> The effects of metallurgy on corrosion resistance and the effects of surface

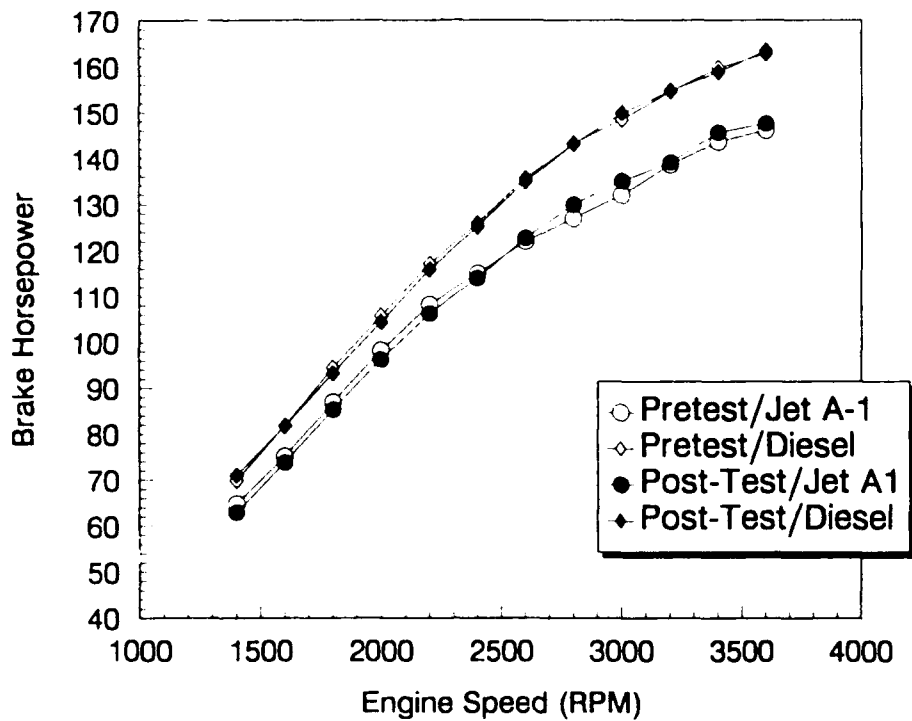
**Figure C-9. Engine power curves for Pump No. 9**

(Reference pump - standard unit, never tested on stand)
