# AIRFIELD PAVEMENT EVALUATION

KING SALMON  
AIRPORT,  
ALASKA

MARCH 1992

AIR FORCE CIVIL ENGINEERING SUPPORT AGENCY  
TYNDALL AIR FORCE BASE

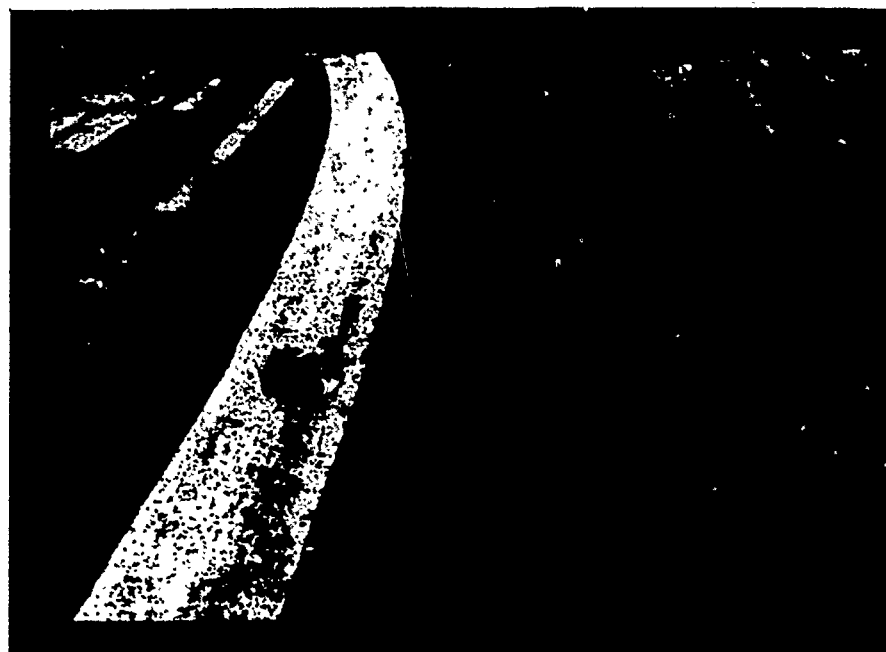
PHOTO 1 : BADLY DETERIORATED PAVEMENT ON THE NORTH END OF RUNWAY 18-36. PAVEMENT HAS ALLIGATOR AND BLOCK CRACKING.

4. Recommend jet aircraft not taxi up Runway 18-36 and across the overrun to Taxiway 4 because of the FOD hazard

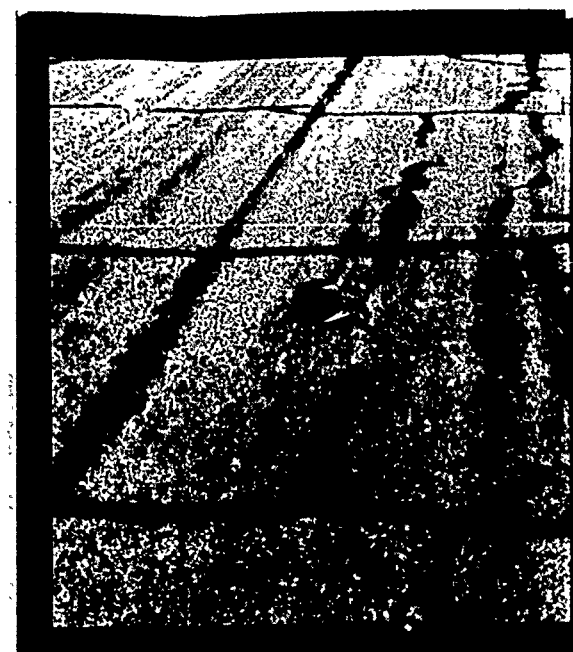
Taxiway 4 is in FAIR condition. The predominant distresses are low to medium severity block cracking, the beginning of alligator cracking, and slight rutting (Photo 2). Most of the cracks have been sealed, but the sealant is deteriorated or nonexistent in some areas. A utility patch crossing the taxiway near the Transient Apron is rutted and badly cracked, and needs to be repaired soon (Photo 3).

PHOTO 2 : BLOCK CRACKING, SHALLOW RUTS, AND THE BEGINNING OF ALLIGATOR CRACKS ON TAXIWAY 4.

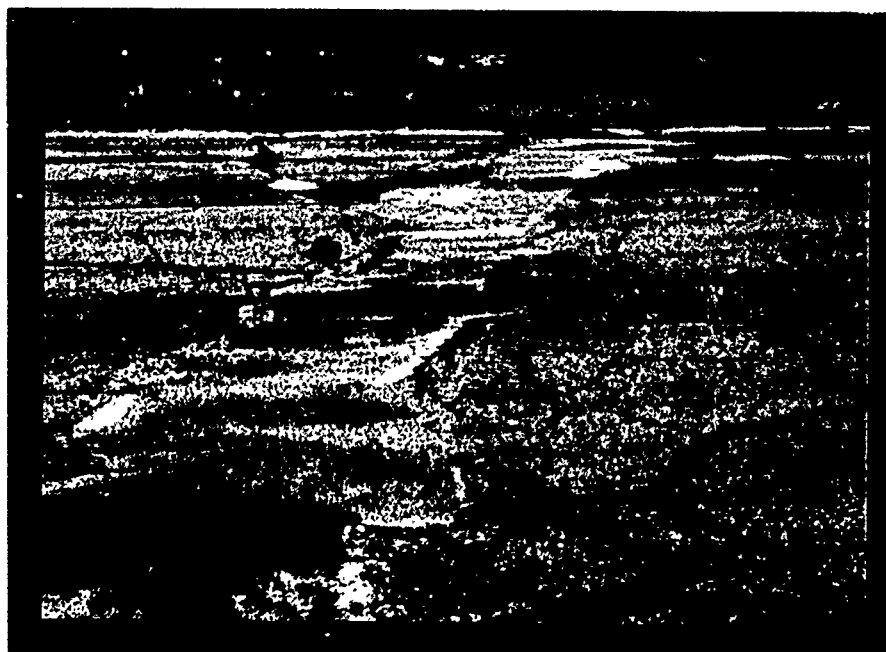
PHOTO 3 : RUTTED UTILITY PATCH ON TAXIWAY 4.

3. Recommend the utility patch on Taxiway 4 be repaired.

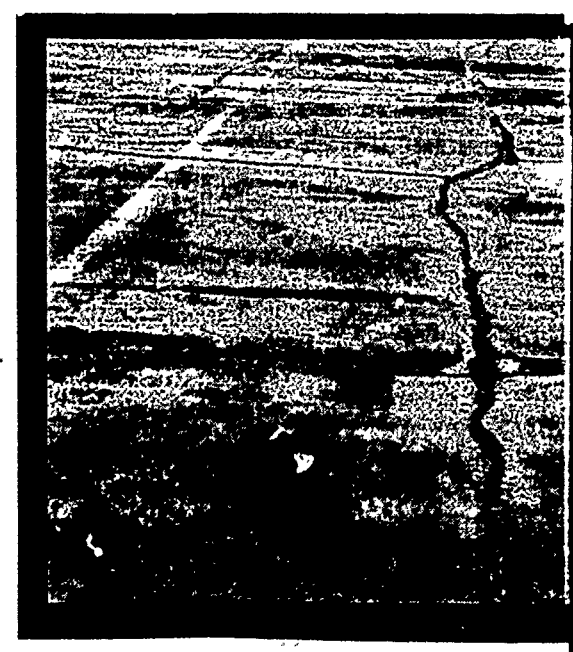
The asphalt portion of the Transient Apron is in FAIR condition, with longitudinal and transverse cracks of low to medium severity, and weathering (Photo 4). The PCC portion is in GOOD condition, with longitudinal cracks, some spalling of the joints and cracks, and sealant in moderate condition.

PHOTO 4 : SPALLING TRANSVERSE CRACK ON TRANSIENT APRON.

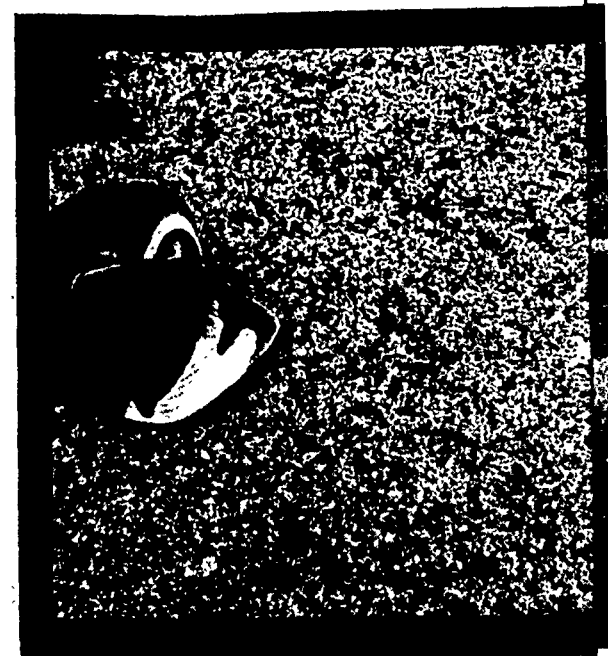
Taxiway 1 is in GOOD condition, with longitudinal and transverse cracks, and numerous voids in the surface where aggregate is missing (Photo 6). The cracks are well sealed. There is a large bird bath at the low spot of this taxiway near its junction with Taxiway 3 (Photo 7).

PHOTO 6 : VOIDS IN THE SURFACE OF THE PAVEMENT WHERE AGGREGATE IS MISSING. TYPICAL OF TAXIWAYS 1,2, AND 3.

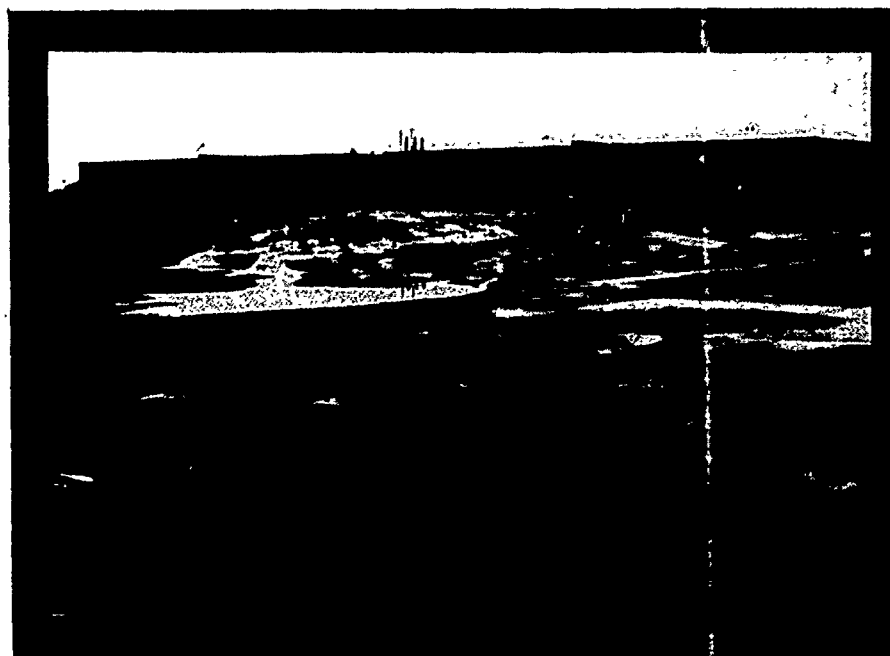
E. DRAINAGE. The storm drainage system (if any) was not observed during the evaluation. Most of the pavements are drained by surface runoff to shallow swales which lead to natural surface drainages at the airfield perimeter. Shallow puddles were observed near Taxiway 1 (Photo 7 in Appendix D), and other locations, after a rainfall.

PHOTO 7 : BIRD BATH AND SEALED CRACKS ON TAXIWAY 1.

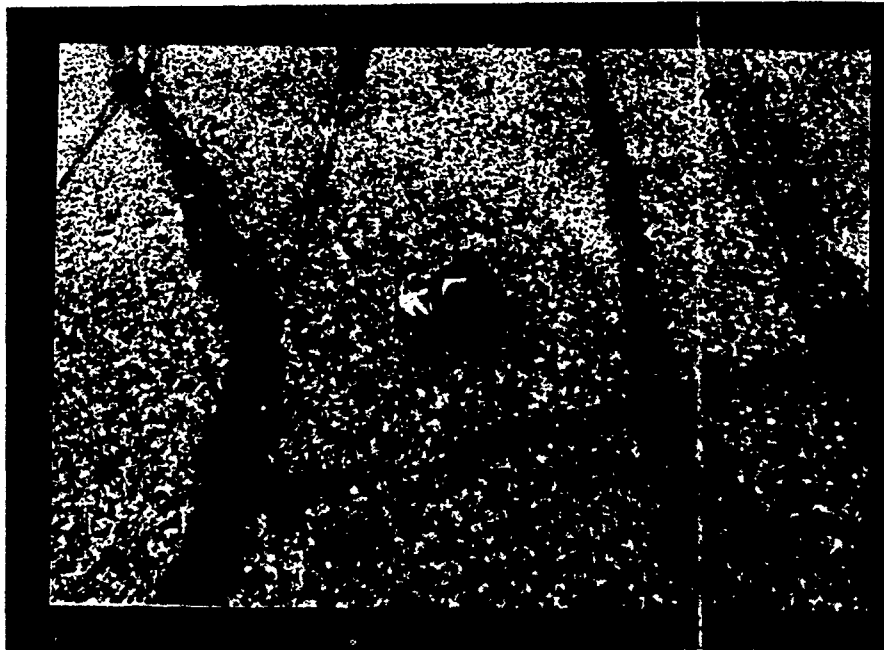
Runway 11-29 has PCC touchdown areas at each end. The 11 end is in FAIR condition, with longitudinal cracks, spalling joints, a few shattered slabs, and joint sealant in poor condition (Photos 8 and 10). Most of the cracks have been sealed and the distresses are low severity, but there are several cases of high severity spalling and medium severity cracks. The cement paste on the surface of some slabs has eroded away, exposing the coarse aggregate (Photo 9).

PHOTO 9 ; ERODED PCC PAVEMENT SURFACE WITH A TYPICAL LONGITUDINAL CRACK ON THE 11 END OF RUNWAY 11-29.

5. Recommend the PCC pavements be scheduled for a project consisting of spall repair, crack sealing, and joint seal replacement. The 11 end of Runway 11-29 is particularly in need of this type repair, but all of the PCC pavements at least need to have the joint sealant replaced within the next two years. The deterioration of the surface of some slabs on the 11 end of the runway should be monitored. If the condition continues to degrade, the affected slabs or the whole feature will have to be replaced.

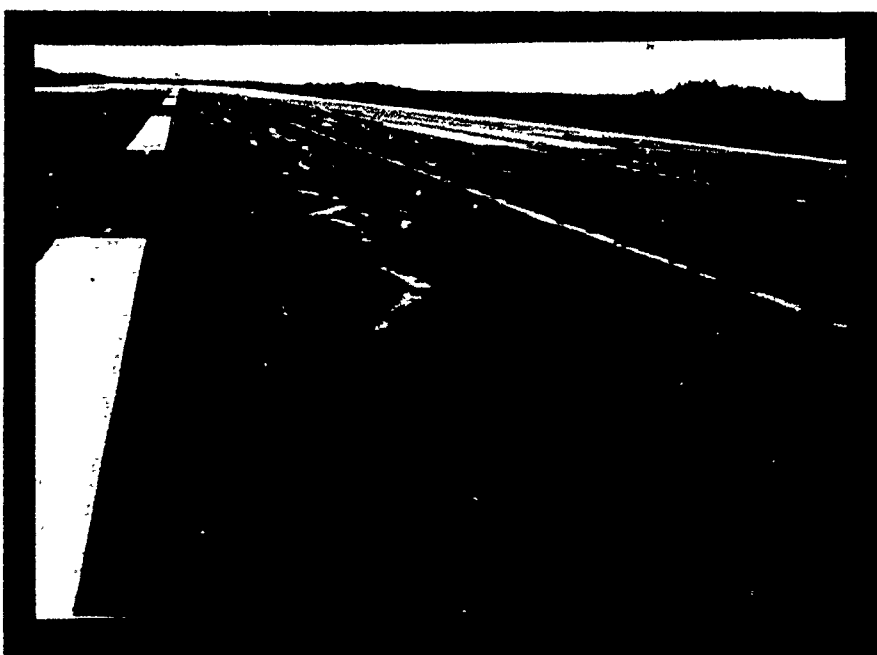
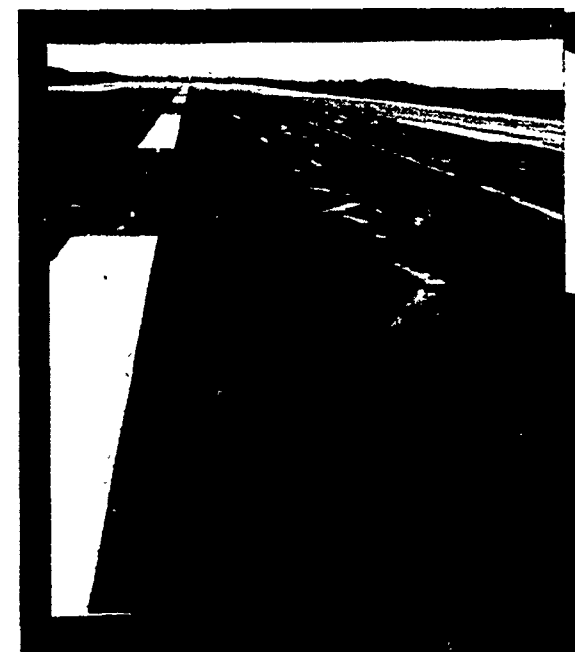
small area with raveled asphalt was observed about 1300 feet from the 11 end (Photo 11). The other half of the runway is in GOOD condition, with block cracking (Photo 12). Most of the asphalt cracks were sealed recently, which is one reason the condition rating is as good as it is.

PHOTO 12: TYPICAL BLOCK CRACKING ON THE RUNWAY. CRACKS HAVE BEEN SEALED.

1. The asphalt pavements should be maintained by sealing the new cracks each year and replacing existing sealant as needed. Crack sealing is very important because it increases pavement life and reduces the possibility of FOD damage to aircraft. Eventually the pavements will need to be resurfaced. For a resurfacing project, recommend as a minimum the existing surface be milled off to remove the old crack sealant and to smooth out the surface, followed by a two inch thick overlay. Severe cracks should be repaired prior to the overlay. With this type of repair, reflective cracks are likely to appear within a few years, and must be sealed at that time. A better option, although more expensive, is to remove all of the asphalt pavement and replace it with new or recycled asphalt. The pavement will then be likely to last as much as five years before cracking begins if the right grade of asphalt cement is used and the pavement is constructed properly.
