AFWAL-YR-88-4047

19. ABSTRACT (Continue on reverse if necessary and identify by block number)			
This program sought basic information about the behavior of coated superalloys versus strain-temperature history in high-temperature, thermal-mechanical exposure. The test plan was based on the observation that test cycle shape strongly impacts the thermal-mechanical-fatigue (TMF) behavior. We found that increasing $T_{max}$ of the Type 1 cycle from 1900 to 2100°F shortened the initiation period for TMF cracking and reduced cycles to specimen failure by about 30 to 50 percent. A more radical change in cycle shape, namely a four-sided shaped cycle, was less mechanically damaging (a factor of two) but more severely oxidizing than Type 1 cycles between the same temperature and strain limits. Cyclic speed experiments showed that crack initiation and cycles-to-failure data were not strongly sensitive to testing speed in the range of 1 to 4 cycles per minute. Lower $N_f$ values for slow speed tests are believed to reflect crack growth in the substrate rather than coating effects. Shut-down steps and hold times at $T_{max}$ and during cool-down from $T_{max}$ generally decreased $N_f$ values.

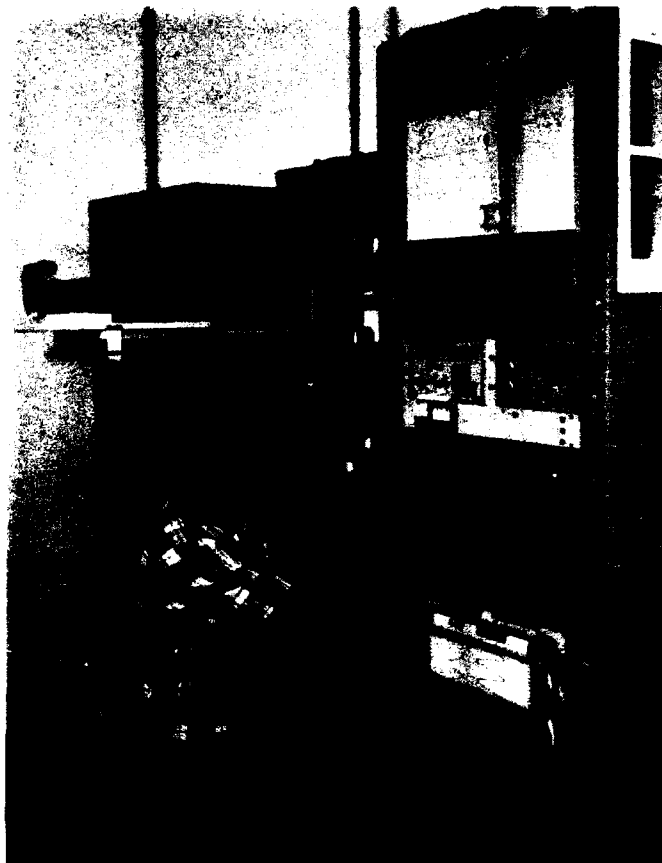
*Figure 4. Load Controlled Thermal Mechanical Fatigue Test Machine*

The extensive testing and experimentation required in this program are rendered cost effective by the load-adjusted thermal mechanical fatigue test described in references 8 and 10. The test equipment is a conventional low cycle fatigue test machine (Figure 4) modified to simultaneously ramp and control temperature. The machine contains two electronically controlled servosystems. One is a hydraulic system for closed-loop control of load, strain, or displacement; the other servosystem is used concurrently for closed-loop control of specimen temperature. The command waveforms for each parameter are independent and can be programmed to conduct any load-temperature cycle within the ramp rate capacity of the hydraulic and thermal servosystems.

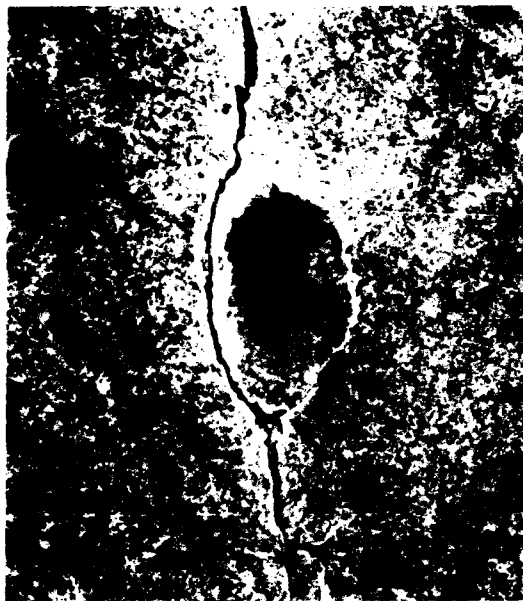
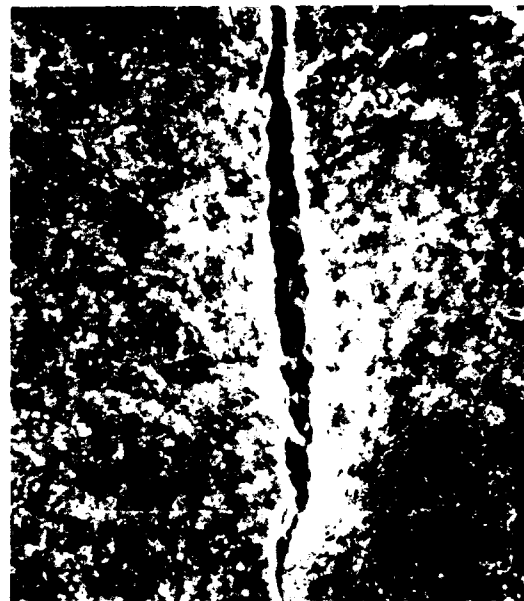
*Figure 11. TMF Cracks in EB-PVD NiCoCrAlY (Exposure Time = 500 Cycles)*

Since cracking was extensive after 1000 cycles, the next two samples were characterized after 500. Cracking of the EB-PVD coating at this point is illustrated in Figure 11. The cracks were short ( $<1$  mm), wavy, and relatively wide in the center. Some were initiated at corn kernels, while others were not readily traced to structural defects.

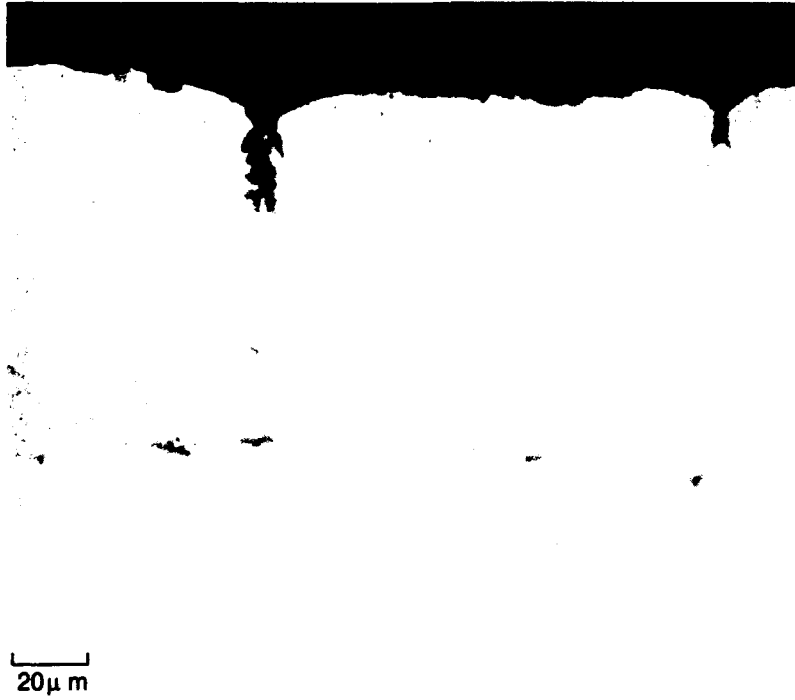
FD 357888

*Figure 13. TMF Cracks in LPPS NiCoCrAlY After 1000 Cycles*

For LPPS NiCoCrAlY (PWA 276) of the same nominal composition, no cracks were detected by binocular microscope, SEM, or metallography after 500 cycles. At 1000 cycles, cracking was discernable by careful binocular microscope examination, although the cracks were not nearly as evident as those on EB-PVD NiCoCrAlY after the same cyclic exposure. Again the cracks appeared relatively wide in polished cross sections (Figure 13), but none were observed to penetrate the coating. Scanning microscopy of the crack tip suggested a tendency to follow grain boundaries and  $\gamma - \beta$  interfaces (Figure 14).

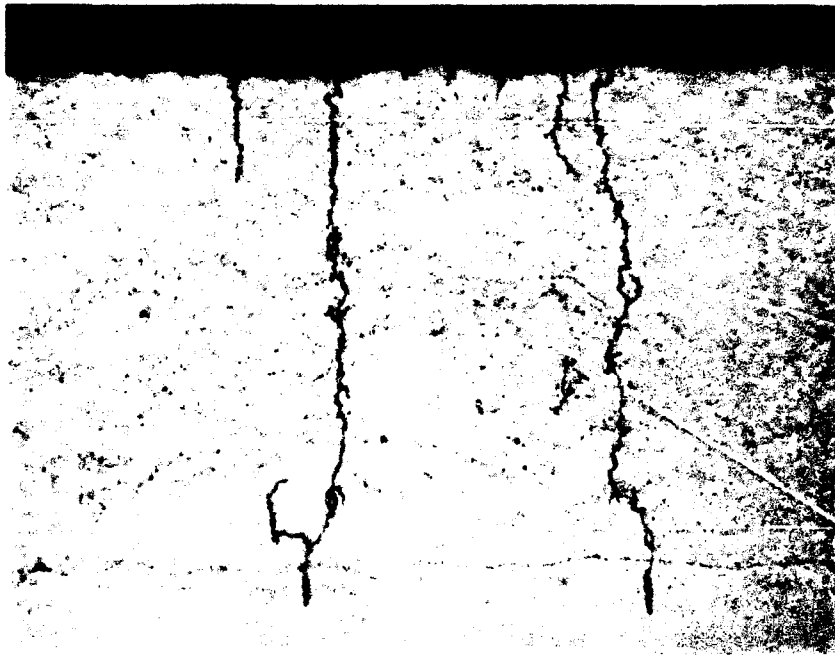
*Figure 17. Variation in Microstructure and Crack Morphology Due to Temperature Gradient Between Radius and Center Gage*

Continuing the microstructural characterization, Figure 17 shows coarsening of the coating microstructure in center gage in comparison with the cooler section toward the threads. The extent of microstructural change is noticeable but not drastic, and it is apparent that cracking can also occur in areas which experienced negligible effects of time-at-temperature exposure.

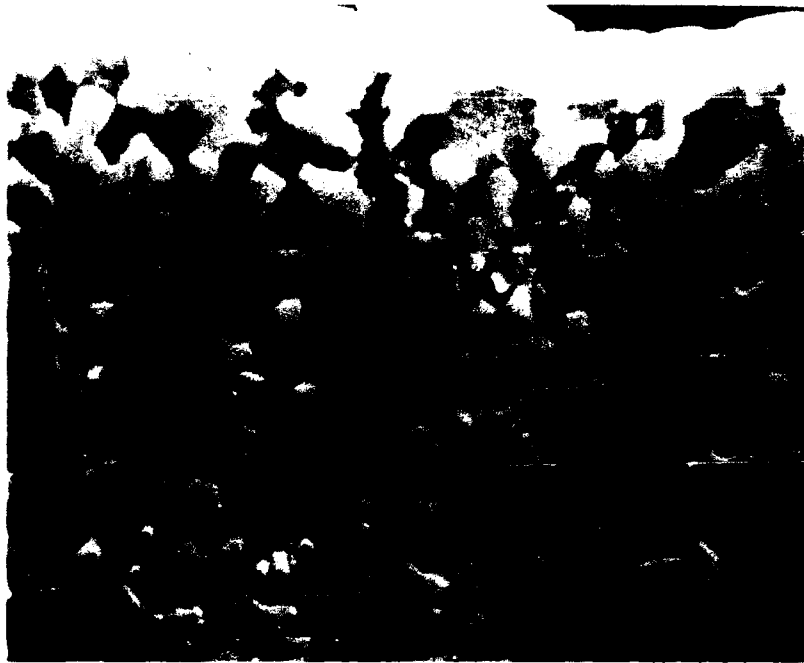
*Figure 18. SEM Characterization of Secondary Crack in Gage Section*

Scanning microscopy of a short secondary crack about halfway between center gage and the radius indicated it was completely surrounded by  $\gamma$  phase (Figure 18a), and the crack seems to stop at an area of  $\beta$  (Figure 18b). However it is difficult to find a continuous  $\gamma$  path of comparable length, suggesting that transformation of  $\beta$  to  $\gamma$  occurred either during crack growth or due to oxidation of the crack surface.

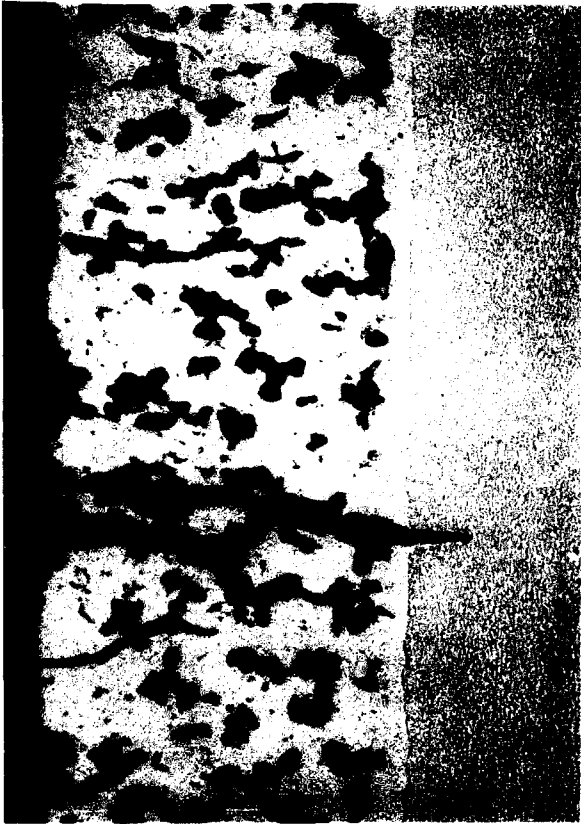
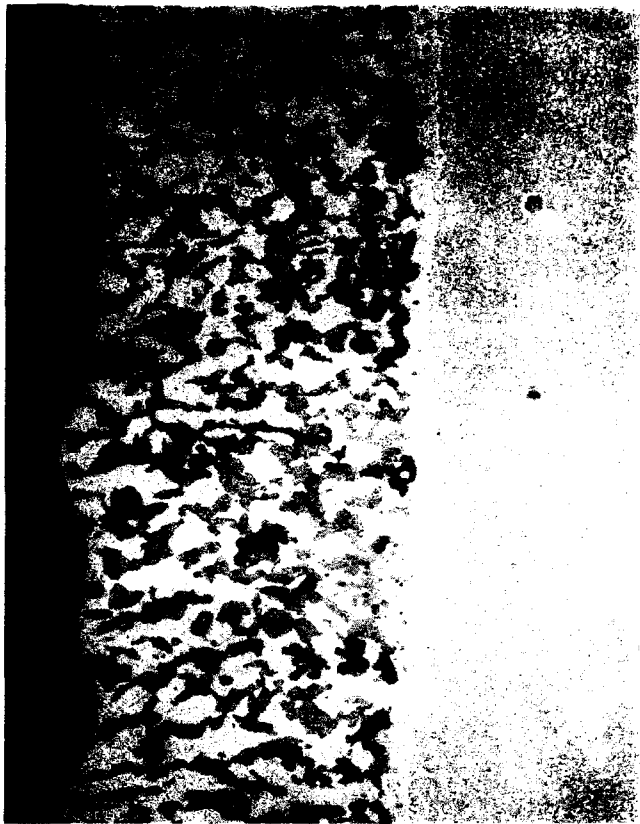
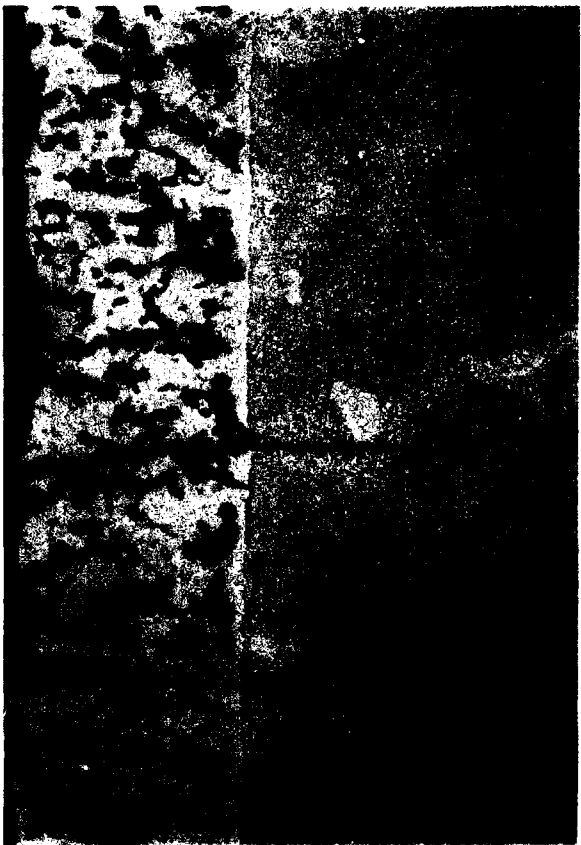
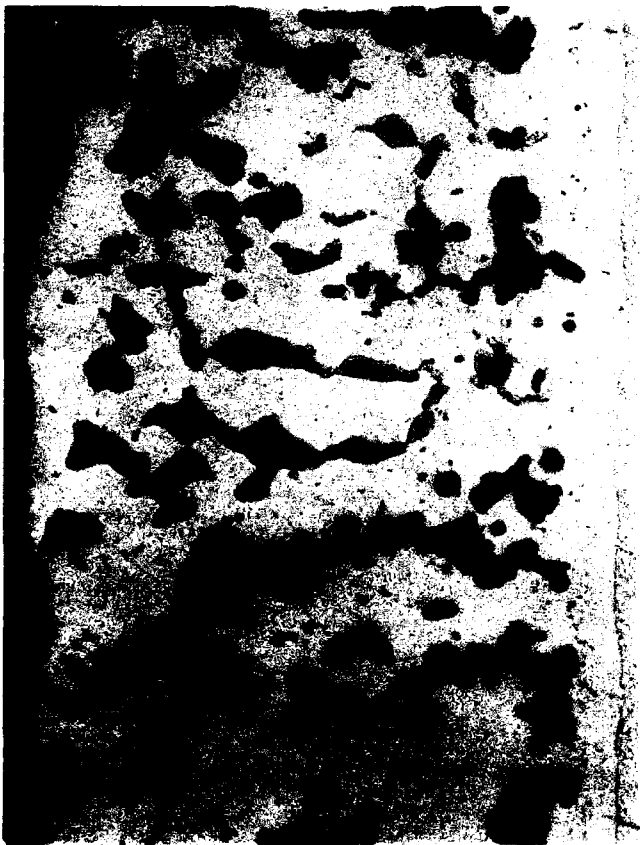
Figure 38. Microstructures of LPPS NiCoCrAlY After 12,842 Quad TMF Cycles

Figure 38 includes degradation microstructures near center gage (a, b, c) and in the less affected areas toward the radius. The  $\beta$ -NiAl phase is almost completely dissolved and/or preferentially oxidized at center gage. However, the substrate interdiffusion zone is very thin (about  $10\ \mu\text{m}$ ), indicating that the microstructural changes are primarily due to loss of aluminum to the surface. Also, in spite of the selective  $\beta$  consumption and aluminum depletion, bulk oxidation of the degraded coating material is minimal.

The oxidation morphology observed in this test is not typical of unstressed exposure, e.g., furnace cyclic or burner rig oxidation, or of isothermal oxidation under load (as in a creep or stress rupture test). Similar features had been observed, however, in  $\beta$ -NiCrAlY and diffusion aluminide coatings exposed to triangle- and dipper-shaped cycles in a previous program (ref. 10). Since the degradation microstructure of these high-aluminum coatings had been found particularly sensitive to the change from type 1 to open cycles, it was decided to run the quad on an hourglass sample of aluminized 1480 for comparison with the unexpected oxidation mechanism of the NiCoCrAlY.

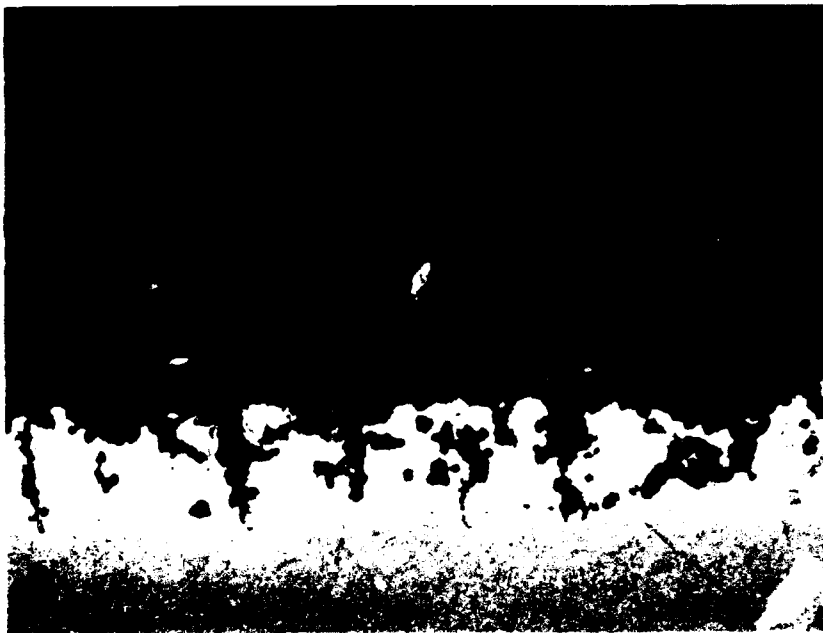
*Figure 47. Bond Coat Oxidation in JTDE 2nd-Stage Vane After 4235 TAC's*

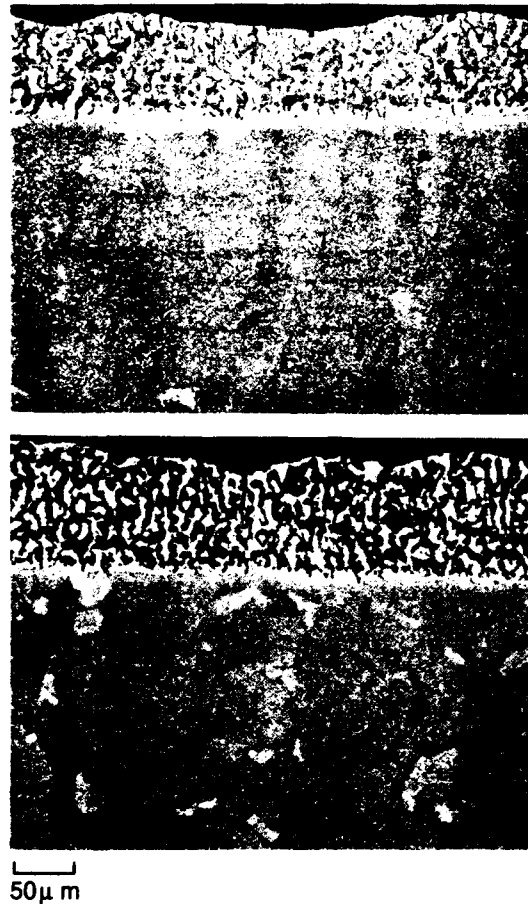
*Figure 53. Longitudinal Section of the Lathe-Polished and As-Tumbled TMF Samples shown in Figure 52*

Center gage microstructures are illustrated in Figure 53. Neither sample is extensively cracked on the plane of polish, although there are numerous sites on the as-tumbled specimen where cracks are about to develop. The depth of rumpling and the spacing between peaks of the rumples appears comparable on both samples.

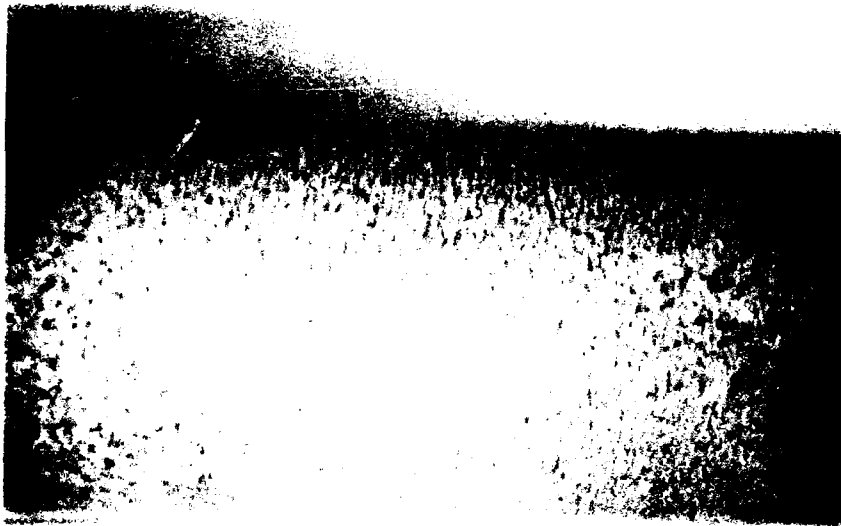
*Figure 58. Surface Condition of Quad Cycle TMF Specimen for Acoustic Emission Ductility Testing (Exposure Time = 3030 Cycles)*

A specimen for ductility testing was exposed to 3030 quad cycles. The TMF exposure resulted in surface rumpling as illustrated in Figure 58. Numerous fine cracks in the oxide scale were evident on binocular microscope inspection, but none appeared to extend into the bulk coating material.

On tensile ductility testing of the TMF-exposed specimen, acoustic emissions were encountered at approximately the same strain as observed for the as-processed material, and those in the gage section were more widely spaced than those near the radius. Rumppling of the coating was evident in a longitudinal cross section, but the tensile cracks did not form in the valleys of the rumples.

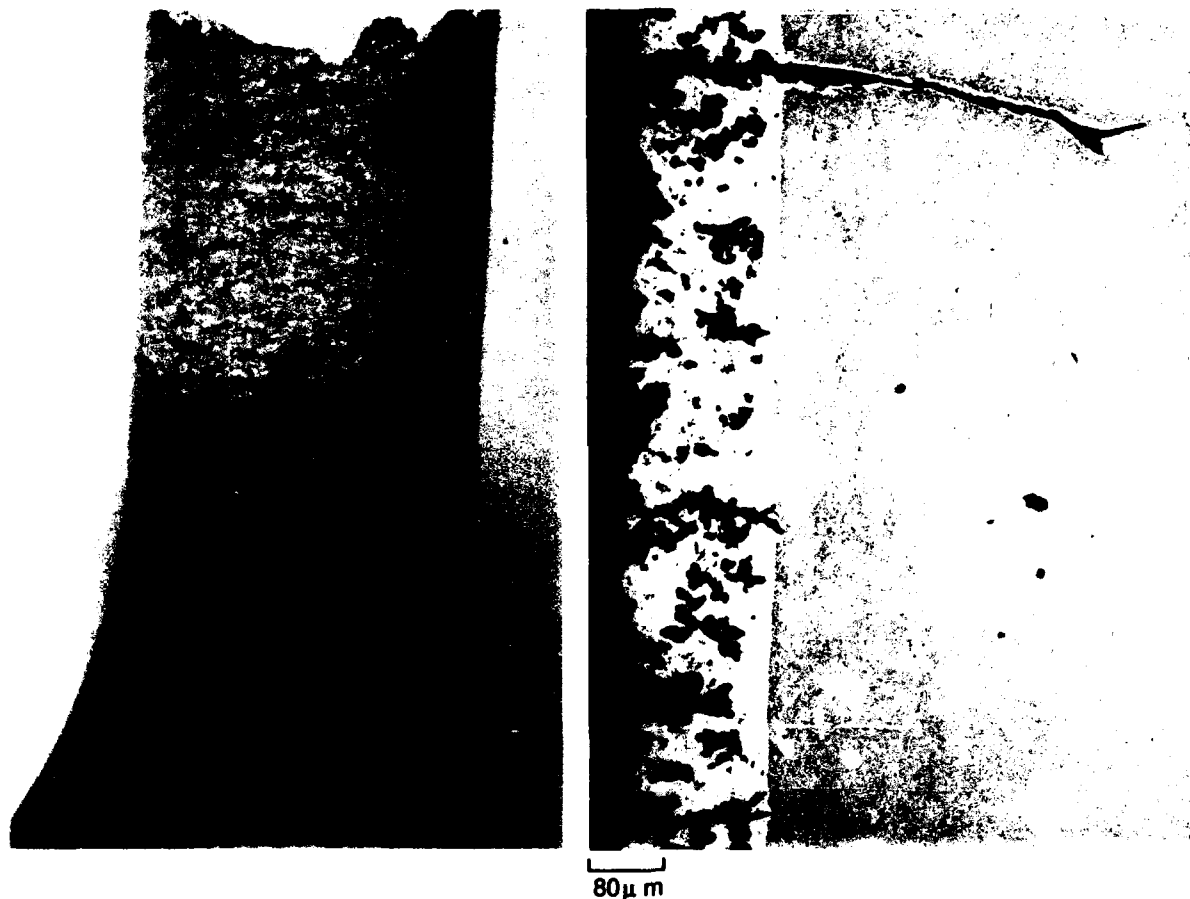
Figure 60. Surface Condition and Longitudinal Microstructure of Quad Cycle ( $-0.1\%/800^{\circ}\text{F}$ ,  $-0.6\%/1800^{\circ}\text{F}$ ,  $-0.3\%/2000^{\circ}\text{F}$ ,  $+0.1\%/1280^{\circ}\text{F}$ ) TMF Specimen (1/4 Cycle per Minute, Cycles to Failure = 10,579)

The surface condition and center gage microstructure of the 1/4 cpm sample are shown in Figure 60. The coating is heavily rumpled, and the microstructure of the hot zone is almost completely devoid of  $\beta$ -NiAl. As in the previously studied quad cycle specimens, however, the interdiffusion zone is thin, indicating that most of the  $\beta$  phase was consumed by surface connected oxidation rather than coating/substrate interdiffusion. The extent of  $\beta$  loss is slightly greater than at faster testing speeds, although there is no evidence that the microstructural effect significantly influenced mechanism of crack initiation/propagation in the coating.

Initial work in this task was documentation of cycle speed effect over a wider temperature range. Tests at 1/4 cpm, i.e., 4 minutes to traverse the quad, and 1/2 cpm failed in 10,579 and 11,473 cycles, respectively (versus 12,842 at 1 cpm).
