MICROSTRUCTURE-BASED FATIGUE LIFE PREDICTION METHODS FOR NAVAL STEEL STRUCTURES

K. S. Chan
D. L. Davidson
R. C. McClung

FIRST ANNUAL REPORT
July 15, 1991-July 15, 1992
SwRI Project No. 06-4414
ONR Contract No. N00014-91-C-0214

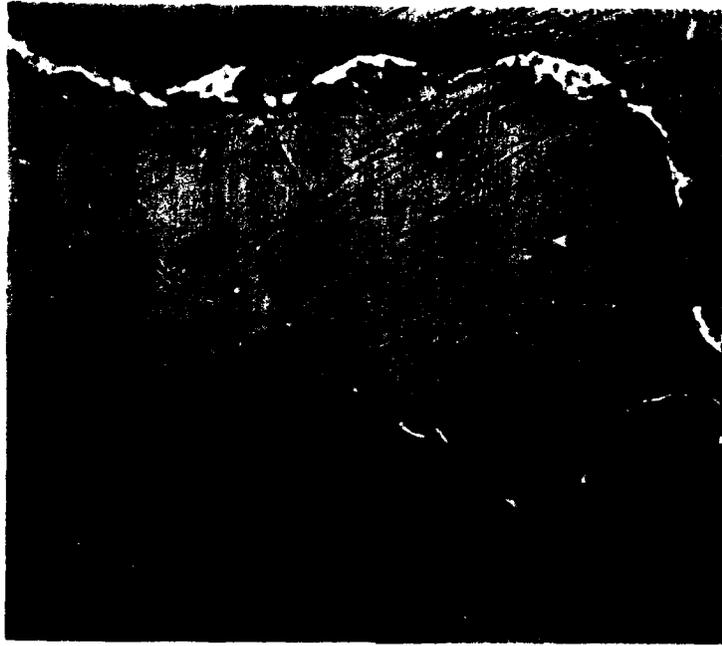
Figure 17. Crack path in relationship to microstructure, HT#2, sp. 357 after 110 kcy. Before and after etching. Stress axis vertical.
